Road Inventory and Condition Assessment

Pu'ukohola Heiau National Historic Site PUHE

Cycle 5 Report

**Prepared By: Federal Highway Administration
Road Inventory Program (RIP)
Data Collected: 04/2014
Report Date: 11/2014**

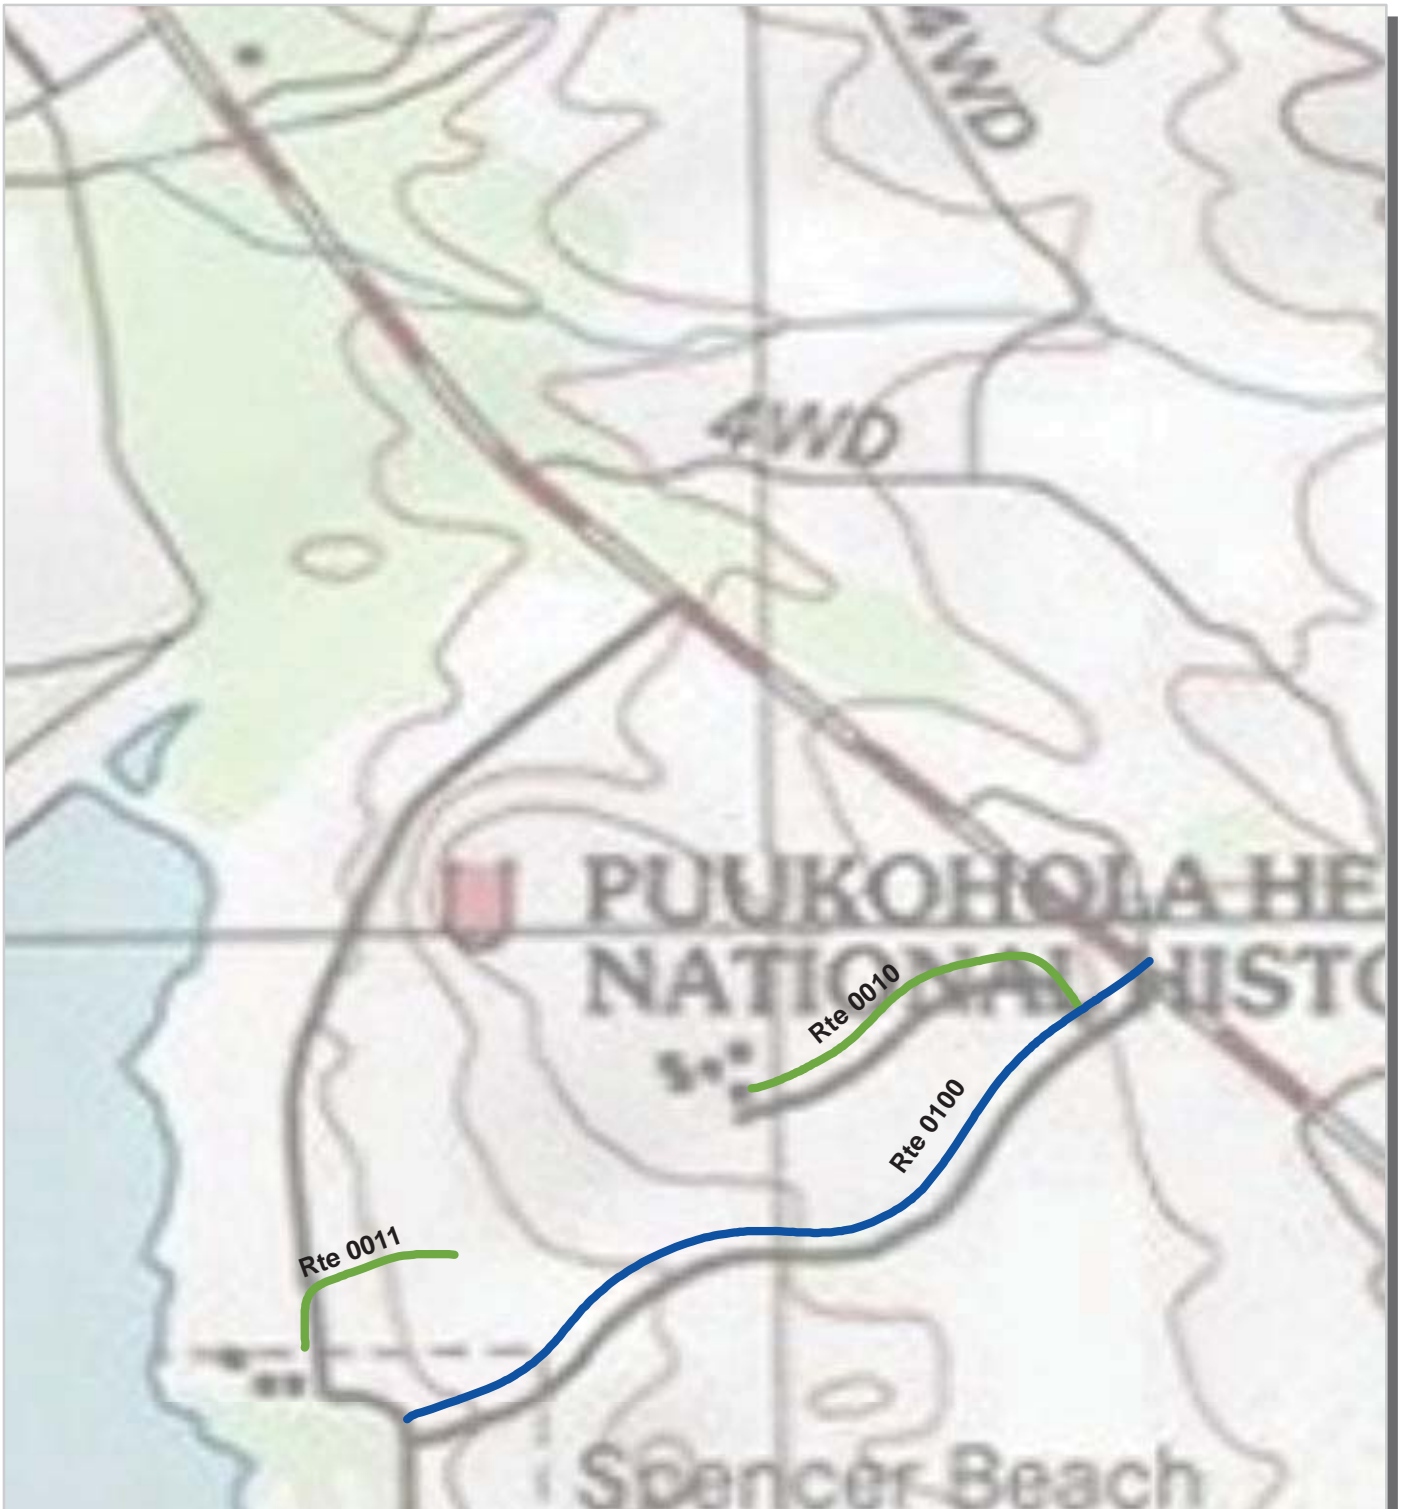
**Pu'ukohola Heiau National Historic Site
Route Condition Map
PCR - Mile by Mile
Area 1**

PCR	Poor		Fair		Good		Excellent		No Data	
	(0 - 60)		(61 - 84)	(85 - 94)	(95 - 100)

* If the PCR rating is not available for a section, the SCR rating will be displayed. See appendix for definitions and formulas.

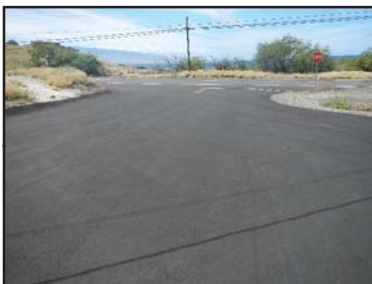
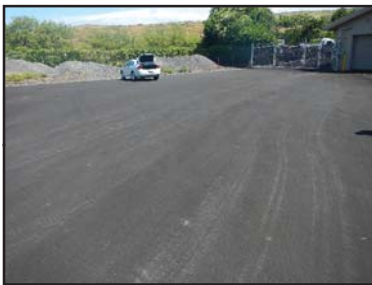
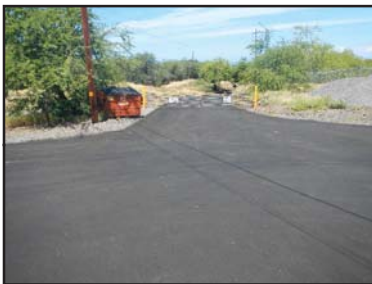
Inspection Date	FMSS Number	User Access	Surface Type
4/8/2014	108666	PUBLIC	ASPHALT
Area (Sq. Ft.)	Lane Miles (11' Widths)	Curb Reveal (Inches)	Curb Recommendation
10,301	0.18	NOT APPLICABLE	N/A
Curb Type		Curb & Gutter Type	
NO CURB		NO CURB AND GUTTER	
Culverts	Drop Inlets	Gates	
0	0	2	
Pavement Recommendation		Condition Rating / PCR	
PREVENTIVE MAINTENANCE		GOOD / 90

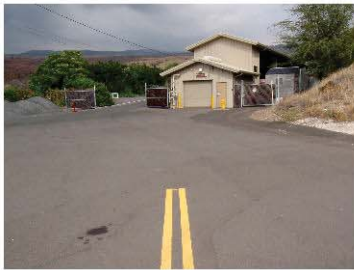
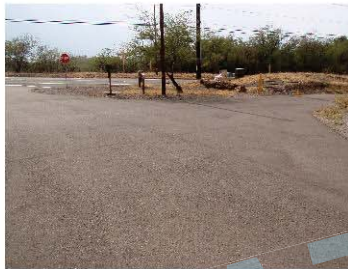
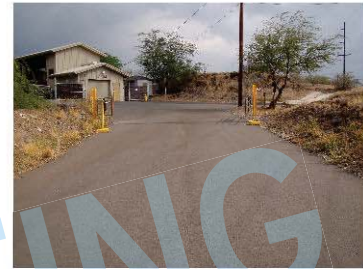
2012 RATING

Route Number	Public / Non Public	Date Visited	Area (sq ft)	Lane Miles *	Surface Type
0400	NONPUBLIC	1/19/2012	10301	0.177	AS
Culverts	Drop Inlets	Gates	Curb & Gutter	Curb	PCR
0	0	2	NO	NO	90 GOOD

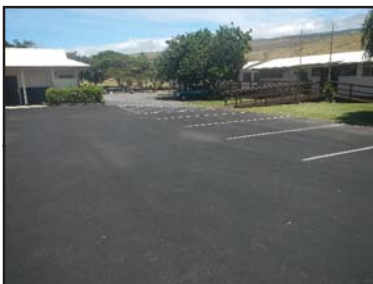
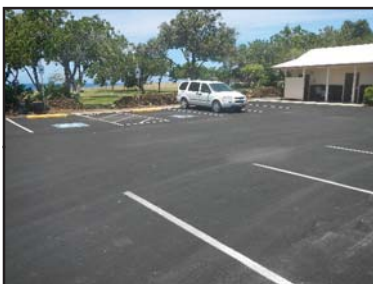
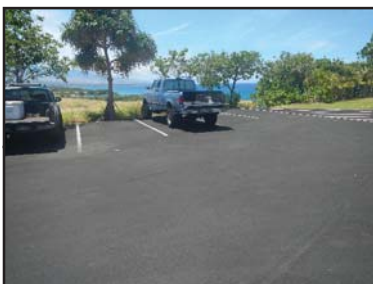
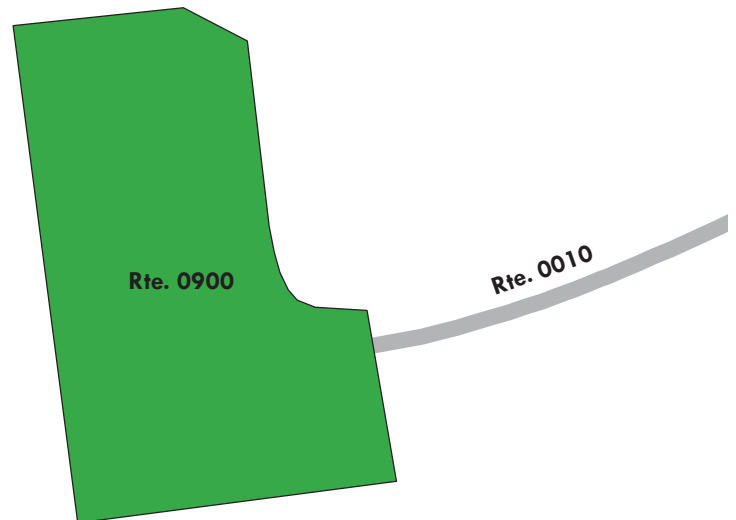
Inspection Date	FMSS Number	User Access	Surface Type						
4/8/2014	104734	PUBLIC	ASPHALT						
Area (Sq. Ft.)	Lane Miles (11' Widths)	Curb Reveal (Inches)	Curb Recommendation						
8,243	0.14	NOT APPLICABLE	N/A						
Curb Type		Curb & Gutter Type							
NO CURB		NO CURB AND GUTTER							
Culverts	Drop Inlets	Gates							
0	0	0							
Pavement Recommendation		Condition Rating / PCR							
PREVENTIVE MAINTENANCE		GOOD / 90							
Route Condition Legend – Pavement Condition Rating (PCR)									
Poor	(0 - 60)	Fair	(61 - 84)	Good	(85 - 94)	Excellent	(95 - 100)	Not Rated	
See Appendix for definitions and formulas

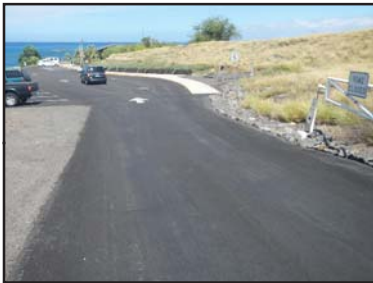
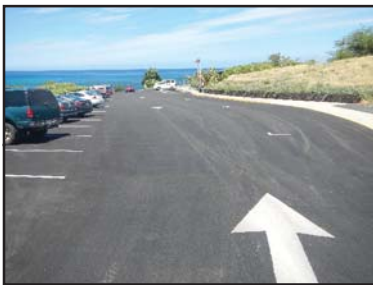
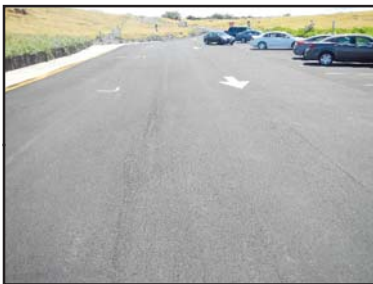
ROUTE 0901: VISITOR CENTER PARKING LOT

Inspection Date	FMSS Number	User Access	Surface Type
4/8/2014	108664	PUBLIC	ASPHALT
Area (Sq. Ft.)	Lane Miles (11' Widths)	Curb Reveal (Inches)	Curb Recommendation
18,796	0.32	5	DO NOTHING
Curb Type		Curb & Gutter Type	
CONCRETE CURB		NO CURB AND GUTTER	
Culverts	Drop Inlets	Gates	
0	0	1	
Pavement Recommendation		Condition Rating / PCR	
PREVENTIVE MAINTENANCE		GOOD / 90

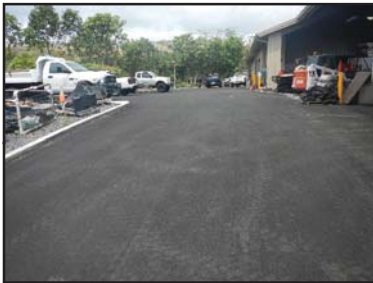
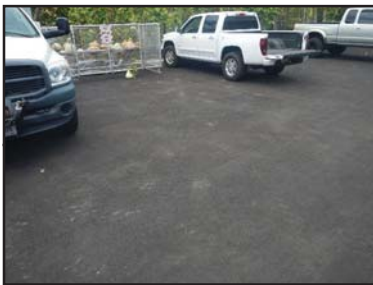
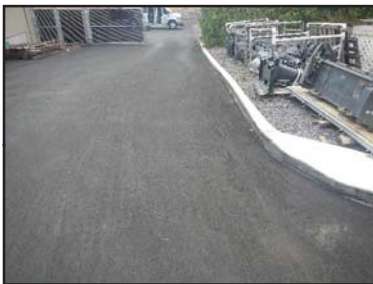
ROUTE 0902: MAINTENANCE FACILITY PARKING AREA

Inspection Date	FMSS Number	User Access	Surface Type						
4/17/2014	108667	NONPUBLIC	ASPHALT						
Area (Sq. Ft.)	Lane Miles (11' Widths)	Curb Reveal (Inches)	Curb Recommendation						
5,795	0.10	5	DO NOTHING						
Curb Type		Curb & Gutter Type							
CONCRETE CURB		NO CURB AND GUTTER							
Culverts	Drop Inlets	Gates							
0	0	1							
Pavement Recommendation		Condition Rating / PCR							
PREVENTIVE MAINTENANCE		GOOD / 90							
Route Condition Legend – Pavement Condition Rating (PCR)									
Poor	(0 - 60)	Fair	(61 - 84)	Good	(85 - 94)	Excellent	(95 - 100)	Not Rated	
See Appendix for definitions and formulas

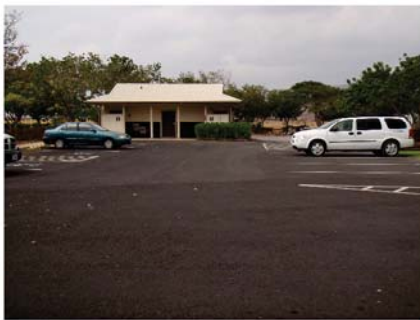
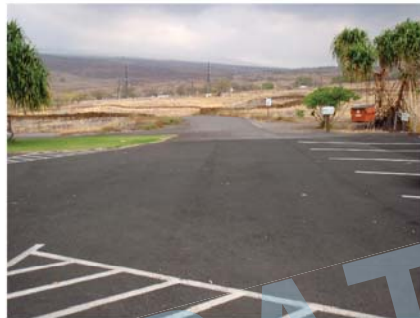
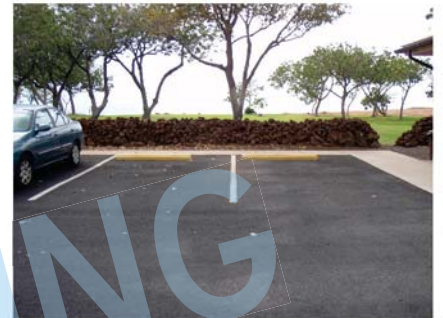
2012 RATING

Route Number	Public / Non Public	Date Visited	Area (sq ft)	Lane Miles *	Surface Type
0900	PUBLIC	1/19/2012	8243	0.142	AS
Culverts	Drop Inlets	Gates	Curb & Gutter	Curb	PCR
0	0	0	NO	NO	90 GOOD

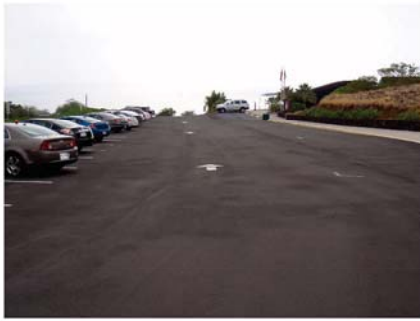
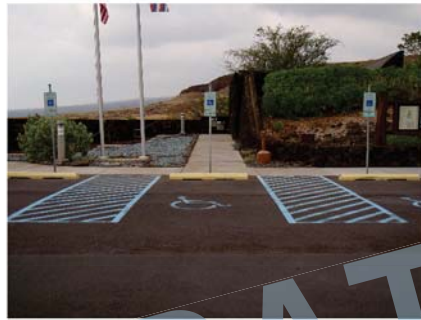
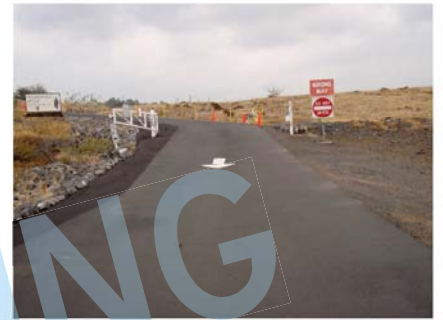
Pu'ukohola Heiau National Historic Site
Route 0901
VISITOR CENTER PARKING LOT

Route Number	Public / Non Public	Date Visited	Area (sq ft)	Lane Miles *	Surface Type
0901	PUBLIC	1/19/2012	18796	0.324	AS
Culverts	Drop Inlets	Gates	Curb & Gutter	Curb	PCR
0	0	1	NO	CONCRETE	90 GOOD

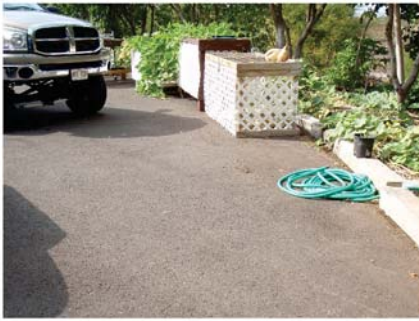
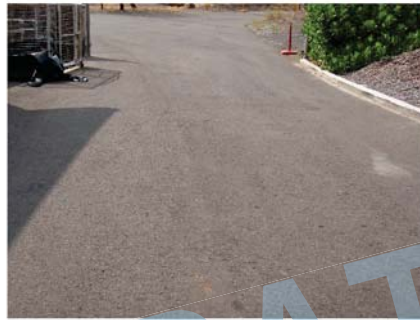
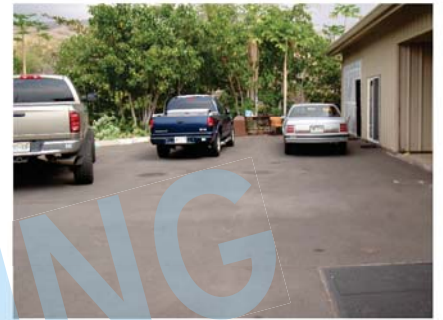
Pu'ukohola Heiau National Historic Site
Route 0902
MAINTENANCE FACILITY PARKING AREA

Route Number	Public / Non Public	Date Visited	Area (sq ft)	Lane Miles *	Surface Type
0902	NONPUBLIC	1/19/2012	5795	0.114	AS
Culverts	Drop Inlets	Gates	Curb & Gutter	Curb	PCR
0	0	1	NO	CONCRETE	90 GOOD
