Federal Lands Highway Road Inventory Program

Road Inventory and Condition Assessment

Redwood National Park
REDW – 8480

Cycle 5 Report

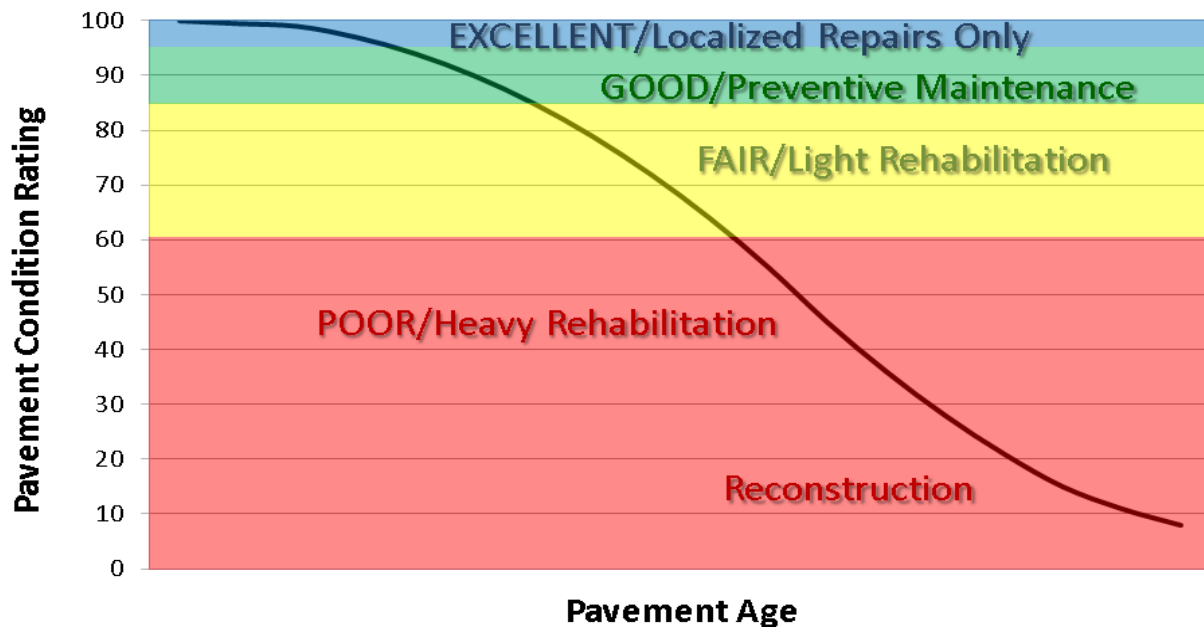
Condition Categories and Treatments

- Excellent/New: PCR of 95-100. Pavements in this range will require only spot repairs
- Good: PCR of 85-94. Pavements in this range will likely be candidates for Preventive Maintenance. Examples include Chip and Slurry Seals, Micro Surfacing and Thin Overlays.
- Fair: PCR of 61-84. Pavements in this range will likely be candidates of Light Rehabilitation (L3R). Examples include single-lift overlays up to 2.5 inches in total thickness, milling and overlays.
- Poor: PCR of 0-60. Pavements in this range will likely be candidates of Heavy Rehabilitation or Reconstruction (H3R or 4R). Examples include Pulverization, Multiple Lift Overlays, and Reconstruction.

At this time, specific Maintenance and Rehabilitation activities should be evaluated and recommended at the project level. Site-specific conditions that influence treatment type should be determined based on performing a subsurface investigation and/or pavement condition survey, and not be based solely on RIP data. Additionally, RIP produces a snapshot of conditions the year in which the data was collected. For further information or to obtain additional Pavement Management System's data from our Highway Pavement Management Application (HPMA) please contact the Eastern Federal Lands pavement team.

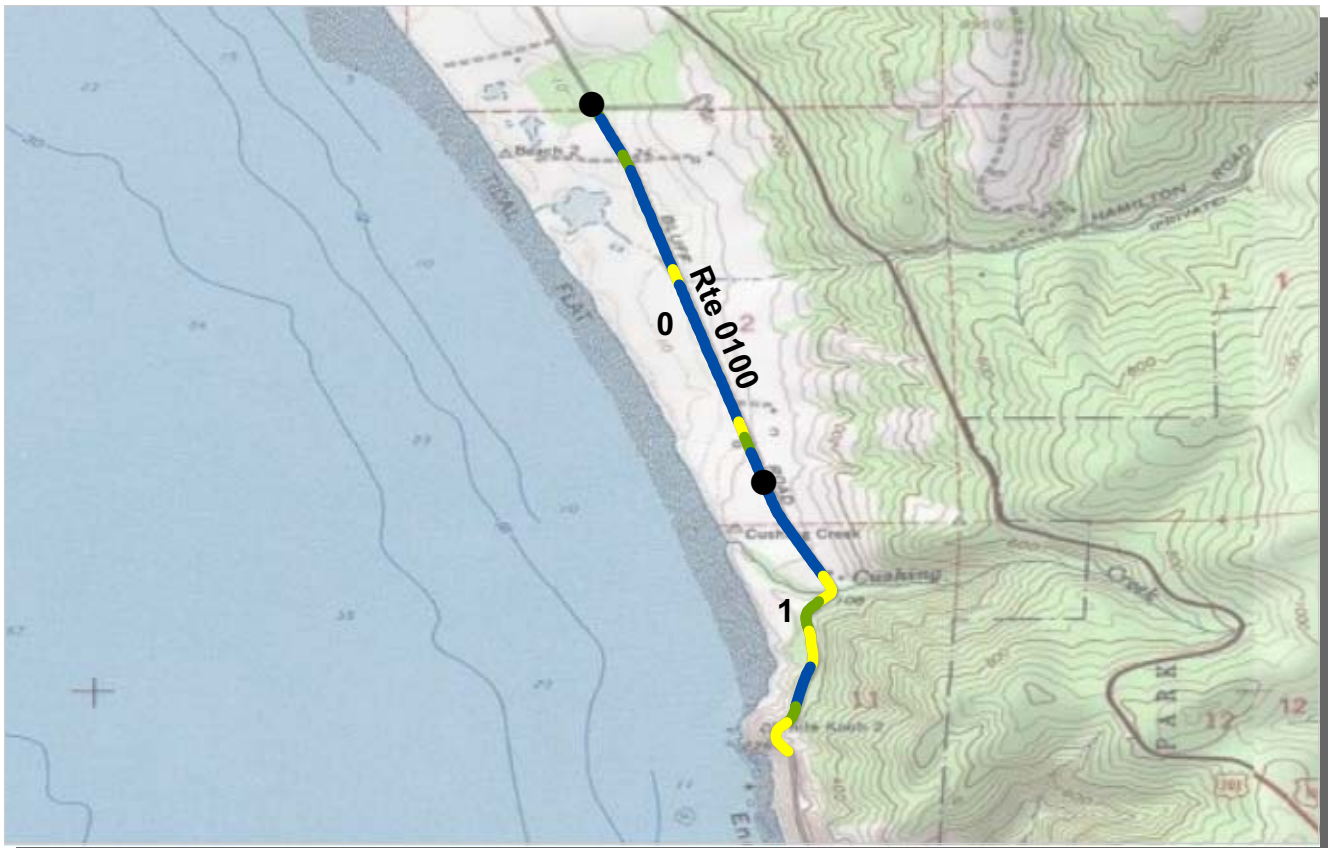
<i>Section Number</i>	0	1			
<i>Section Length (mi)</i>	1.00	0.74			
<i>Cross Section Information</i>					
Number of Lanes	2	2			
Paved Width (ft)	22	21			
Lane Width (ft)	11	10			
<i>Roadway Condition Information</i>					
SCR (Surface Condition Rating)	95	94			
PCR (Pavement Condition Rating)	95	88			
<i>Distress Index Values</i>					
Structural Crack Index	100	100			
Transverse Cracking Index	100	100			
Patching Index	100	100			
Rutting Index	95	94			
Roughness Condition Index (RCI)	96	80

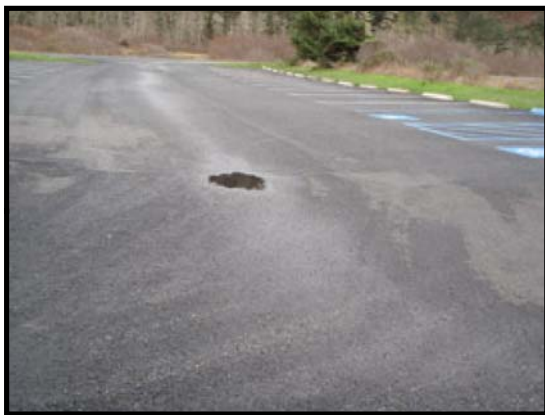
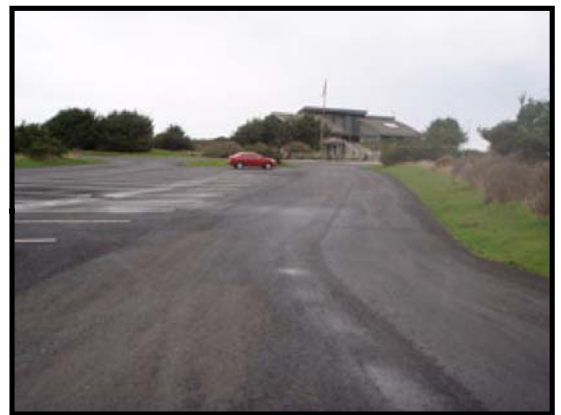
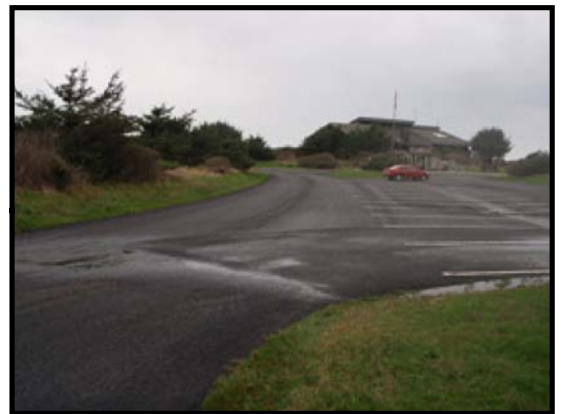
Route Number	Public / NonPublic	Date Visited	Area (sq ft)	Lane Miles *	Surface Type
0900	PUBLIC	1/25/2010	47,198	0.81	AS
Culverts	Drop Inlets	Gates	Curb & Gutter	Curb	PCR
0	3	0	CONCRETE CURB AND GUTTER	NO CURB	GOOD/90

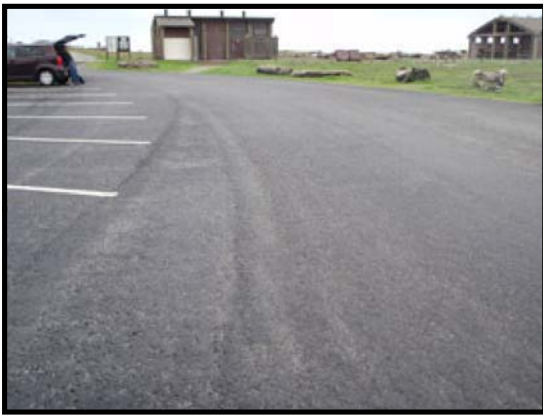
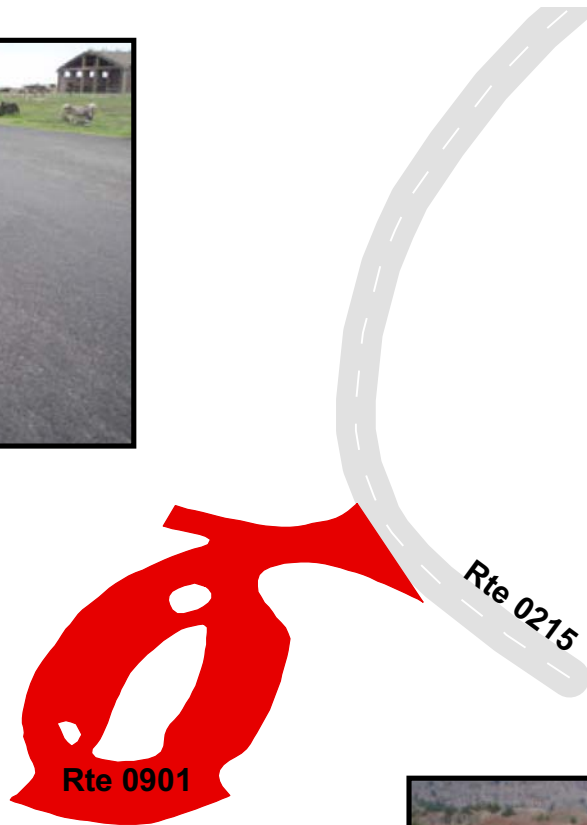
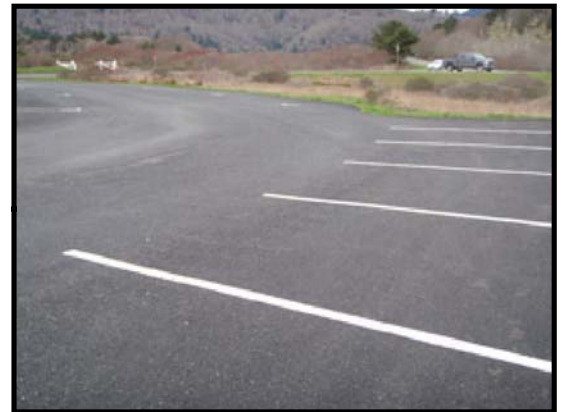
Route 0901

Route Number	Public / NonPublic	Date Visited	Area (sq ft)	Lane Miles *	Surface Type
0901	PUBLIC	1/25/2010	25,647	0.44	AS
Culverts	Drop Inlets	Gates	Curb & Gutter	Curb	PCR
0	0	0	NO CURB AND GUTTER	NO CURB	GOOD/90

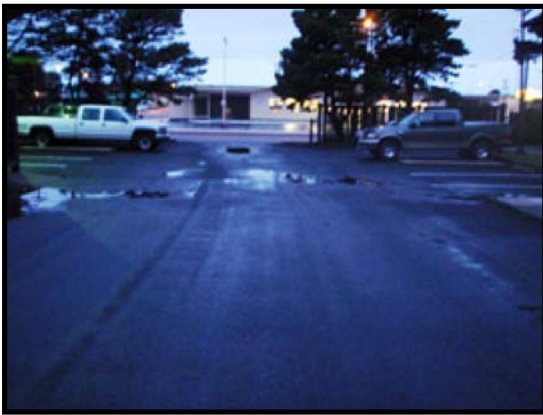
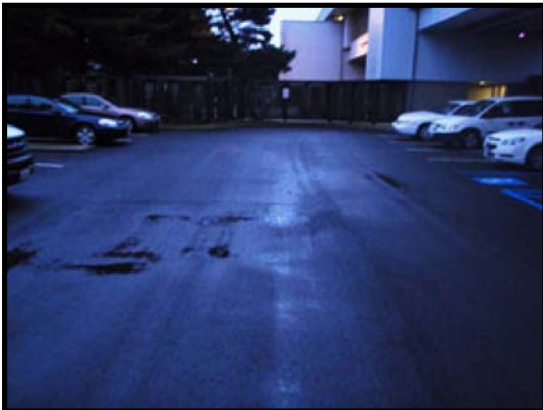
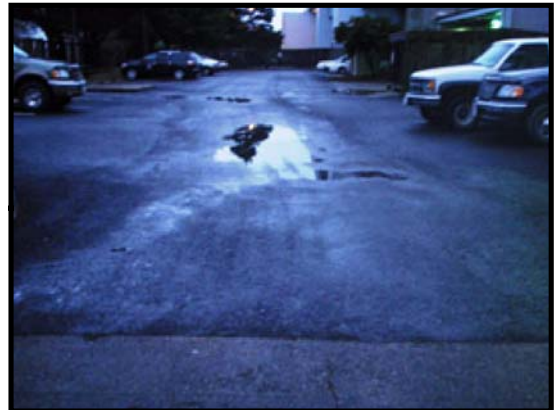
Route 0902

Route Number	Public / NonPublic	Date Visited	Area (sq ft)	Lane Miles *	Surface Type
0902	PUBLIC	1/26/2010	11,512	0.20	AS
Culverts	Drop Inlets	Gates	Curb & Gutter	Curb	PCR
0	3	0	CONCRETE CURB AND GUTTER	CONCRETE CURB	GOOD/90

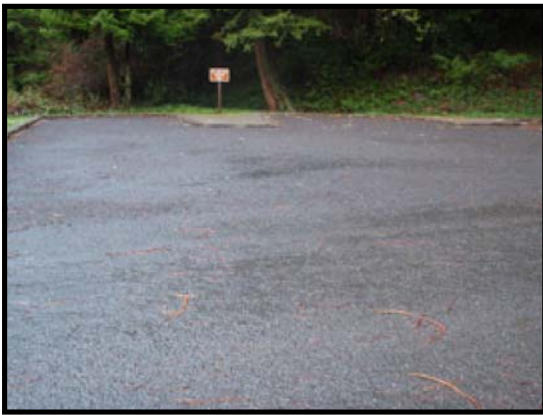
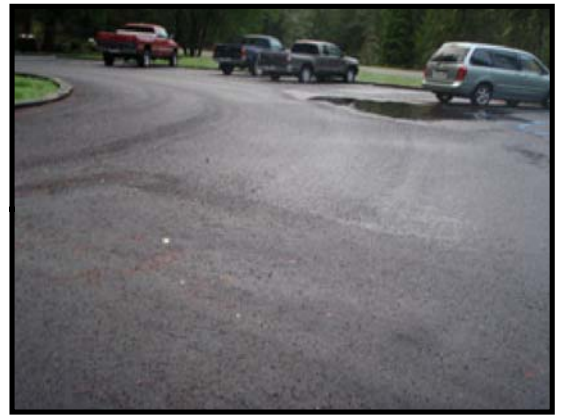
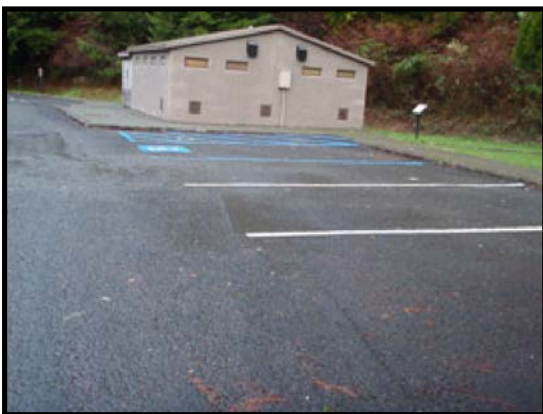
Route 0903

Route Number	Public / NonPublic	Date Visited	Area (sq ft)	Lane Miles *	Surface Type
0903	PUBLIC	1/26/2010	29,772	0.51	AS
Culverts	Drop Inlets	Gates	Curb & Gutter	Curb	PCR
0	0	0	NO CURB AND GUTTER	STONE CURB	GOOD/90

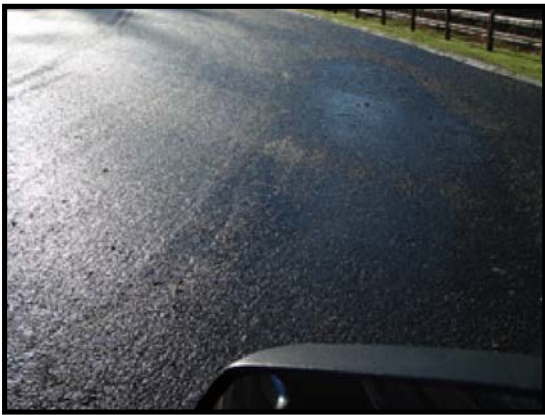
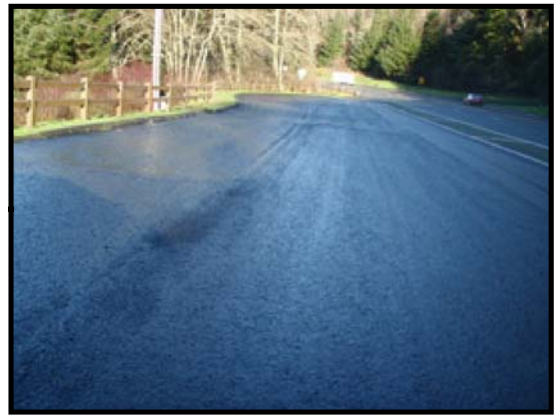
Route 0904

Route Number	Public / NonPublic	Date Visited	Area (sq ft)	Lane Miles *	Surface Type
0904	PUBLIC	1/26/2010	19,141	0.33	AS
Culverts	Drop Inlets	Gates	Curb & Gutter	Curb	PCR
0	0	0	NO CURB AND GUTTER	ASPHALT CURB	GOOD/90

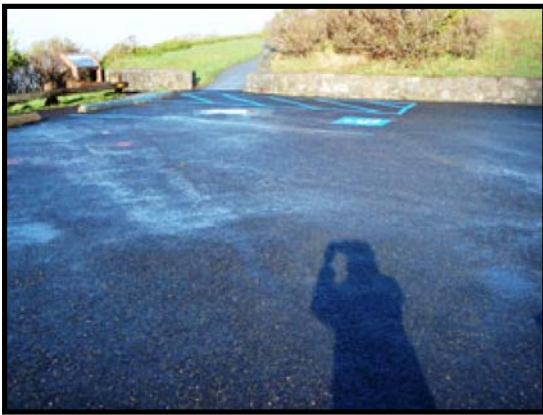
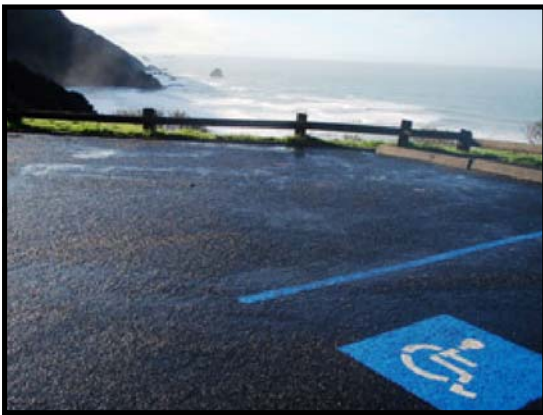
Route 0906

Route Number	Public / NonPublic	Date Visited	Area (sq ft)	Lane Miles *	Surface Type
0906	PUBLIC	1/26/2010	2,796	0.05	AS
Culverts	Drop Inlets	Gates	Curb & Gutter	Curb	PCR
0	0	0	NO CURB AND GUTTER	NO CURB	GOOD/90

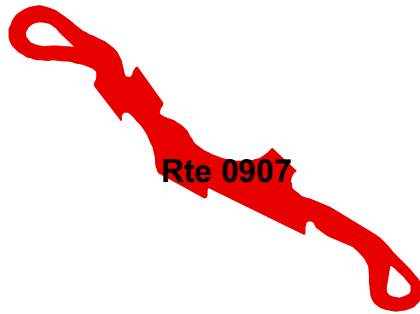
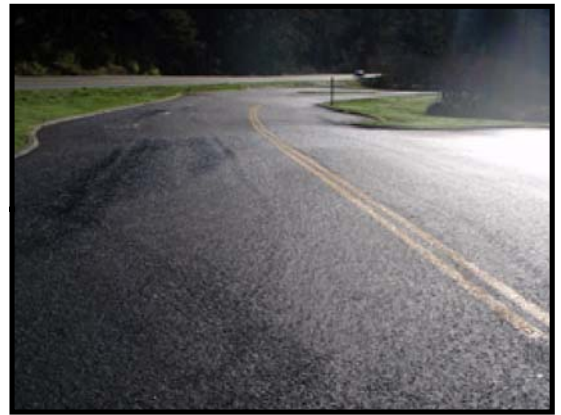
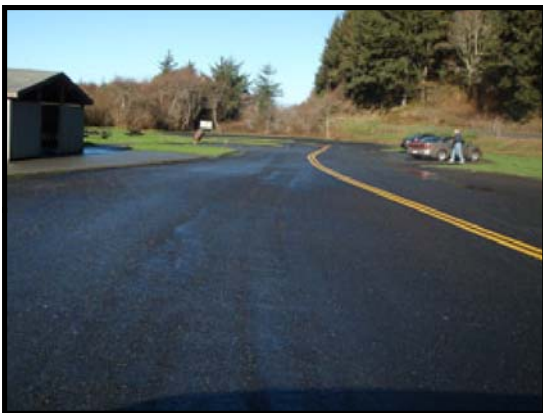
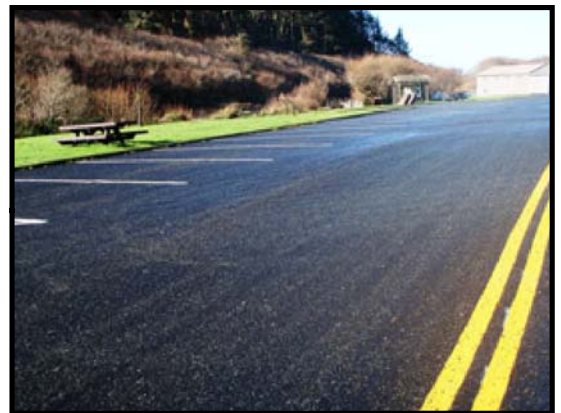
Route 0907

Route Number	Public / NonPublic	Date Visited	Area (sq ft)	Lane Miles *	Surface Type
0907	PUBLIC	1/26/2010	36,884	0.64	AS
Culverts	Drop Inlets	Gates	Curb & Gutter	Curb	PCR
0	5	0	NO CURB AND GUTTER	ASPHALT CURB	GOOD/90

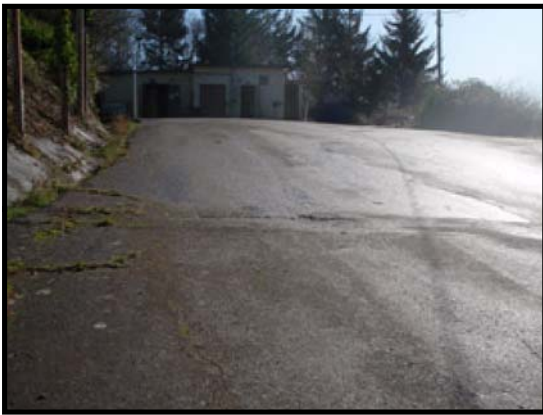
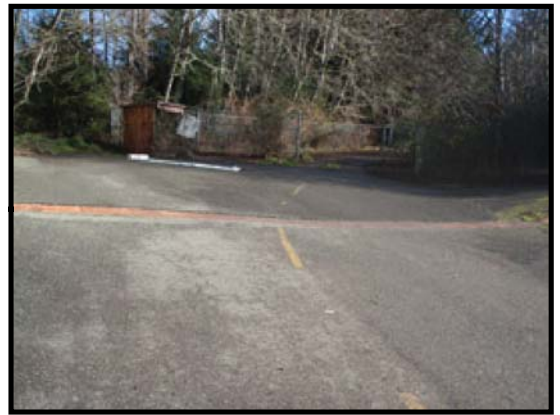
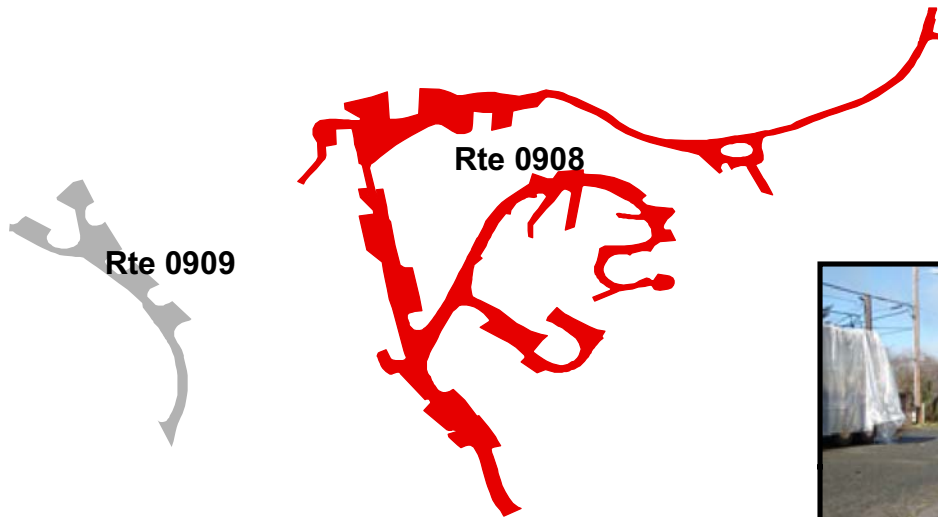
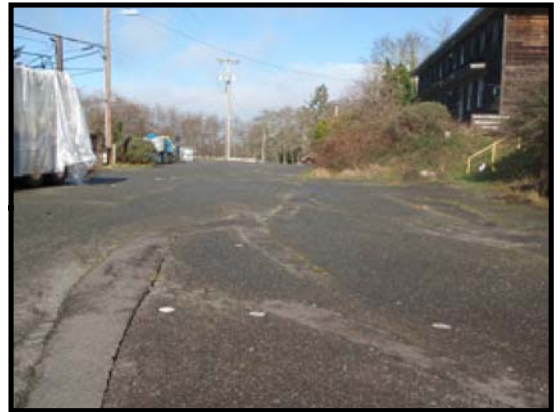
Route Number	Public / NonPublic	Date Visited	Area (sq ft)	Lane Miles *	Surface Type
0908	NONPUBLIC	1/26/2010	138,563	2.39	AS
Culverts	Drop Inlets	Gates	Curb & Gutter	Curb	PCR
4	0	2	NO CURB AND GUTTER	ASPHALT CURB	POOR/45

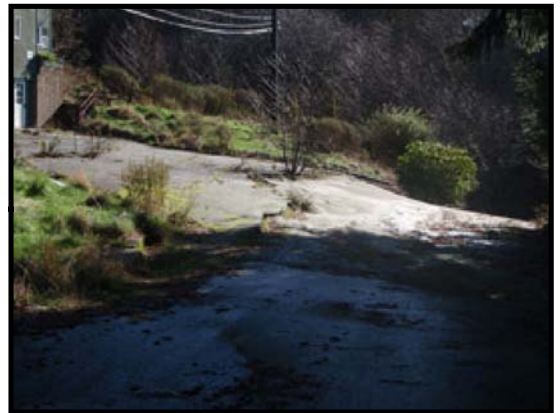
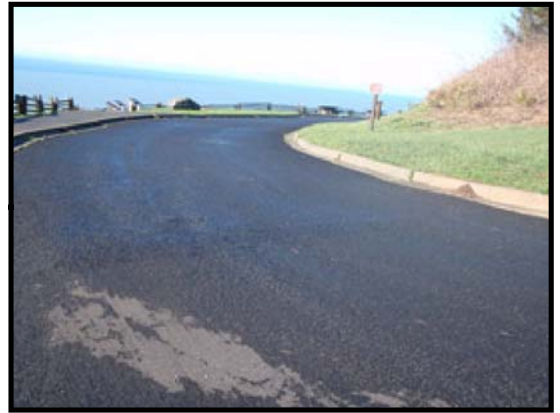
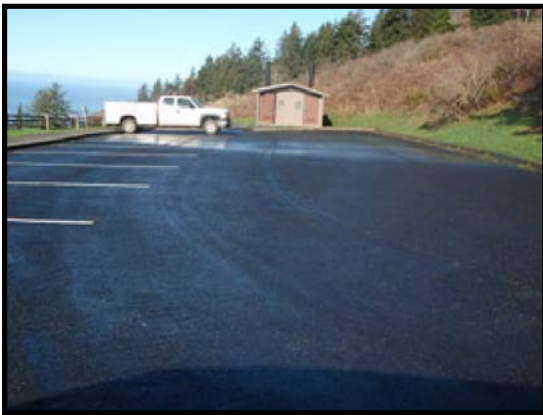
Route 0910

Route Number	Public / NonPublic	Date Visited	Area (sq ft)	Lane Miles *	Surface Type
0910	PUBLIC	1/26/2010	11,091	0.19	AS
Culverts	Drop Inlets	Gates	Curb & Gutter	Curb	PCR
0	1	0	CONCRETE CURB AND GUTTER	NO CURB	GOOD/90

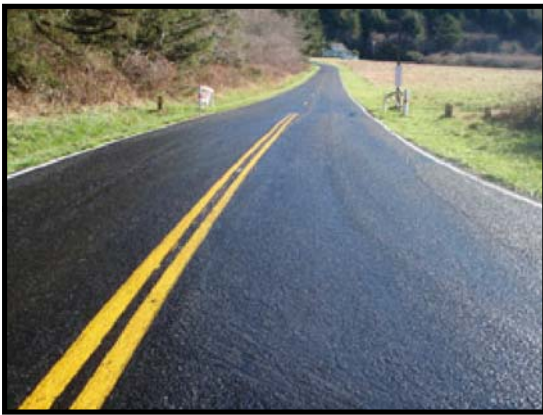
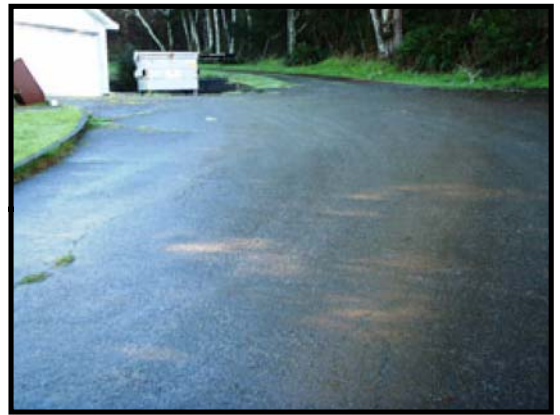
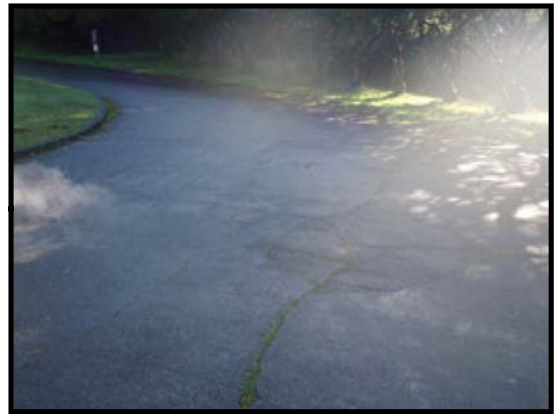
Route 0911

Route Number	Public / NonPublic	Date Visited	Area (sq ft)	Lane Miles *	Surface Type
0911	PUBLIC	1/26/2010	32,378	0.56	AS
Culverts	Drop Inlets	Gates	Curb & Gutter	Curb	PCR
0	0	1	NO CURB AND GUTTER	CONCRETE CURB	FAIR/73

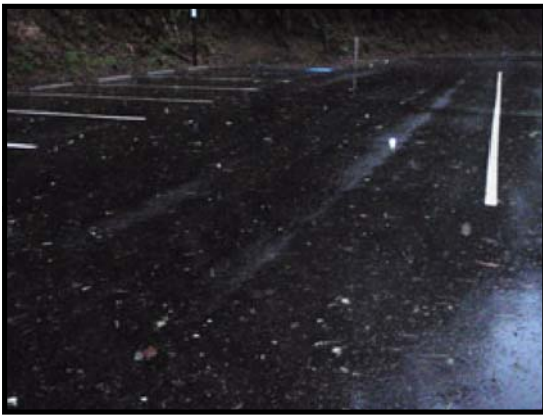
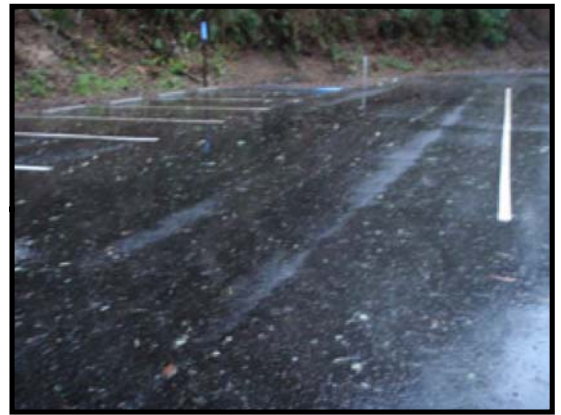
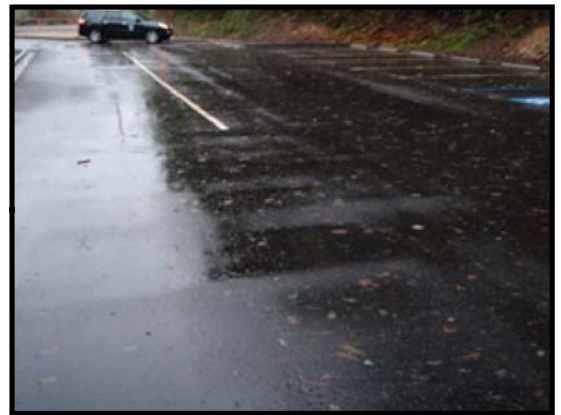
Route 0912

Route Number	Public / NonPublic	Date Visited	Area (sq ft)	Lane Miles *	Surface Type
0912	PUBLIC	1/26/2010	5,993	0.10	AS
Culverts	Drop Inlets	Gates	Curb & Gutter	Curb	PCR
0	0	0	CONCRETE CURB AND GUTTER	ASPHALT CURB	GOOD/90

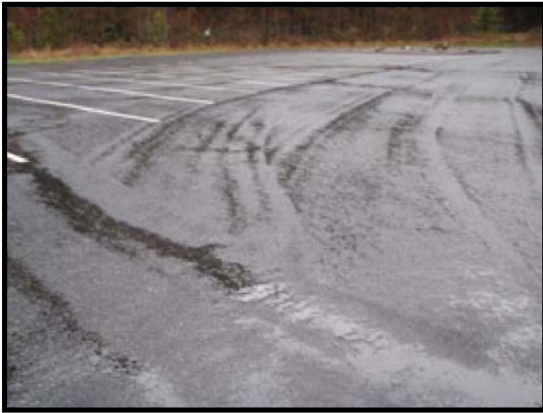
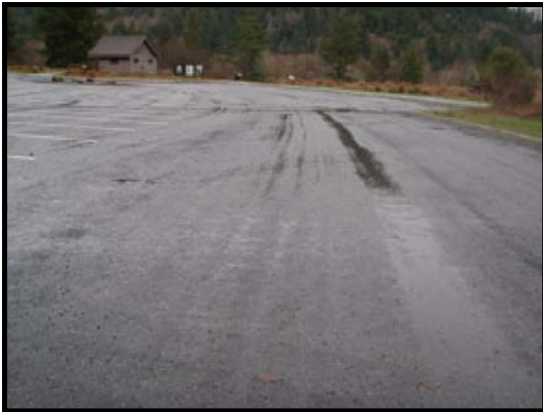
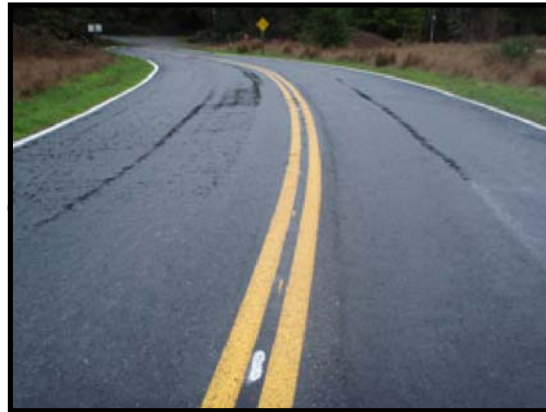
Route 0913

Route Number	Public / NonPublic	Date Visited	Area (sq ft)	Lane Miles *	Surface Type
0913	PUBLIC	1/26/2010	45,328	0.78	AS
Culverts	Drop Inlets	Gates	Curb & Gutter	Curb	PCR
0	1	0	NO CURB AND GUTTER	NO CURB	GOOD/90

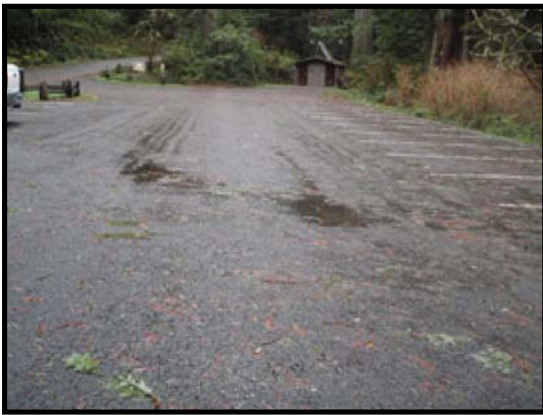
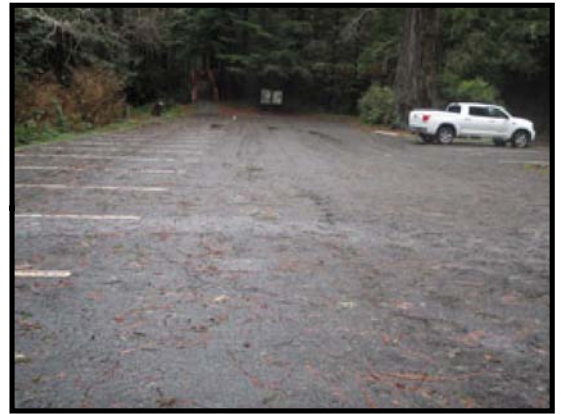
Route 0914

Route Number	Public / NonPublic	Date Visited	Area (sq ft)	Lane Miles *	Surface Type
0914	PUBLIC	1/26/2010	14,205	0.25	AS
Culverts	Drop Inlets	Gates	Curb & Gutter	Curb	PCR
0	0	0	NO CURB AND GUTTER	ASPHALT CURB	GOOD/90

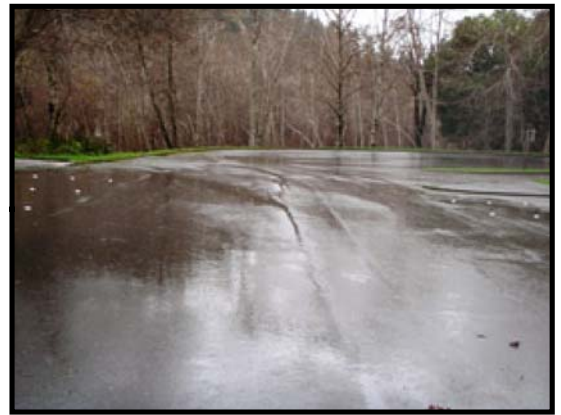
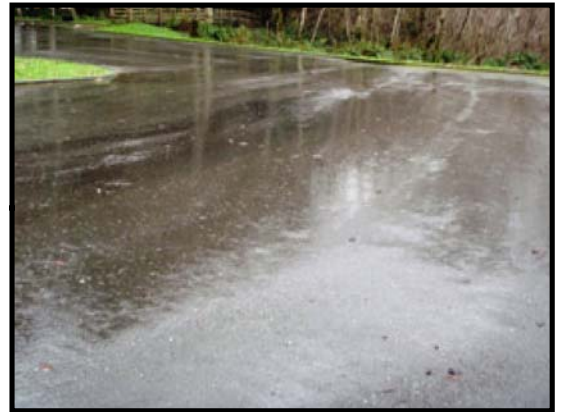
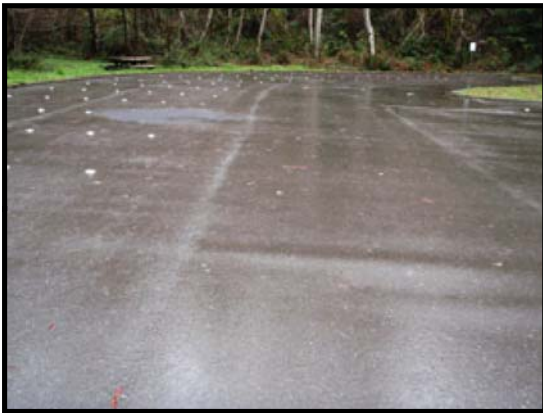
Route 0915

Route Number	Public / NonPublic	Date Visited	Area (sq ft)	Lane Miles *	Surface Type
0915	PUBLIC	1/26/2010	24,367	0.42	AS
Culverts	Drop Inlets	Gates	Curb & Gutter	Curb	PCR
1	2	0	CONCRETE CURB AND GUTTER	ASPHALT CURB	GOOD/90

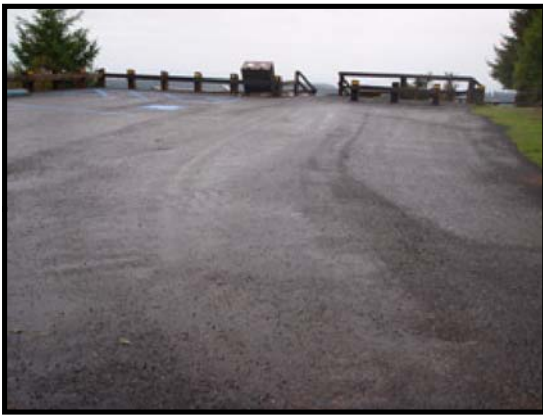
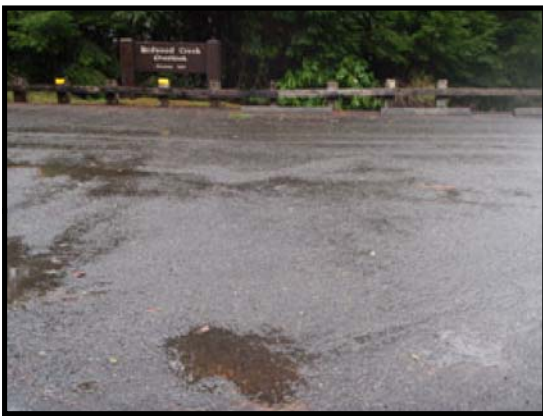
Route 0916

Route Number	Public / NonPublic	Date Visited	Area (sq ft)	Lane Miles *	Surface Type
0916	PUBLIC	1/26/2010	4,067	0.07	AS
Culverts	Drop Inlets	Gates	Curb & Gutter	Curb	PCR
0	0	0	NO CURB AND GUTTER	NO CURB	GOOD/90

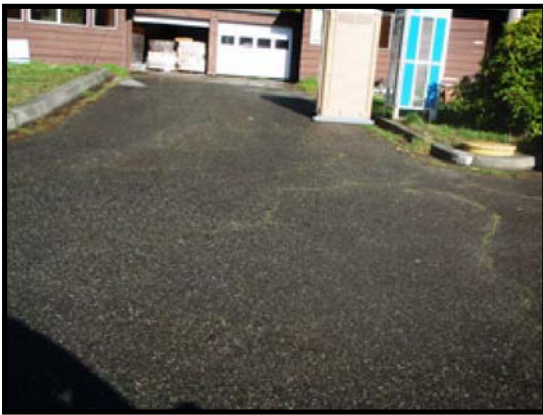
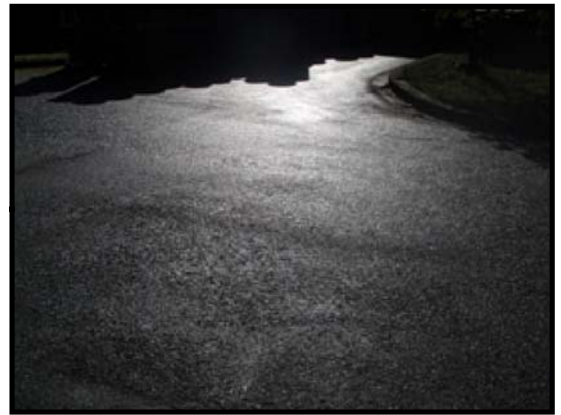
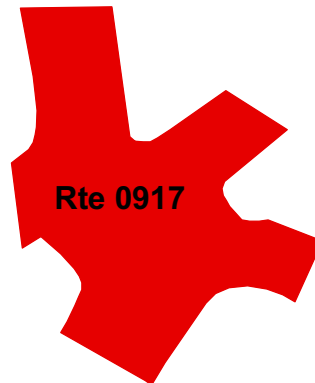
Route 0917

Route Number	Public / NonPublic	Date Visited	Area (sq ft)	Lane Miles *	Surface Type
0917	NONPUBLIC	1/26/2010	3,348	0.06	AS
Culverts	Drop Inlets	Gates	Curb & Gutter	Curb	PCR
0	0	0	CONCRETE CURB AND GUTTER	NO CURB	FAIR/73

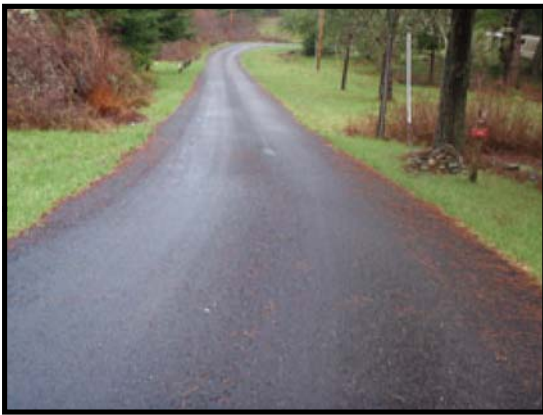
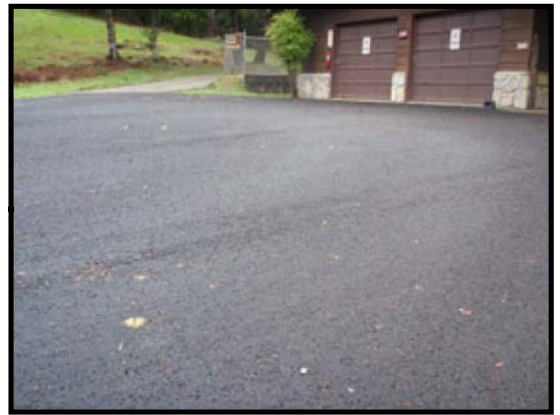
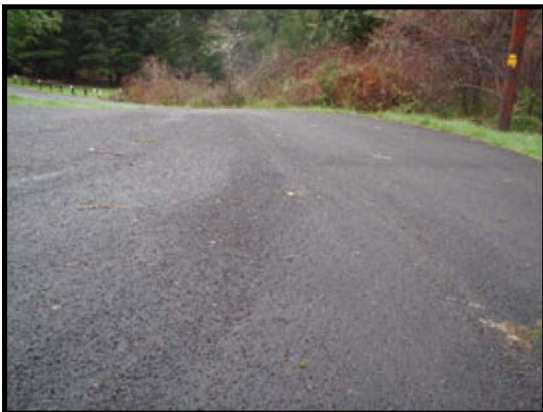
Route 0918

Route Number	Public / NonPublic	Date Visited	Area (sq ft)	Lane Miles *	Surface Type
0918	NONPUBLIC	1/26/2010	9,627	0.17	AS
Culverts	Drop Inlets	Gates	Curb & Gutter	Curb	PCR
1	0	0	NO CURB AND GUTTER	NO CURB	GOOD/90

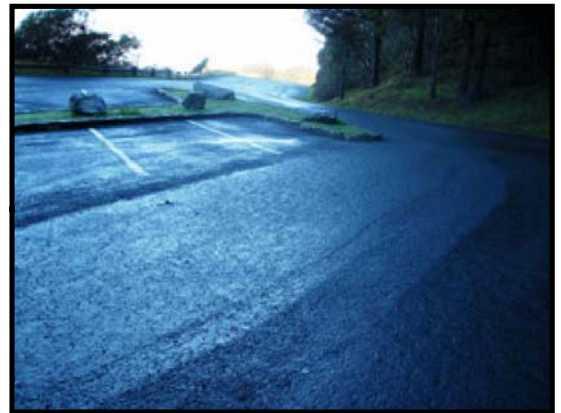
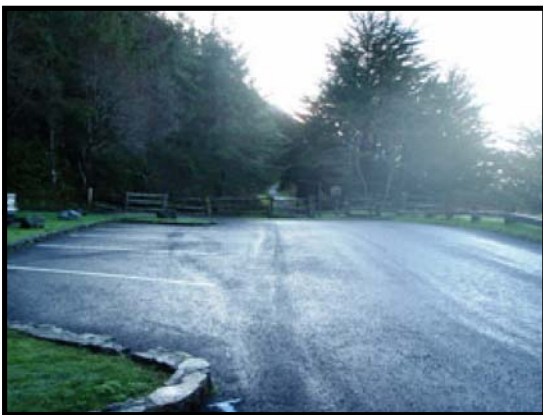
Route 0919

Route Number	Public / NonPublic	Date Visited	Area (sq ft)	Lane Miles *	Surface Type
0919	PUBLIC	1/26/2010	8,643	0.15	AS
Culverts	Drop Inlets	Gates	Curb & Gutter	Curb	PCR
0	0	1	NO CURB AND GUTTER	STONE CURB	GOOD/90

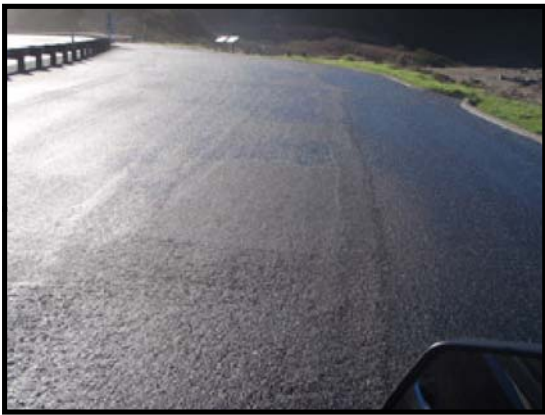
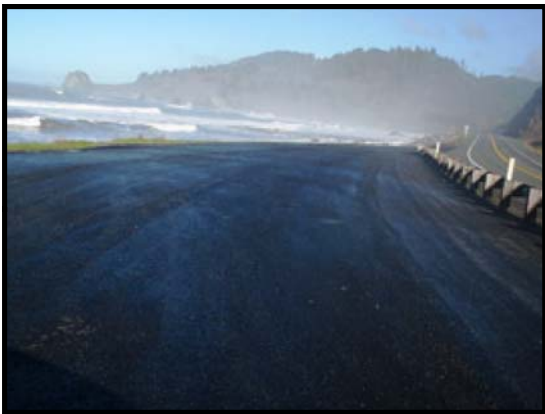
Route 0920

Route Number	Public / NonPublic	Date Visited	Area (sq ft)	Lane Miles *	Surface Type
0920	PUBLIC	1/26/2010	9,608	0.17	AS
Culverts	Drop Inlets	Gates	Curb & Gutter	Curb	PCR
0	0	0	NO CURB AND GUTTER	ASPHALT CURB	GOOD/90

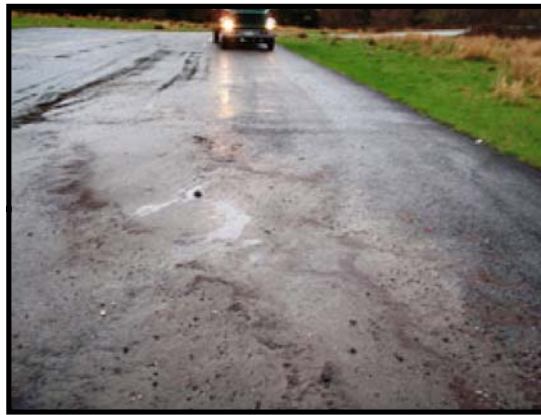
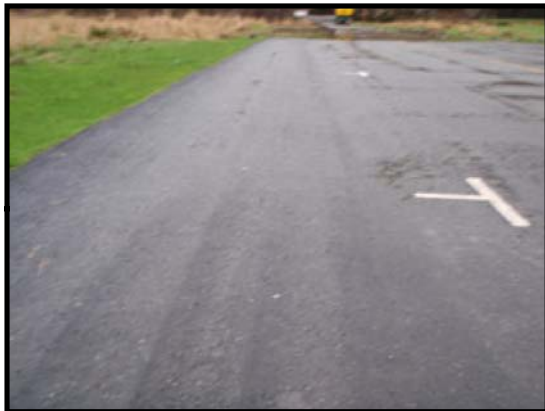
Route 0921AZ

Route Number	Public / NonPublic	Date Visited	Area (sq ft)	Lane Miles *	Surface Type
0921AZ	PUBLIC	1/25/2010	3,075	0.05	AS
Culverts	Drop Inlets	Gates	Curb & Gutter	Curb	PCR
0	0	0	NO CURB AND GUTTER	NO CURB	GOOD/90

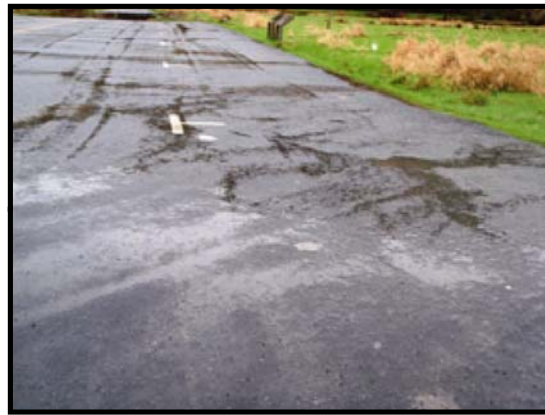
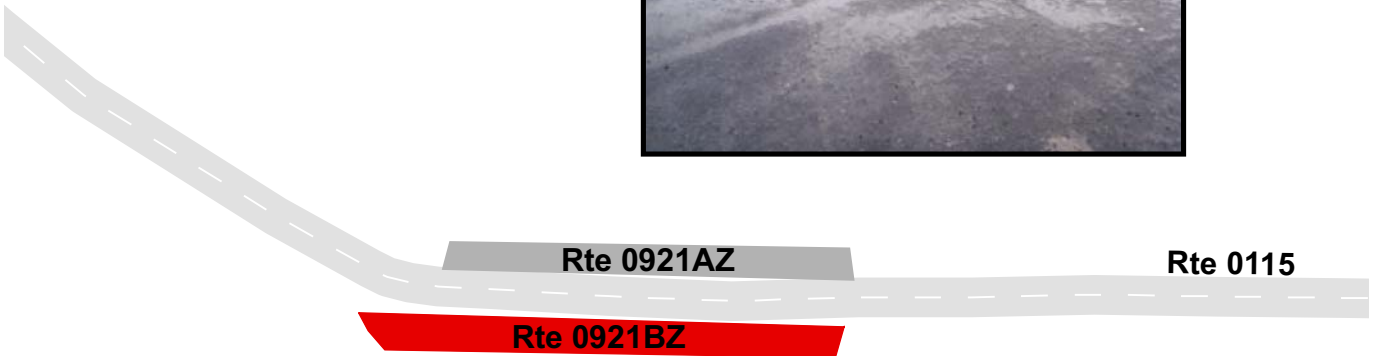
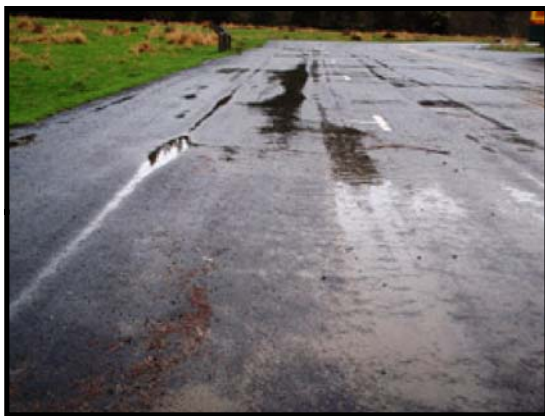
Route Number	Public / NonPublic	Date Visited	Area (sq ft)	Lane Miles *	Surface Type
0921BZ	PUBLIC	1/25/2010	3,868	0.07	AS
Culverts	Drop Inlets	Gates	Curb & Gutter	Curb	PCR
0	0	0	NO CURB AND GUTTER	NO CURB	GOOD/90

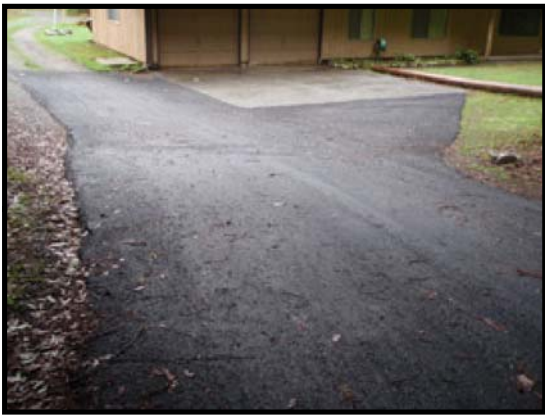
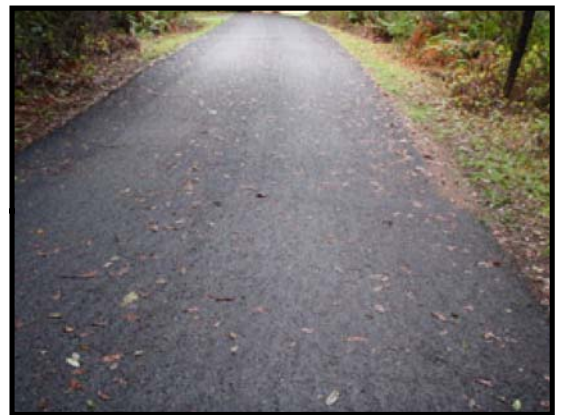
Route 0922

Route Number	Public / NonPublic	Date Visited	Area (sq ft)	Lane Miles *	Surface Type
0922	NONPUBLIC	1/26/2010	12,439	0.21	AS
Culverts	Drop Inlets	Gates	Curb & Gutter	Curb	PCR
0	0	0	NO CURB AND GUTTER	NO CURB	GOOD/90

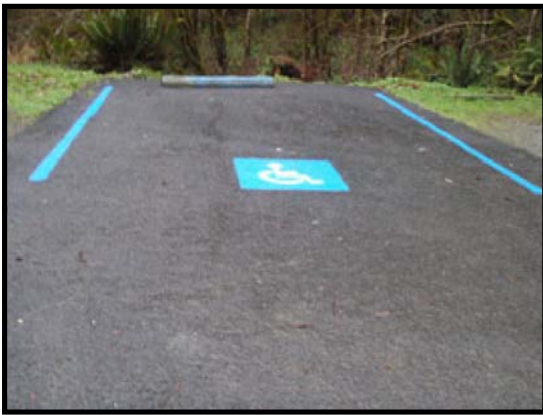
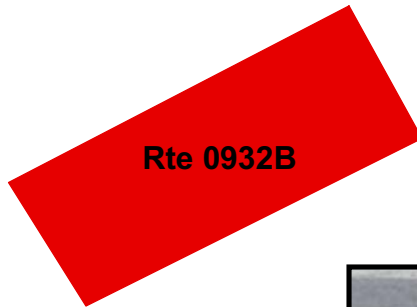
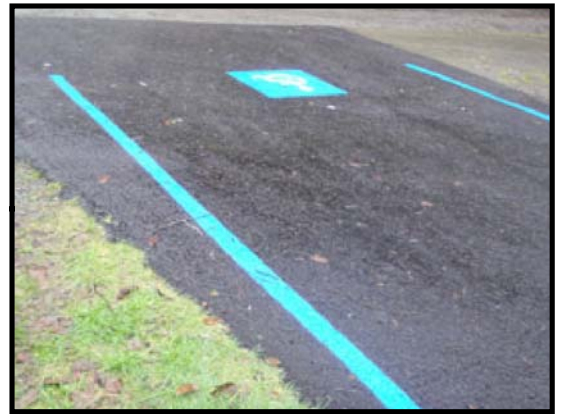
Route 0932B

Route Number	Public / NonPublic	Date Visited	Area (sq ft)	Lane Miles *	Surface Type
0932B	PUBLIC	1/25/2010	982	0.02	AS
Culverts	Drop Inlets	Gates	Curb & Gutter	Curb	PCR
0	0	0	NO CURB AND GUTTER	NO CURB	FAIR/73

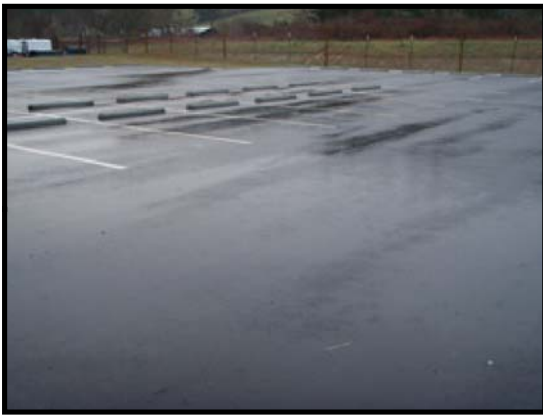
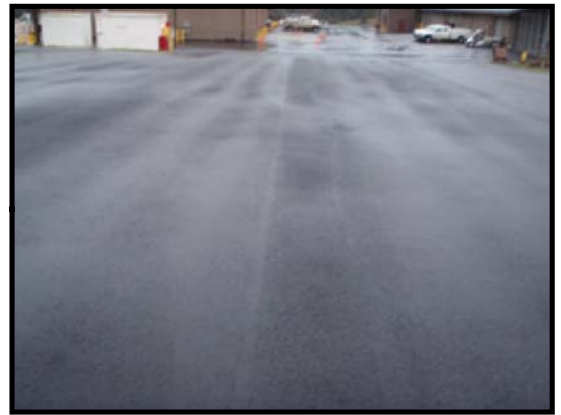
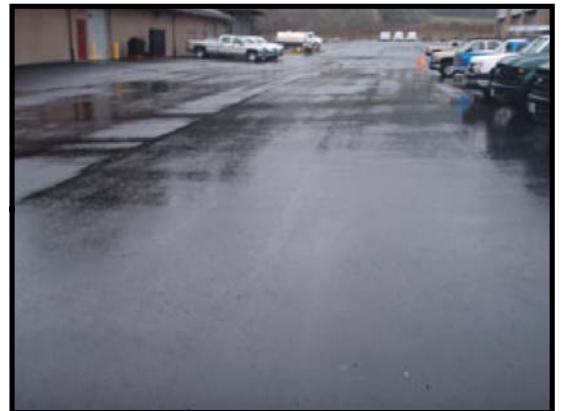
Route 0938

Route Number	Public / NonPublic	Date Visited	Area (sq ft)	Lane Miles *	Surface Type
0938	PUBLIC	1/26/2010	105,888	1.82	AS
Culverts	Drop Inlets	Gates	Curb & Gutter	Curb	PCR
1	5	1	NO CURB AND GUTTER	NO CURB	GOOD/90

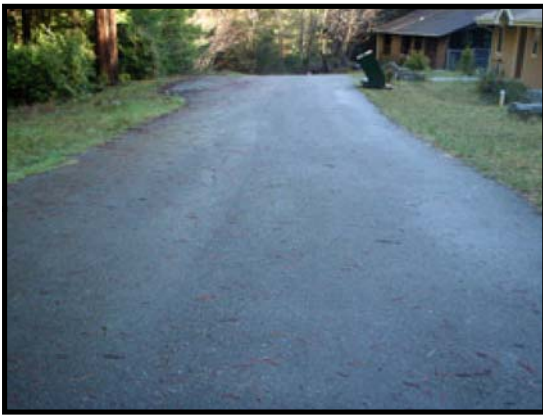
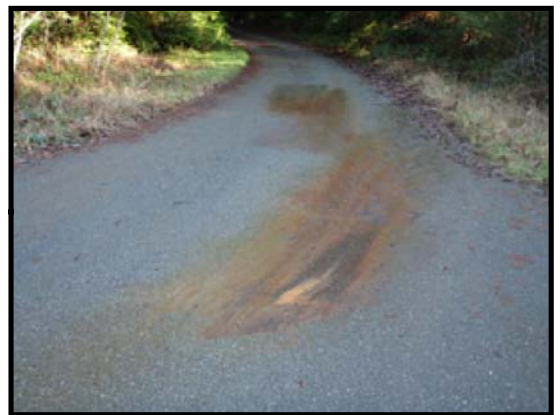
Route 0939

Route Number	Public / NonPublic	Date Visited	Area (sq ft)	Lane Miles *	Surface Type
0939	NONPUBLIC	1/26/2010	15,910	0.27	AS
Culverts	Drop Inlets	Gates	Curb & Gutter	Curb	PCR
1	0	0	NO CURB AND GUTTER	NO CURB	GOOD/90
