# Federal Lands Highway Road Inventory Program

Road Inventory and Condition Assessment

## Rock Creek Park ROCR

### Cycle 5 Report

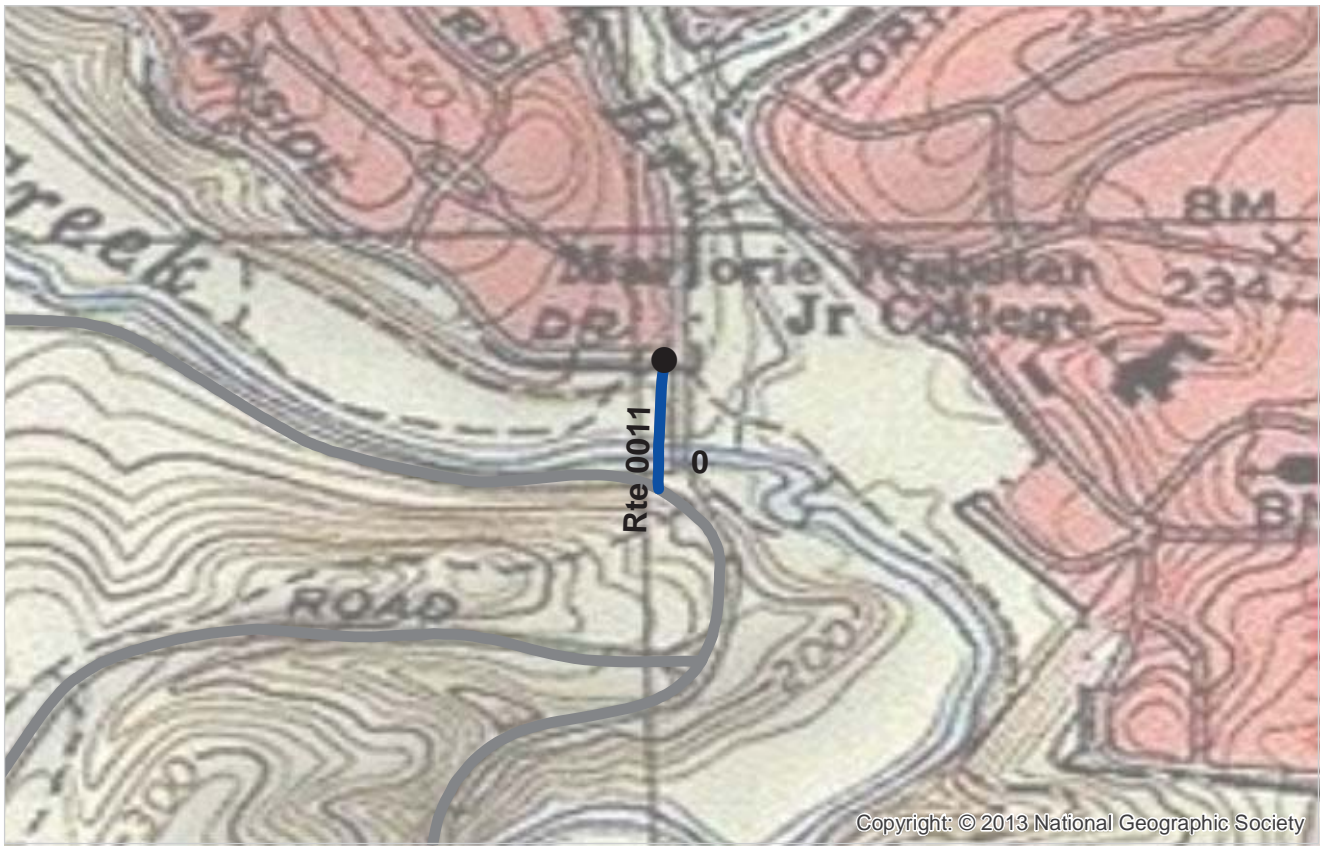
ROUTE: 0011 WEST BEACH DRIVE NORTHWEST

<b>Section Number</b>	0				
<b>Section Length (mi)</b>	0.08				
<b>Cross Section Information</b>					
Number of Lanes	2				
Paved Width (ft)	25				
Lane Width (ft)	12				
<b>Roadway Condition Information</b>					
SCR (Surface Condition Rating)	99				
PCR (Pavement Condition Rating)	99				
<b>Distress Index Values</b>					
Structural Crack Index	100				
Transverse Cracking Index	99				
Patching Index	100				
Rutting Index	99				
Roughness Condition Index (RCI)	NC

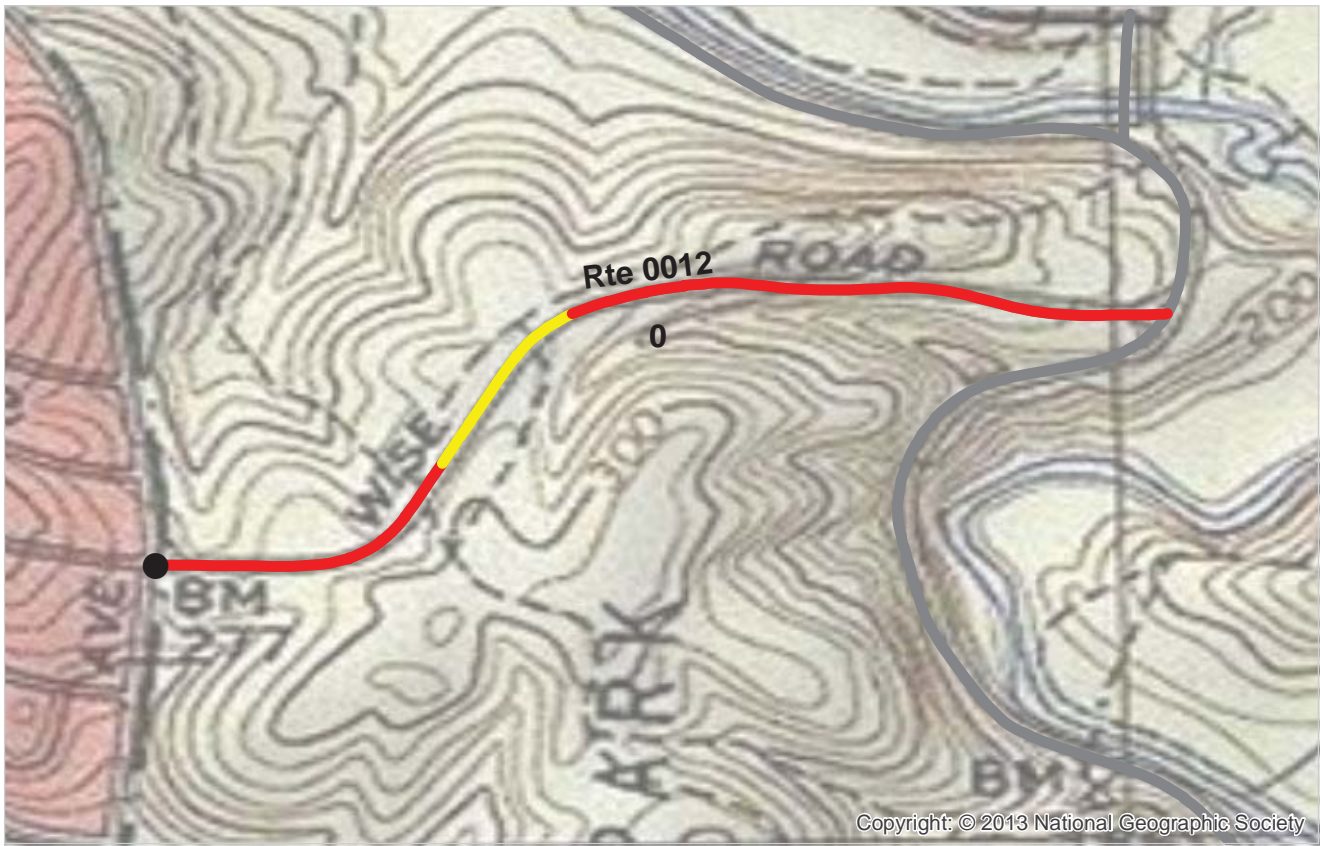
**ROUTE: 0012 WISE ROAD NORTHWEST**

<i>Section Number</i>	0				
<i>Section Length (mi)</i>	0.61				
<i>Cross Section Information</i>					
Number of Lanes	2				
Paved Width (ft)	22				
Lane Width (ft)	11				
<i>Roadway Condition Information</i>					
SCR (Surface Condition Rating)	0				
PCR (Pavement Condition Rating)	26				
<i>Distress Index Values</i>					
Structural Crack Index	0				
Transverse Cracking Index	99				
Patching Index	93				
Rutting Index	95				
Roughness Condition Index (RCI)	65

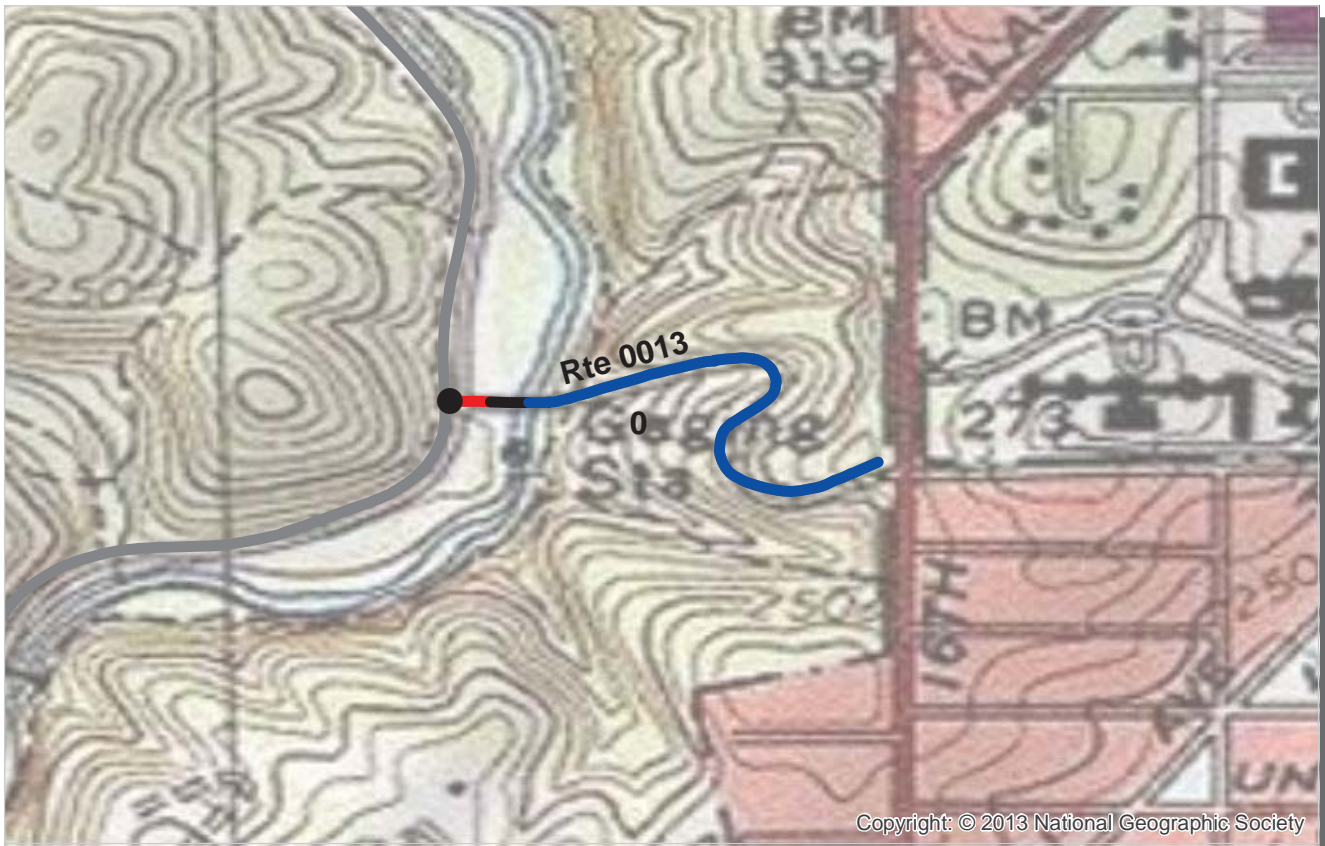
**ROUTE: 0013 SHERRILL DRIVE NORTHWEST**

<i>Section Number</i>	0				
<i>Section Length (mi)</i>	0.33				
<i>Cross Section Information</i>					
Number of Lanes	2				
Paved Width (ft)	19				
Lane Width (ft)	9				
<i>Roadway Condition Information</i>					
SCR (Surface Condition Rating)	90				
PCR (Pavement Condition Rating)	90				
<i>Distress Index Values</i>					
Structural Crack Index	90				
Transverse Cracking Index	99				
Patching Index	100				
Rutting Index	99				
Roughness Condition Index (RCI)	NC

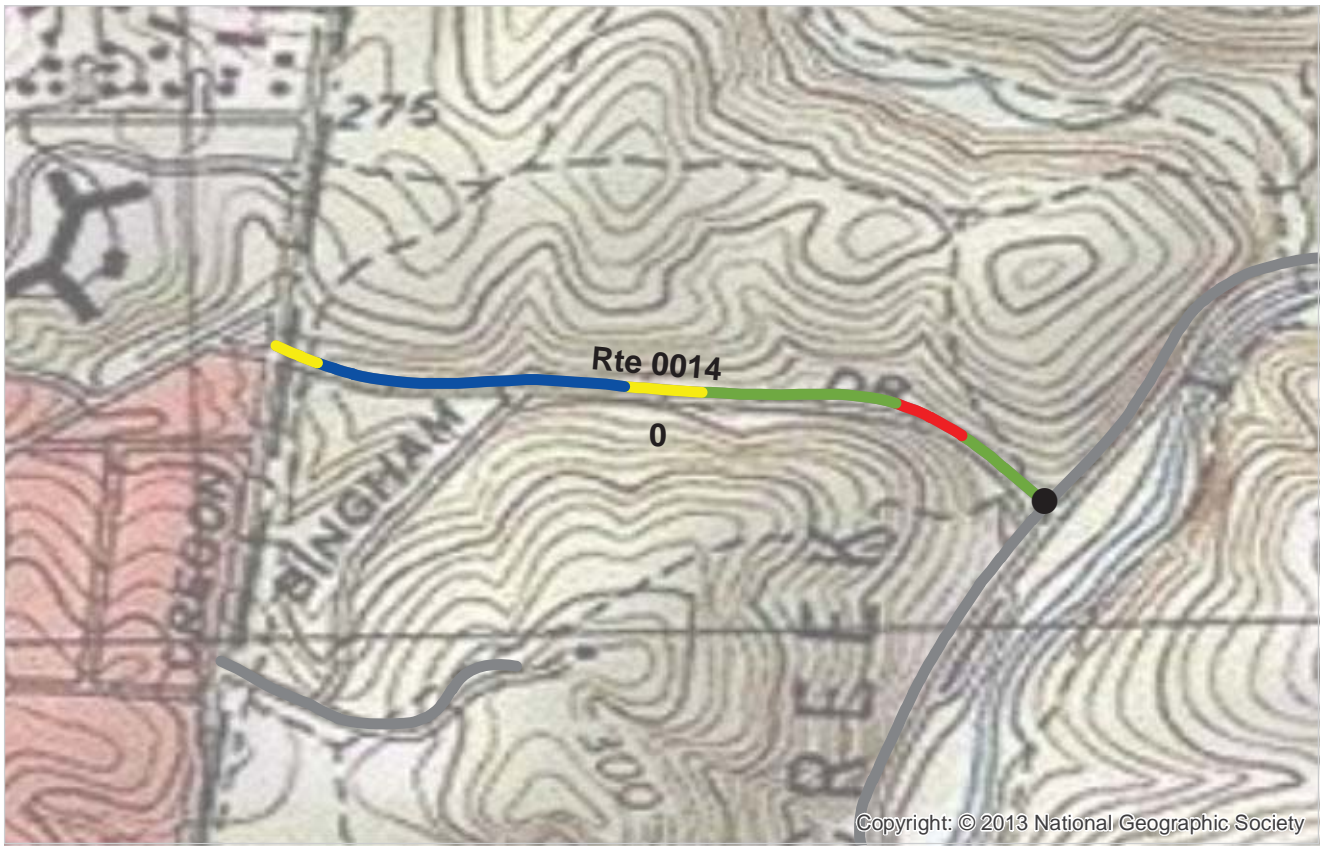
**ROUTE: 0014 BINGHAM DRIVE NORTHWEST**

<b>Section Number</b>	0				
<b>Section Length (mi)</b>	0.42				
<b>Cross Section Information</b>					
Number of Lanes	2				
Paved Width (ft)	18				
Lane Width (ft)	9				
<b>Roadway Condition Information</b>					
SCR (Surface Condition Rating)	66				
PCR (Pavement Condition Rating)	66				
<b>Distress Index Values</b>					
Structural Crack Index	66				
Transverse Cracking Index	96				
Patching Index	100				
Rutting Index	99				
Roughness Condition Index (RCI)	NC

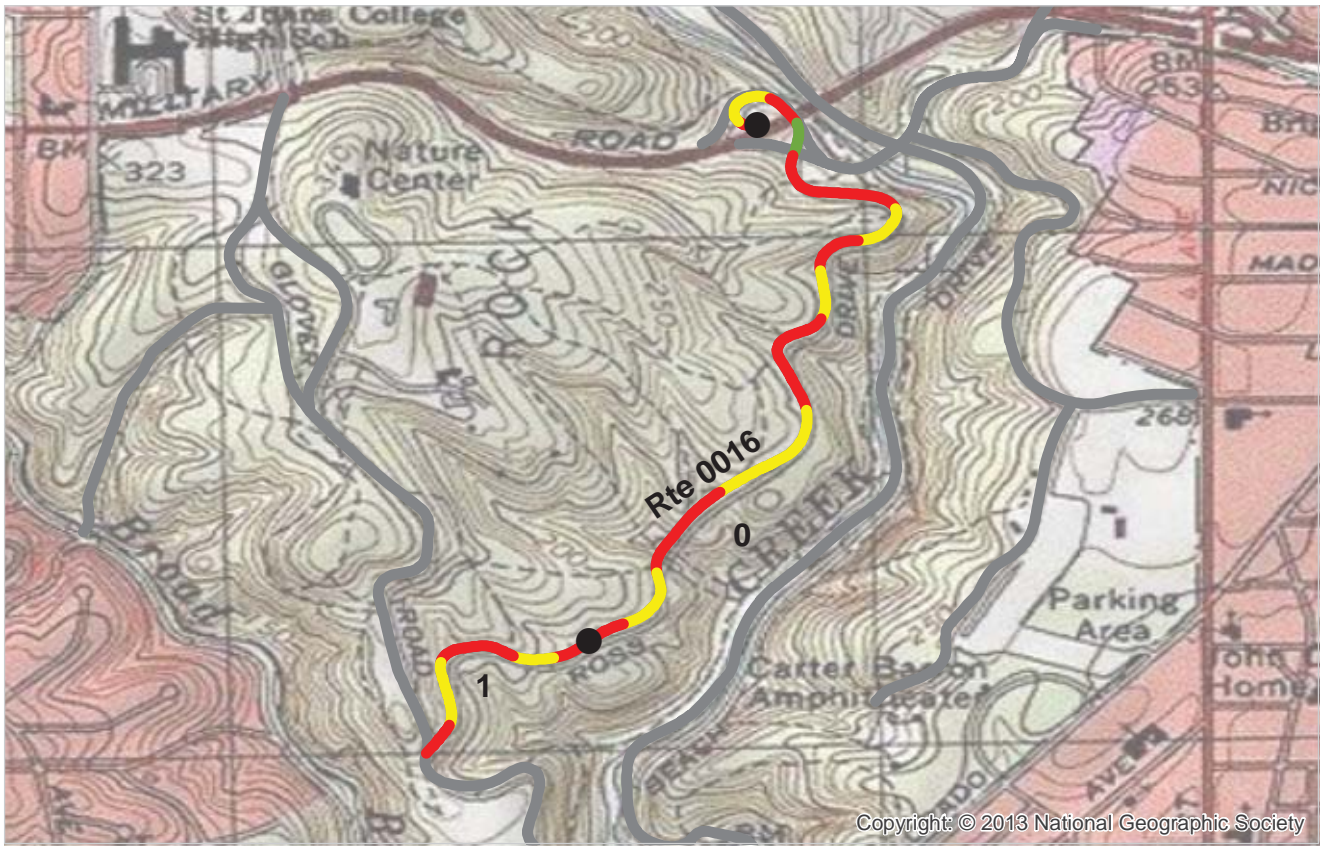
**ROUTE: 0016 ROSS DRIVE NORTHWEST**

Section Number	0	1			
Section Length (mi)	1.00	0.27			
<b>Cross Section Information</b>					
Number of Lanes	2	2			
Paved Width (ft)	19	22			
Lane Width (ft)	10	11			
<b>Roadway Condition Information</b>					
SCR (Surface Condition Rating)	63	69			
PCR (Pavement Condition Rating)	59	66			
<b>Distress Index Values</b>					
Structural Crack Index	63	70			
Transverse Cracking Index	93	95			
Patching Index	99	100			
Rutting Index	72	69			
Roughness Condition Index (RCI)	52	61

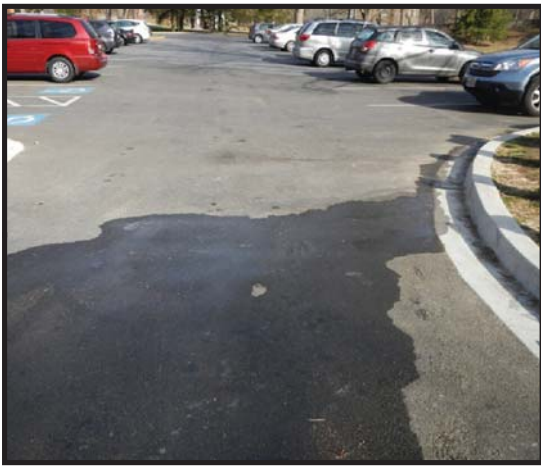
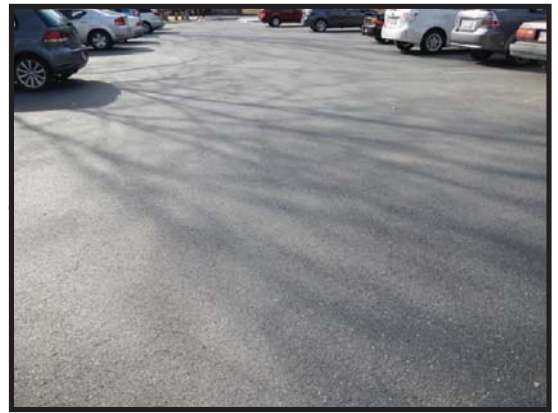
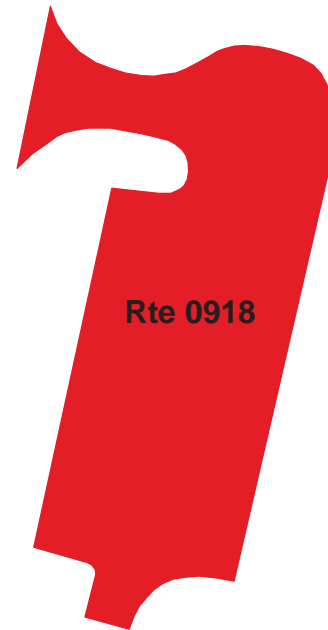
**ROCK CREEK PARK**  
**Route 0918**  
**PICNIC GROVE #1 PARKING**  
**FROM SHOEMAKER STREET NORTHWEST**  
**TO PARKING**

Route Number	Public / NonPublic	Date Visited	Area (sq ft)	Lane Miles *	Surface Type
0918	PUBLIC	1/8/2013	10,686	0.18	AS
Culverts	Drop Inlets	Gates	Curb & Gutter	Curb	PCR
0	2	1	CONCRETE CURB AND GUTTER	NO CURB	GOOD/90

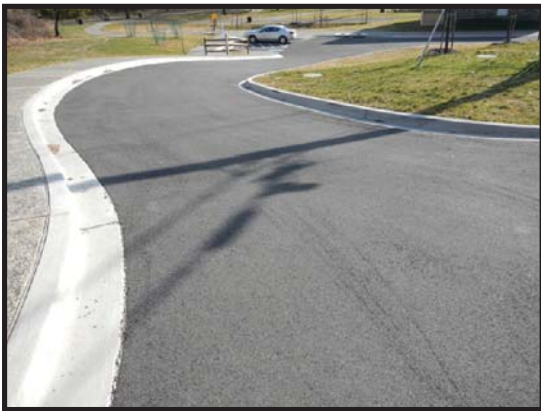
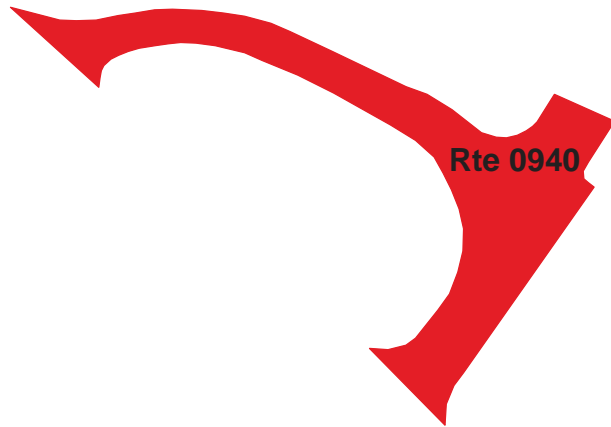
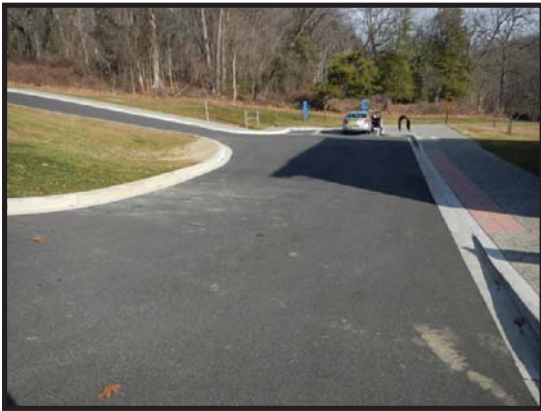
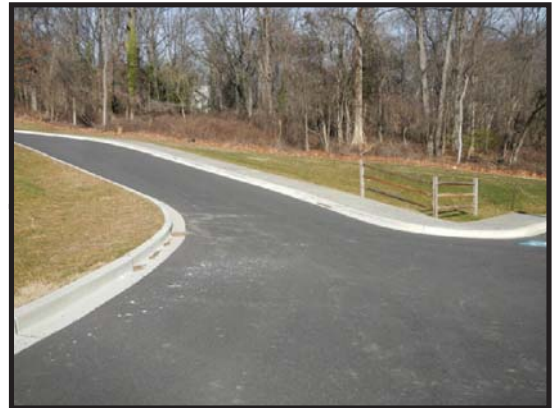
**ROCK CREEK PARK**  
**Route 0940**  
 PIERCE MILL BUS LOOP  
 FROM TILDEN STREET NORTHWEST  
 TO TILDEN STREET NORTHWEST

Route Number	Public / NonPublic	Date Visited	Area (sq ft)	Lane Miles *	Surface Type
0940	PUBLIC	1/8/2013	4,274	0.07	AS
Culverts	Drop Inlets	Gates	Curb & Gutter	Curb	PCR
0	4	0	CONCRETE CURB AND GUTTER	NO CURB	EXCELLENT/97
