Federal Lands Highway Road Inventory Program

Road Inventory and Condition Assessment

Russell Cave National Monument RUCA

Cycle 5 Report

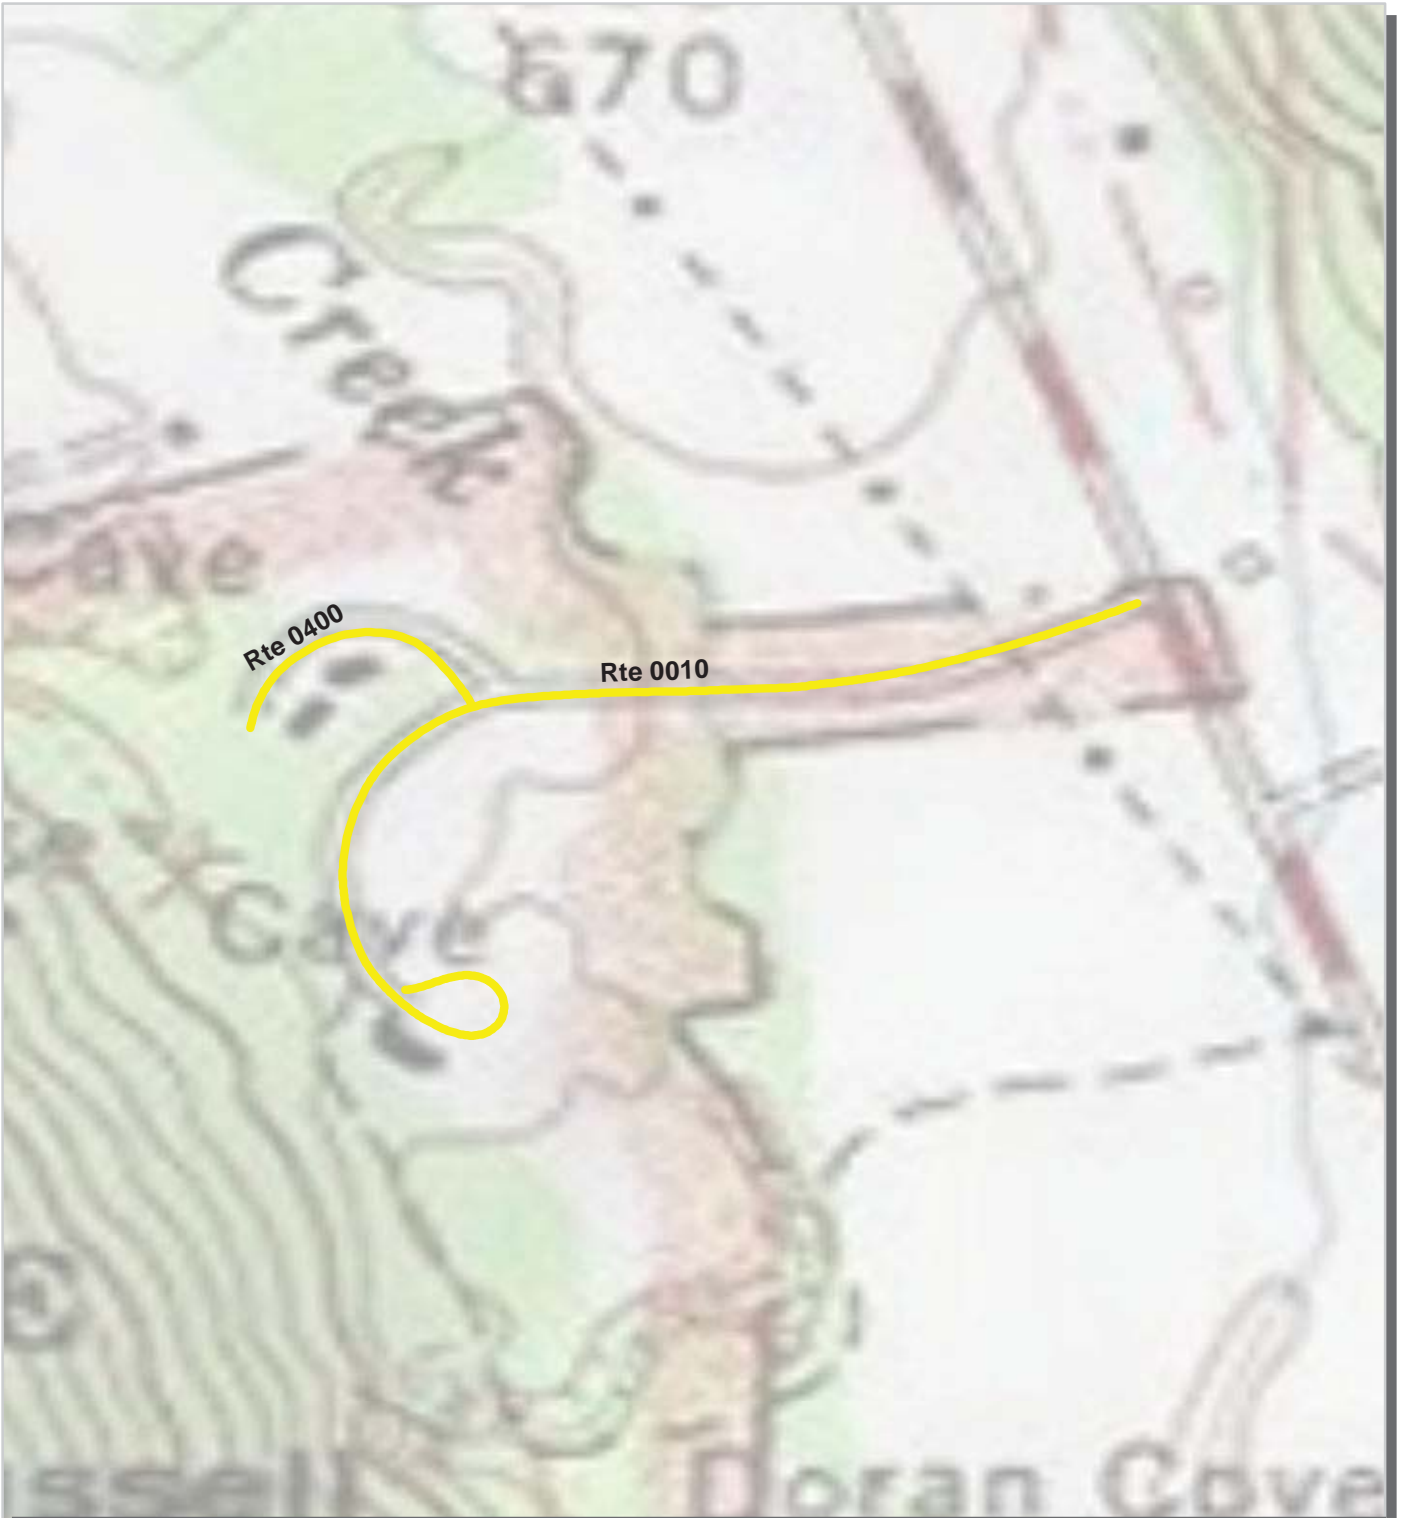
**Russell Cave National Monument
Route Condition Map
PCR - Mile by Mile
Area 1**

PCR	Poor	Fair	Good	Excellent	No Data
	(0 - 60)	(61 - 84)	(85 - 94)	(95 - 100)

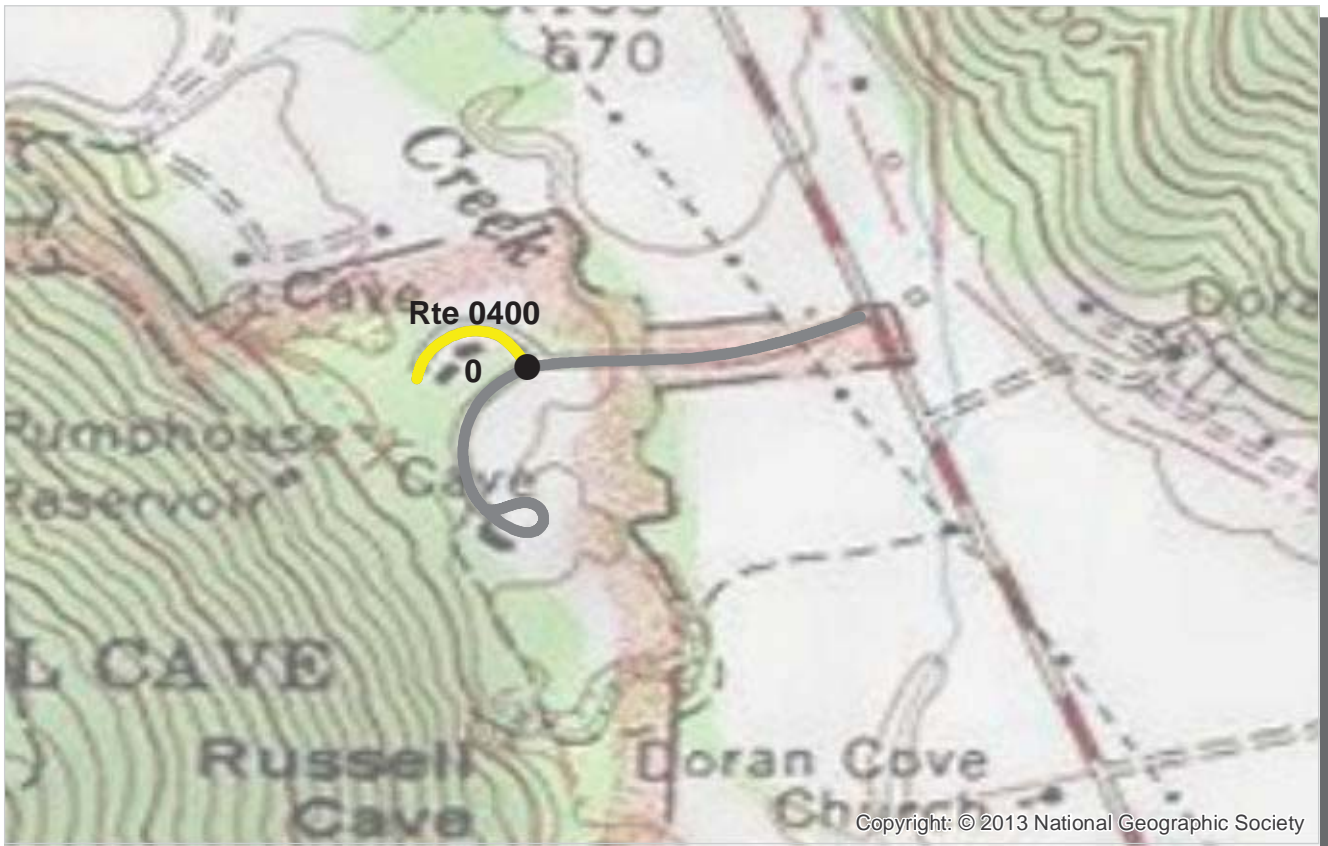
ROUTE: 0400 RESIDENCE AREA ROAD

Section Number	0				
Section Length (mi)	0.09				
Cross Section Information					
Number of Lanes	2				
Paved Width (ft)	17				
Lane Width (ft)	9				
Roadway Condition Information					
SCR (Surface Condition Rating)	NC				
PCR (Pavement Condition Rating)	73				
Distress Index Values					
Structural Crack Index	NC				
Transverse Cracking Index	NC				
Patching Index	NC				
Rutting Index	NC				
Roughness Condition Index (RCI)	NC

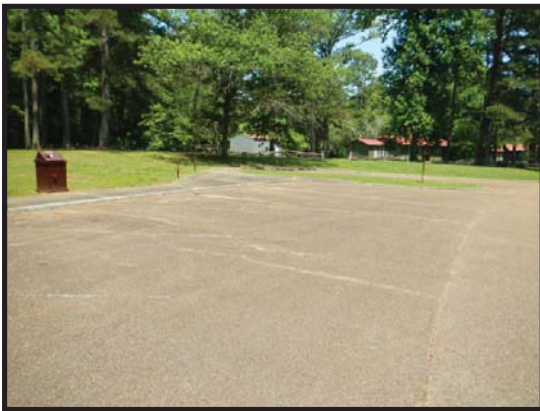
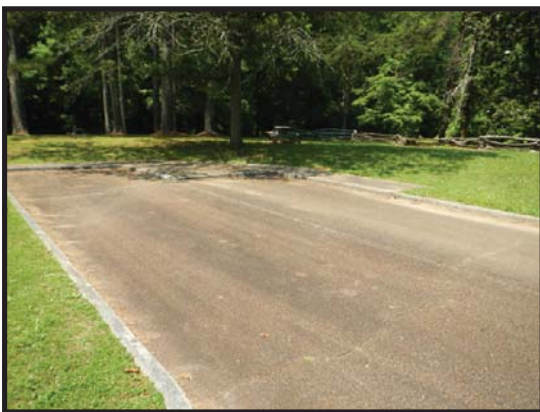
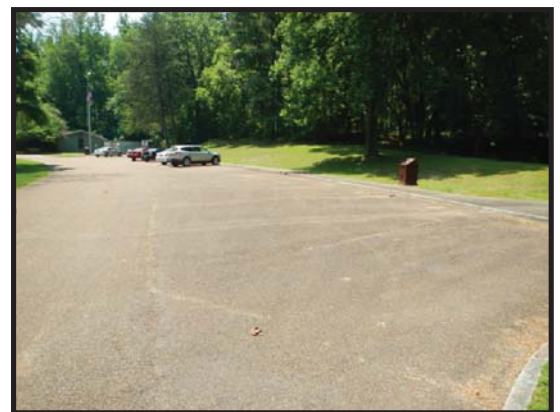
Route Number	Public / NonPublic	Date Visited	Area (sq ft)	Lane Miles *	Surface Type
0900	PUBLIC	5/24/2012	7,209	0.12	AS
Culverts	Drop Inlets	Gates	Curb & Gutter	Curb	PCR
0	0	0	NO CURB AND GUTTER	CONCRETE CURB	FAIR/73

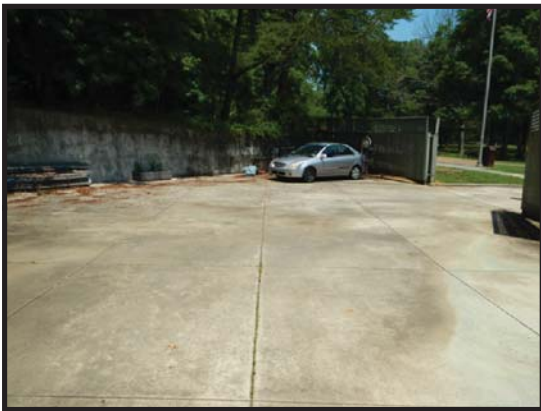
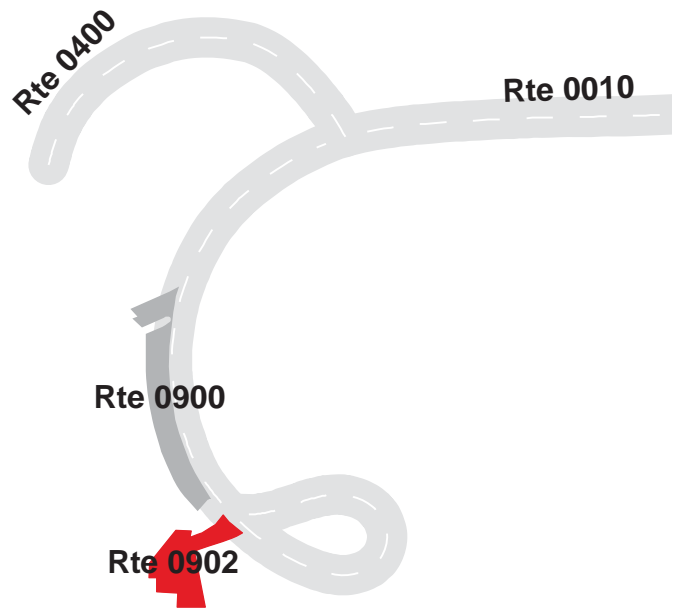
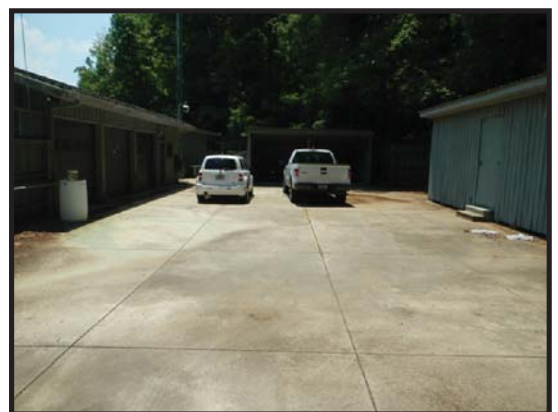
Route 0902

Route Number	Public / NonPublic	Date Visited	Area (sq ft)	Lane Miles *	Surface Type
0902	NONPUBLIC	5/24/2012	4,937	0.09	CO
Culverts	Drop Inlets	Gates	Curb & Gutter	Curb	PCR
0	0	2	NO CURB AND GUTTER	CONCRETE CURB	GOOD/90
