Federal Lands Highway Road Inventory Program

Road Inventory and Condition Assessment

St. Croix National Scenic Riverway SACN

Cycle 5 Report

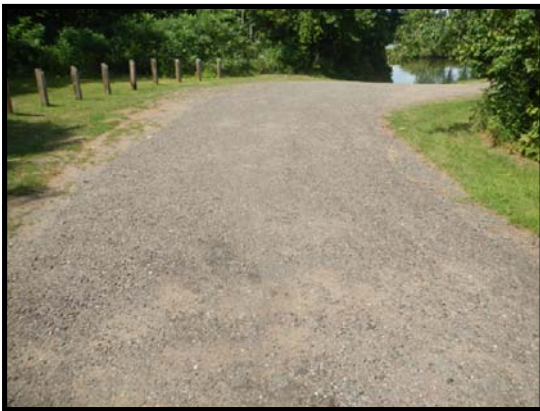
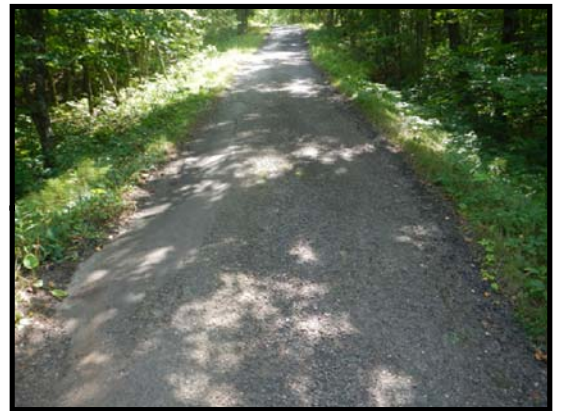
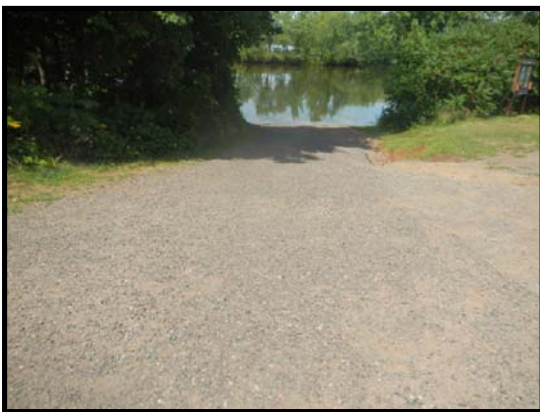
Route 0201

Route Number	Public / NonPublic	Date Visited	Area (sq ft)	Lane Miles *	Paved Length (mi)	Paved Width (ft)
0201	PUBLIC	8/11/2012	3,231	0.06	0.04	17
Culverts	Drop Inlets	Gates	Curb & Gutter	Curb	PCR	Surface Type
0	0	0	NO CURB AND GUTTER	NO CURB	GOOD/90	AS

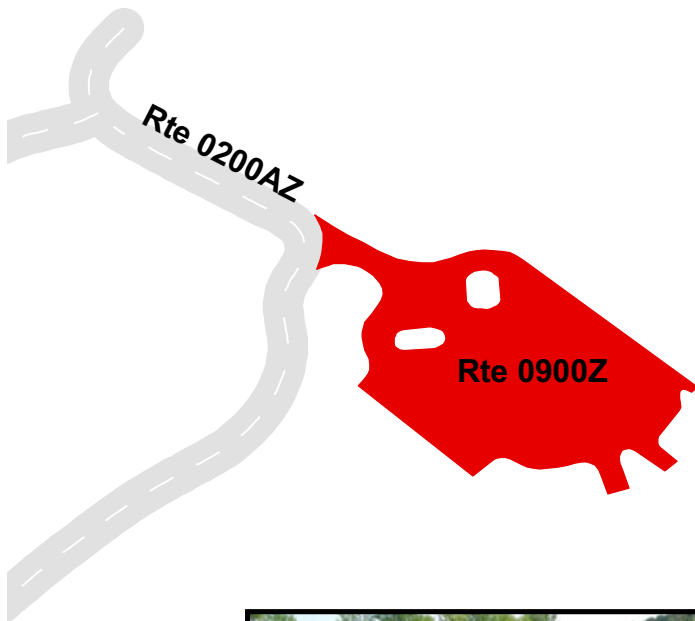
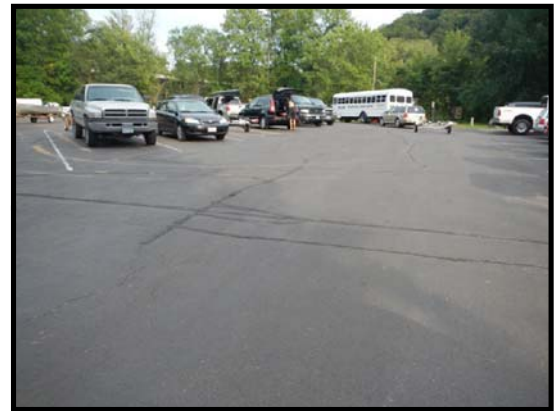
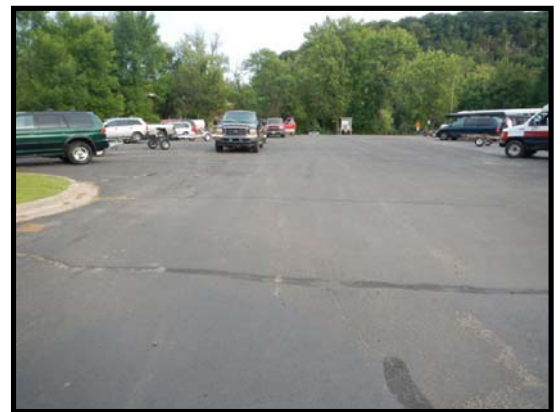
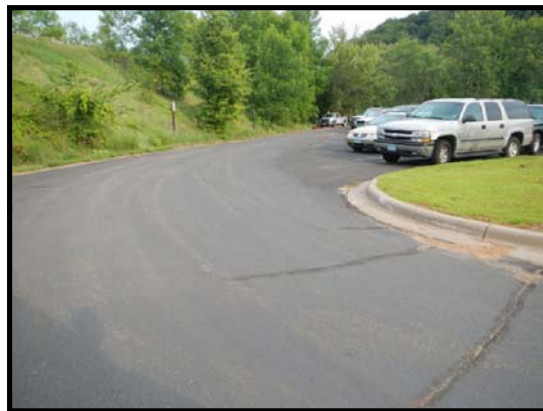
Route 0914Z

Route Number	Public / NonPublic	Date Visited	Area (sq ft)	Lane Miles *	Surface Type
0914Z	PUBLIC	8/11/2012	11,498	0.20	AS
Culverts	Drop Inlets	Gates	Curb & Gutter	Curb	PCR
0	0	0	NO CURB AND GUTTER	NO CURB	FAIR/73

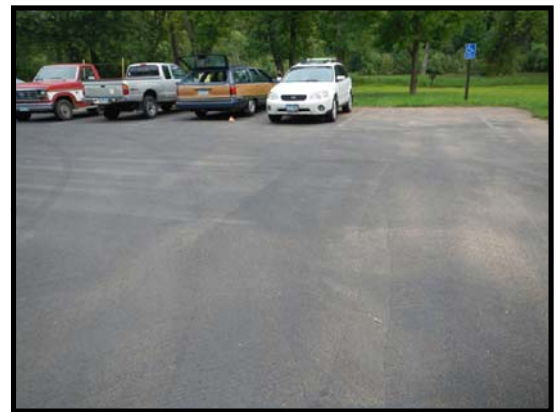
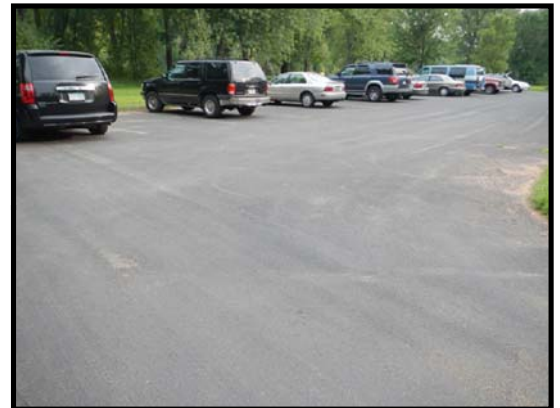
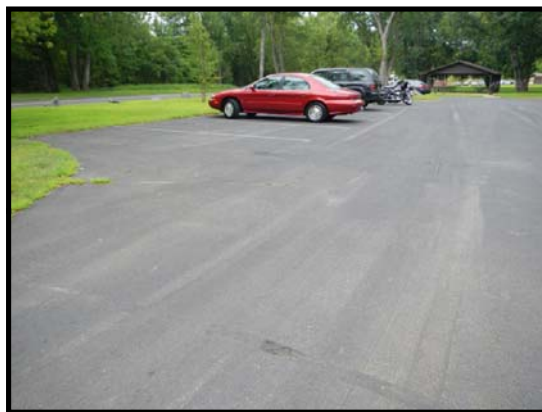
Route 0915Z

Route Number	Public / NonPublic	Date Visited	Area (sq ft)	Lane Miles *	Surface Type
0915Z	PUBLIC	8/11/2012	9,355	0.16	AS
Culverts	Drop Inlets	Gates	Curb & Gutter	Curb	PCR
0	0	0	NO CURB AND GUTTER	NO CURB	FAIR/73

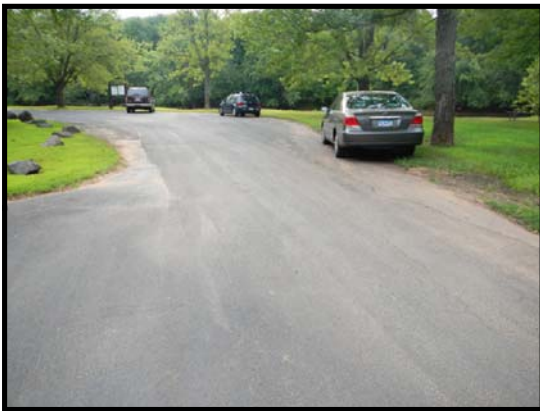
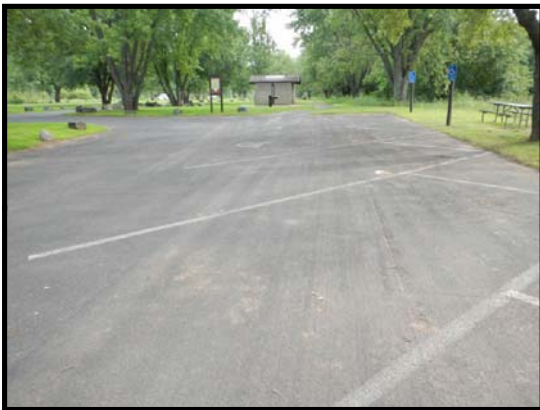
Route 0916Z

Route Number	Public / NonPublic	Date Visited	Area (sq ft)	Lane Miles *	Surface Type
0916Z	PUBLIC	8/11/2012	4,391	0.08	AS
Culverts	Drop Inlets	Gates	Curb & Gutter	Curb	PCR
0	0	0	NO CURB AND GUTTER	NO CURB	GOOD/90

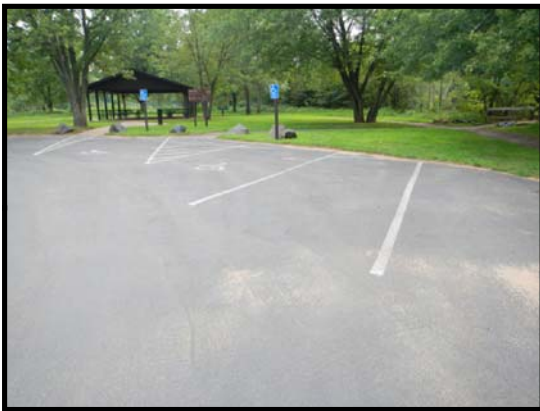
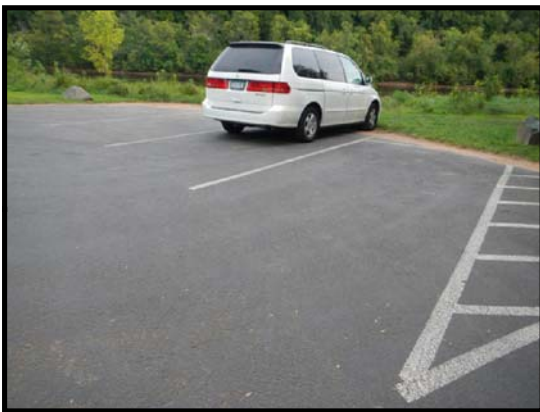
Route 0902

Route Number	Public / NonPublic	Date Visited	Area (sq ft)	Lane Miles *	Surface Type
0902	PUBLIC	8/11/2012	26,714	0.46	AS
Culverts	Drop Inlets	Gates	Curb & Gutter	Curb	PCR
0	0	0	NO CURB AND GUTTER	NO CURB	POOR/45

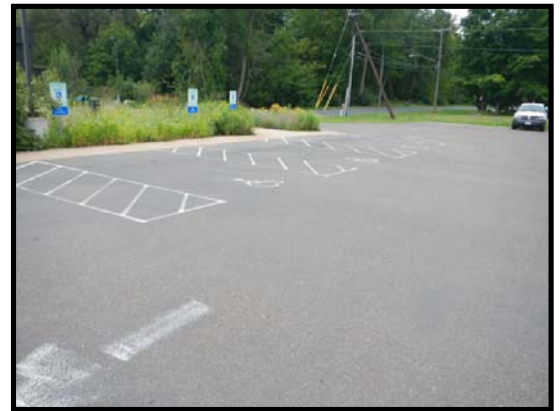
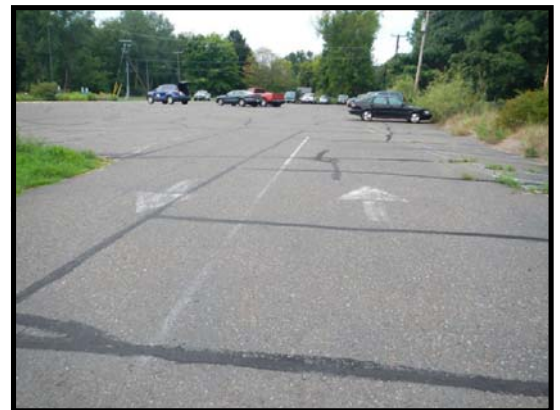
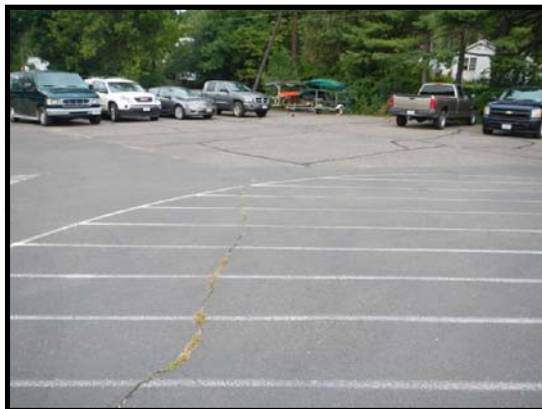
Route 0903

Route Number	Public / NonPublic	Date Visited	Area (sq ft)	Lane Miles *	Surface Type
0903	PUBLIC	8/11/2012	31,978	0.55	AS
Culverts	Drop Inlets	Gates	Curb & Gutter	Curb	PCR
0	0	0	NO CURB AND GUTTER	NO CURB	GOOD/90

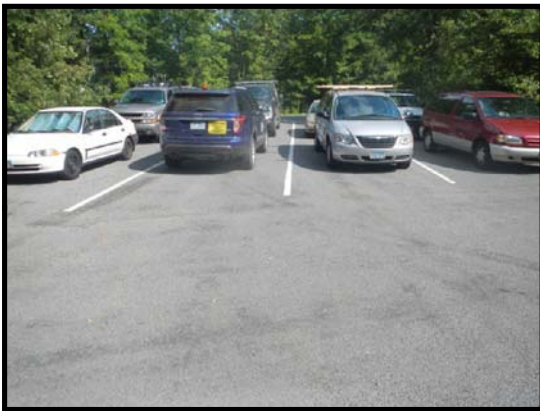
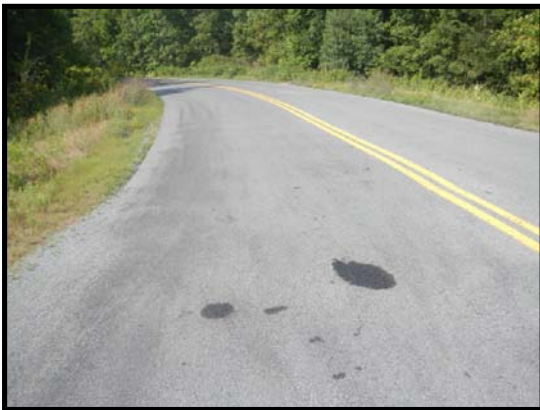
Route 0904

Route Number	Public / NonPublic	Date Visited	Area (sq ft)	Lane Miles *	Surface Type
0904	PUBLIC	8/11/2012	26,230	0.45	AS
Culverts	Drop Inlets	Gates	Curb & Gutter	Curb	PCR
0	0	0	CONCRETE CURB AND GUTTER	NO CURB	GOOD/90

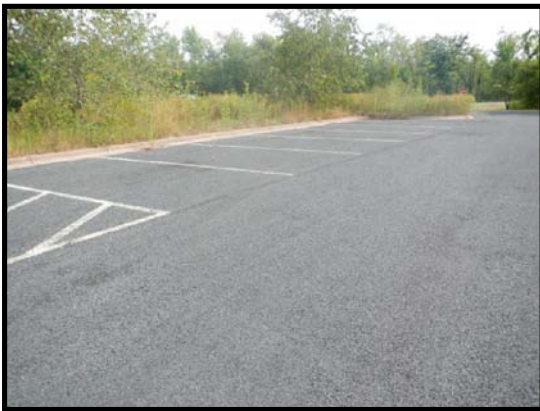
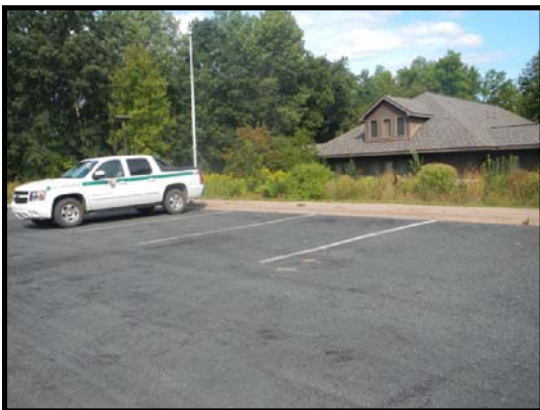
Route 0907

Route Number	Public / NonPublic	Date Visited	Area (sq ft)	Lane Miles *	Surface Type
0907	PUBLIC	8/11/2012	2,869	0.05	AS
Culverts	Drop Inlets	Gates	Curb & Gutter	Curb	PCR
0	0	0	NO CURB AND GUTTER	NO CURB	POOR/45

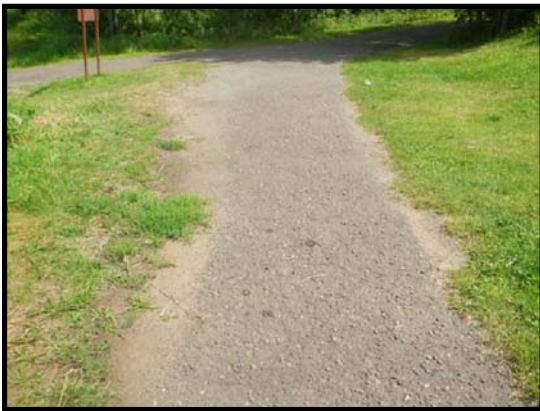
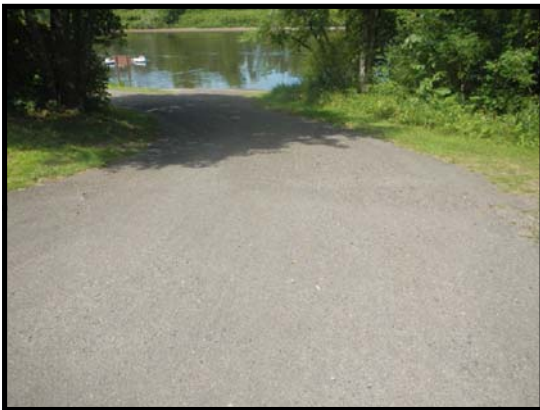
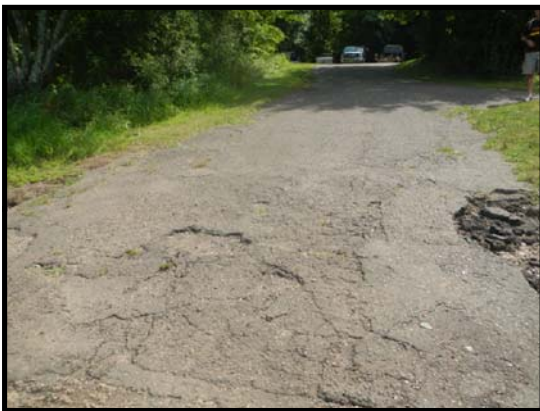
Route 0908

Route Number	Public / NonPublic	Date Visited	Area (sq ft)	Lane Miles *	Surface Type
0908	PUBLIC	8/11/2012	16,719	0.29	AS
Culverts	Drop Inlets	Gates	Curb & Gutter	Curb	PCR
1	0	0	NO CURB AND GUTTER	ASPHALT CURB	GOOD/90

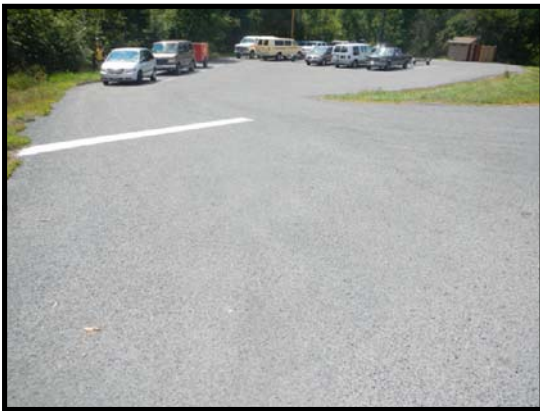
Route 0909

Route Number	Public / NonPublic	Date Visited	Area (sq ft)	Lane Miles *	Surface Type
0909	PUBLIC	8/11/2012	47,063	0.81	AS
Culverts	Drop Inlets	Gates	Curb & Gutter	Curb	PCR
0	0	1	CONCRETE CURB AND GUTTER	NO CURB	GOOD/90

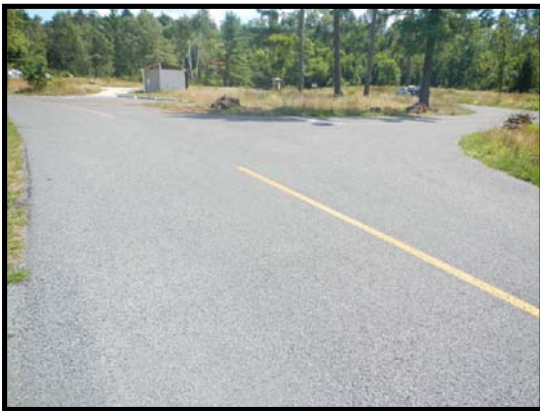
Route 0911

Route Number	Public / NonPublic	Date Visited	Area (sq ft)	Lane Miles *	Surface Type
0911	PUBLIC	8/11/2012	8,568	0.15	AS
Culverts	Drop Inlets	Gates	Curb & Gutter	Curb	PCR
0	0	0	NO CURB AND GUTTER	NO CURB	GOOD/90

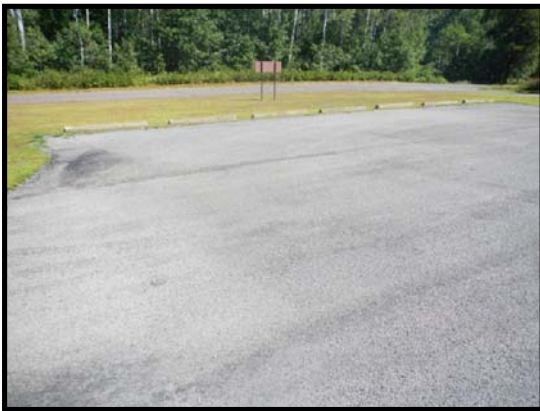
Route 0912

Route Number	Public / NonPublic	Date Visited	Area (sq ft)	Lane Miles *	Surface Type
0912	PUBLIC	8/11/2012	27,082	0.47	AS
Culverts	Drop Inlets	Gates	Curb & Gutter	Curb	PCR
0	0	0	CONCRETE CURB AND GUTTER	NO CURB	GOOD/90

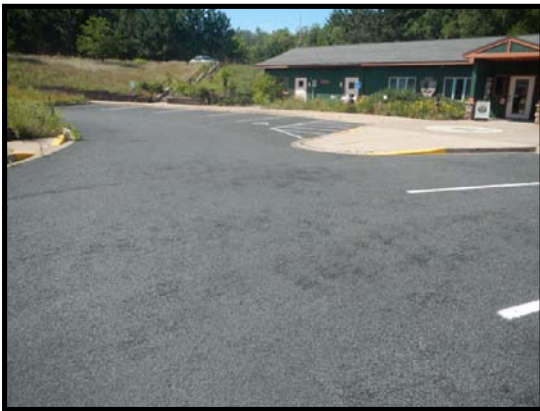
Route 0913

Route Number	Public / NonPublic	Date Visited	Area (sq ft)	Lane Miles *	Surface Type
0913	PUBLIC	8/11/2012	13,344	0.23	AS
Culverts	Drop Inlets	Gates	Curb & Gutter	Curb	PCR
0	0	0	NO CURB AND GUTTER	NO CURB	FAIR/73

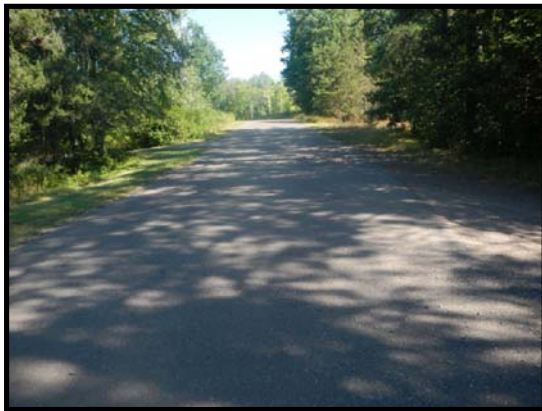
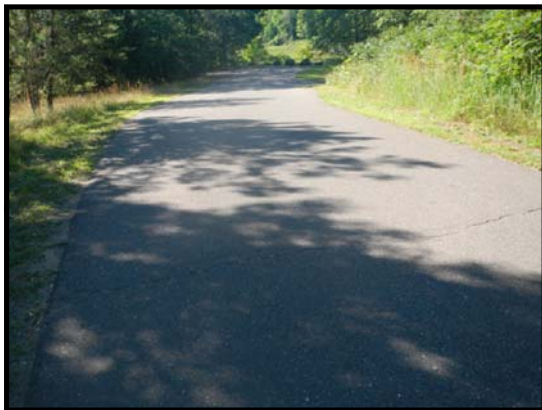
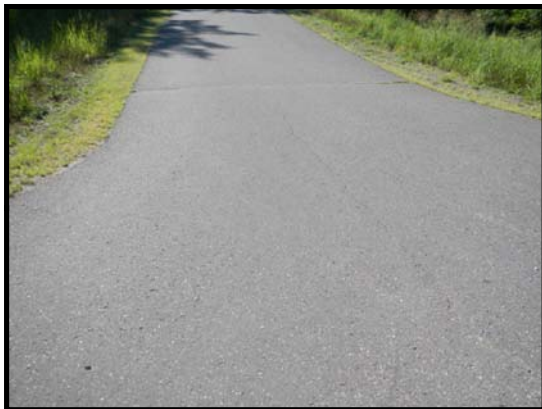
Route 0932

Route Number	Public / NonPublic	Date Visited	Area (sq ft)	Lane Miles *	Surface Type
0932	PUBLIC	8/11/2012	35,590	0.61	AS
Culverts	Drop Inlets	Gates	Curb & Gutter	Curb	PCR
0	0	0	CONCRETE CURB AND GUTTER	NO CURB	GOOD/90
