Federal Lands Highway Road Inventory Program

Road Inventory and Condition Assessment

San Francisco Maritime National Historical Park

Cycle 5 Report

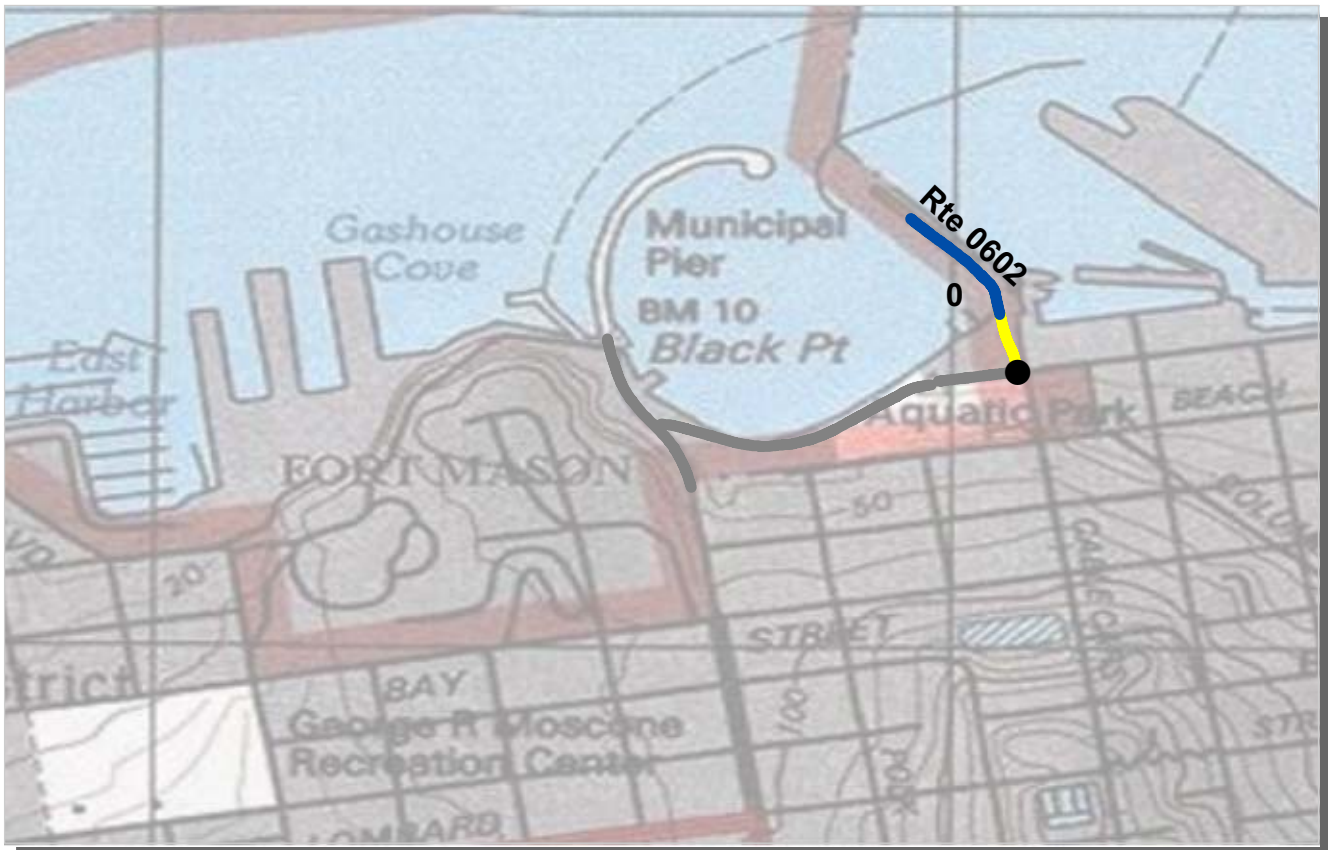
ROUTE: 0602 HYDE STREET HISTORIC ROAD / PIER

Section Number	0				
Section Length (mi)	0.18				
Cross Section Information					
Number of Lanes	2				
Paved Width (ft)	28				
Lane Width (ft)	17				
Roadway Condition Information					
SCR (Surface Condition Rating)	95				
PCR (Pavement Condition Rating)	95				
Distress Index Values					
Structural Crack Index	95				
Transverse Cracking Index	96				
Patching Index	96				
Rutting Index	95				
Roughness Condition Index (RCI)	NC

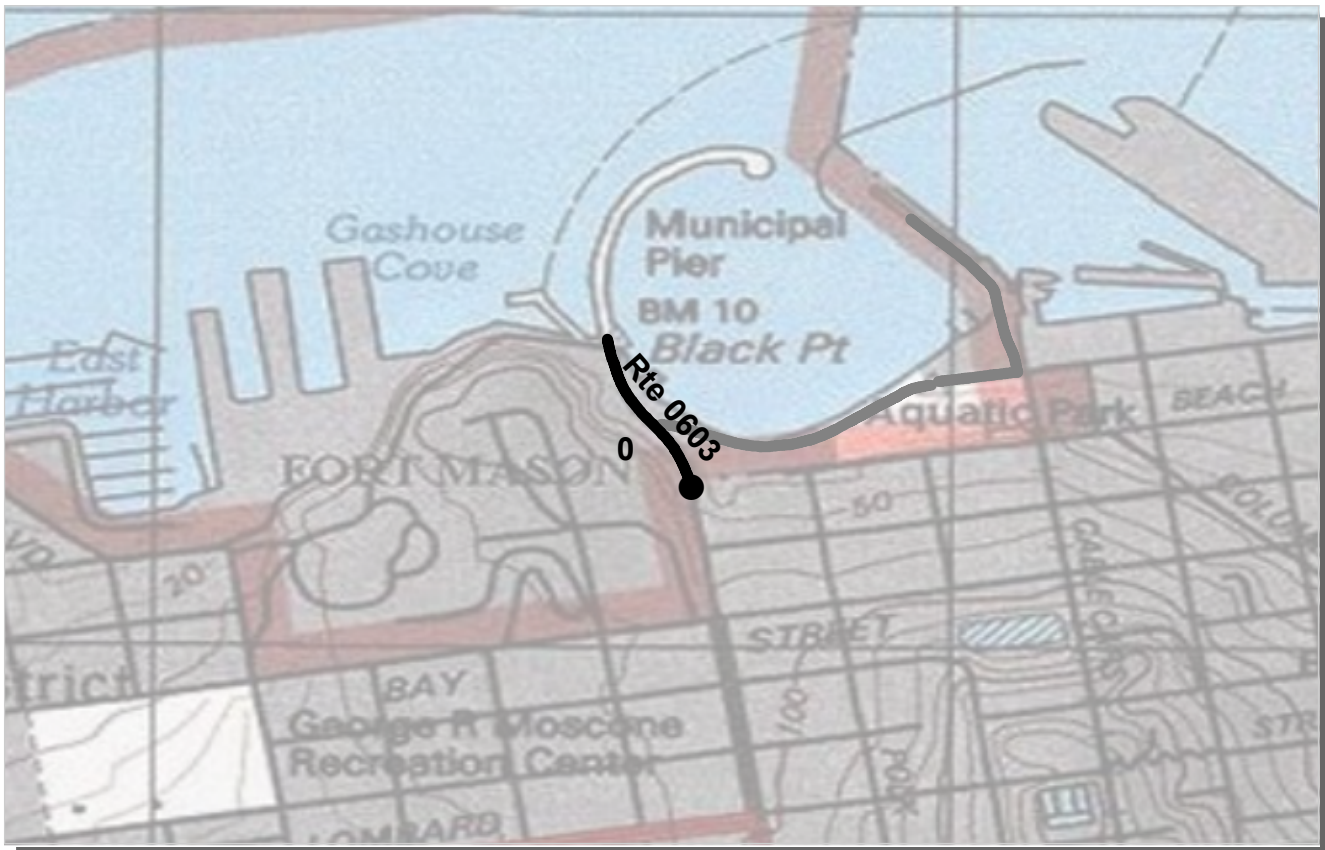
ROUTE: 0603 LOWER VAN NESS ROAD

Section Number	0				
Section Length (mi)	0.16				
Cross Section Information					
Number of Lanes	2				
Paved Width (ft)	21				
Lane Width (ft)	11				
Roadway Condition Information					
SCR (Surface Condition Rating)	NC				
PCR (Pavement Condition Rating)	NC				
Distress Index Values					
Structural Crack Index	NC				
Transverse Cracking Index	NC				
Patching Index	NC				
Rutting Index	NC				
Roughness Condition Index (RCI)	NC

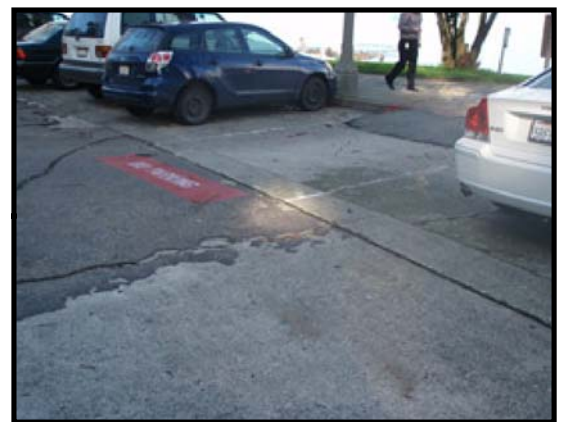
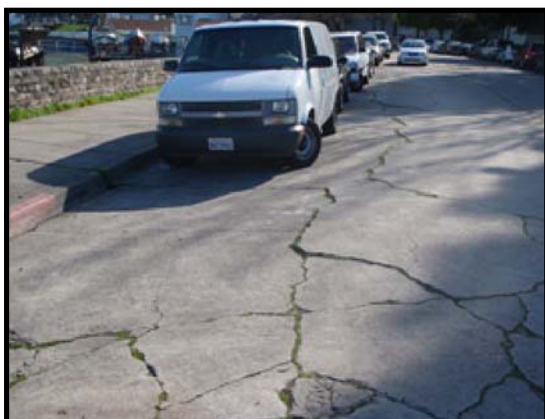
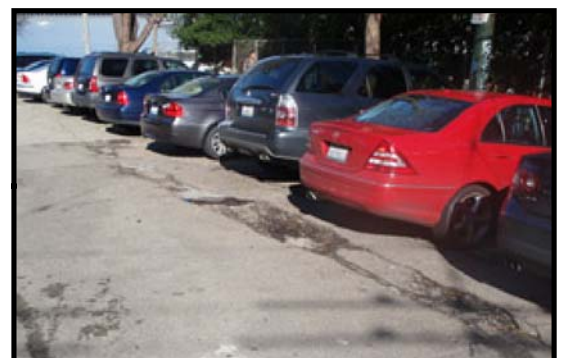
Route 0900BZ

Route Number	Public / NonPublic	Date Visited	Area (sq ft)	Lane Miles *	Surface Type
0900BZ	PUBLIC	1/27/2010	14,749	0.25	CO
Culverts	Drop Inlets	Gates	Curb & Gutter	Curb	PCR
0	1	0	NO CURB AND GUTTER	CONCRETE & STONE CURB	POOR/45

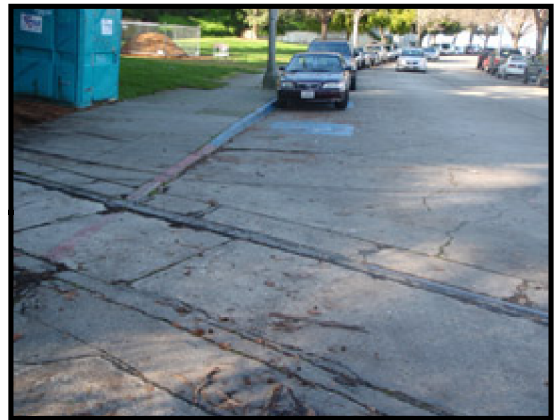
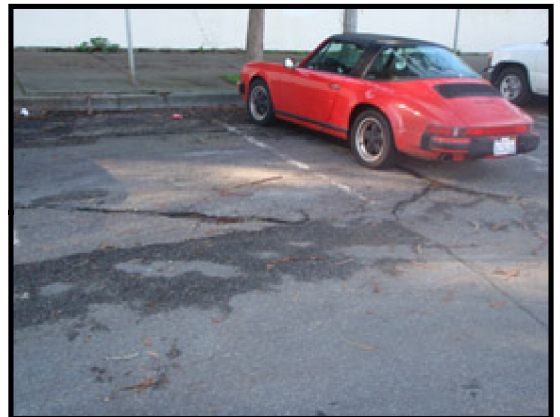
Route 0900CZ

Route Number	Public / NonPublic	Date Visited	Area (sq ft)	Lane Miles *	Surface Type
0900CZ	PUBLIC	1/27/2010	1,022	0.02	CO
Culverts	Drop Inlets	Gates	Curb & Gutter	Curb	PCR
0	0	0	NO CURB AND GUTTER	CONCRETE CURB	POOR/45

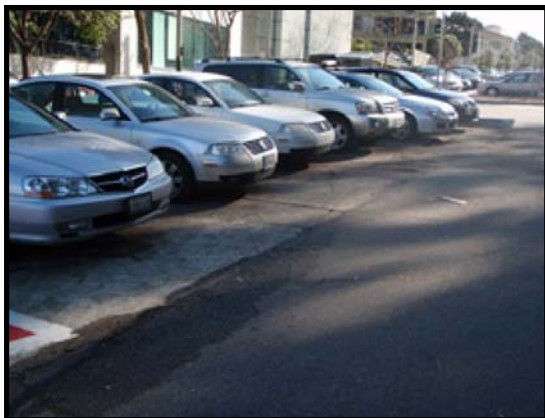
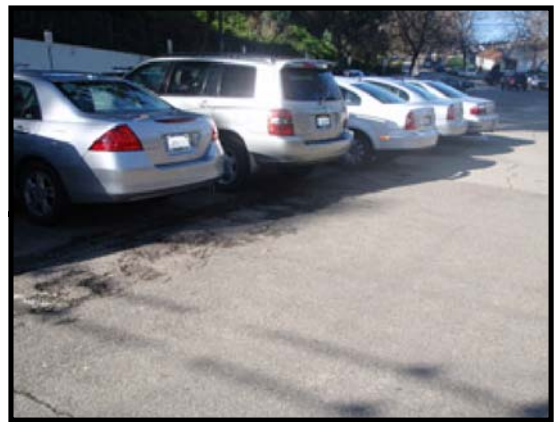
Route 0901A

Route Number	Public / NonPublic	Date Visited	Area (sq ft)	Lane Miles *	Surface Type
0901A	PUBLIC	1/27/2010	1,763	0.03	AS
Culverts	Drop Inlets	Gates	Curb & Gutter	Curb	PCR
0	0	0	NO CURB AND GUTTER	CONCRETE CURB	GOOD/90

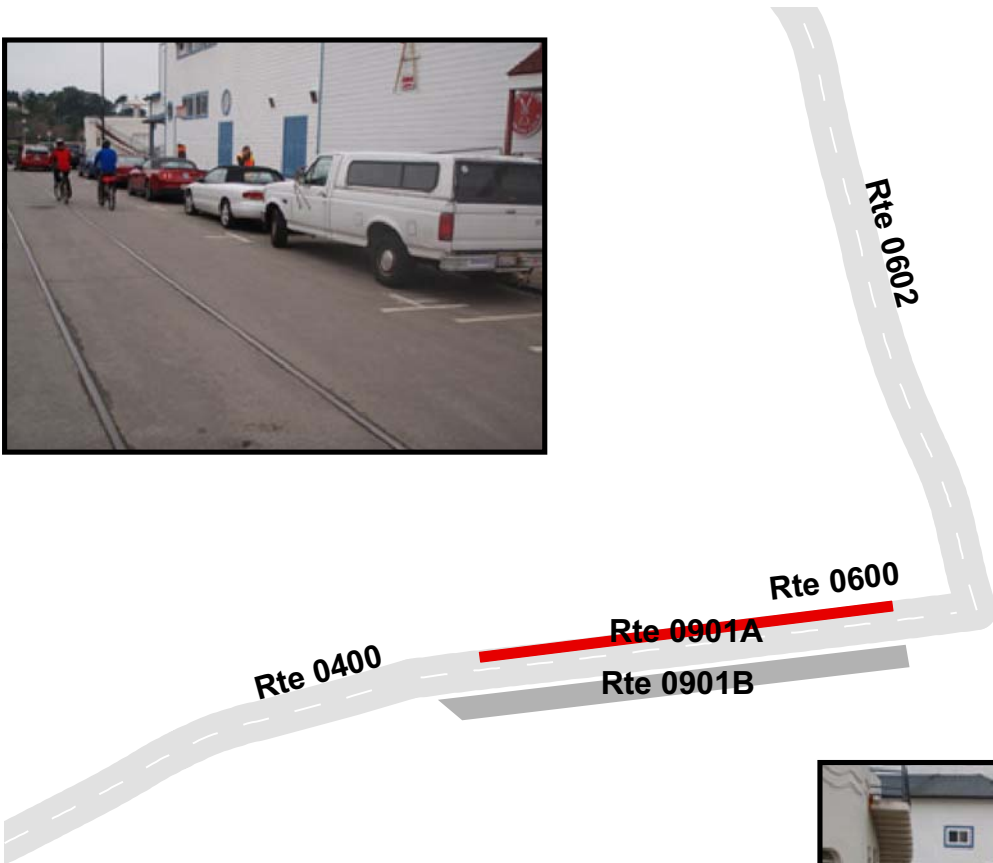
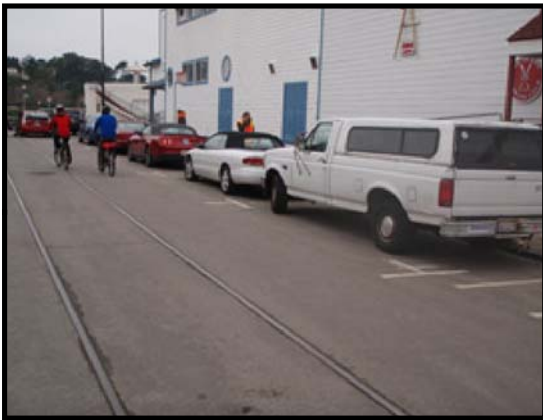
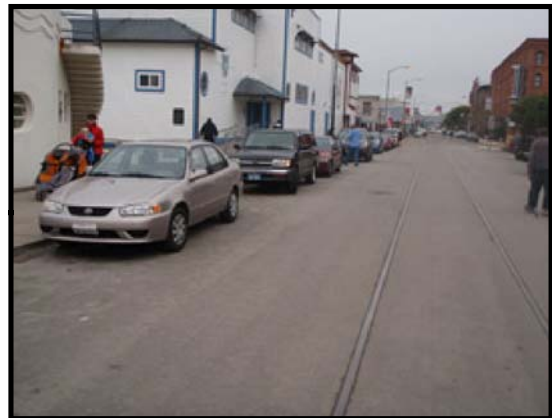
Route 0901B

Route Number	Public / NonPublic	Date Visited	Area (sq ft)	Lane Miles *	Surface Type
0901B	PUBLIC	1/27/2010	4,480	0.08	AS
Culverts	Drop Inlets	Gates	Curb & Gutter	Curb	PCR
0	0	0	NO CURB AND GUTTER	CONCRETE CURB	GOOD/90
