Federal Lands Highway Road Inventory Program

Road Inventory and Condition Assessment

Sagamore Hill National Historic Site SAHI

Cycle 5 Report

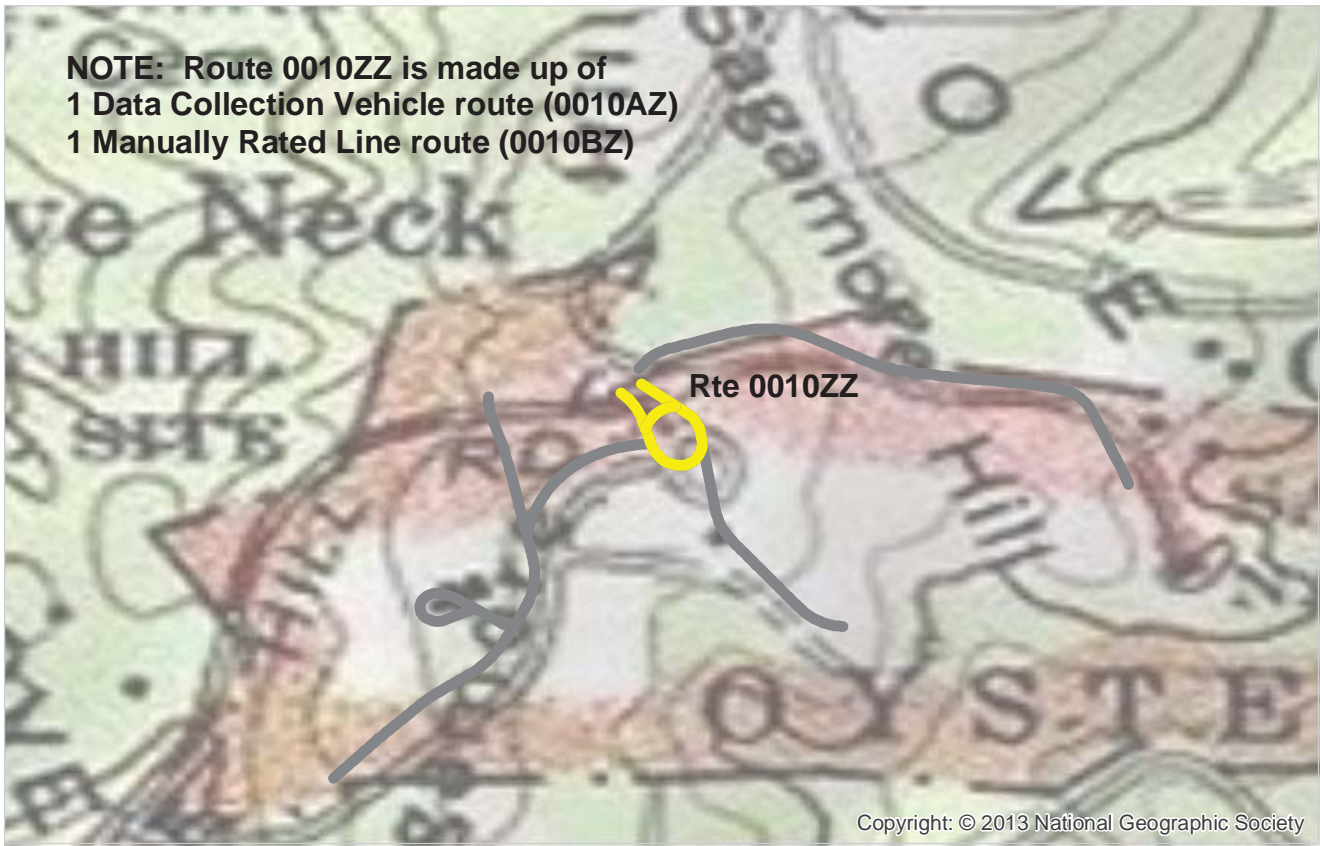
**NOTE: Route 0010ZZ is made up of
1 Data Collection Vehicle route (0010AZ)
1 Manually Rated Line route (0010BZ)**

Section Number					
Section Length (mi)					
Cross Section Information					
Number of Lanes	N/A				
Paved Width (ft)	N/A				
Lane Width (ft)	N/A				
Roadway Condition Information					
SCR (Surface Condition Rating)	77				
PCR (Pavement Condition Rating)	79				
Distress Index Values					
Structural Crack Index	N/A				
Transverse Cracking Index	N/A				
Patching Index	N/A				
Rutting Index	N/A				
Roughness Condition Index (RCI)	N/A

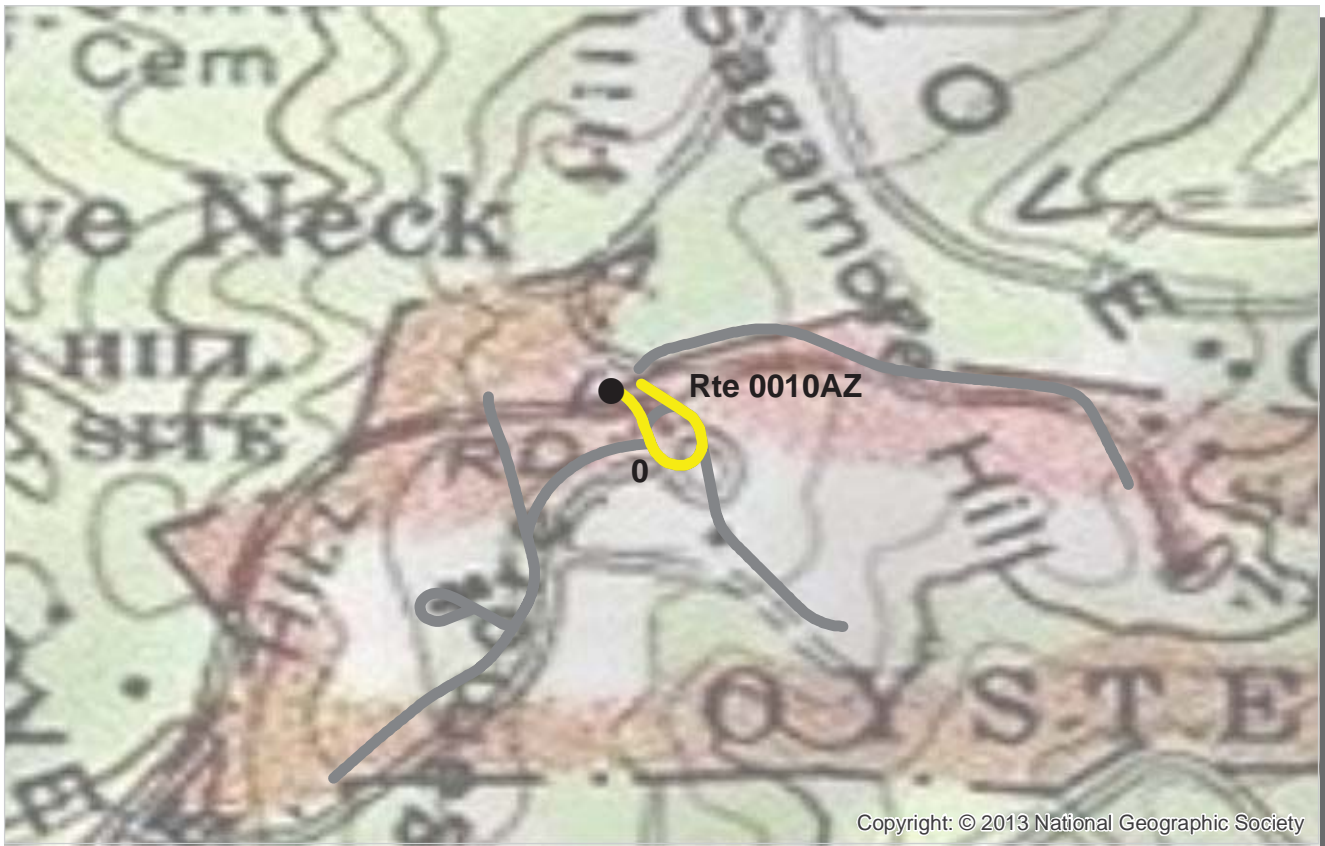
ROUTE: 0010ZZ ENTRY CIRCLE ROADS

<i>Section Number</i>	0				
<i>Section Length (mi)</i>	0.10				
<i>Cross Section Information</i>					
Number of Lanes	1				
Paved Width (ft)	20				
Lane Width (ft)	20				
<i>Roadway Condition Information</i>					
SCR (Surface Condition Rating)	77				
PCR (Pavement Condition Rating)	77				
<i>Distress Index Values</i>					
Structural Crack Index	91				
Transverse Cracking Index	77				
Patching Index	98				
Rutting Index	97				
Roughness Condition Index (RCI)	NC

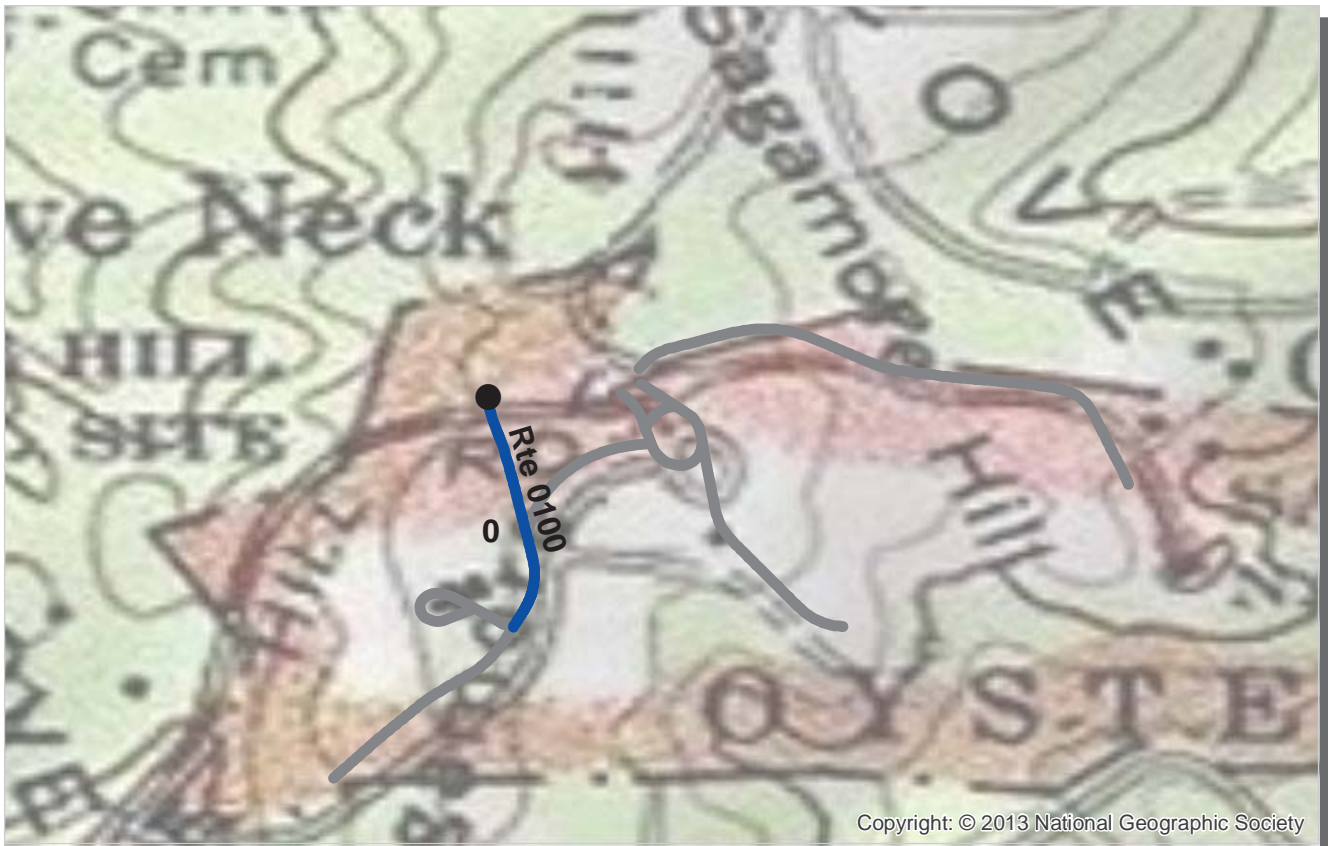
ROUTE: 0010AZ ENTRY CIRCLE ROAD A

Section Number	0				
Section Length (mi)	0.12				
Cross Section Information					
Number of Lanes	1				
Paved Width (ft)	13				
Lane Width (ft)	13				
Roadway Condition Information					
SCR (Surface Condition Rating)	98				
PCR (Pavement Condition Rating)	98				
Distress Index Values					
Structural Crack Index	98				
Transverse Cracking Index	100				
Patching Index	99				
Rutting Index	99				
Roughness Condition Index (RCI)	NC

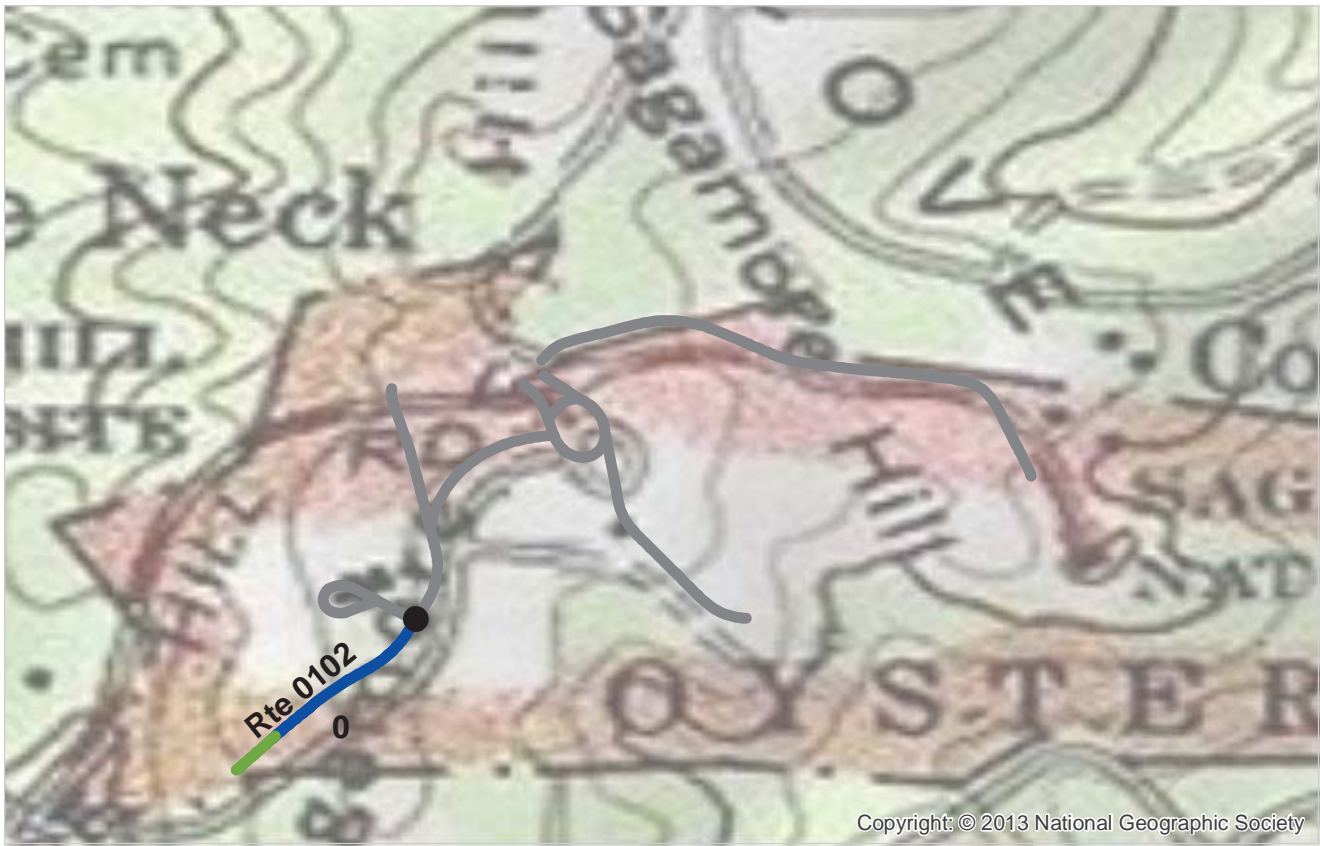
ROUTE: 0100 THEODORE ROOSEVELT HOUSE ROAD

Section Number	0				
Section Length (mi)	0.10				
Cross Section Information					
Number of Lanes	1				
Paved Width (ft)	14				
Lane Width (ft)	14				
Roadway Condition Information					
SCR (Surface Condition Rating)	97				
PCR (Pavement Condition Rating)	97				
Distress Index Values					
Structural Crack Index	98				
Transverse Cracking Index	97				
Patching Index	100				
Rutting Index	100				
Roughness Condition Index (RCI)	NC

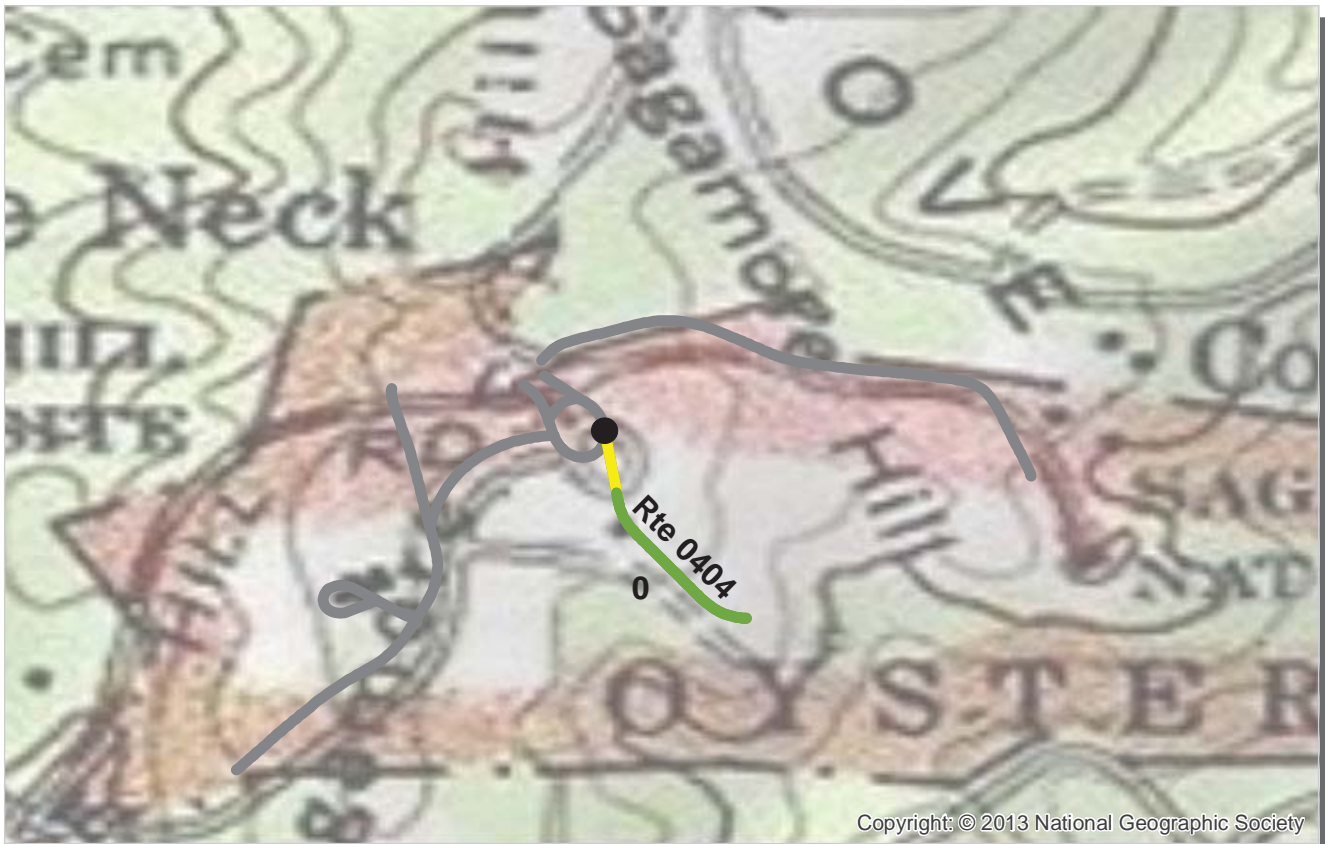
ROUTE: 0105 SPUR TO THEODORE ROOSEVELT HOUSE ROAD

<i>Section Number</i>	0				
<i>Section Length (mi)</i>	0.10				
<i>Cross Section Information</i>					
Number of Lanes	1				
Paved Width (ft)	11				
Lane Width (ft)	11				
<i>Roadway Condition Information</i>					
SCR (Surface Condition Rating)	91				
PCR (Pavement Condition Rating)	91				
<i>Distress Index Values</i>					
Structural Crack Index	91				
Transverse Cracking Index	93				
Patching Index	99				
Rutting Index	99				
Roughness Condition Index (RCI)	NC

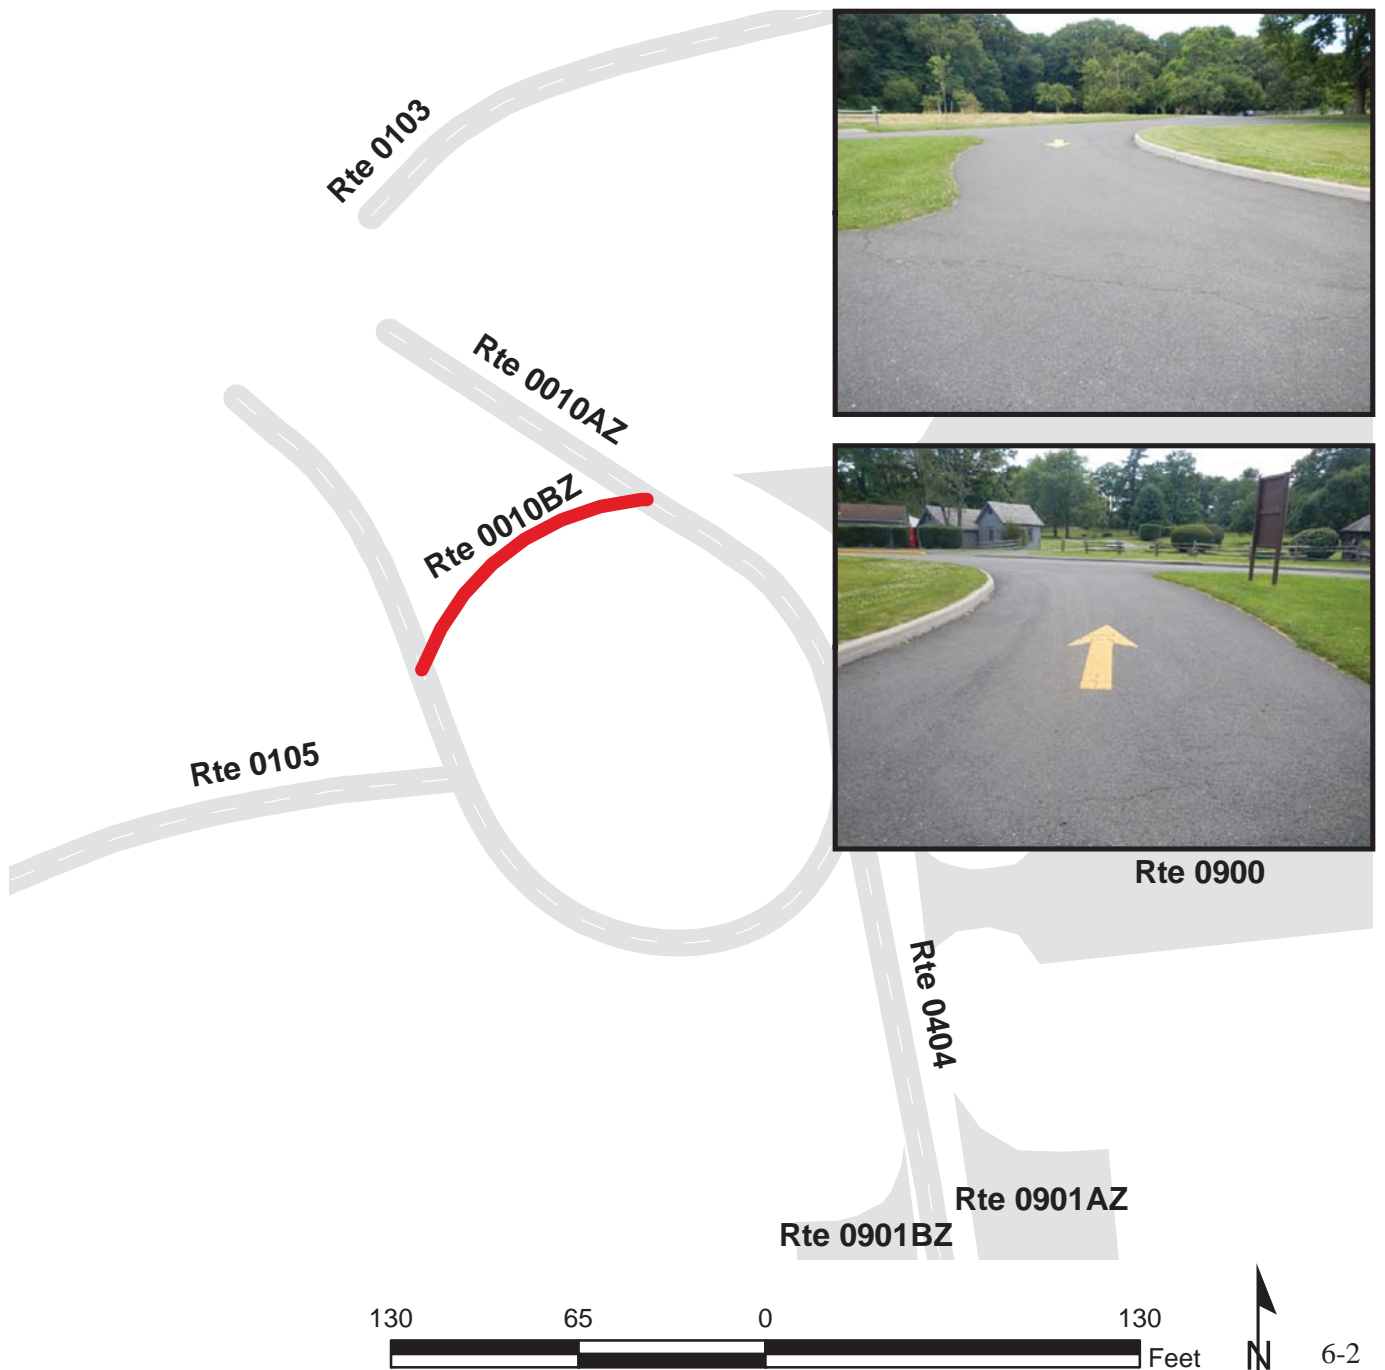
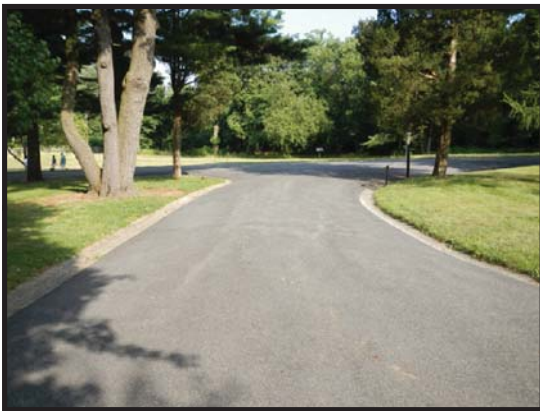
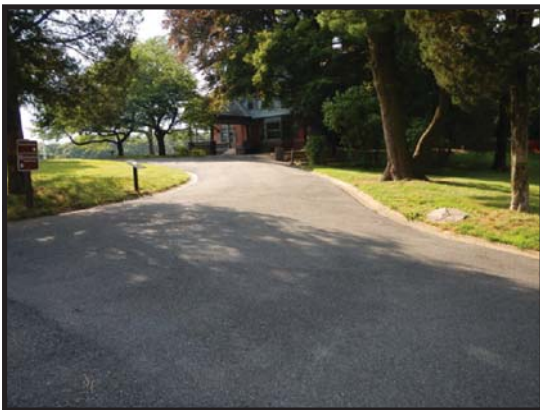
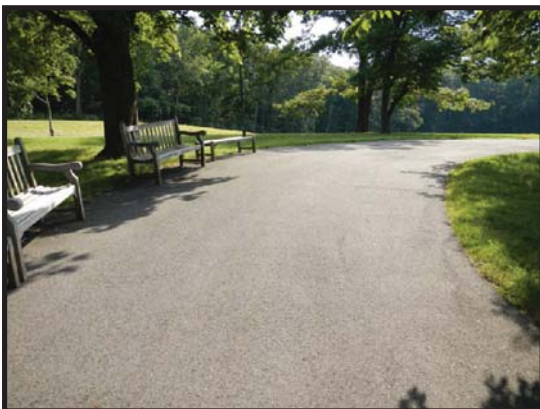
Route 0106

Route Number	Public / NonPublic	Date Visited	Area (sq ft)	Lane Miles *	Paved Length (mi)	Paved Width (ft)
0106	PUBLIC	6/30/2012	6,721	0.12	0.07	19
Culverts	Drop Inlets	Gates	Curb & Gutter	Curb	PCR	Surface Type
0	0	0	NO CURB AND GUTTER	NO CURB	GOOD/90	AS

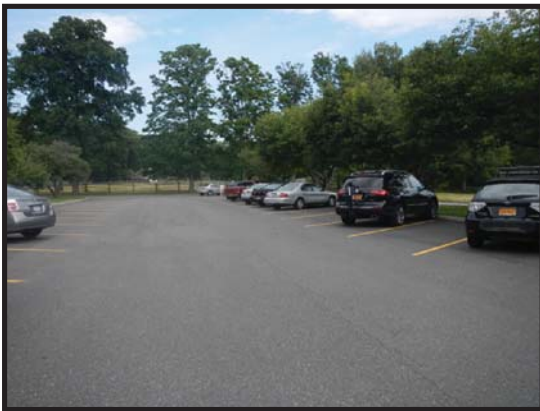
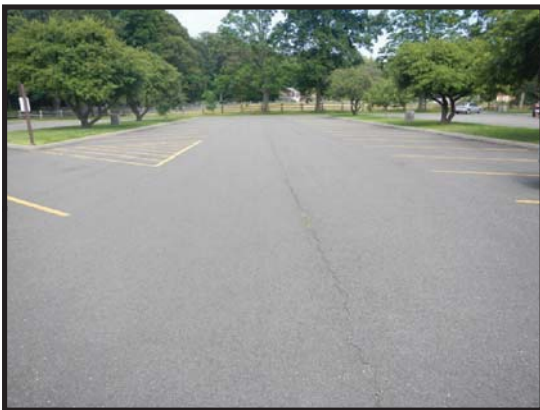
Route 0901ZZ

Route Number	Public / NonPublic	Date Visited	Area (sq ft)	Lane Miles *	Surface Type
0901ZZ	NONPUBLIC	6/30/2012	2,885	0.05	AS
Culverts	Drop Inlets	Gates	Curb & Gutter	Curb	PCR
0	0	0	NO CURB AND GUTTER	CONCRETE CURB	SUMMARY/90

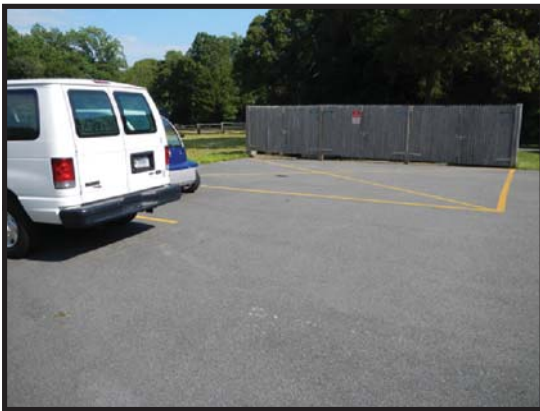
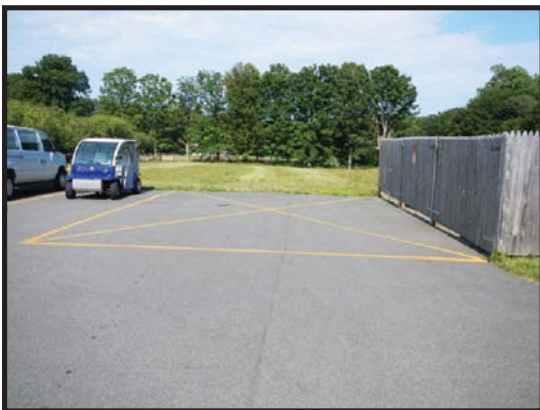
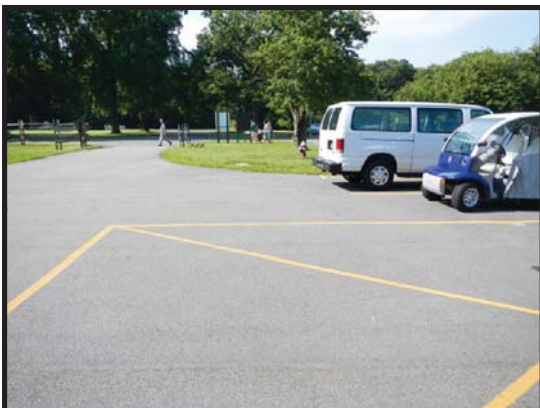
Route 0901BZ

Route Number	Public / NonPublic	Date Visited	Area (sq ft)	Lane Miles *	Surface Type
0901BZ	NONPUBLIC	6/30/2012	992	0.02	AS
Culverts	Drop Inlets	Gates	Curb & Gutter	Curb	PCR
0	0	0	NO CURB AND GUTTER	CONCRETE CURB	GOOD/90

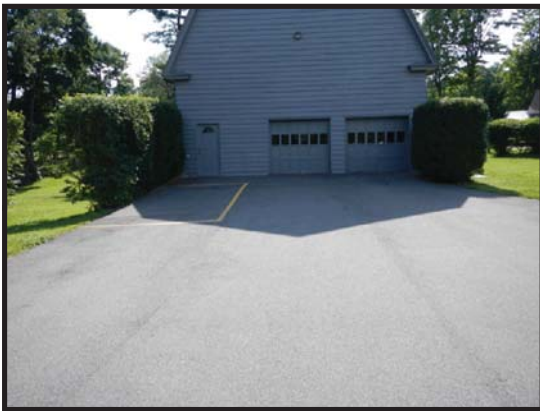
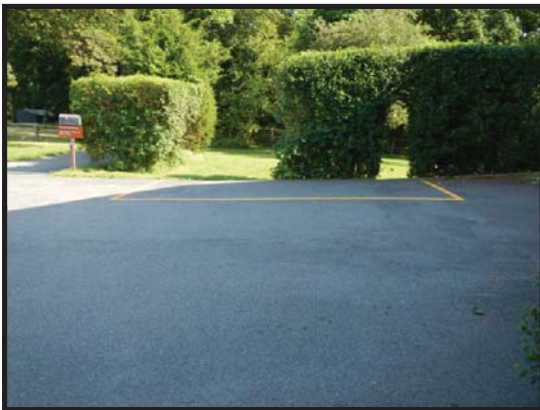
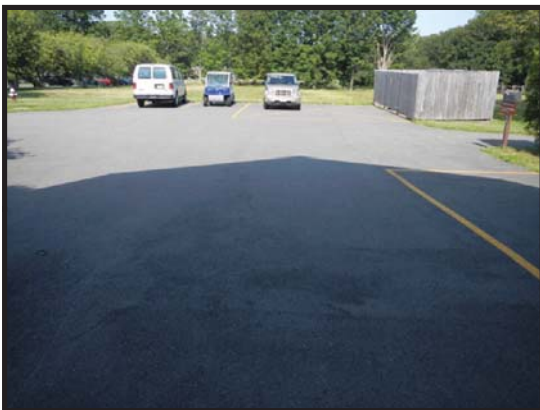
Route 0902

Route Number	Public / NonPublic	Date Visited	Area (sq ft)	Lane Miles *	Surface Type
0902	PUBLIC	6/30/2012	3,698	0.06	AS
Culverts	Drop Inlets	Gates	Curb & Gutter	Curb	PCR
0	0	0	NO CURB AND GUTTER	NO CURB	GOOD/90

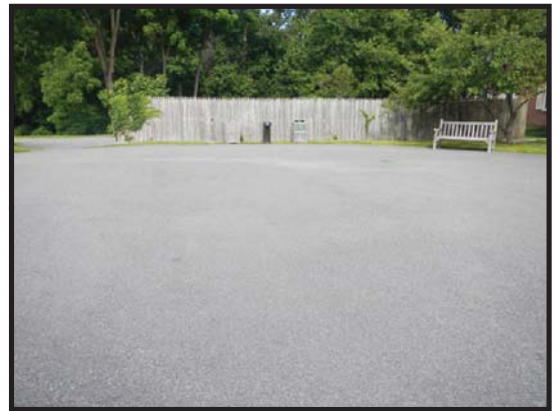
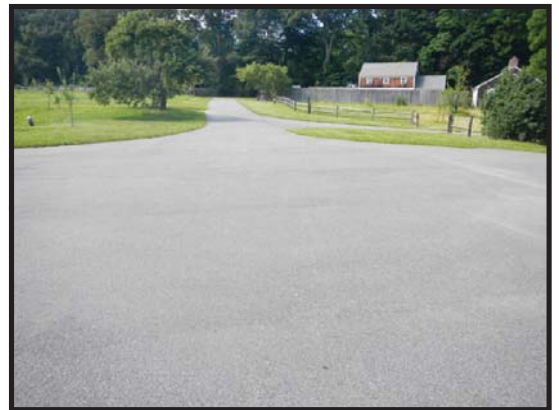
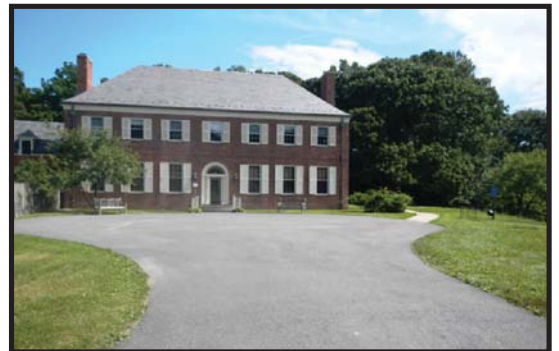
Route 0903

Route Number	Public / NonPublic	Date Visited	Area (sq ft)	Lane Miles *	Surface Type
0903	PUBLIC	6/30/2012	4,829	0.08	AS
Culverts	Drop Inlets	Gates	Curb & Gutter	Curb	PCR
0	1	0	NO CURB AND GUTTER	NO CURB	GOOD/90

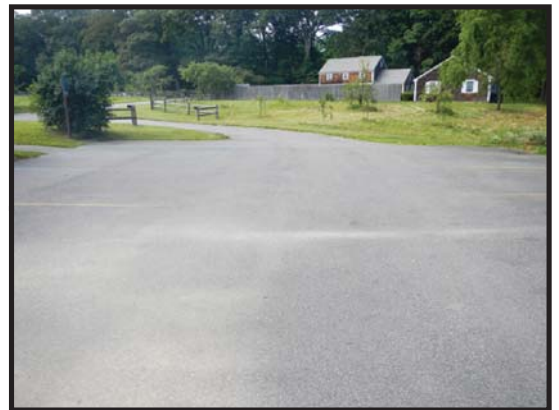
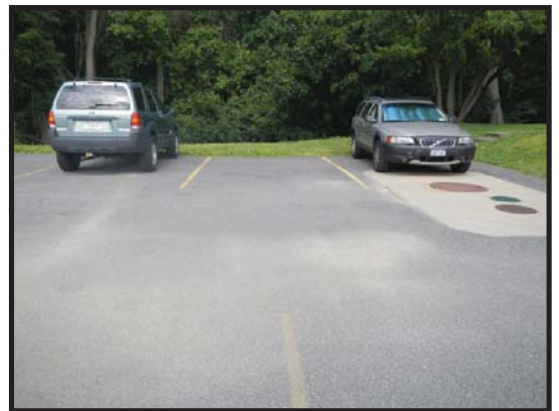
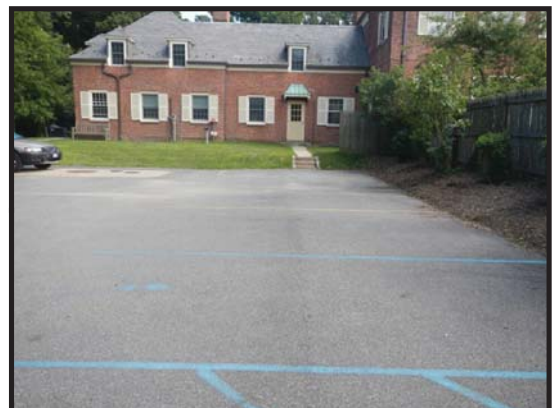
Route 0904

Route Number	Public / NonPublic	Date Visited	Area (sq ft)	Lane Miles *	Surface Type
0904	NONPUBLIC	6/30/2012	4,728	0.08	AS
Culverts	Drop Inlets	Gates	Curb & Gutter	Curb	PCR
0	0	0	NO CURB AND GUTTER	CONCRETE CURB	GOOD/90

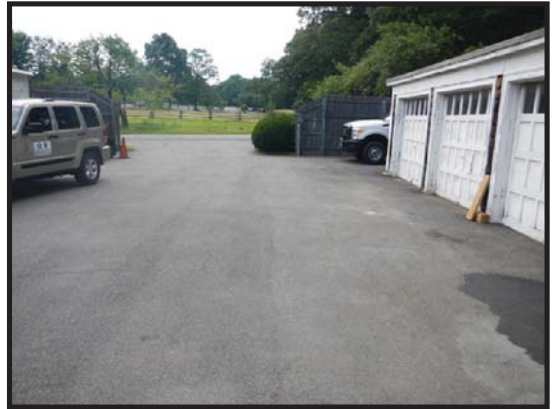
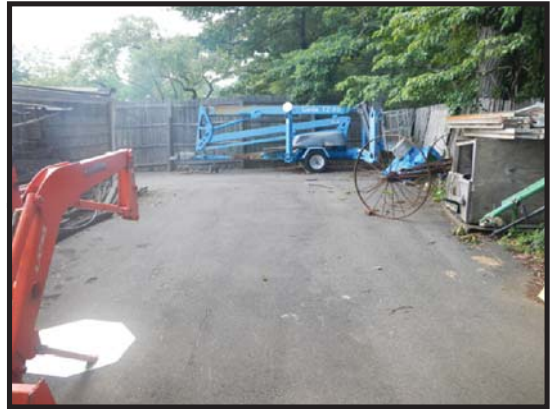
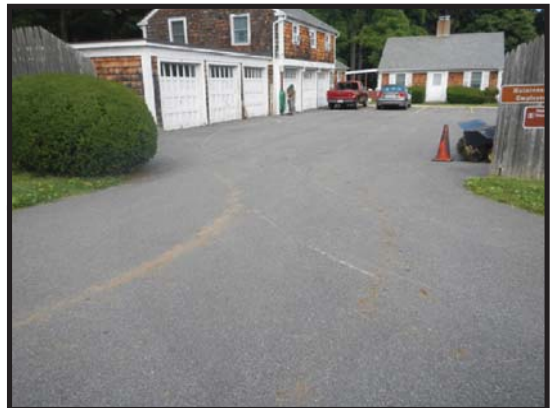
Route 0905

Route Number	Public / NonPublic	Date Visited	Area (sq ft)	Lane Miles *	Surface Type
0905	NONPUBLIC	6/30/2012	3,133	0.05	AS
Culverts	Drop Inlets	Gates	Curb & Gutter	Curb	PCR
0	0	0	NO CURB AND GUTTER	NO CURB	GOOD/90

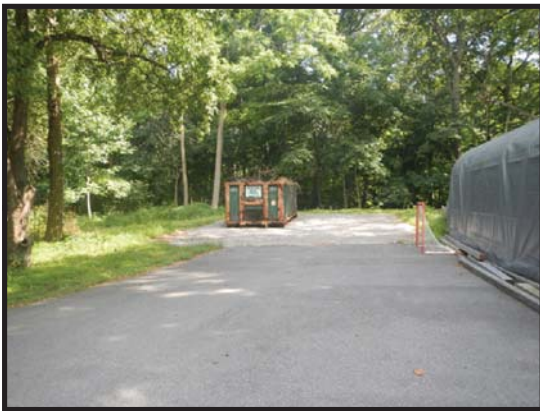
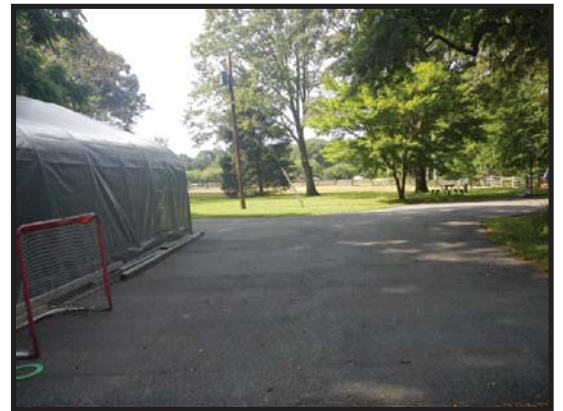
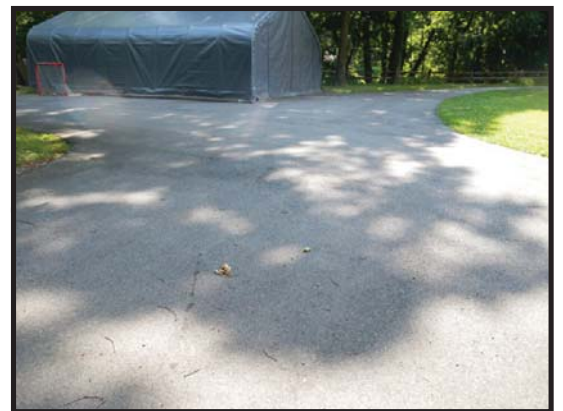
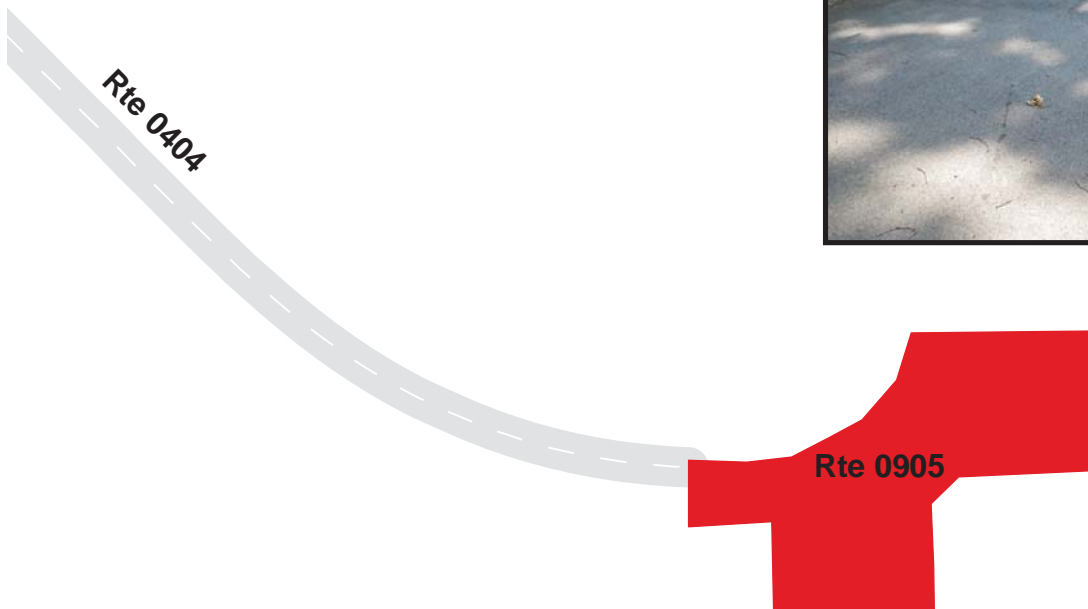
Route 0906

Route Number	Public / NonPublic	Date Visited	Area (sq ft)	Lane Miles *	Surface Type
0906	NONPUBLIC	6/30/2012	2,341	0.04	AS
Culverts	Drop Inlets	Gates	Curb & Gutter	Curb	PCR
0	0	0	NO CURB AND GUTTER	NO CURB	FAIR/73
