Federal Lands Highway Road Inventory Program

Road Inventory and Condition Assessment

San Juan Island National Historical Park
SAJH - 9530

Cycle 5 Report

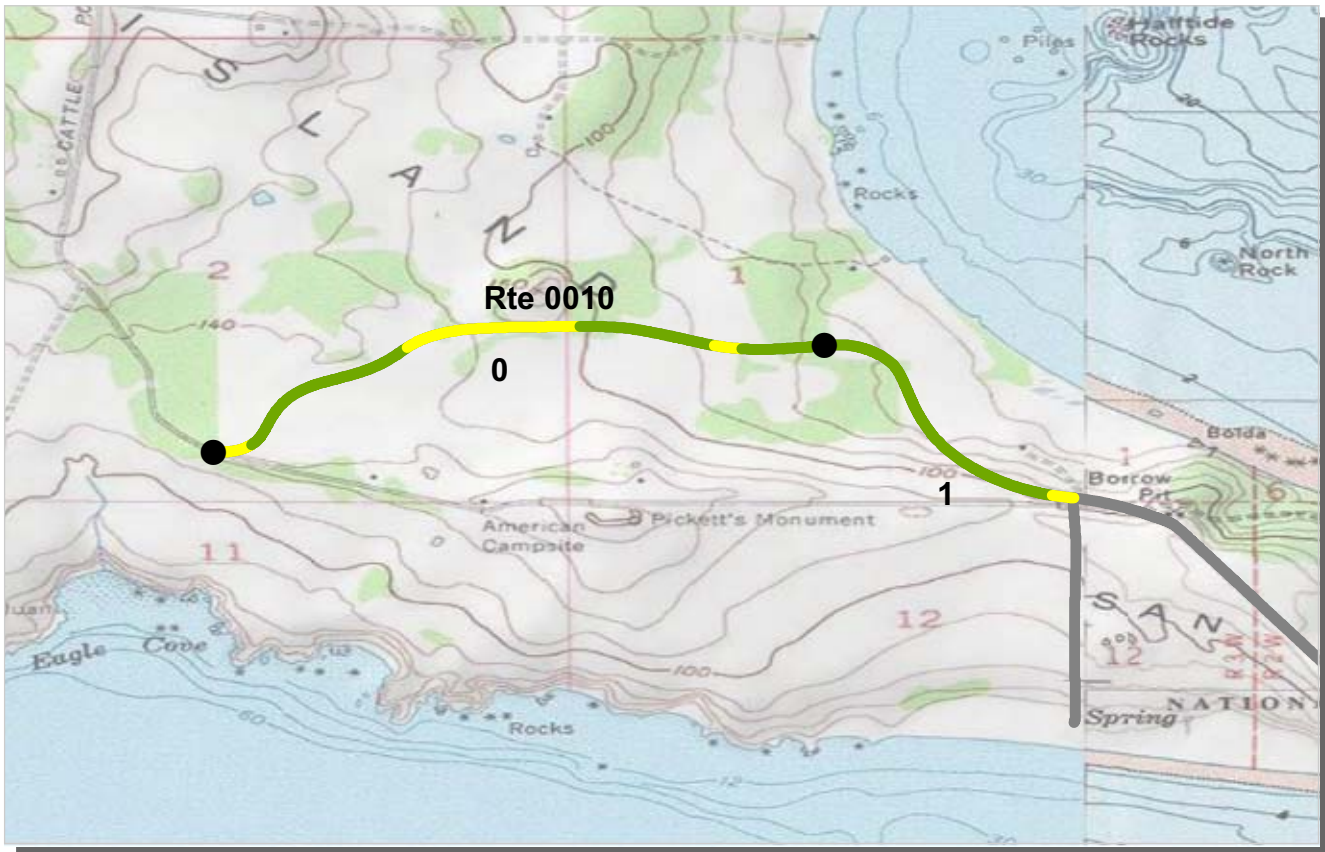
ROUTE: 0010 CATTLE POINT ROAD (WEST)

<i>Section Number</i>	0	1			
<i>Section Length (mi)</i>	1.00	0.53			
<i>Cross Section Information</i>					
Number of Lanes	2	2			
Paved Width (ft)	27	26			
Lane Width (ft)	14	14			
<i>Roadway Condition Information</i>					
SCR (Surface Condition Rating)	86	88			
PCR (Pavement Condition Rating)	86	90			
<i>Distress Index Values</i>					
Structural Crack Index	100	100			
Transverse Cracking Index	100	100			
Patching Index	100	100			
Rutting Index	86	88			
Roughness Condition Index (RCI)	86	94

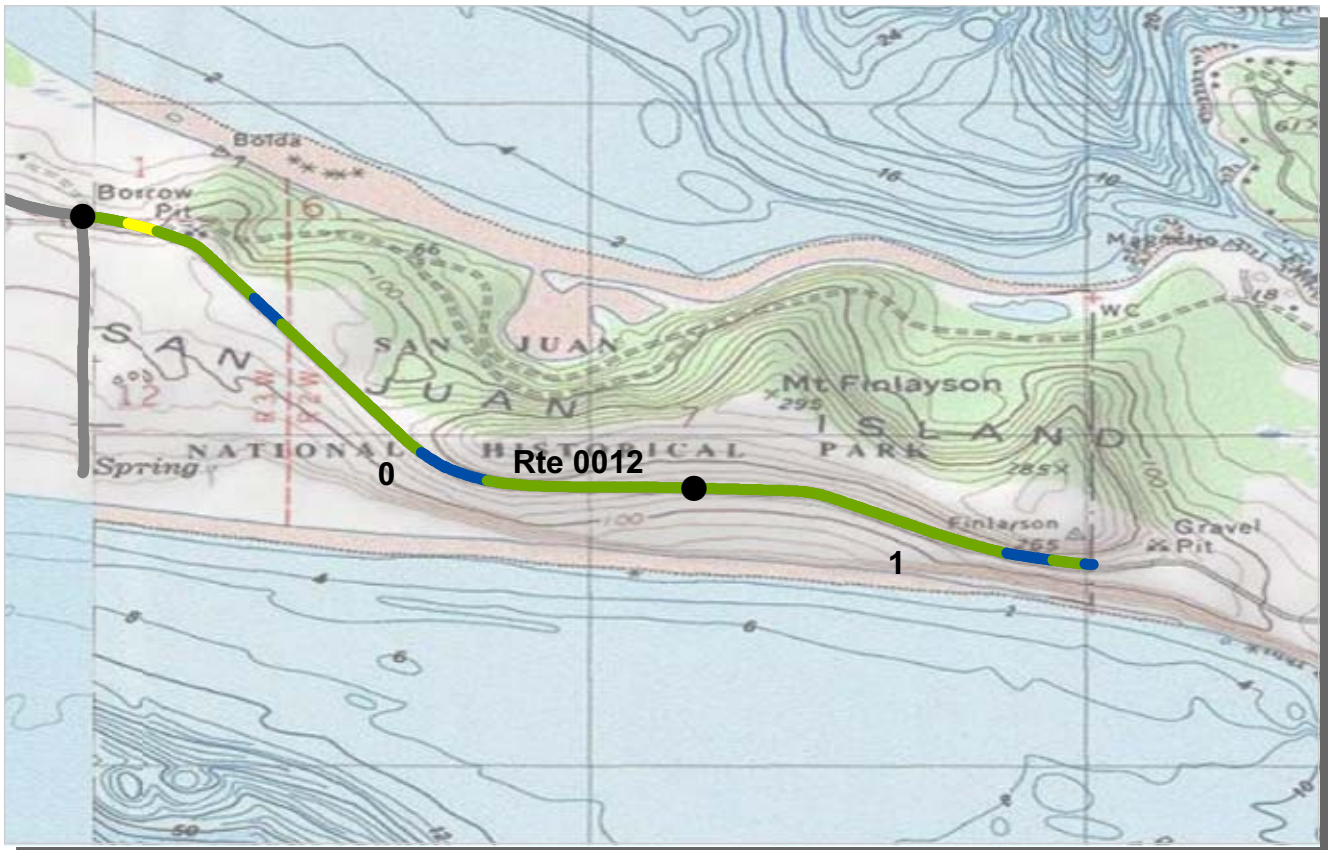
ROUTE: 0012 CATTLE POINT ROAD (EAST)

<i>Section Number</i>	0	1			
<i>Section Length (mi)</i>	1.00	0.53			
<i>Cross Section Information</i>					
Number of Lanes	2	2			
Paved Width (ft)	23	22			
Lane Width (ft)	11	10			
<i>Roadway Condition Information</i>					
SCR (Surface Condition Rating)	95	93			
PCR (Pavement Condition Rating)	91	91			
<i>Distress Index Values</i>					
Structural Crack Index	100	100			
Transverse Cracking Index	100	100			
Patching Index	100	100			
Rutting Index	95	93			
Roughness Condition Index (RCI)	85	87

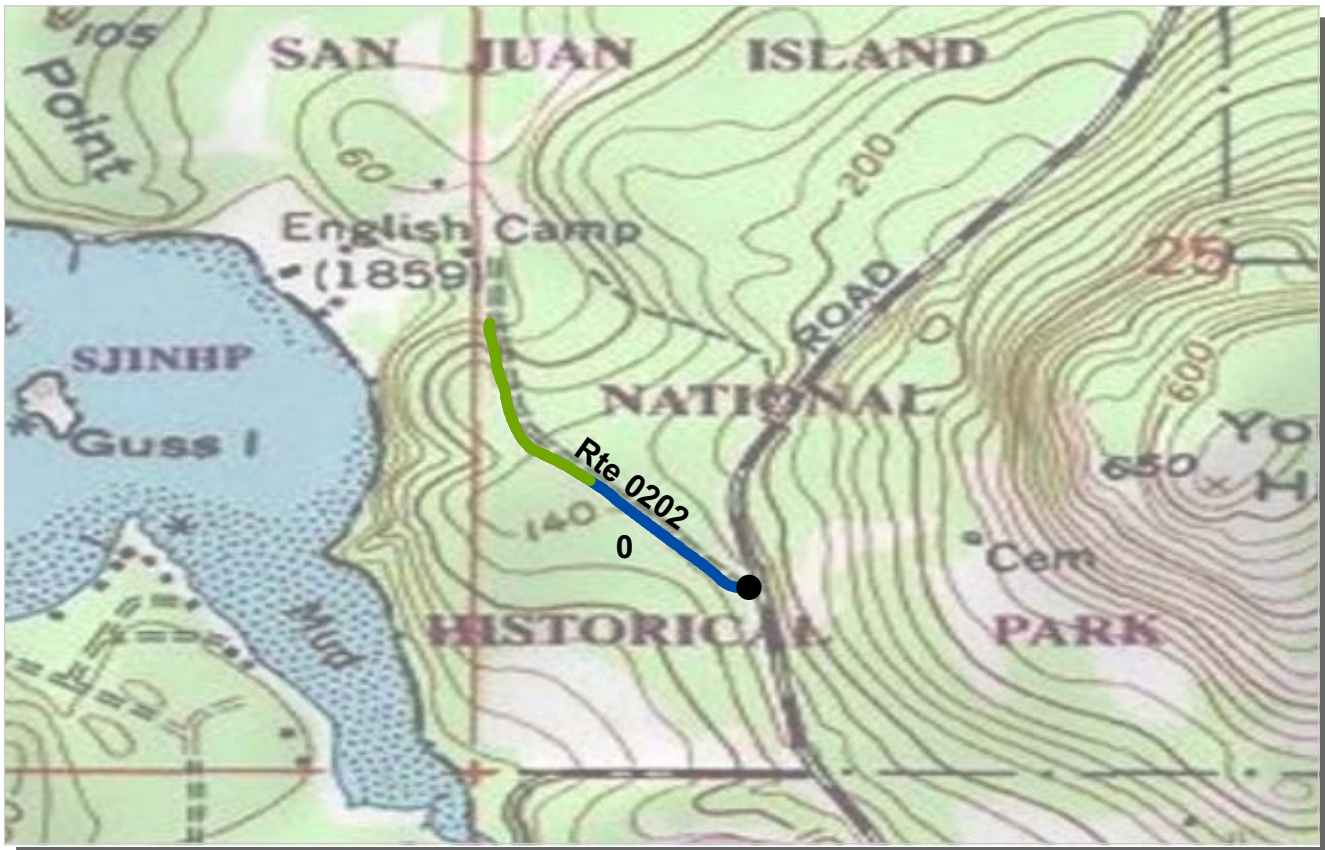
ROUTE: 0202 ENGLISH CAMP ENTRANCE ROAD

Section Number	0				
Section Length (mi)	0.32				
Cross Section Information					
Number of Lanes	2				
Paved Width (ft)	17				
Lane Width (ft)	8				
Roadway Condition Information					
SCR (Surface Condition Rating)	91				
PCR (Pavement Condition Rating)	91				
Distress Index Values					
Structural Crack Index	100				
Transverse Cracking Index	100				
Patching Index	100				
Rutting Index	91				
Roughness Condition Index (RCI)	NC

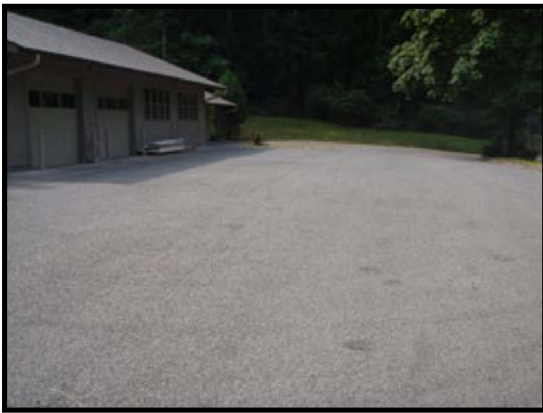
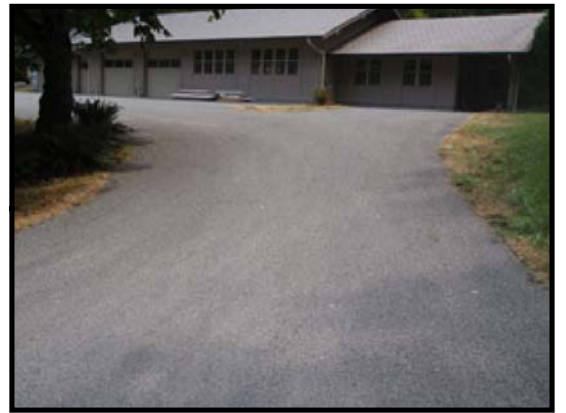
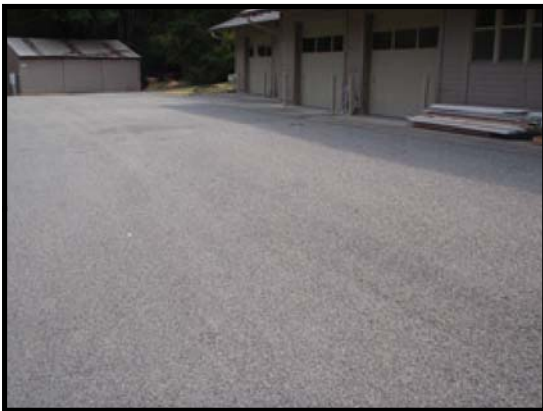
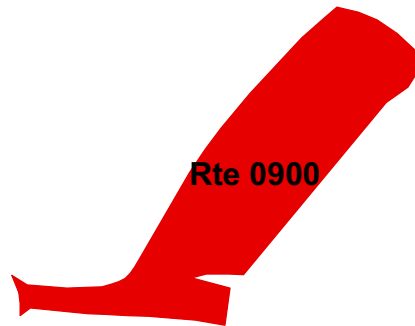
Route 0900

Route Number	Public / NonPublic	Date Visited	Area (sq ft)	Lane Miles *	Surface Type
0900	PUBLIC	8/3/2010	9,015	0.16	AS
Culverts	Drop Inlets	Gates	Curb & Gutter	Curb	PCR
0	0	0	CONCRETE CURB AND GUTTER	NO CURB	FAIR/73

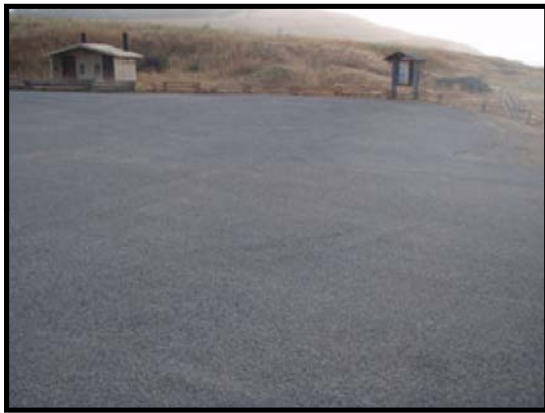
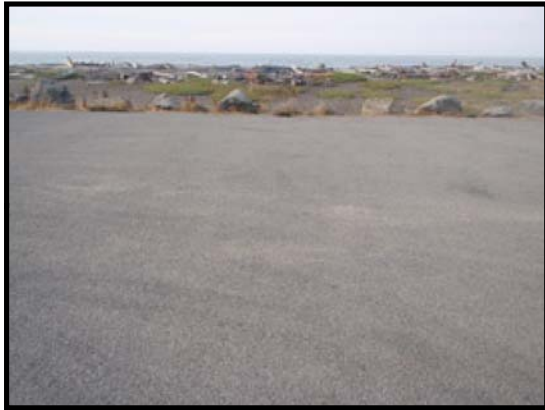
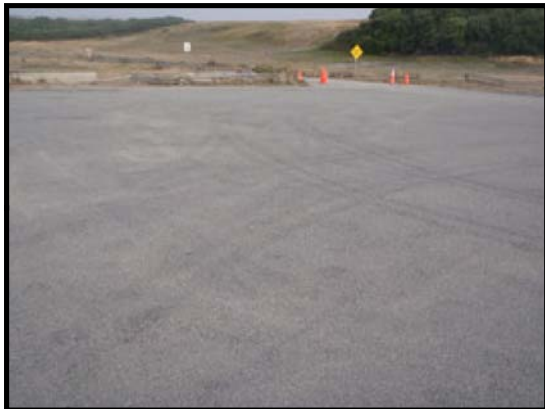
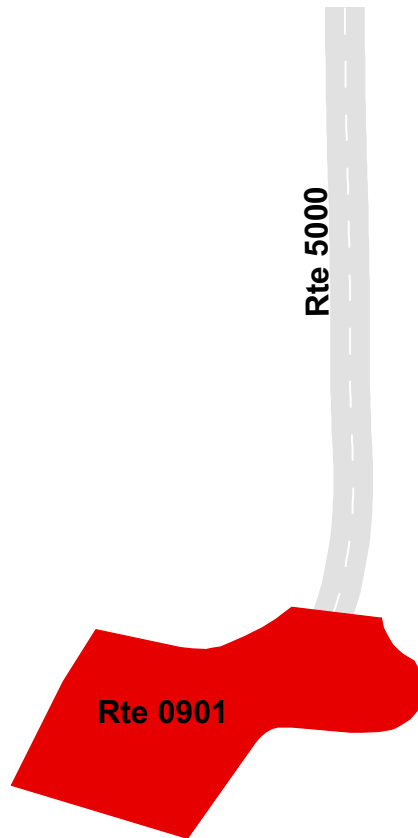
Route 0901

Route Number	Public / NonPublic	Date Visited	Area (sq ft)	Lane Miles *	Surface Type
0901	PUBLIC	8/3/2010	18,038	0.31	AS
Culverts	Drop Inlets	Gates	Curb & Gutter	Curb	PCR
0	0	0	NO CURB AND GUTTER	NO CURB	FAIR/73

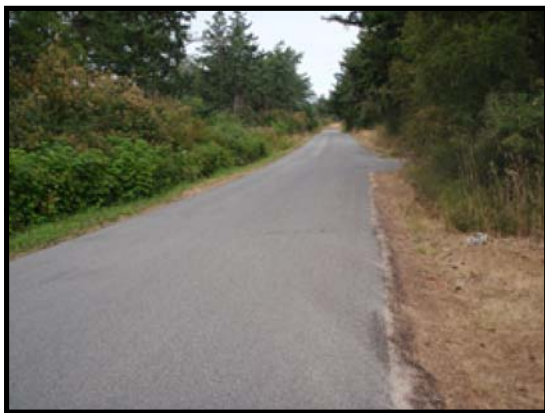
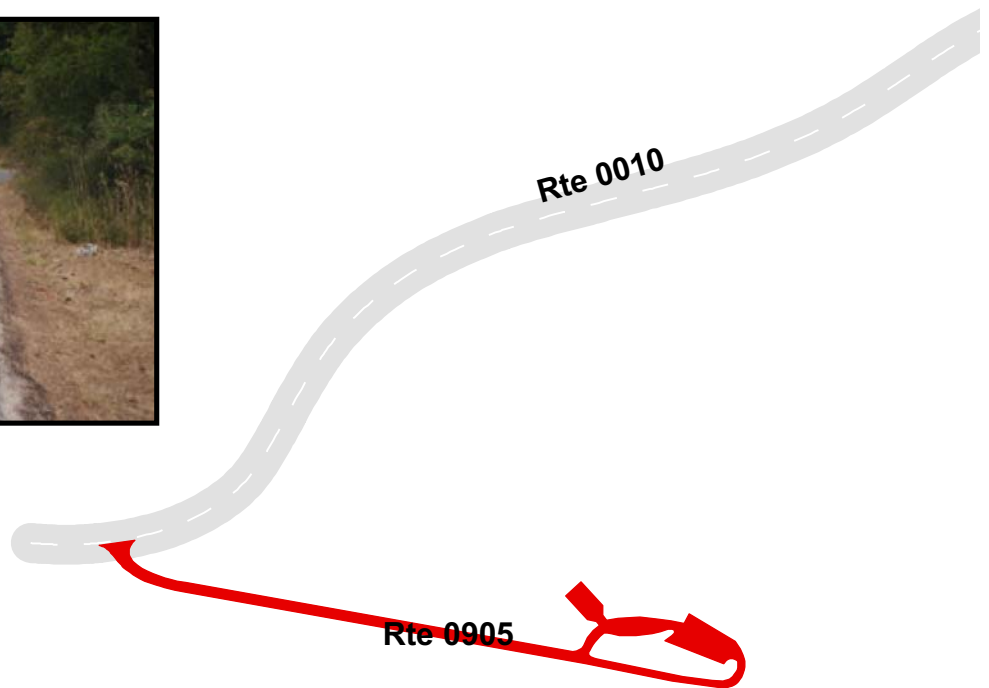
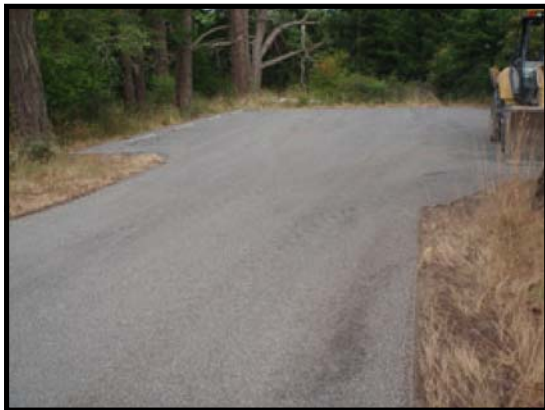
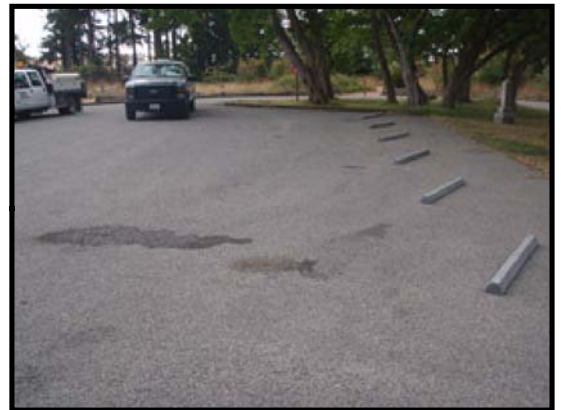
Route 0905

Route Number	Public / NonPublic	Date Visited	Area (sq ft)	Lane Miles *	Surface Type
0905	PUBLIC	8/3/2010	40,218	0.69	AS
Culverts	Drop Inlets	Gates	Curb & Gutter	Curb	PCR
0	0	0	NO CURB AND GUTTER	WOOD CURB	GOOD/90

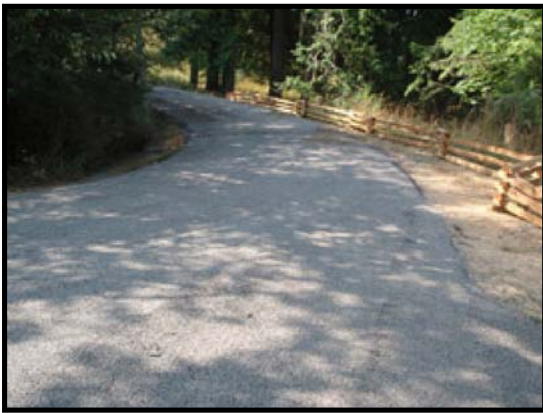
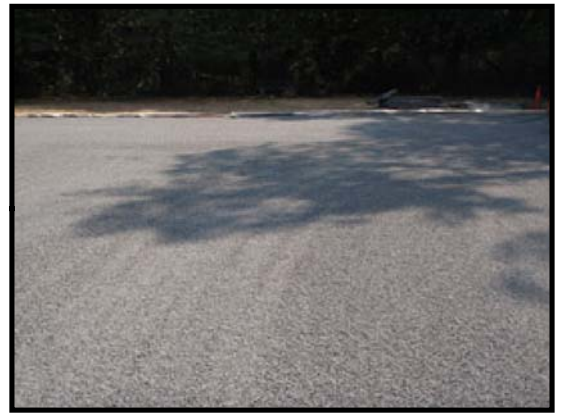
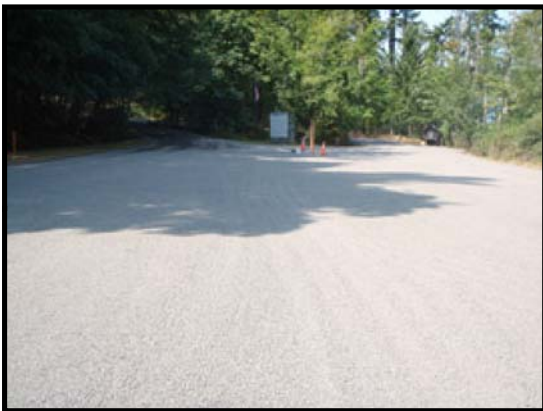
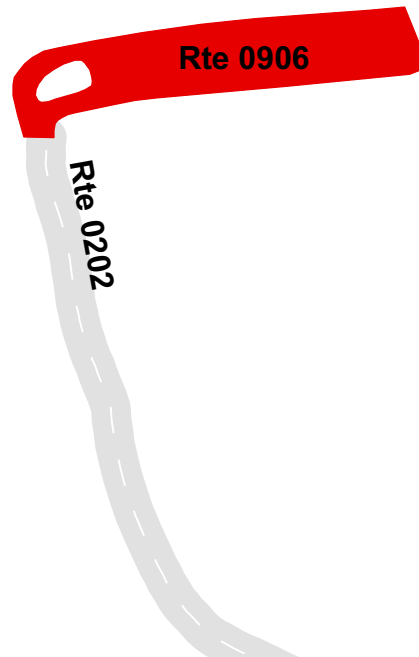
Route 0906

Route Number	Public / NonPublic	Date Visited	Area (sq ft)	Lane Miles *	Surface Type
0906	PUBLIC	8/3/2010	29,469	0.51	AS
Culverts	Drop Inlets	Gates	Curb & Gutter	Curb	PCR
0	0	0	NO CURB AND GUTTER	NO CURB	GOOD/90
