# Federal Lands Highway Road Inventory Program

Road Inventory and Condition Assessment

## Santa Monica Mountains National Recreation Area SAMO

### Cycle 5 Report

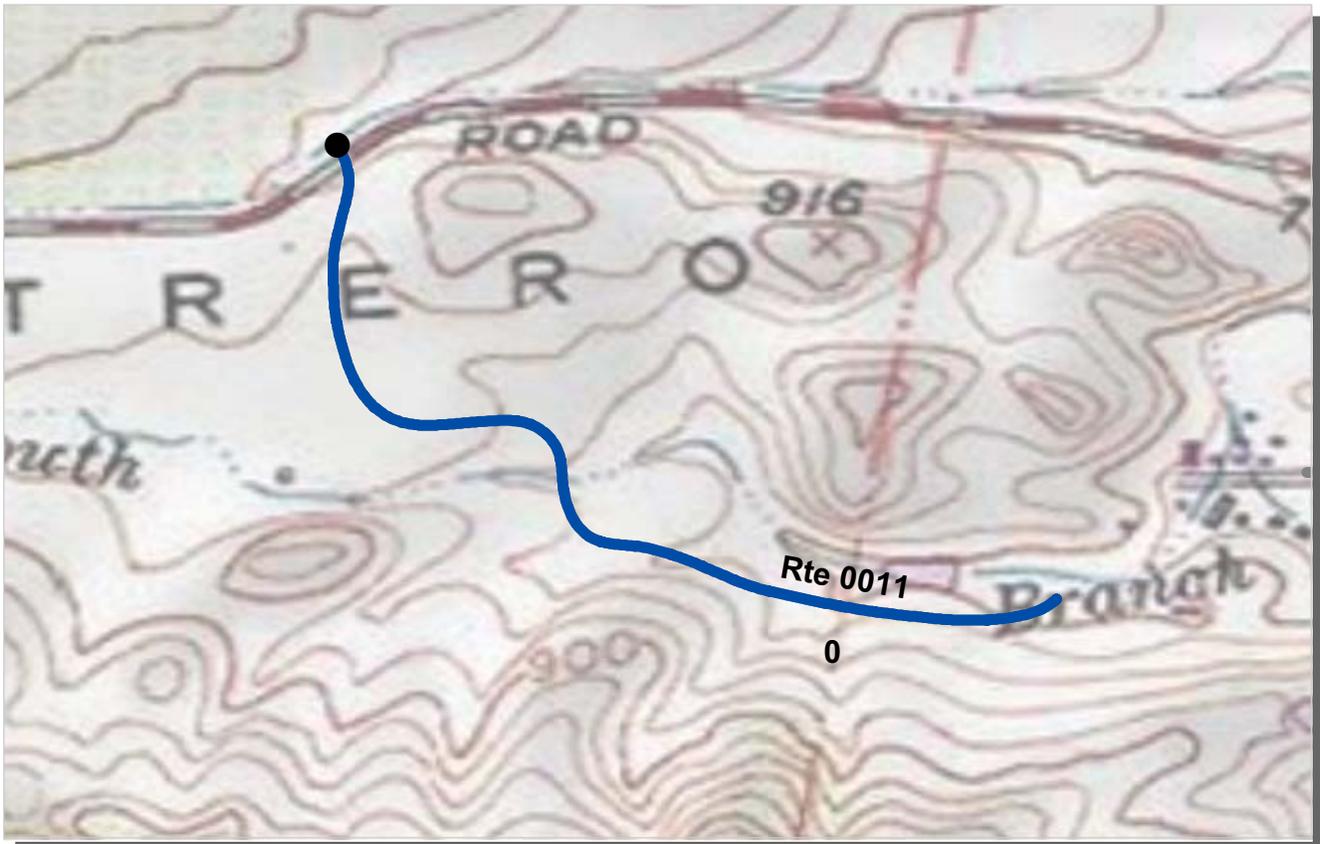
**ROUTE: 0011 RANCHO SIERRA VISTA/SATWIWA ENTRANCE ROAD**

<b>Section Number</b>	0				
<b>Section Length (mi)</b>	0.62				
<b>Cross Section Information</b>					
Number of Lanes	2				
Paved Width (ft)	23				
Lane Width (ft)	11				
<b>Roadway Condition Information</b>					
SCR (Surface Condition Rating)	99				
PCR (Pavement Condition Rating)	99				
<b>Distress Index Values</b>					
Structural Crack Index	100				
Transverse Cracking Index	100				
Patching Index	100				
Rutting Index	99				
Roughness Condition Index (RCI)	NC

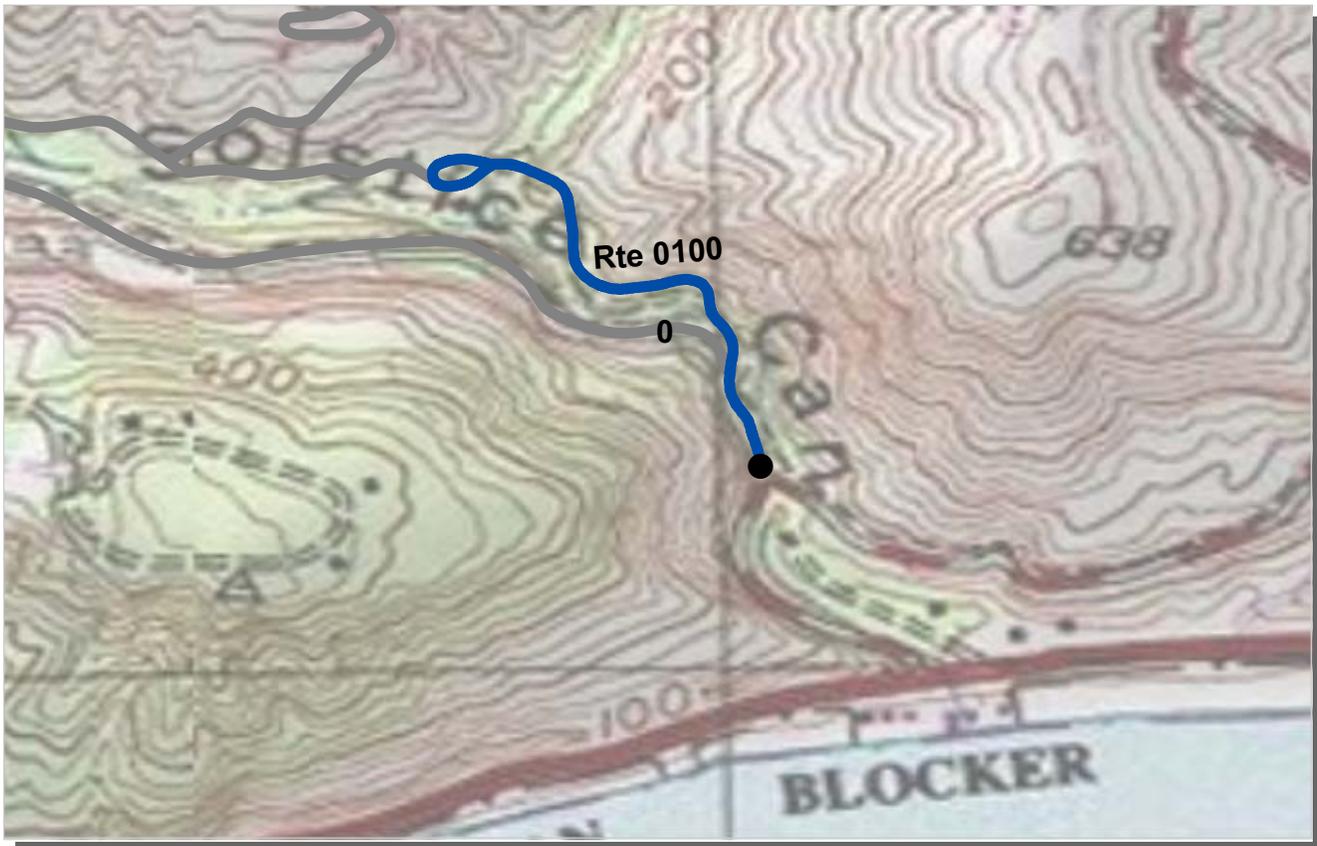
**ROUTE: 0100 SOLSTICE CANYON ACCESS ROAD**

<b>Section Number</b>	0				
<b>Section Length (mi)</b>	0.38				
<b>Cross Section Information</b>					
Number of Lanes	2				
Paved Width (ft)	19				
Lane Width (ft)	10				
<b>Roadway Condition Information</b>					
SCR (Surface Condition Rating)	98				
PCR (Pavement Condition Rating)	98				
<b>Distress Index Values</b>					
Structural Crack Index	99				
Transverse Cracking Index	100				
Patching Index	100				
Rutting Index	98				
Roughness Condition Index (RCI)	NC

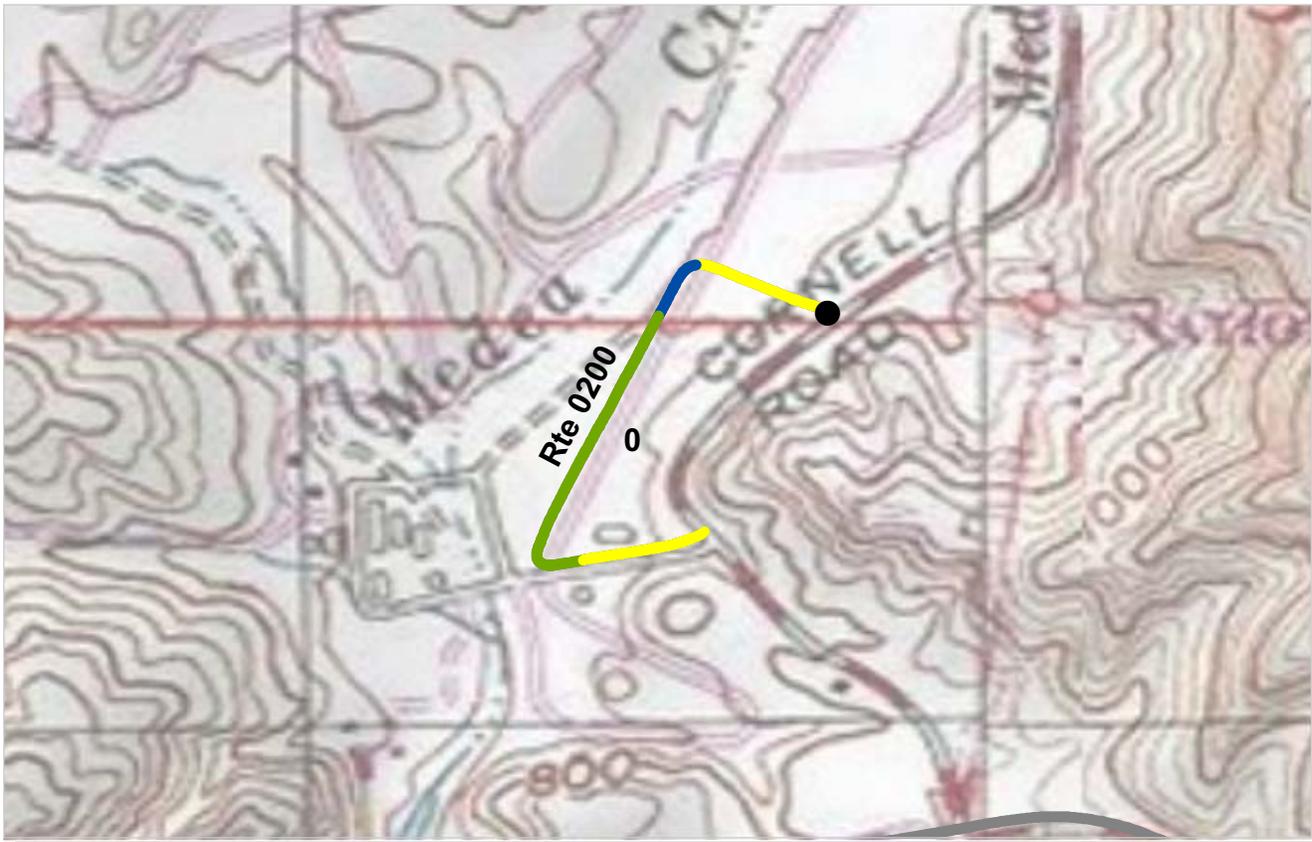
**ROUTE: 0200 PARAMOUNT RANCH ACCESS ROAD**

<b>Section Number</b>	0				
<b>Section Length (mi)</b>	0.39				
<b>Cross Section Information</b>					
Number of Lanes	2				
Paved Width (ft)	23				
Lane Width (ft)	12				
<b>Roadway Condition Information</b>					
SCR (Surface Condition Rating)	88				
PCR (Pavement Condition Rating)	88				
<b>Distress Index Values</b>					
Structural Crack Index	90				
Transverse Cracking Index	88				
Patching Index	100				
Rutting Index	98				
Roughness Condition Index (RCI)	NC

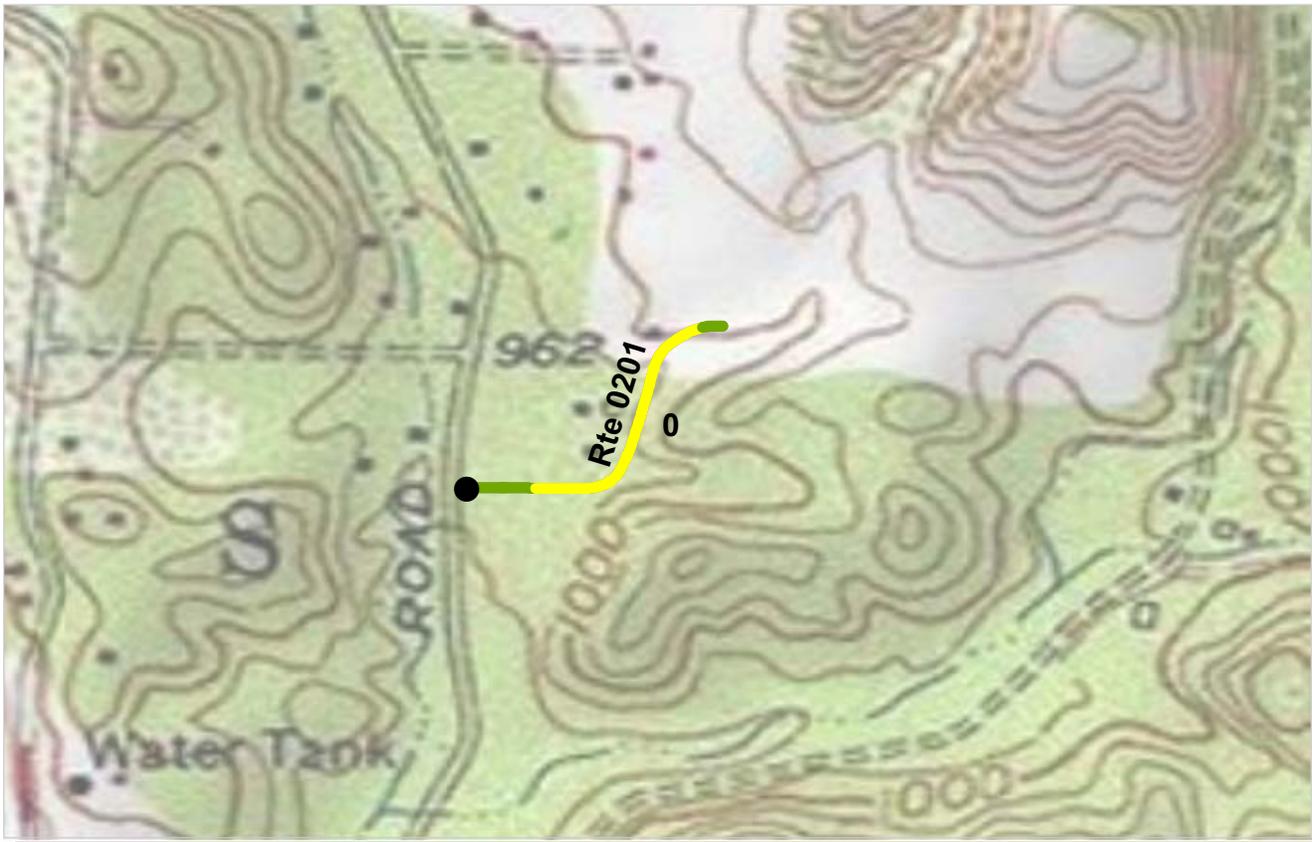
**ROUTE: 0201 CHEESEBORO CANYON ENTRANCE ROAD**

<b>Section Number</b>	0				
<b>Section Length (mi)</b>	0.21				
<b>Cross Section Information</b>					
Number of Lanes	2				
Paved Width (ft)	23				
Lane Width (ft)	11				
<b>Roadway Condition Information</b>					
SCR (Surface Condition Rating)	74				
PCR (Pavement Condition Rating)	74				
<b>Distress Index Values</b>					
Structural Crack Index	74				
Transverse Cracking Index	83				
Patching Index	100				
Rutting Index	97				
Roughness Condition Index (RCI)	NC

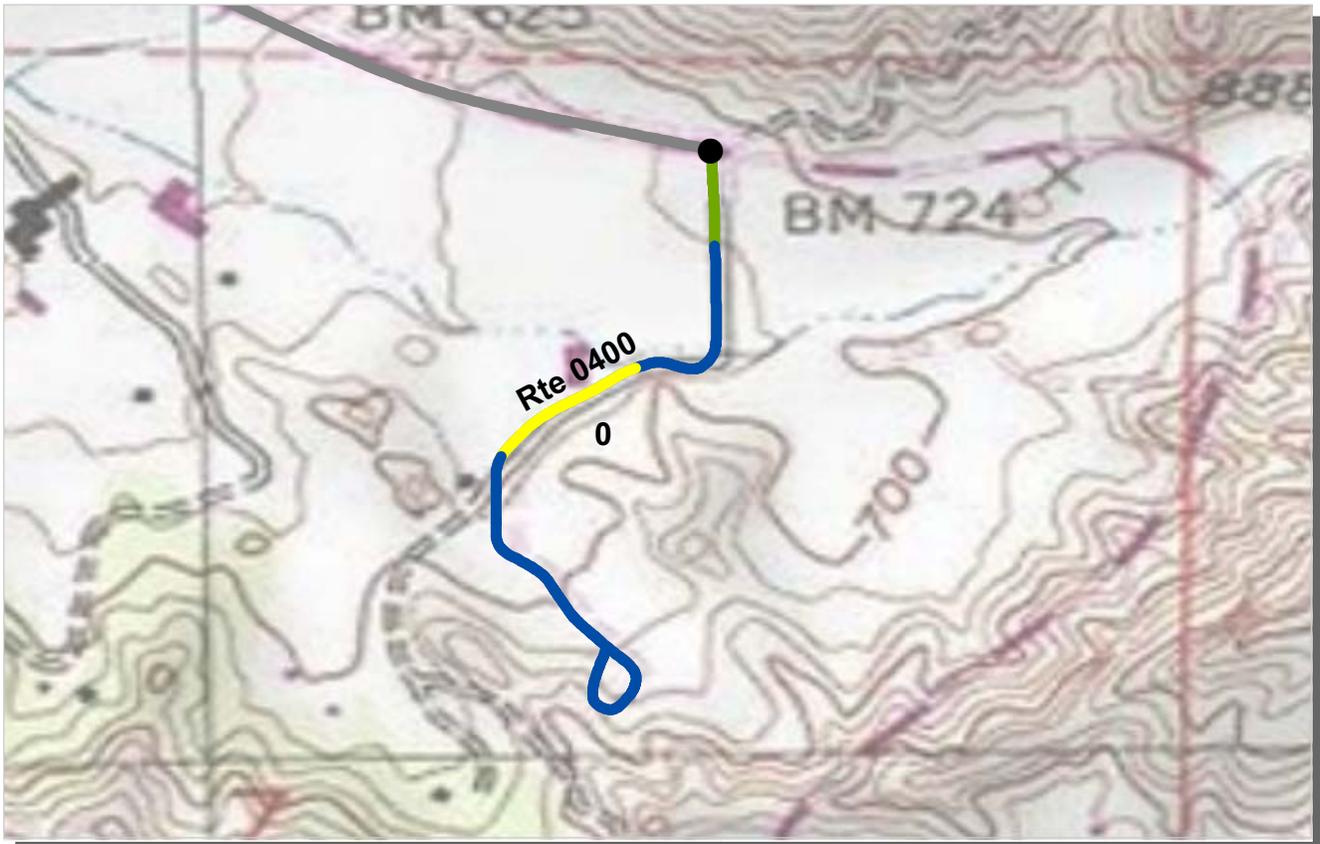
ROUTE: 0400 DIAMOND X RANCH MAINTENANCE FACILITY ENTRANCE ROAD

<b>Section Number</b>	0				
<b>Section Length (mi)</b>	0.53				
<b>Cross Section Information</b>					
Number of Lanes	2				
Paved Width (ft)	19				
Lane Width (ft)	9				
<b>Roadway Condition Information</b>					
SCR (Surface Condition Rating)	93				
PCR (Pavement Condition Rating)	93				
<b>Distress Index Values</b>					
Structural Crack Index	93				
Transverse Cracking Index	99				
Patching Index	100				
Rutting Index	98				
Roughness Condition Index (RCI)	NC

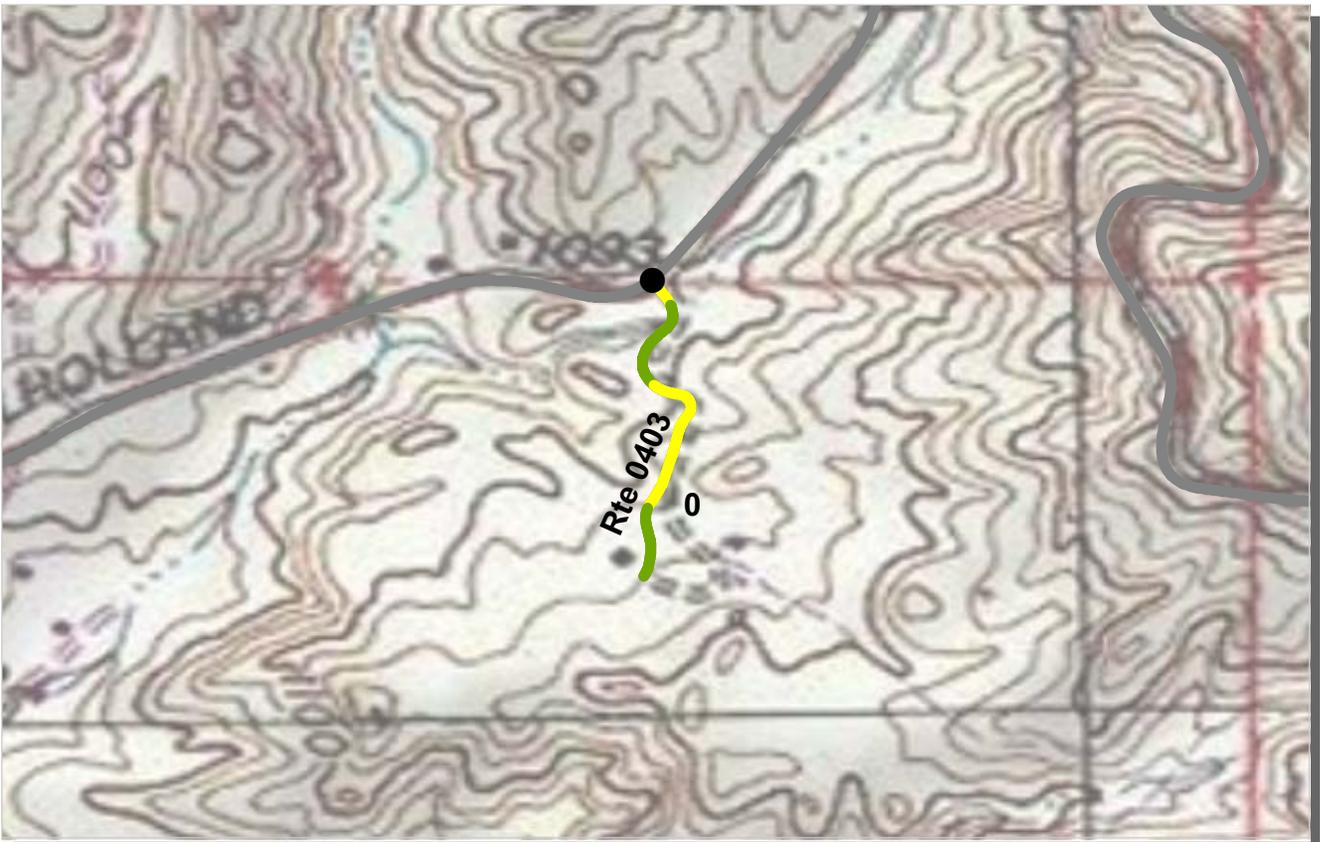
ROUTE: 0403 ARROYO SEQUIT ACCESS ROAD

<b>Section Number</b>	0				
<b>Section Length (mi)</b>	0.22				
<b>Cross Section Information</b>					
Number of Lanes	1				
Paved Width (ft)	11				
Lane Width (ft)	11				
<b>Roadway Condition Information</b>					
SCR (Surface Condition Rating)	84				
PCR (Pavement Condition Rating)	84				
<b>Distress Index Values</b>					
Structural Crack Index	98				
Transverse Cracking Index	99				
Patching Index	100				
Rutting Index	84				
Roughness Condition Index (RCI)	NC

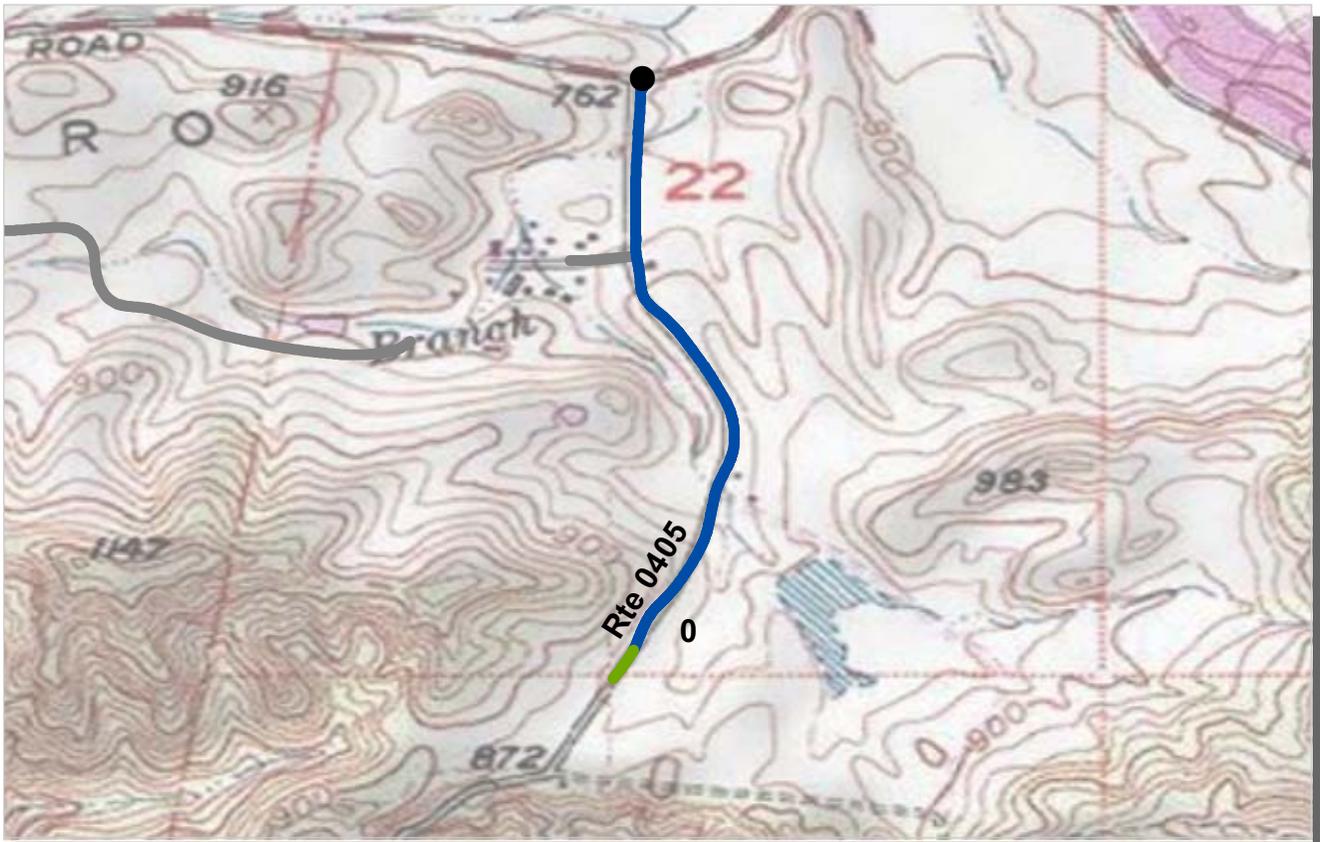
**ROUTE: 0405 RANCHO SIERRA VISTA/SATWIWA SERVICE ROAD**

<b>Section Number</b>	0				
<b>Section Length (mi)</b>	0.67				
<b>Cross Section Information</b>					
Number of Lanes	1				
Paved Width (ft)	15				
Lane Width (ft)	11				
<b>Roadway Condition Information</b>					
SCR (Surface Condition Rating)	95				
PCR (Pavement Condition Rating)	95				
<b>Distress Index Values</b>					
Structural Crack Index	95				
Transverse Cracking Index	100				
Patching Index	100				
Rutting Index	96				
Roughness Condition Index (RCI)	NC

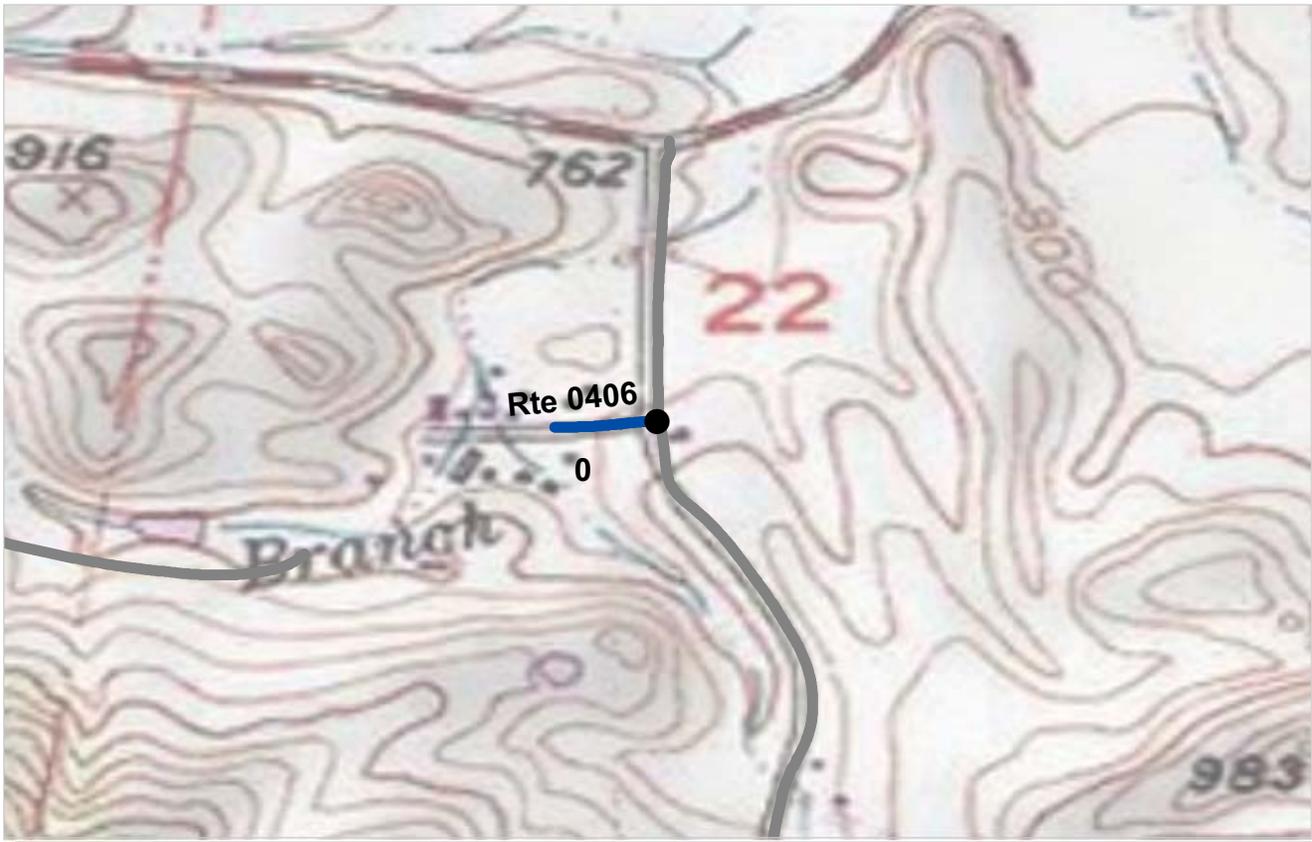
**ROUTE: 0406 RANCH CENTER ROAD**

<b>Section Number</b>	0				
<b>Section Length (mi)</b>	0.06				
<b>Cross Section Information</b>					
Number of Lanes	2				
Paved Width (ft)	20				
Lane Width (ft)	10				
<b>Roadway Condition Information</b>					
SCR (Surface Condition Rating)	97				
PCR (Pavement Condition Rating)	97				
<b>Distress Index Values</b>					
Structural Crack Index	97				
Transverse Cracking Index	99				
Patching Index	100				
Rutting Index	97				
Roughness Condition Index (RCI)	NC

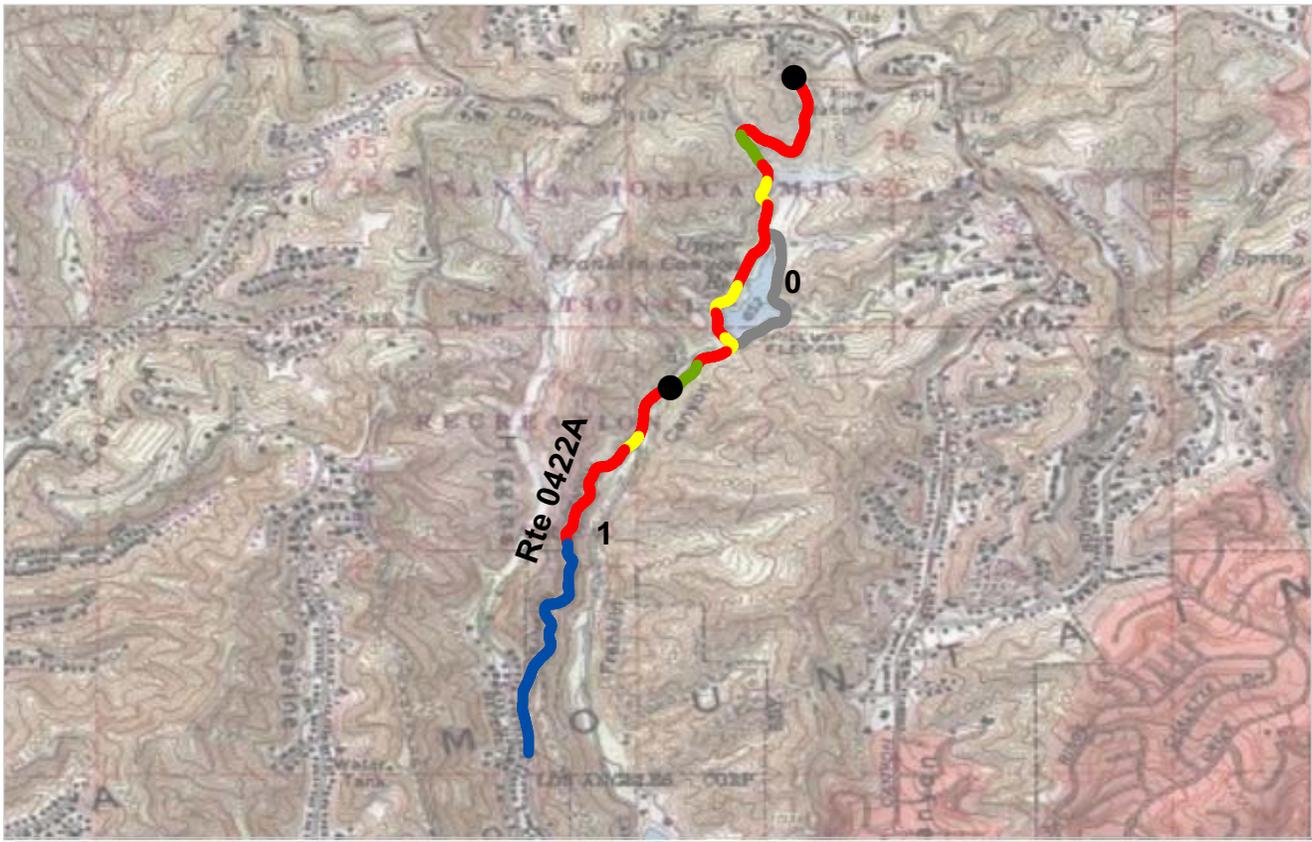
**ROUTE: 0422A FRANKLIN CANYON DRIVE**

<i>Section Number</i>	0	1			
<i>Section Length (mi)</i>	1.00	0.96			
<i>Cross Section Information</i>					
Number of Lanes	2	2			
Paved Width (ft)	20	17			
Lane Width (ft)	12	9			
<i>Roadway Condition Information</i>					
SCR (Surface Condition Rating)	0	2			
PCR (Pavement Condition Rating)	0	2			
<i>Distress Index Values</i>					
Structural Crack Index	0	2			
Transverse Cracking Index	96	98			
Patching Index	98	99			
Rutting Index	85	91			
Roughness Condition Index (RCI)	NC	NC

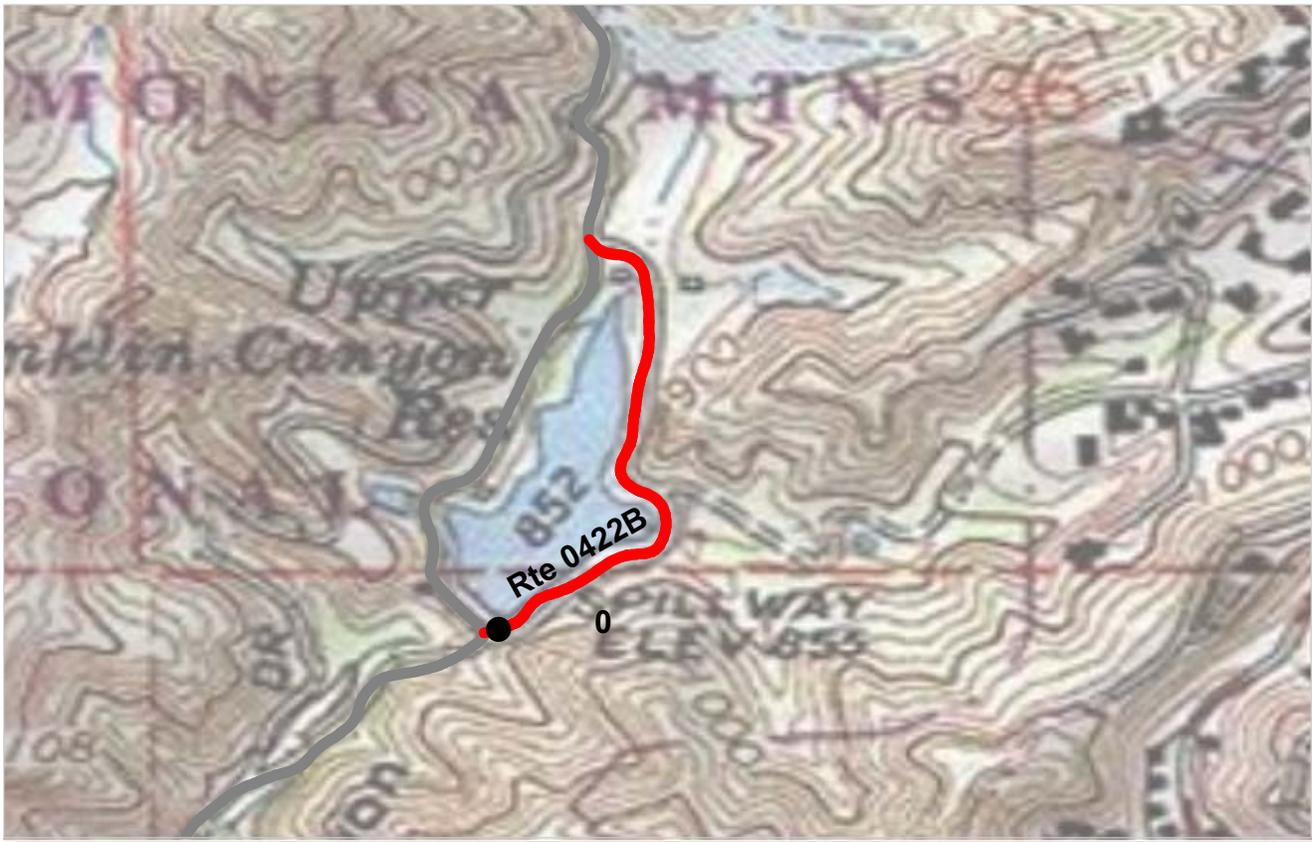
**ROUTE: 0422B FRANKLIN CANYON DRIVE LOOP**

<b>Section Number</b>	0				
<b>Section Length (mi)</b>	0.34				
<b>Cross Section Information</b>					
Number of Lanes	1				
Paved Width (ft)	17				
Lane Width (ft)	17				
<b>Roadway Condition Information</b>					
SCR (Surface Condition Rating)	0				
PCR (Pavement Condition Rating)	0				
<b>Distress Index Values</b>					
Structural Crack Index	0				
Transverse Cracking Index	99				
Patching Index	99				
Rutting Index	81				
Roughness Condition Index (RCI)	NC

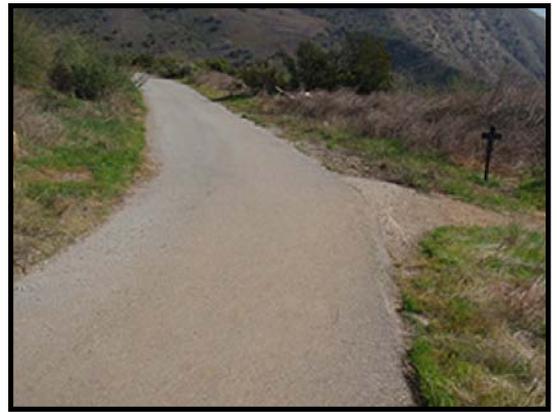
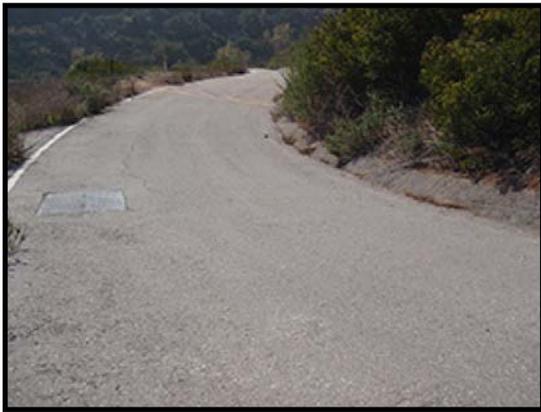
Route Number	Public / NonPublic	Date Visited	Area (sq ft)	Lane Miles *	Paved Length (mi)	Paved Width (ft)
0401	NONPUBLIC	11/17/2010	26,389	0.45	0.29	17
Culverts	Drop Inlets	Gates	Curb & Gutter	Curb	PCR	Surface Type
0	1	0	NO CURB AND GUTTER	ASPHALT CURB	FAIR/73	AS

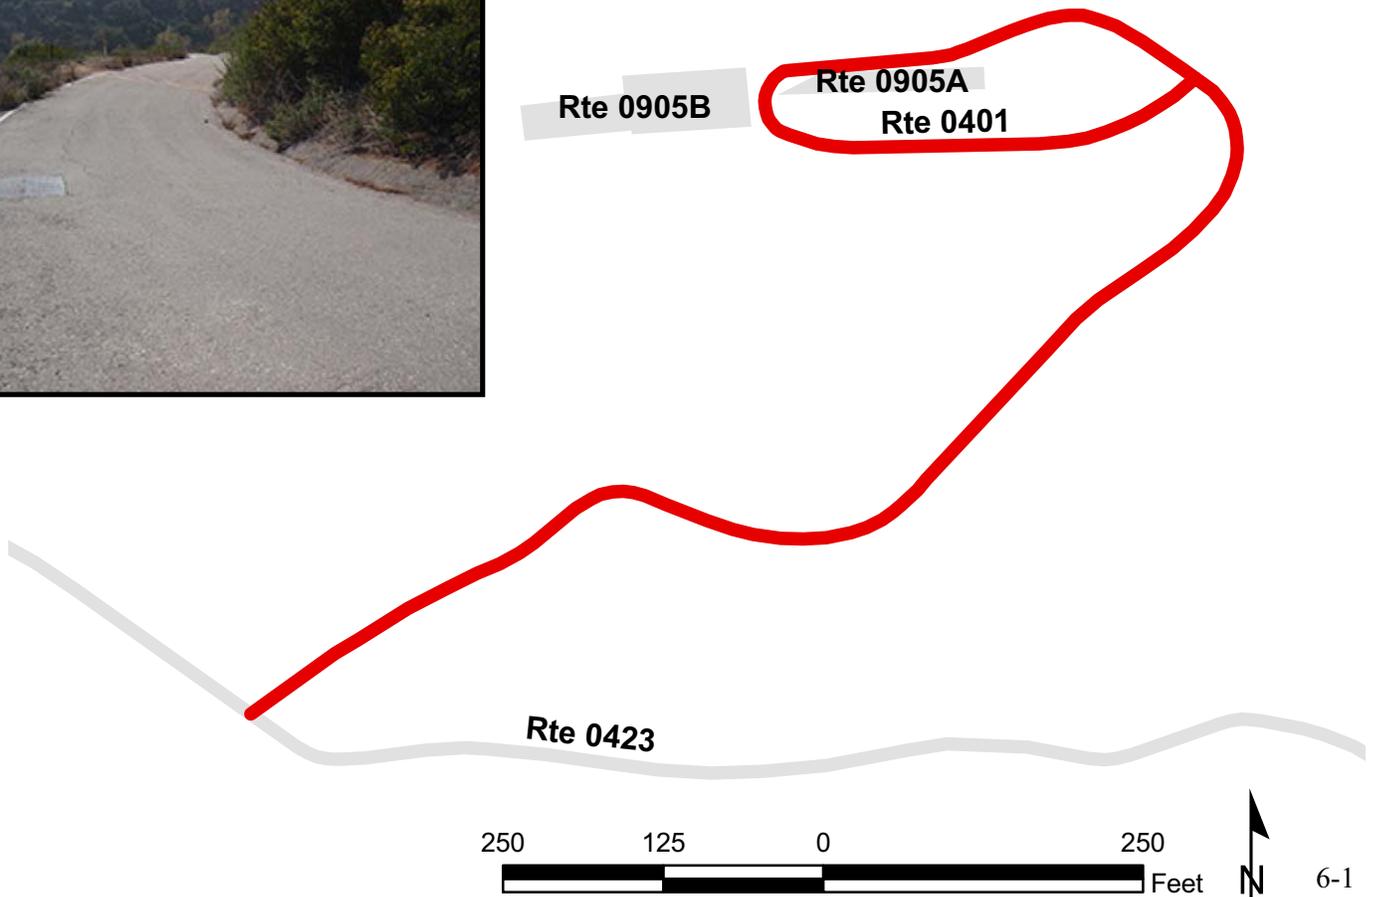
## Route 0402

0402	SOLSTICE CANYON UPPER ROAD	COLLECTION METHOD CHANGE	ROUTE MANUALLY RATED IN CYCLE 5 BECAUSE IT IS IN POOR CONDITION AND IS NOT SAFE TO DRIVE THE COLLECTION VEHICLE OVER.
0403	ARROYO SEQUIT ACCESS ROAD	FUNCTIONAL CLASS CHANGE	FUNCTIONAL CLASS CHANGED FROM 5 TO 6 IN CYCLE 5.
0423	OLD KELLER HOUSE ACCESS ROAD, SOLSTICE CANYON	ROUTE SPLIT	ROUTE 0100 SPLIT INTO TWO SECTIONS IN CYCLE 5. BECAUSE PART OF THE ROAD HAS PUBLIC ACCESS (ROUTE 0100) AND THE OTHER DOES NOT (ROUTE 0423).

Route Number	Public / NonPublic	Date Visited	Area (sq ft)	Lane Miles *	Paved Length (mi)	Paved Width (ft)
0402	NONPUBLIC	11/17/2010	44,014	0.76	0.52	16
Culverts	Drop Inlets	Gates	Curb & Gutter	Curb	PCR	Surface Type
0	0	0	NO CURB AND GUTTER	NO CURB	POOR/45	AS

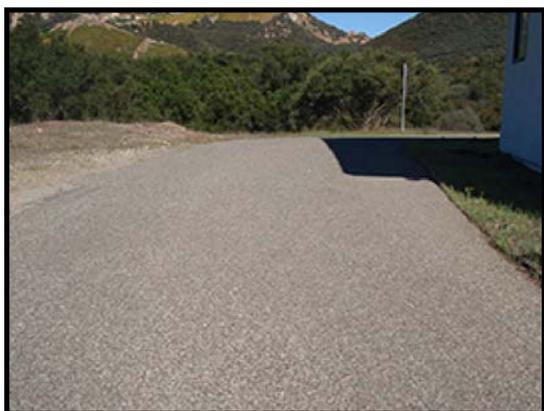
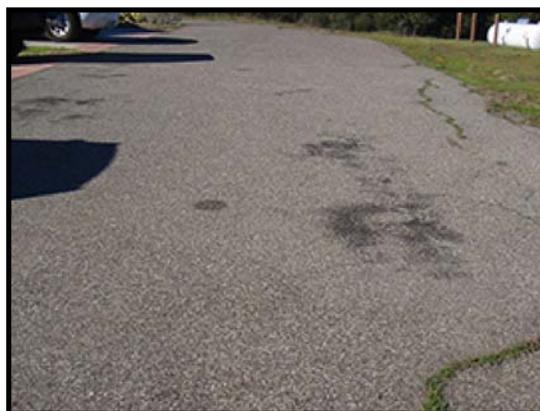
## Route 0425

Route Number	Public / NonPublic	Date Visited	Area (sq ft)	Lane Miles *	Surface Type
0425	NONPUBLIC	11/17/2010	5,520	0.10	AS
Culverts	Drop Inlets	Gates	Curb & Gutter	Curb	PCR
0	0	0	NO CURB AND GUTTER	NO CURB	FAIR/73

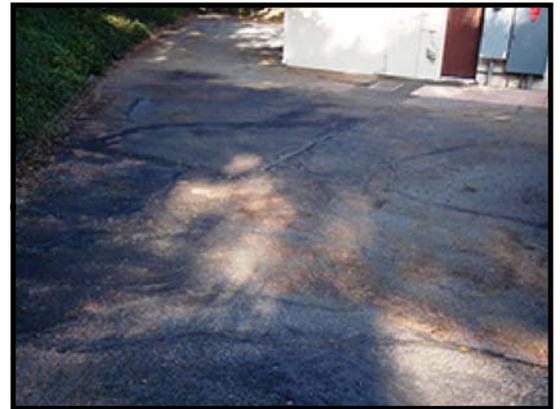
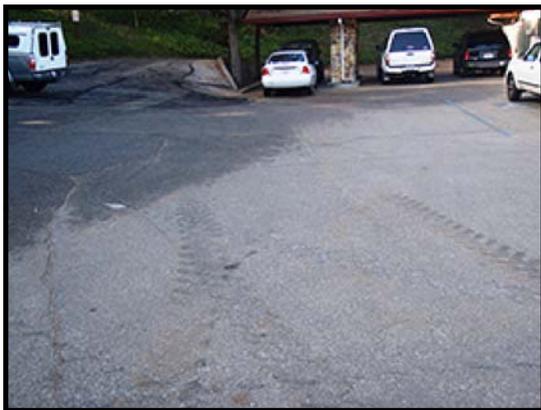
Route Number	Public / NonPublic	Date Visited	Area (sq ft)	Lane Miles *	Surface Type
0900	NONPUBLIC	11/17/2010	13,832	0.24	AS
Culverts	Drop Inlets	Gates	Curb & Gutter	Curb	PCR
0	0	0	NO CURB AND GUTTER	ASPHALT & CONCRETE CURB	POOR/45

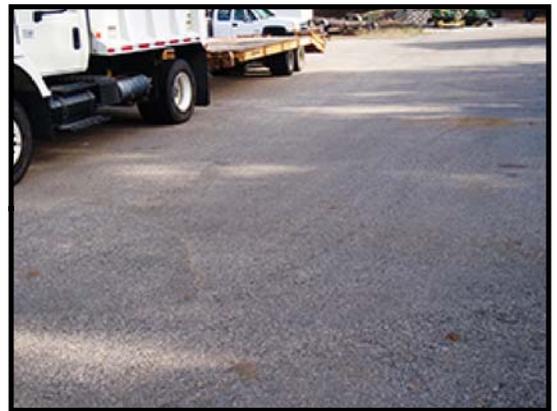
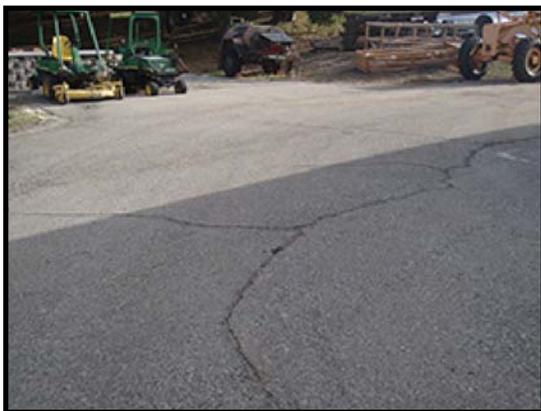
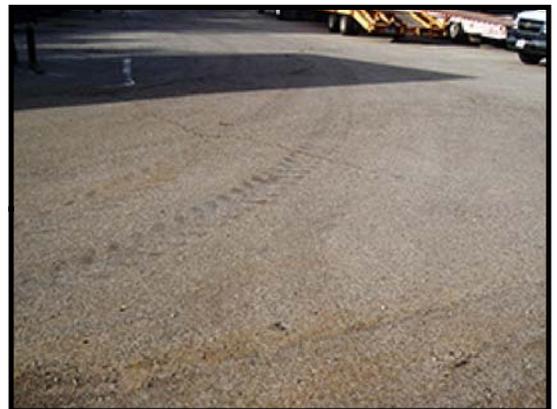
## Route 0901

Route Number	Public / NonPublic	Date Visited	Area (sq ft)	Lane Miles *	Surface Type
0901	NONPUBLIC	11/17/2010	9,871	0.17	AS
Culverts	Drop Inlets	Gates	Curb & Gutter	Curb	PCR
0	0	0	NO CURB AND GUTTER	CONCRETE CURB	FAIR/73

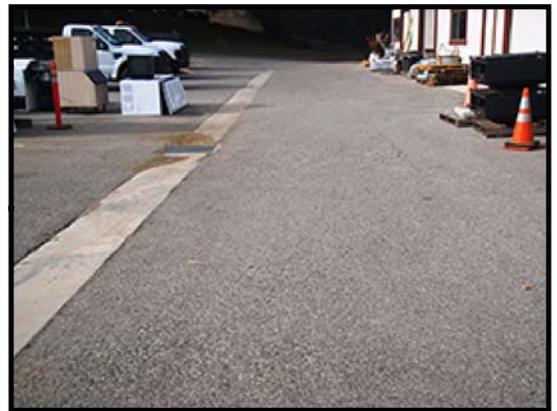
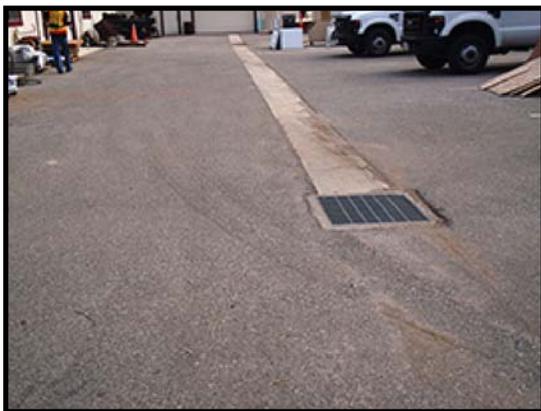
## Route 0902

Route Number	Public / NonPublic	Date Visited	Area (sq ft)	Lane Miles *	Surface Type
0902	NONPUBLIC	11/17/2010	6,197	0.11	AS
Culverts	Drop Inlets	Gates	Curb & Gutter	Curb	PCR
0	2	0	NO CURB AND GUTTER	NO CURB	GOOD/90

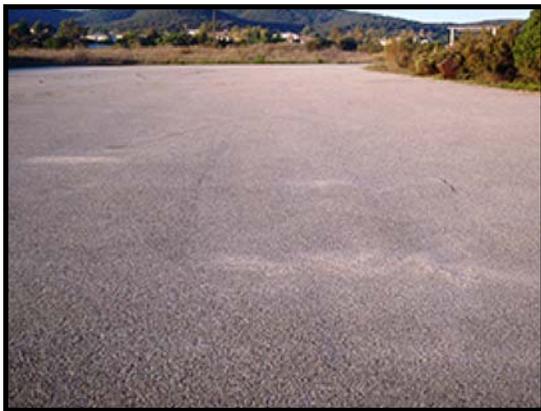
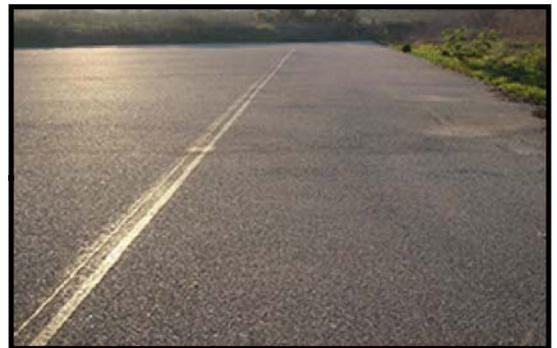
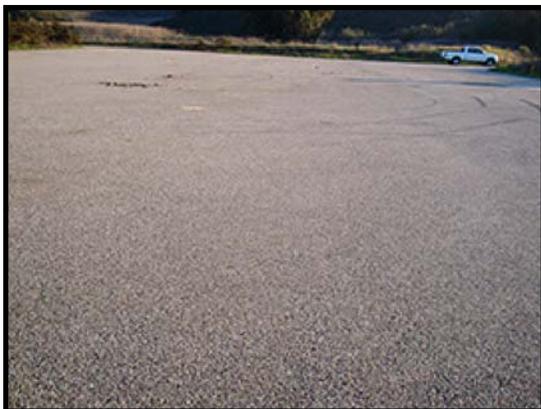
Route Number	Public / NonPublic	Date Visited	Area (sq ft)	Lane Miles *	Surface Type
0906	PUBLIC	11/17/2010	33,662	0.58	AS
Culverts	Drop Inlets	Gates	Curb & Gutter	Curb	PCR
0	0	0	NO CURB AND GUTTER	NO CURB	GOOD/90

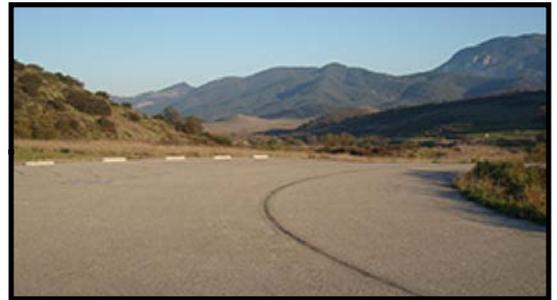
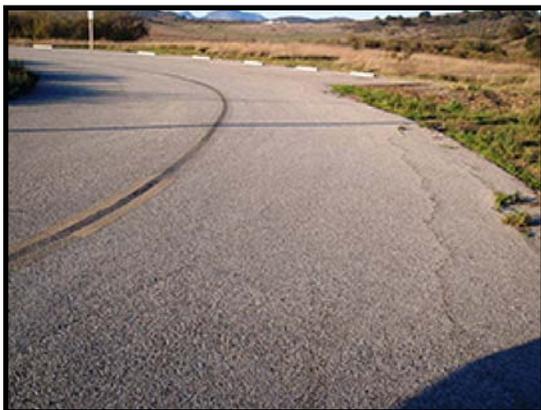
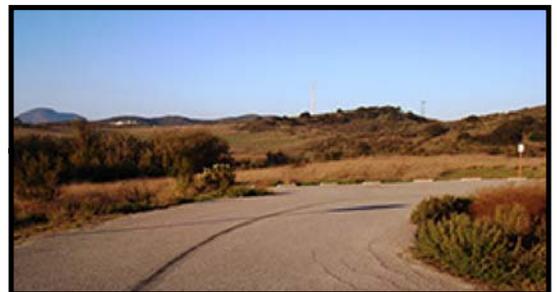
## Route 0907

Route Number	Public / NonPublic	Date Visited	Area (sq ft)	Lane Miles *	Surface Type
0907	PUBLIC	11/17/2010	8,898	0.15	AS
Culverts	Drop Inlets	Gates	Curb & Gutter	Curb	PCR
0	0	0	NO CURB AND GUTTER	NO CURB	GOOD/90
