# Federal Lands Highway Road Inventory Program

Road Inventory and Condition Assessment

## Saratoga National Historical Park SARA

### Cycle 5 Report

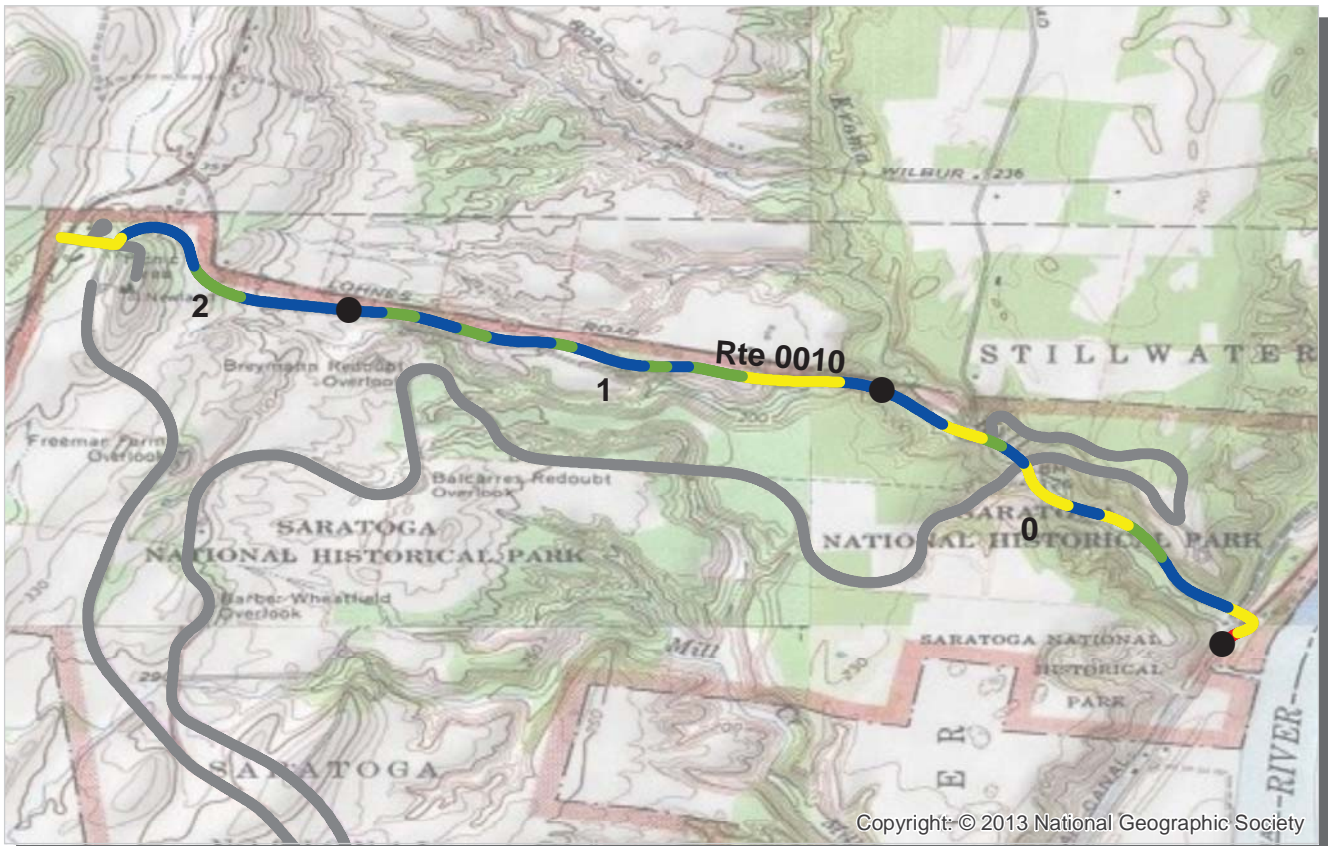
**ROUTE: 0010 ENTRANCE ROAD**

<i>Section Number</i>	0	1	2		
<i>Section Length (mi)</i>	1.00	1.00	0.64		
<i>Cross Section Information</i>					
Number of Lanes	2	2	2		
Paved Width (ft)	19	19	19		
Lane Width (ft)	9	9	9		
<i>Roadway Condition Information</i>					
SCR (Surface Condition Rating)	91	89	94		
PCR (Pavement Condition Rating)	86	93	89		
<i>Distress Index Values</i>					
Structural Crack Index	91	89	94		
Transverse Cracking Index	96	98	96		
Patching Index	100	100	100		
Rutting Index	99	98	100		
Roughness Condition Index (RCI)	78	100	82

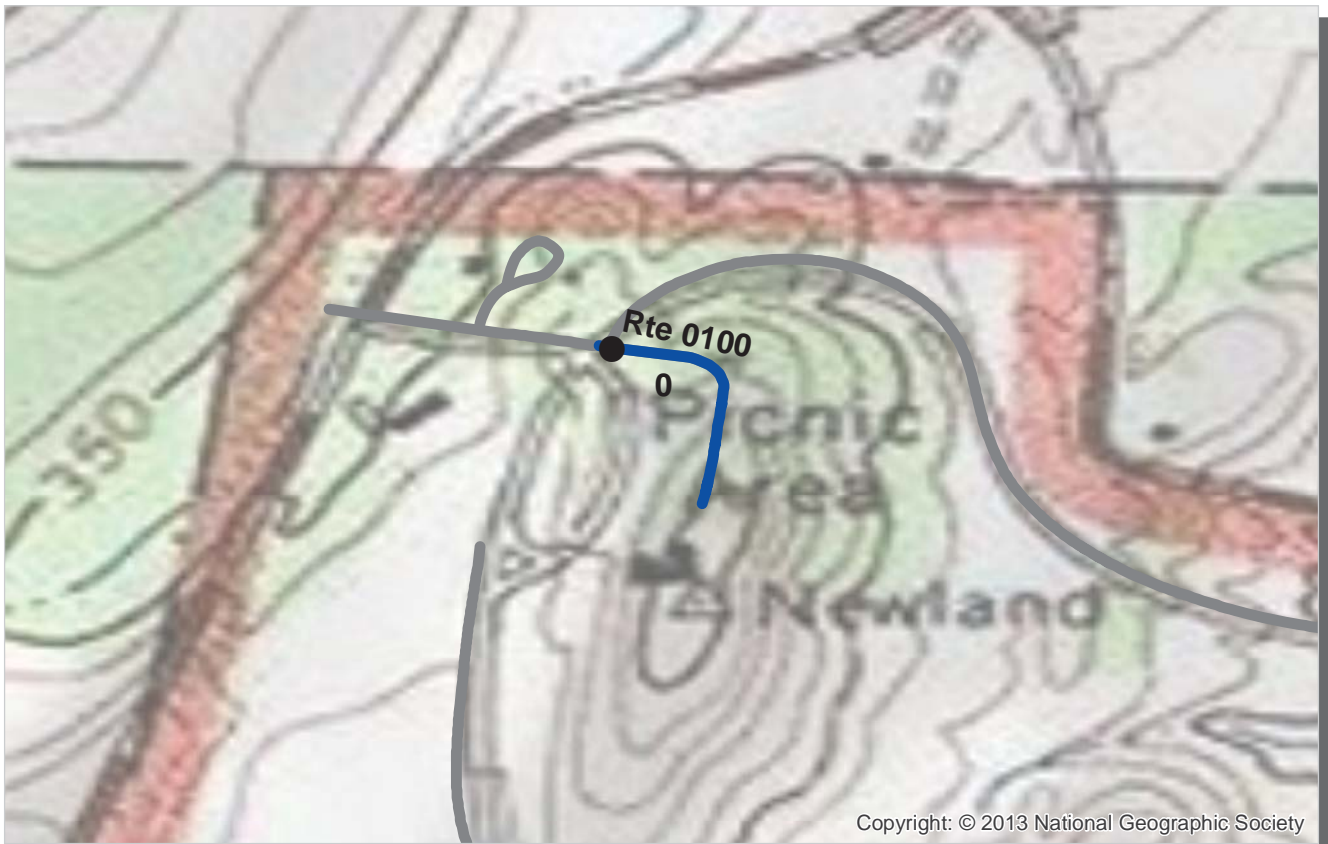
**ROUTE: 0100 ROOSEVELT ROAD**

<b>Section Number</b>	0				
<b>Section Length (mi)</b>	0.11				
<b>Cross Section Information</b>					
Number of Lanes	1				
Paved Width (ft)	11				
Lane Width (ft)	11				
<b>Roadway Condition Information</b>					
SCR (Surface Condition Rating)	96				
PCR (Pavement Condition Rating)	96				
<b>Distress Index Values</b>					
Structural Crack Index	96				
Transverse Cracking Index	100				
Patching Index	100				
Rutting Index	99				
Roughness Condition Index (RCI)	NC

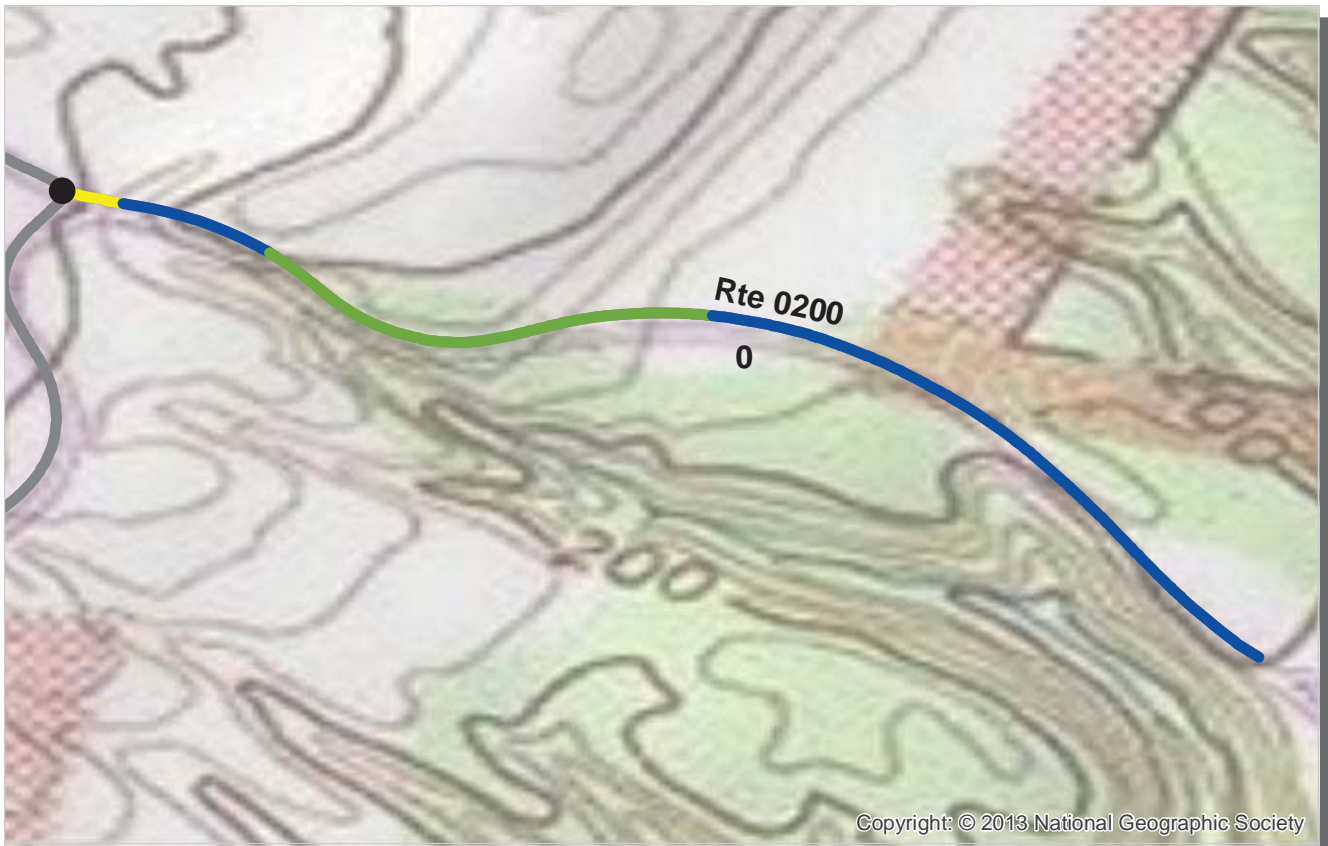
**ROUTE: 0200 TOUR ROAD TO STOP 3**

<b>Section Number</b>	0				
<b>Section Length (mi)</b>	0.53				
<b>Cross Section Information</b>					
Number of Lanes	2				
Paved Width (ft)	24				
Lane Width (ft)	12				
<b>Roadway Condition Information</b>					
SCR (Surface Condition Rating)	97				
PCR (Pavement Condition Rating)	96				
<b>Distress Index Values</b>					
Structural Crack Index	97				
Transverse Cracking Index	100				
Patching Index	100				
Rutting Index	99				
Roughness Condition Index (RCI)	94
