# Federal Lands Highway Road Inventory Program

Road Inventory and Condition Assessment

**Sequoia National Park**  
**SEQU**

**Cycle 5 Report**

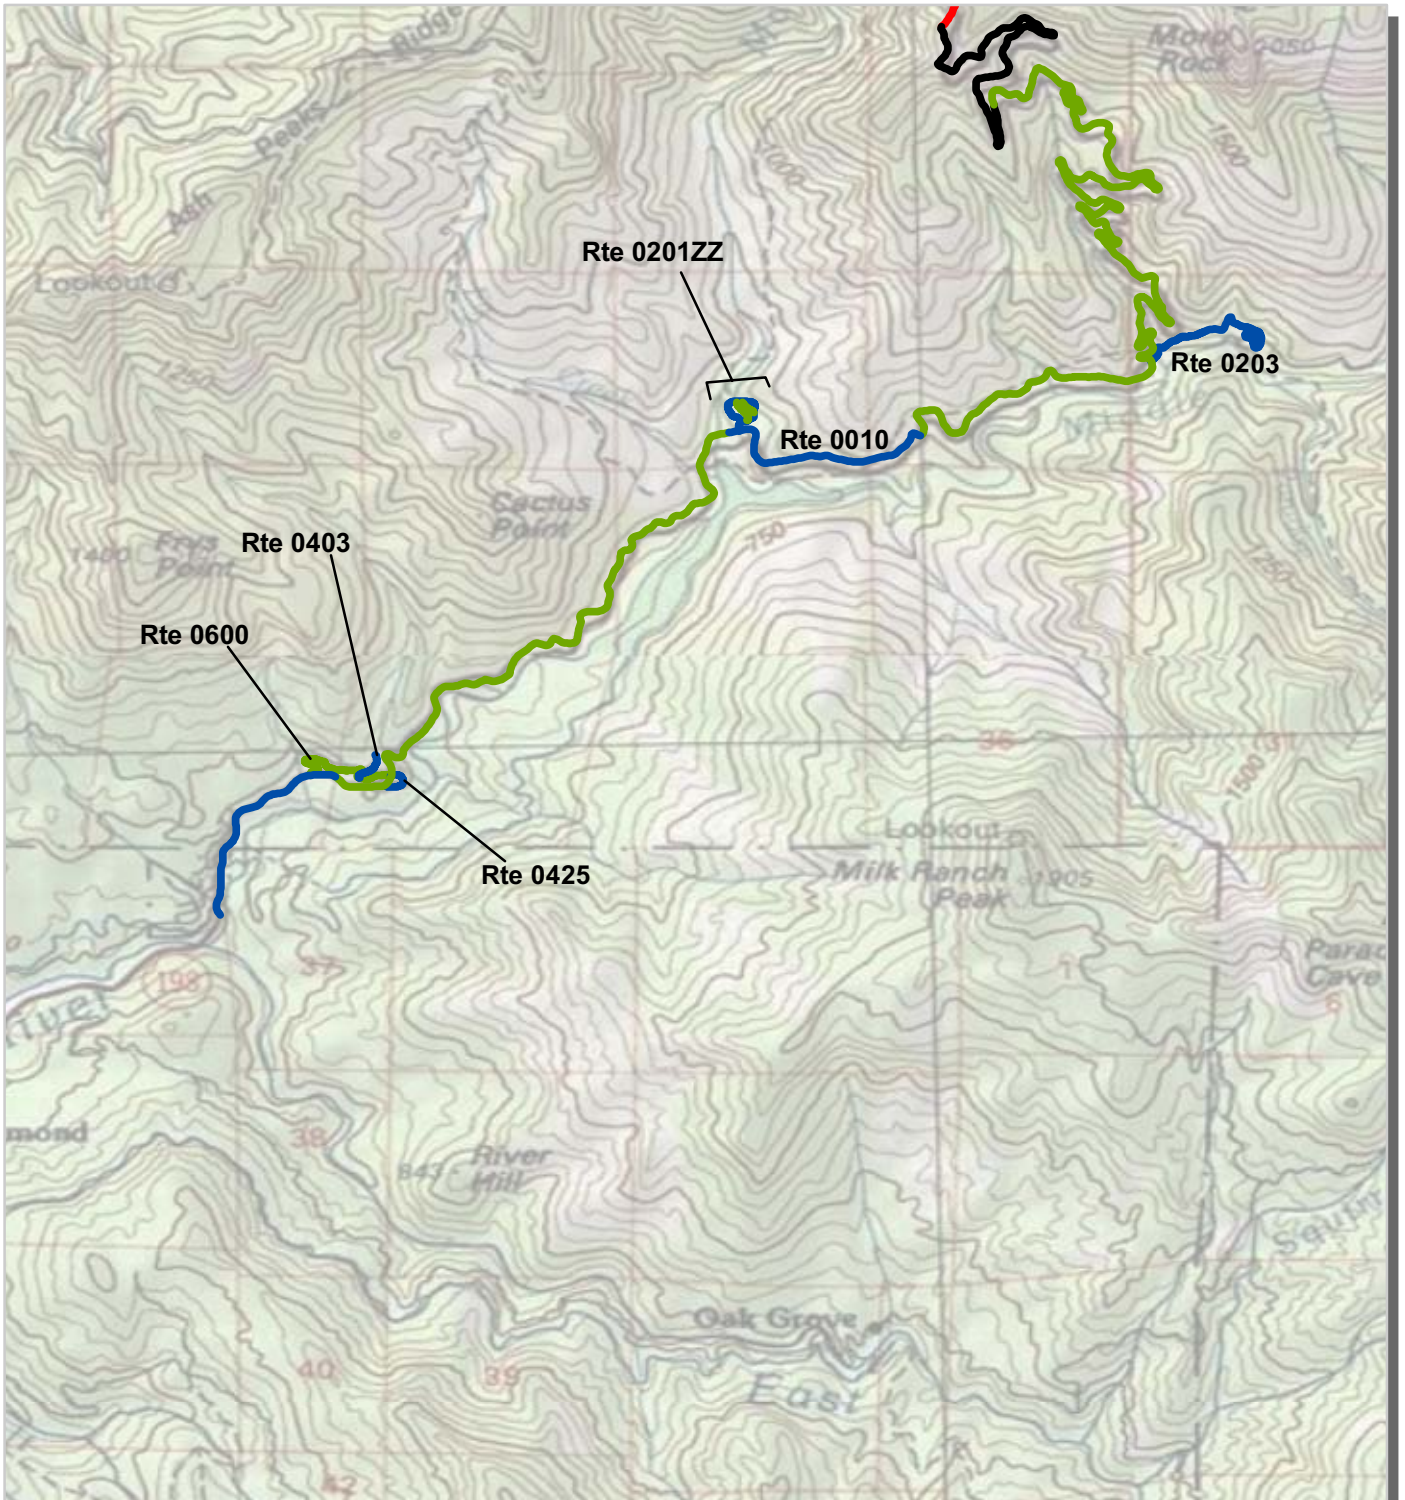
# Sequoia National Park Route Condition Map PCR - Mile by Mile Area 2

PCR	Poor	<span style="display: inline-block; width: 15px; height: 15px; background-color: red; border: 1px solid black;"></span>	Fair	<span style="display: inline-block; width: 15px; height: 15px; background-color: yellow; border: 1px solid black;"></span>	Good	<span style="display: inline-block; width: 15px; height: 15px; background-color: green; border: 1px solid black;"></span>	Excellent	<span style="display: inline-block; width: 15px; height: 15px; background-color: blue; border: 1px solid black;"></span>	No Data	<span style="display: inline-block; width: 15px; height: 15px; background-color: black; border: 1px solid black;"></span>
	(0 - 60)		(61 - 84)	(85 - 94)		(95 - 100)

\* If the PCR rating is not available for a section, the SCR rating will be displayed. See appendix for definitions and formulas.

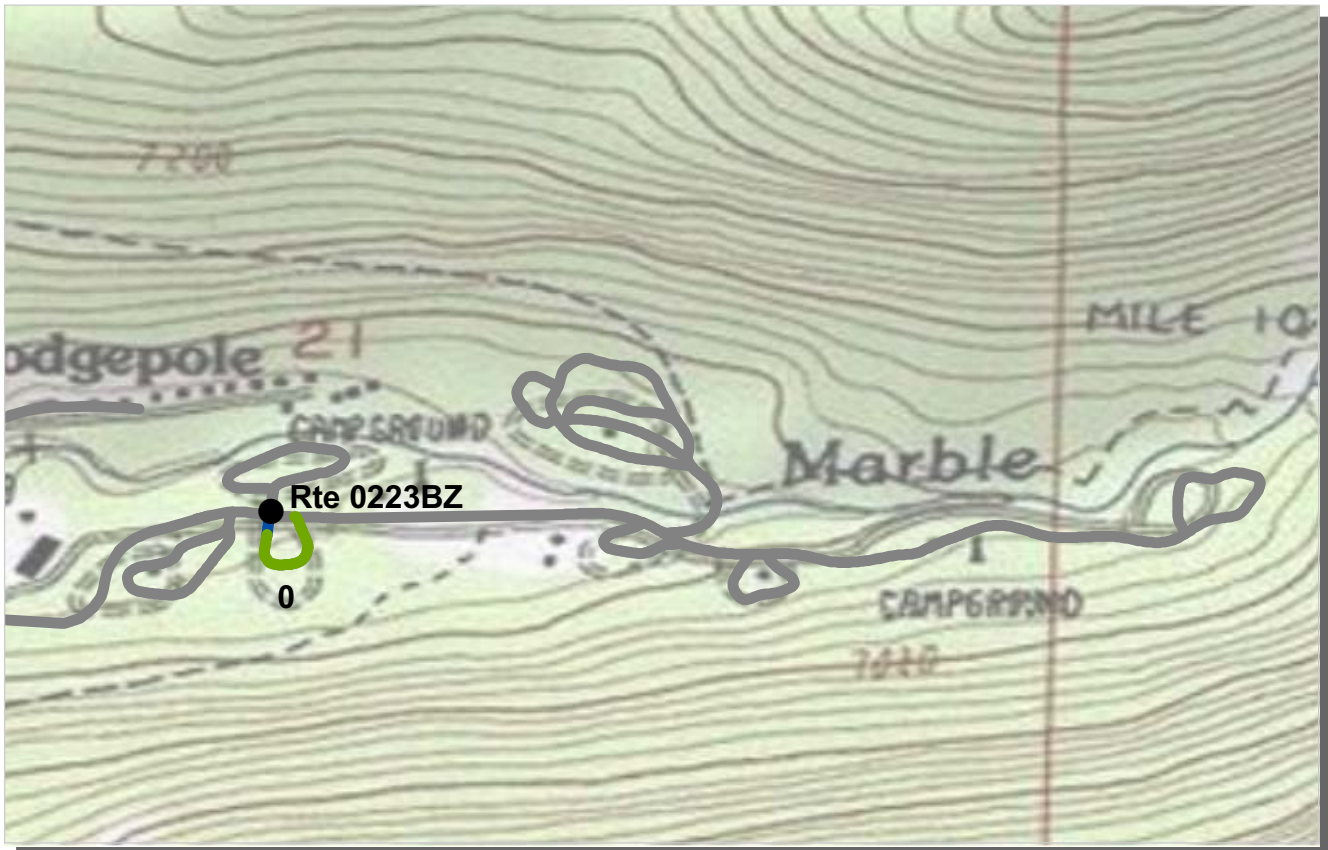
**ROUTE: 0223AZ LODGEPOLE CAMPGROUND LOOP A**

PCR	Poor	Fair	Good	Excellent	No Data
	(0 - 60)	(61 - 84)	(85 - 94)	(95 - 100)

\* If the PCR rating is not available for a section, the SCR rating will be displayed. See appendix for definitions and formulas.

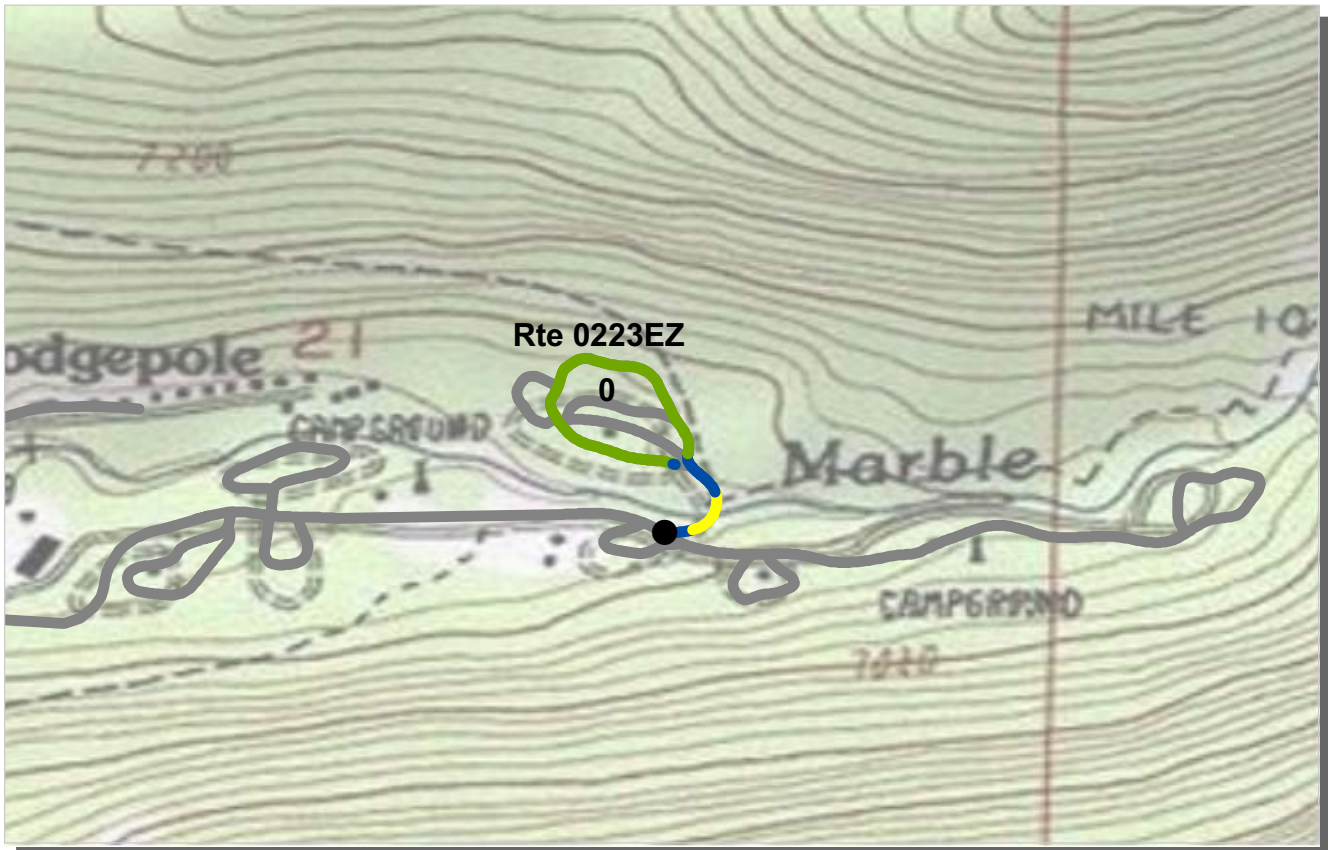
ROUTE: 0223ECZ LODGEPOLE CAMPGROUND LOOP EC

PCR    Poor ■    Fair ■    Good ■    Excellent ■    No Data ■  
           (0 - 60)           (61 - 84)           (85 - 94)           (95 - 100)

\* If the PCR rating is not available for a section, the SCR rating will be displayed. See appendix for definitions and formulas.

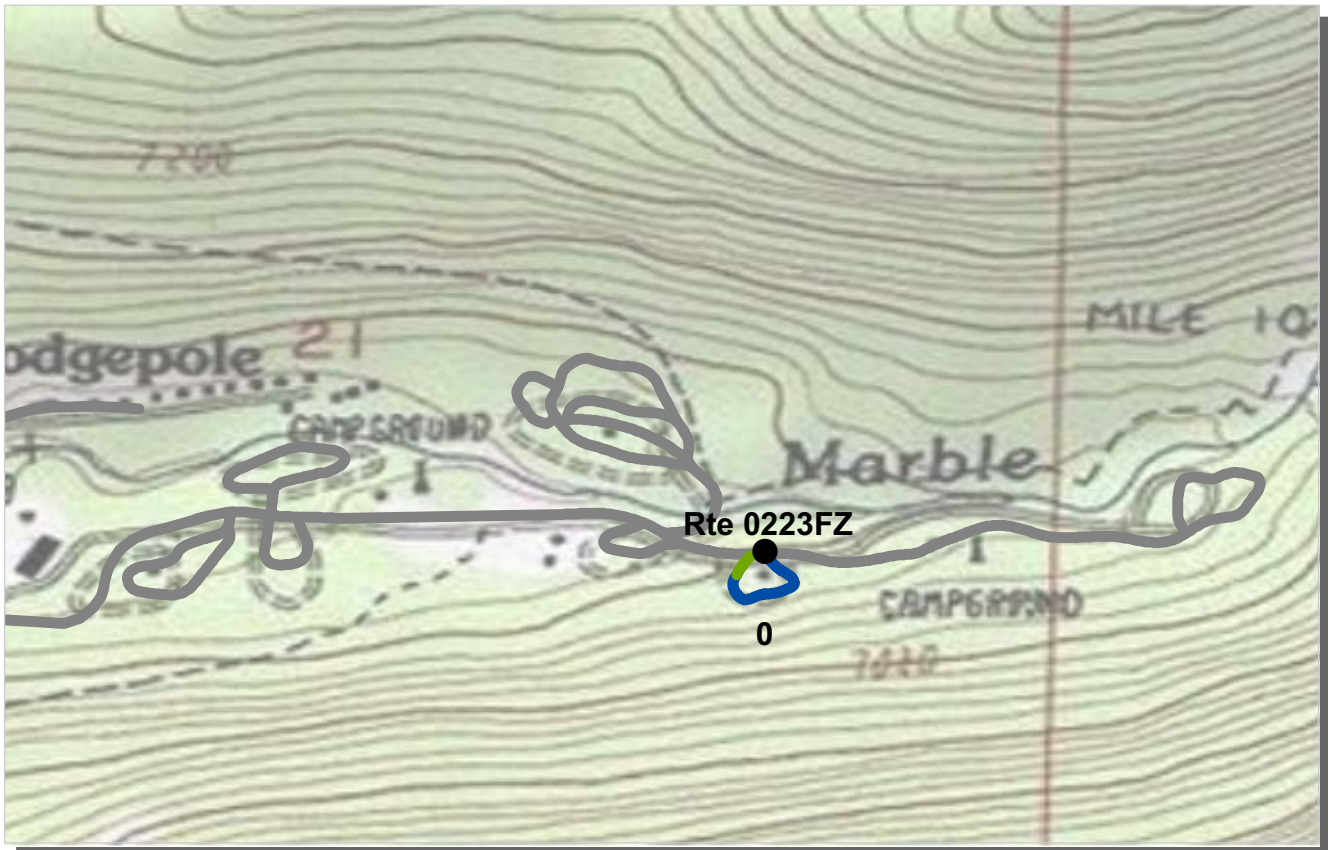
ROUTE: 0223EZ LODGEPOLE CAMPGROUND LOOP E

PCR    Poor ■    Fair ■    Good ■    Excellent ■    No Data ■  
           (0 - 60)           (61 - 84)           (85 - 94)           (95 - 100)

\* If the PCR rating is not available for a section, the SCR rating will be displayed. See appendix for definitions and formulas.

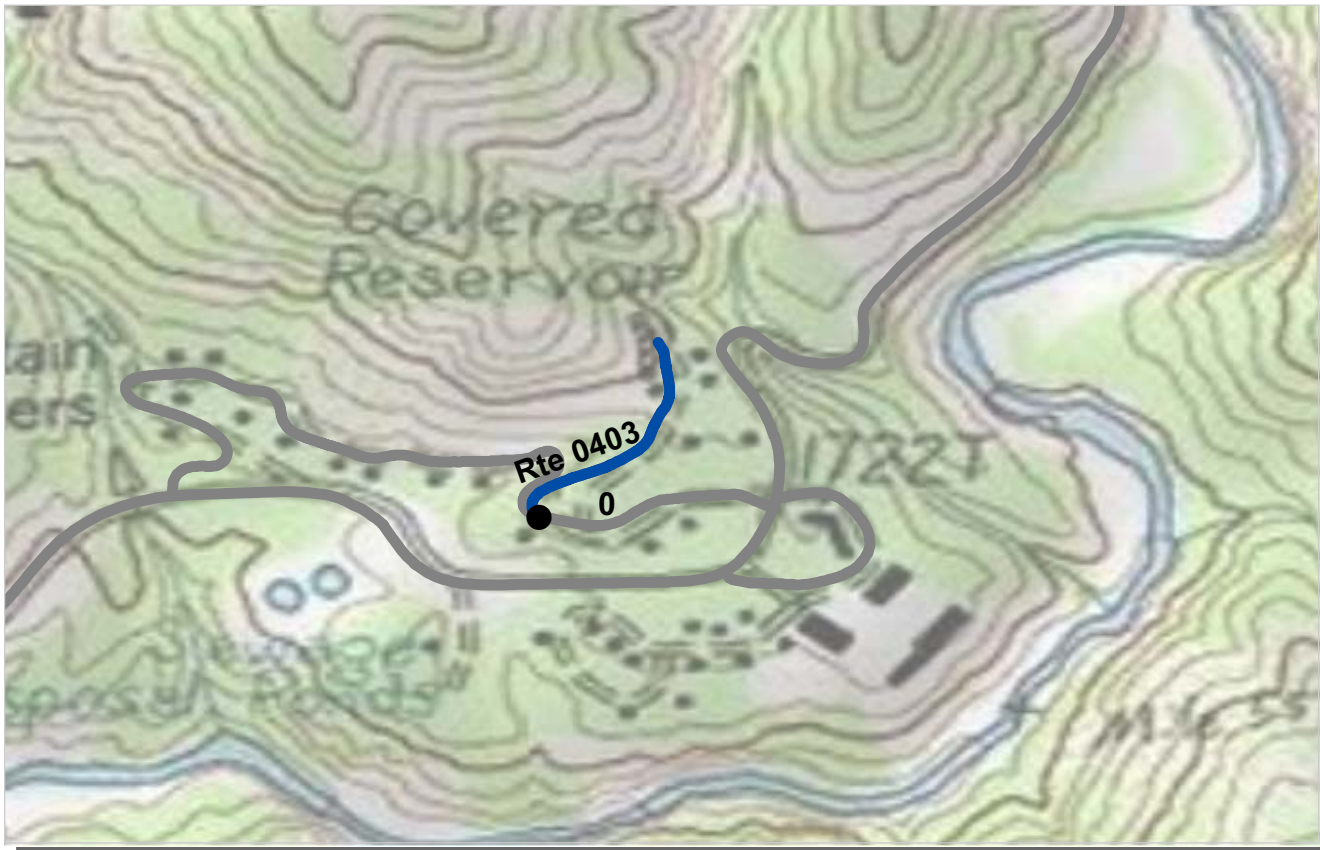
**ROUTE: 0225 WOLVERTON ROAD**

PCR    Poor ■    Fair ■    Good ■    Excellent ■    No Data ■  
           (0 - 60)           (61 - 84)           (85 - 94)           (95 - 100)

\* If the PCR rating is not available for a section, the SCR rating will be displayed. See appendix for definitions and formulas.

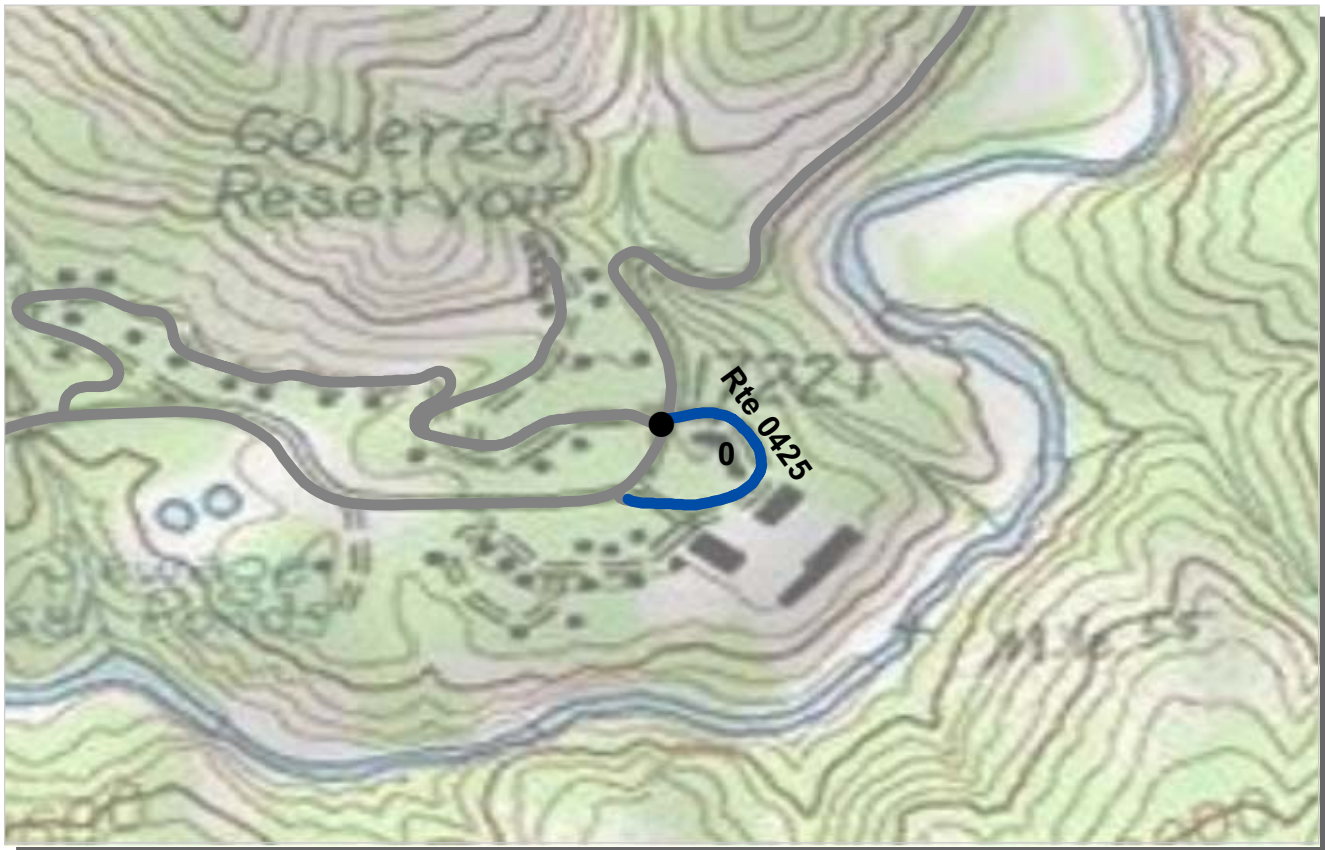
**ROUTE: 0403 DRURY LANE**

PCR	Poor	Fair	Good	Excellent	No Data
	(0 - 60)	(61 - 84)	(85 - 94)	(95 - 100)

\* If the PCR rating is not available for a section, the SCR rating will be displayed. See appendix for definitions and formulas.

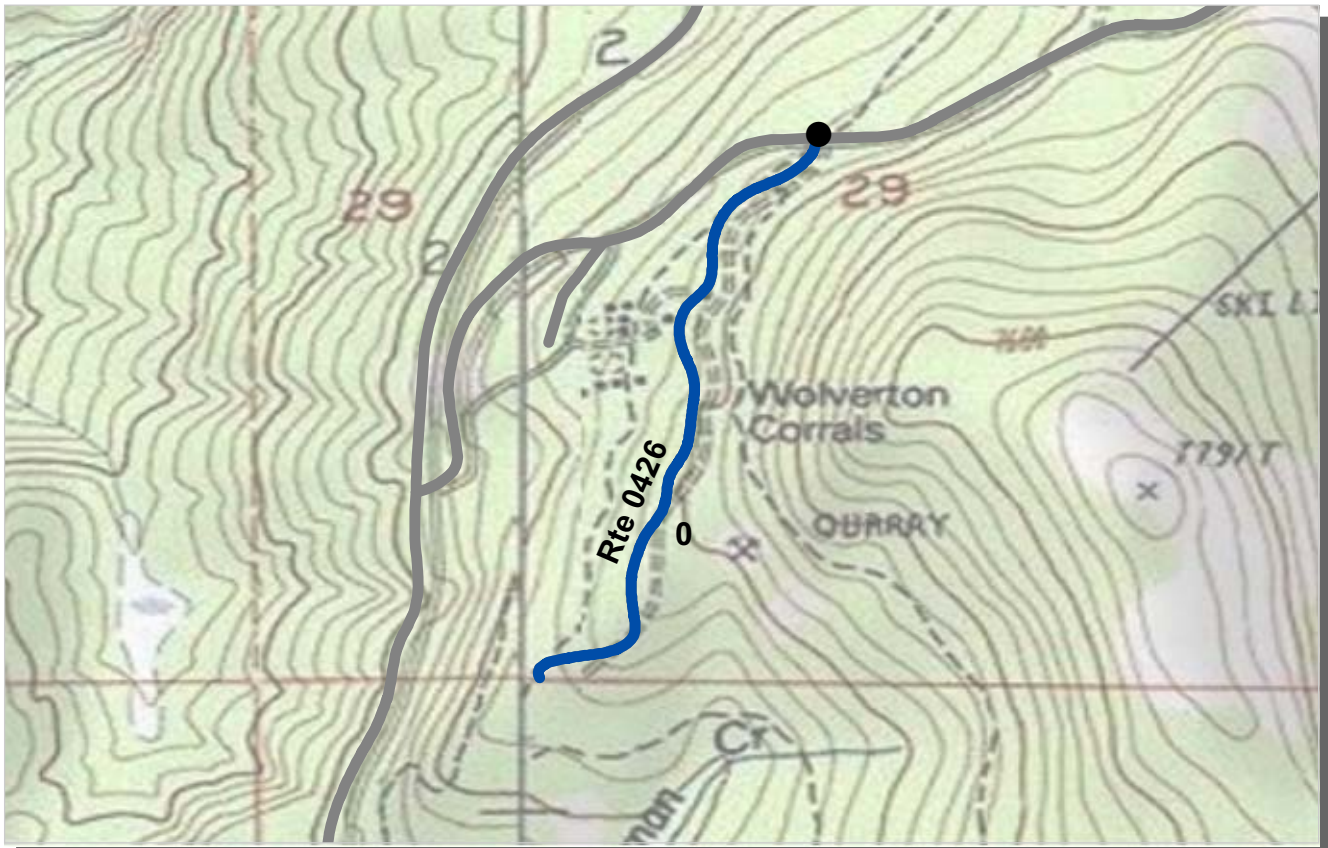
**ROUTE: 0425 HEADQUARTERS STREET**

PCR    Poor ■    Fair ■    Good ■    Excellent ■    No Data ■  
           (0 - 60)           (61 - 84)           (85 - 94)           (95 - 100)

\* If the PCR rating is not available for a section, the SCR rating will be displayed. See appendix for definitions and formulas.

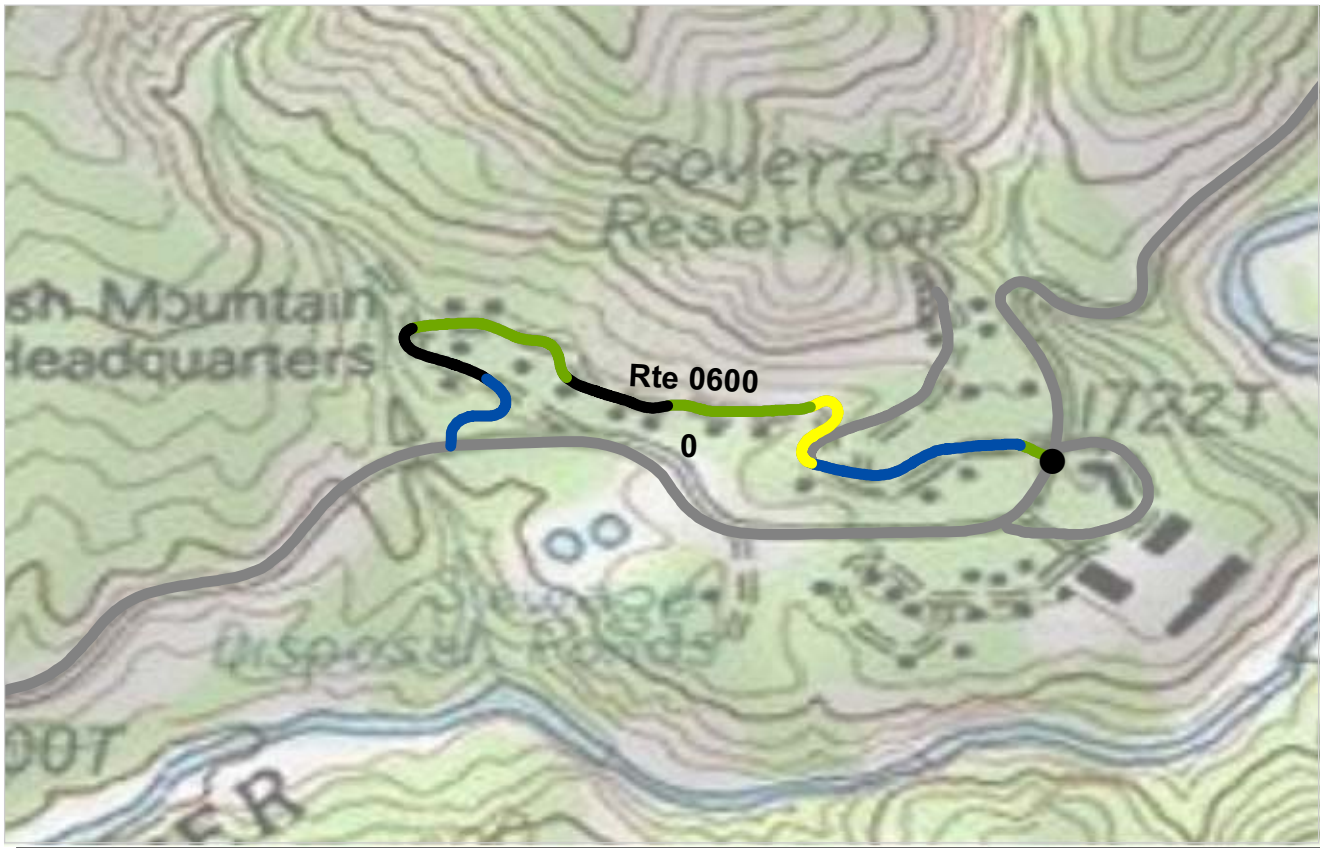
**ROUTE: 0500 MORO ROCK LOOP**

PCR    Poor ■    Fair ■    Good ■    Excellent ■    No Data ■  
           (0 - 60)           (61 - 84)           (85 - 94)           (95 - 100)

\* If the PCR rating is not available for a section, the SCR rating will be displayed. See appendix for definitions and formulas.

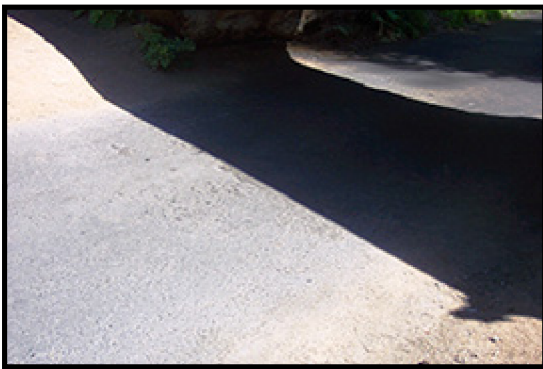
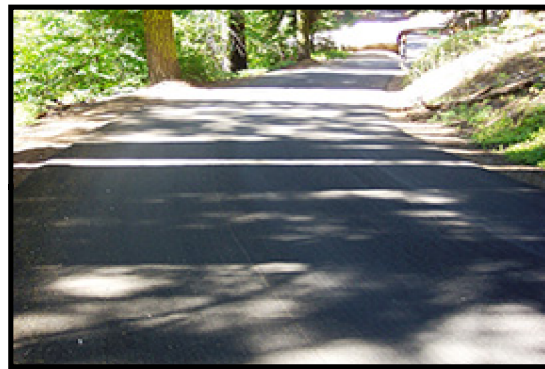
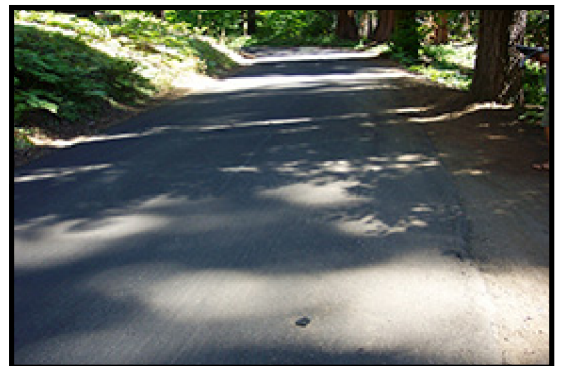
Route Number	Public / NonPublic	Date Visited	Area (sq ft)	Lane Miles *	Paved Length (mi)	Paved Width (ft)
0102AZ	PUBLIC	9/19/2011	3,696	0.06	0.05	14
Culverts	Drop Inlets	Gates	Curb & Gutter	Curb	PCR	Surface Type
0	0	0	NO CURB AND GUTTER	NO CURB	GOOD/90	AS

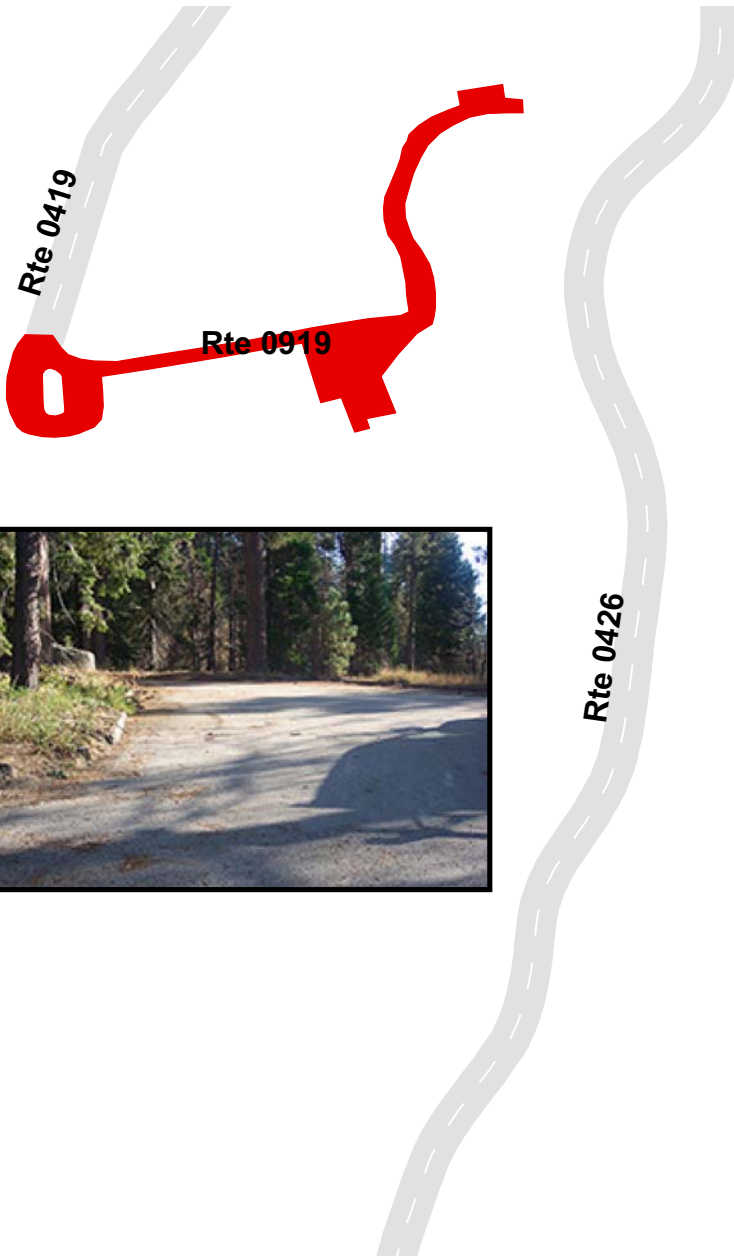
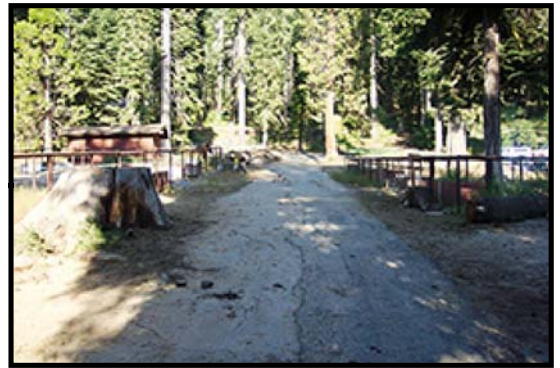
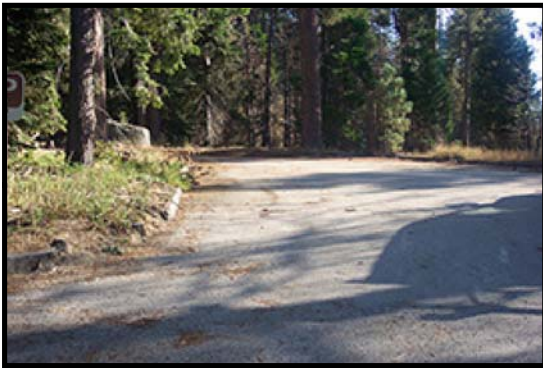
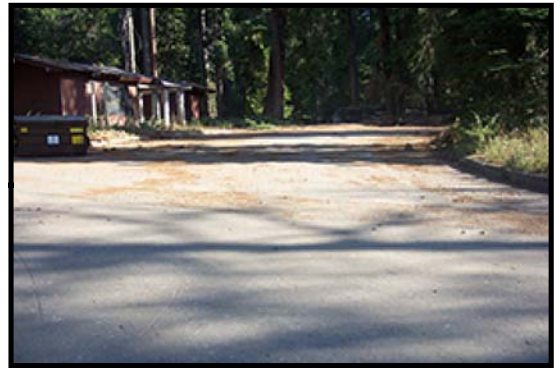
## Route 0919

Route Number	Public / NonPublic	Date Visited	Area (sq ft)	Lane Miles *	Surface Type
0919	NONPUBLIC	9/19/2011	33,712	0.58	AS
Culverts	Drop Inlets	Gates	Curb & Gutter	Curb	PCR
0	0	0	NO CURB AND GUTTER	ASPHALT CURB	POOR/45

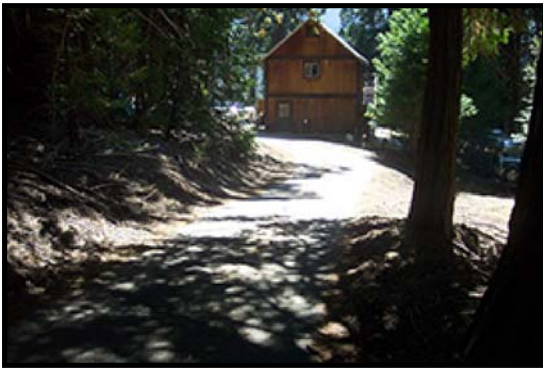
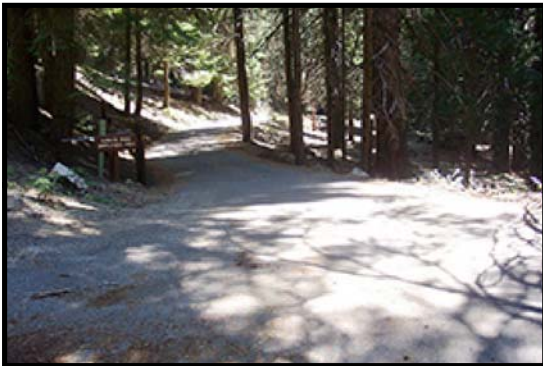
## Route 0921

Route Number	Public / NonPublic	Date Visited	Area (sq ft)	Lane Miles *	Surface Type
0921	NONPUBLIC	9/19/2011	14,573	0.25	AS
Culverts	Drop Inlets	Gates	Curb & Gutter	Curb	PCR
1	0	1	NO CURB AND GUTTER	NO CURB	GOOD/90

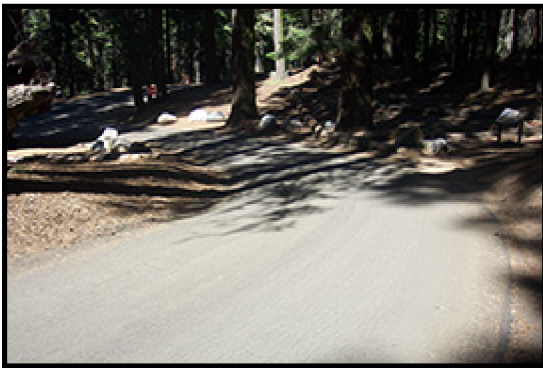
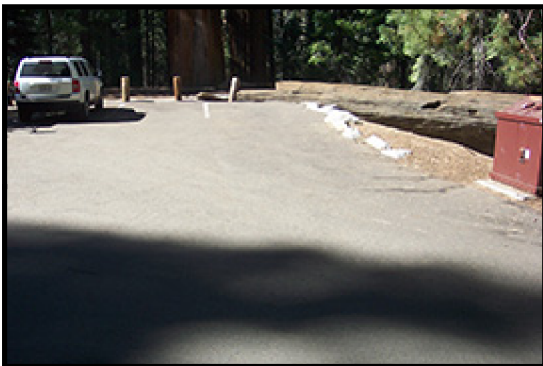
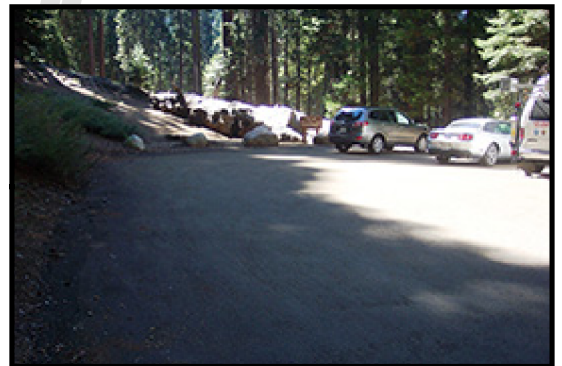
## Route 0931

Route Number	Public / NonPublic	Date Visited	Area (sq ft)	Lane Miles *	Surface Type
0931	PUBLIC	9/19/2011	8,105	0.14	AS
Culverts	Drop Inlets	Gates	Curb & Gutter	Curb	PCR
0	0	0	NO CURB AND GUTTER	NO CURB	GOOD/90
