Federal Lands Highway Road Inventory Program

Road Inventory and Condition Assessment

Springfield Armory National Historic Site SPAR

Cycle 5 Report

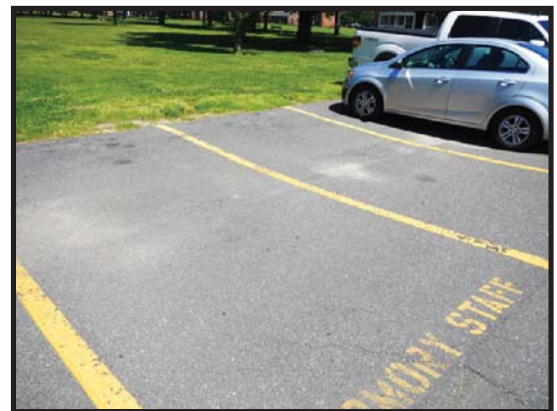
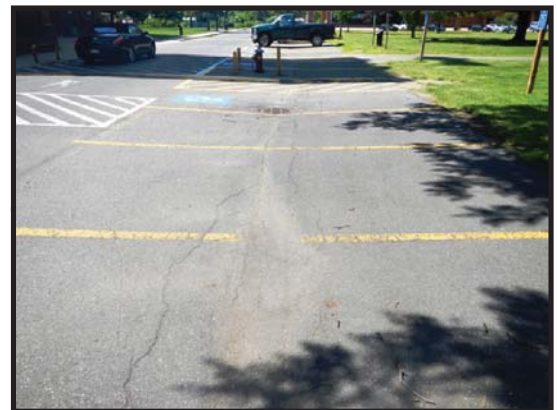
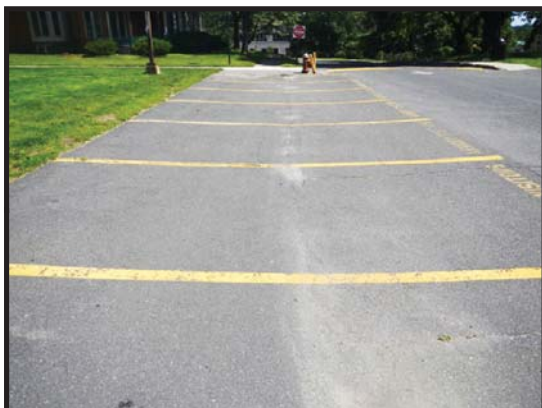
Route Number	Public / NonPublic	Date Visited	Area (sq ft)	Lane Miles *	Surface Type
0900	PUBLIC	6/20/2013	7,315	0.13	AS
Culverts	Drop Inlets	Gates	Curb & Gutter	Curb	PCR
0	7	0	NO CURB AND GUTTER	NO CURB	POOR/45
