Federal Lands Highway Road Inventory Program

Road Inventory and Condition Assessment

Stones River National Battlefield STRI - 5590

Cycle 5 Report

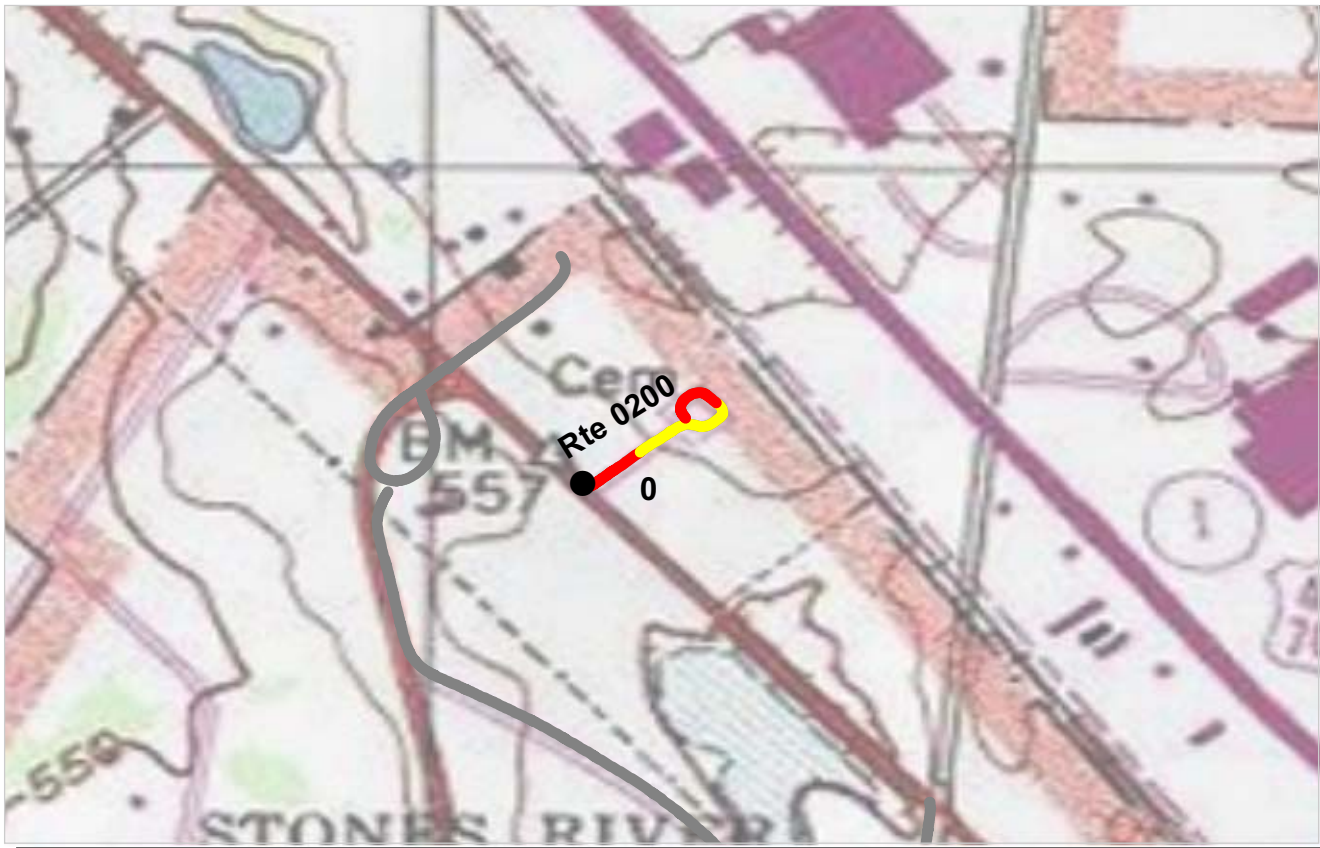
ROUTE: 0200 CEMETERY ROAD

Section Number	0				
Section Length (mi)	0.13				
Cross Section Information					
Number of Lanes	2				
Paved Width (ft)	15				
Lane Width (ft)	7				
Roadway Condition Information					
SCR (Surface Condition Rating)	5				
PCR (Pavement Condition Rating)	5				
Distress Index Values					
Structural Crack Index	5				
Transverse Cracking Index	99				
Patching Index	100				
Rutting Index	96				
Roughness Condition Index (RCI)	NC

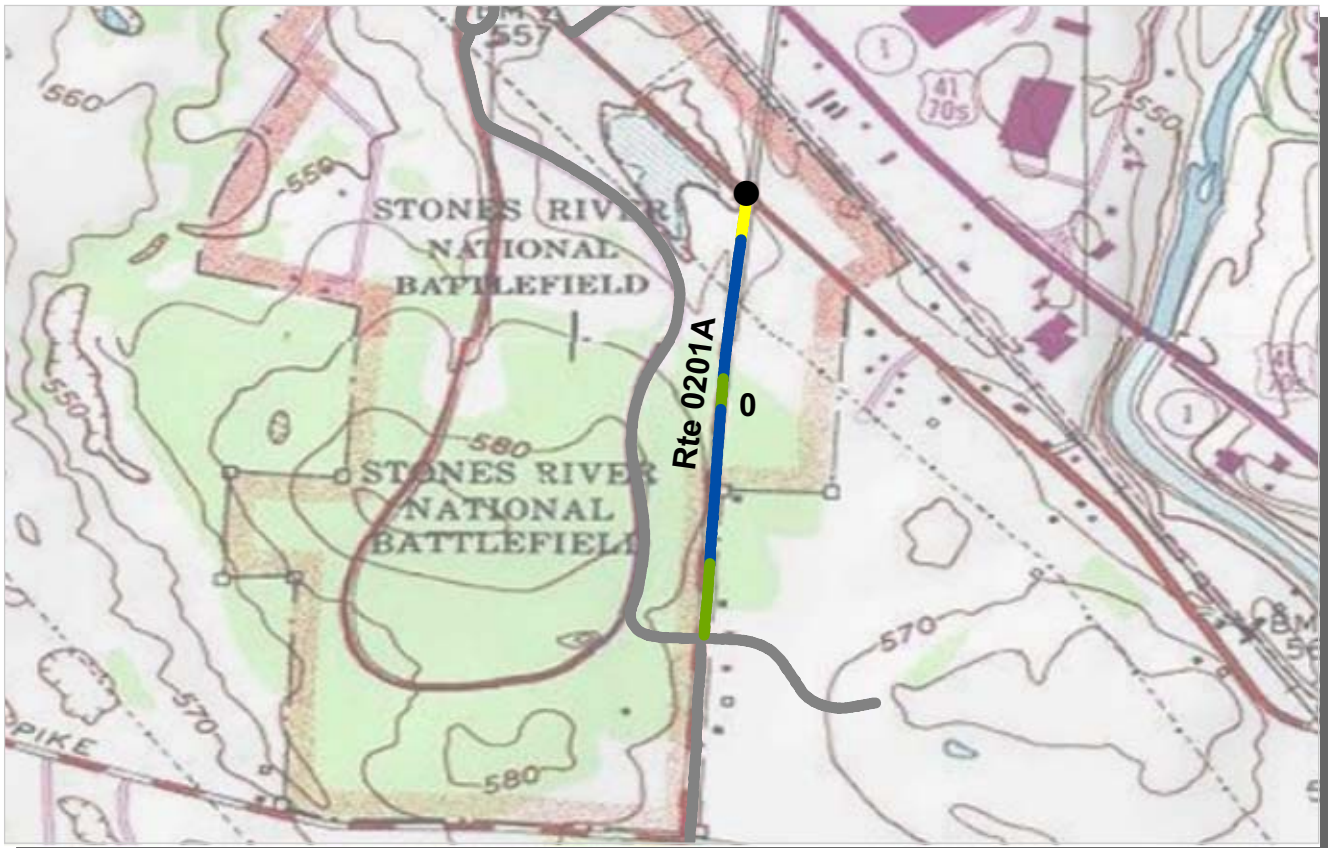
ROUTE: 0201A VAN CLEVE LANE

Section Number	0				
Section Length (mi)	0.57				
Cross Section Information					
Number of Lanes	1				
Paved Width (ft)	22				
Lane Width (ft)	11				
Roadway Condition Information					
SCR (Surface Condition Rating)	100				
PCR (Pavement Condition Rating)	88				
Distress Index Values					
Structural Crack Index	100				
Transverse Cracking Index	100				
Patching Index	100				
Rutting Index	100				
Roughness Condition Index (RCI)	70

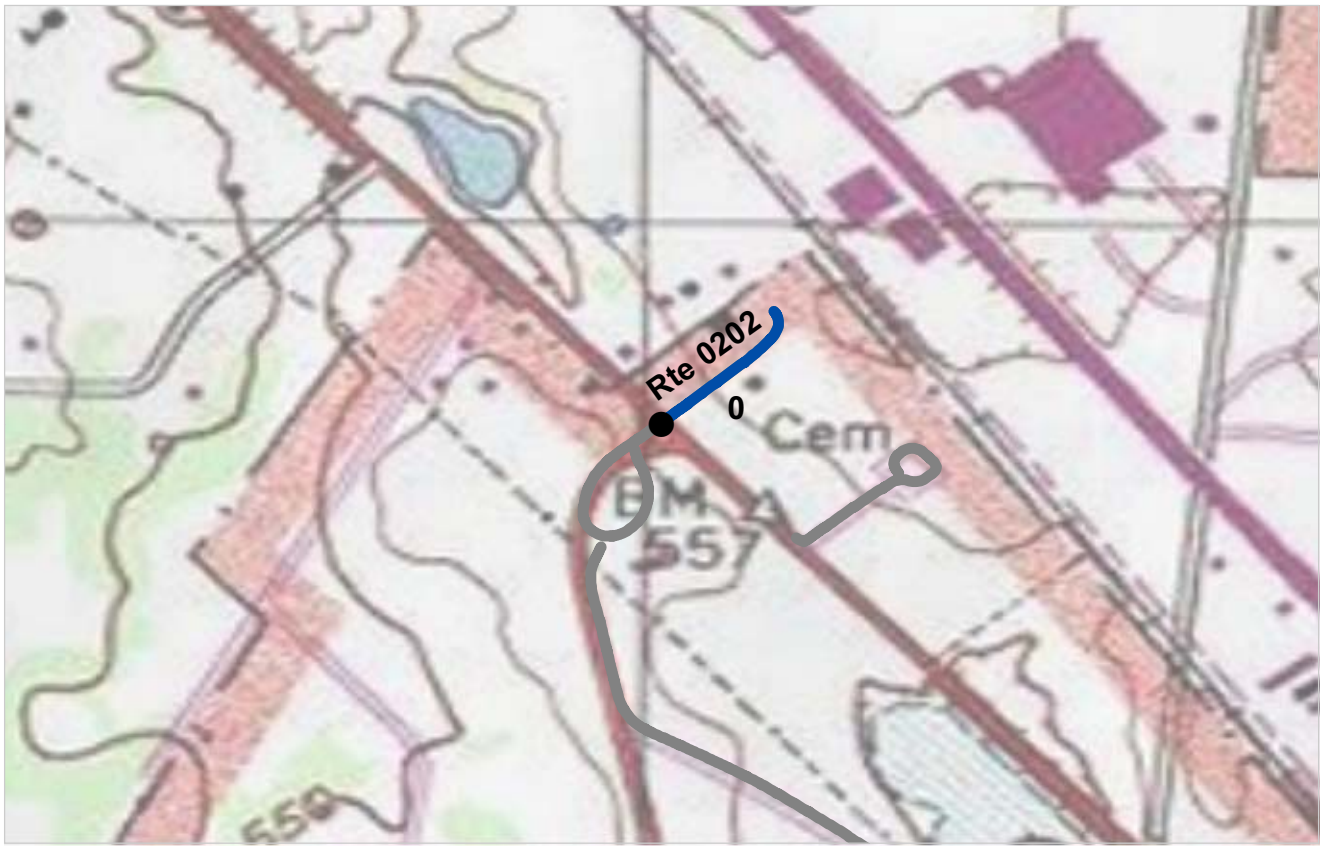
ROUTE: 0202 OLD LODGE LANE

Section Number	0				
Section Length (mi)	0.10				
Cross Section Information					
Number of Lanes	2				
Paved Width (ft)	16				
Lane Width (ft)	8				
Roadway Condition Information					
SCR (Surface Condition Rating)	98				
PCR (Pavement Condition Rating)	98				
Distress Index Values					
Structural Crack Index	100				
Transverse Cracking Index	100				
Patching Index	100				
Rutting Index	98				
Roughness Condition Index (RCI)	NC

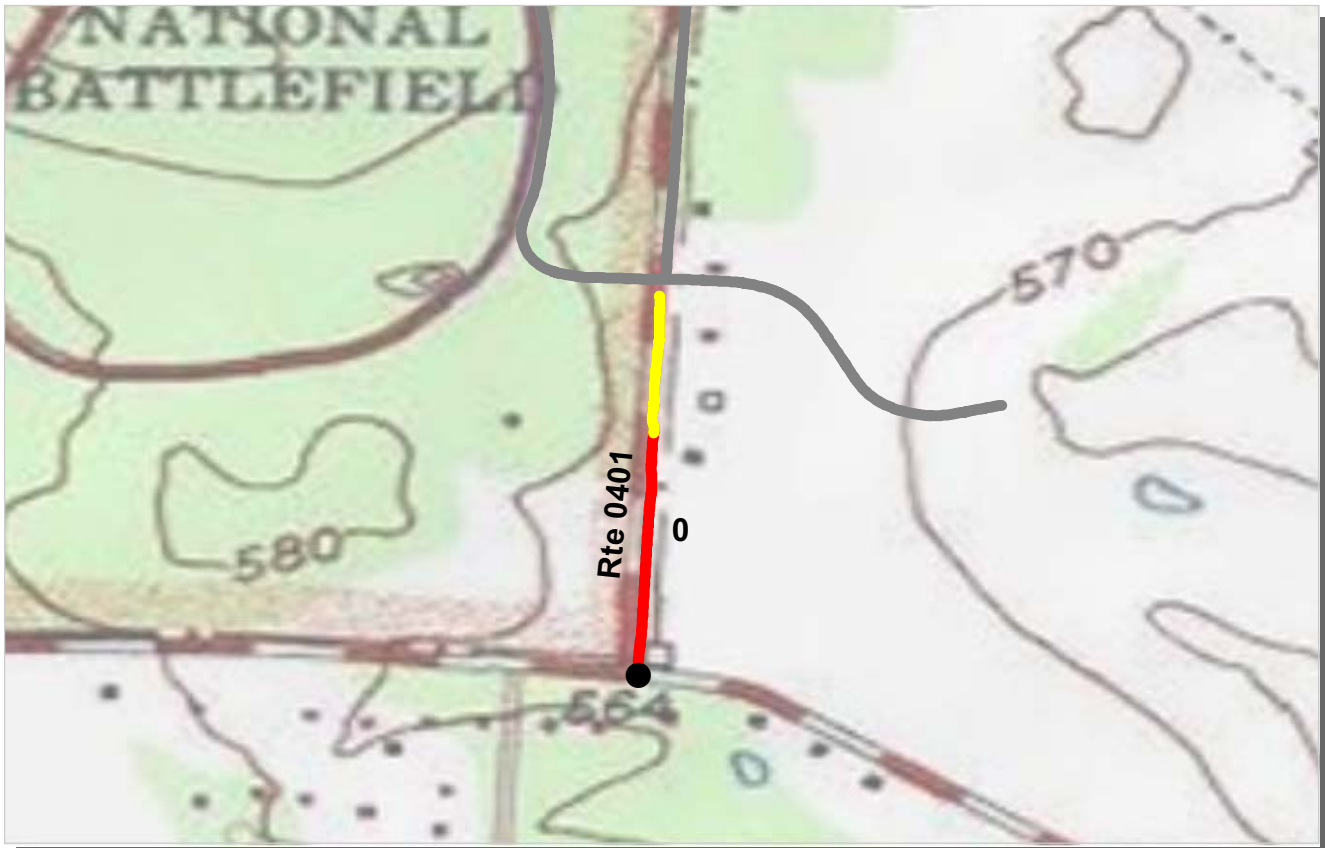
ROUTE: 0401 VAN CLEVE LANE (MAINTENANCE AREA)

Section Number	0				
Section Length (mi)	0.25				
Cross Section Information					
Number of Lanes	2				
Paved Width (ft)	18				
Lane Width (ft)	9				
Roadway Condition Information					
SCR (Surface Condition Rating)	70				
PCR (Pavement Condition Rating)	70				
Distress Index Values					
Structural Crack Index	70				
Transverse Cracking Index	99				
Patching Index	100				
Rutting Index	83				
Roughness Condition Index (RCI)	NC
