# Federal Lands Highway Road Inventory Program

Road Inventory and Condition Assessment

## Theodore Roosevelt National Park THRO - 1540

### Cycle 5 Report

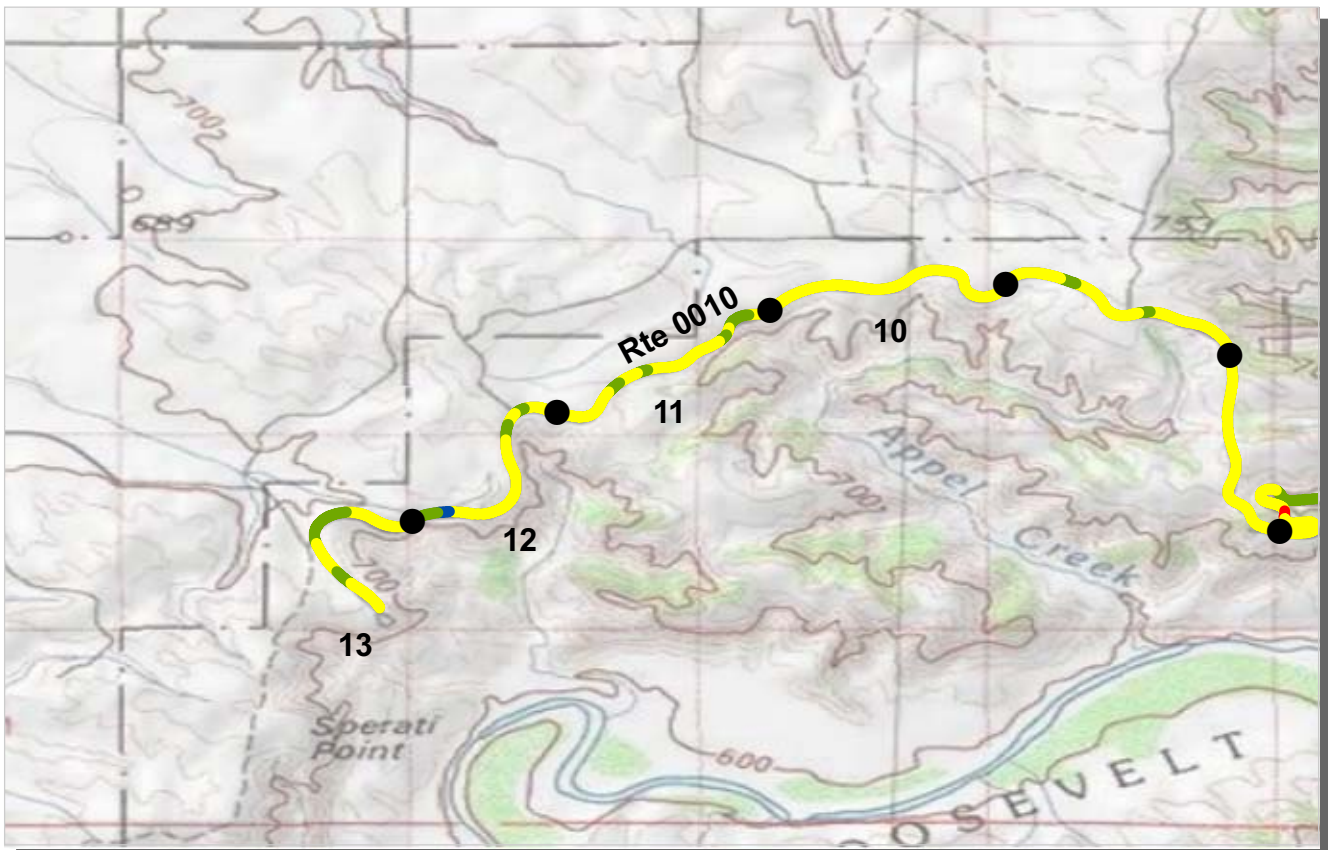
**ROUTE: 0010 SCENIC DRIVE**

<i>Section Number</i>	10	11	12	13	
<i>Section Length (mi)</i>	1.00	1.00	1.00	0.88	
<i>Cross Section Information</i>					
Number of Lanes	2	2	2	2	
Paved Width (ft)	29	28	27	26	
Lane Width (ft)	12	12	12	12	
<i>Roadway Condition Information</i>					
SCR (Surface Condition Rating)	84	87	86	89	
PCR (Pavement Condition Rating)	75	79	76	80	
<i>Distress Index Values</i>					
Structural Crack Index	94	97	99	99	
Transverse Cracking Index	94	93	94	93	
Patching Index	100	100	100	100	
Rutting Index	84	87	86	89	
Roughness Condition Index (RCI)	61	67	61	67

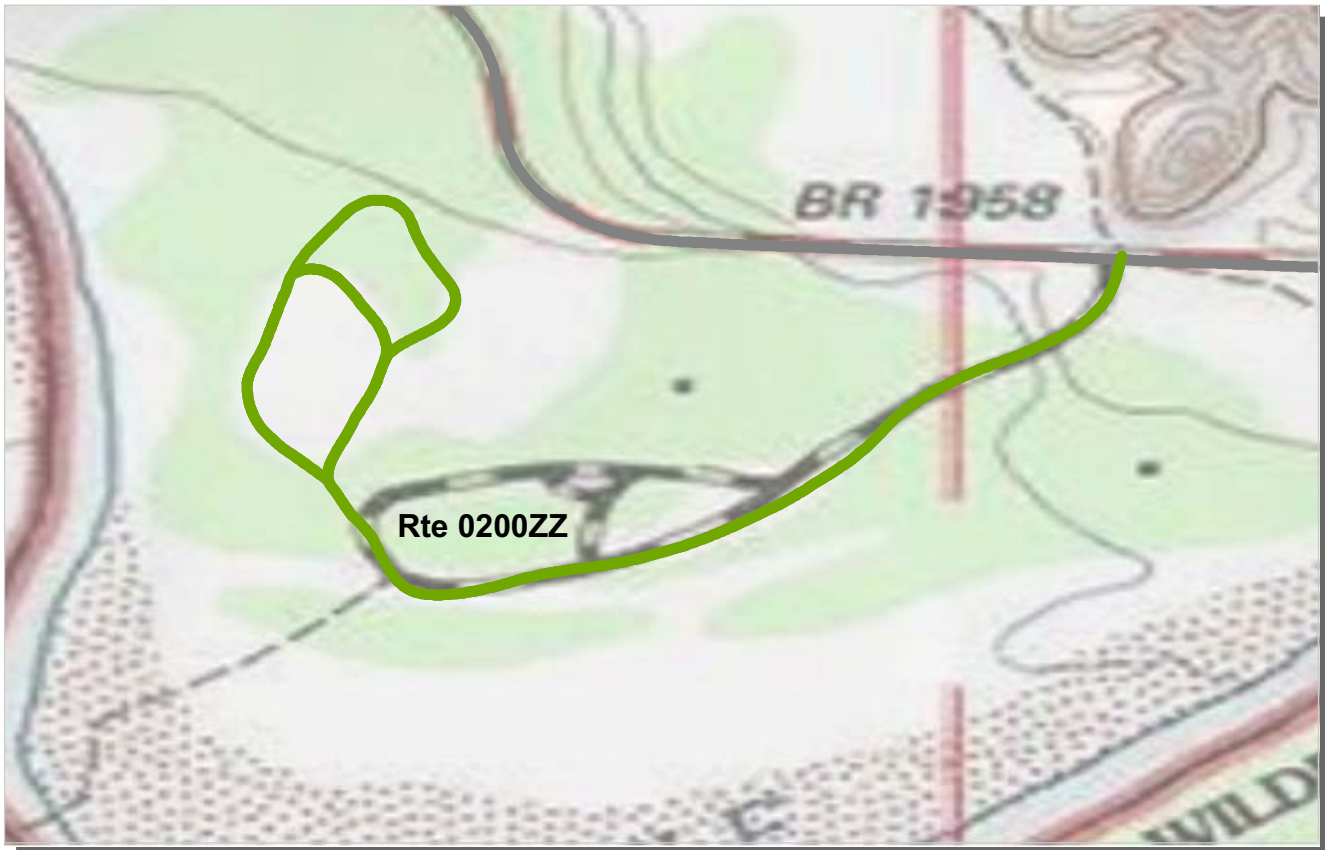
**ROUTE: 0200ZZ JUNIPER CAMPGROUND AREA**

<b>Section Number</b>					
<b>Section Length (mi)</b>					
<b>Cross Section Information</b>					
Number of Lanes	N/A				
Paved Width (ft)	N/A				
Lane Width (ft)	N/A				
<b>Roadway Condition Information</b>					
SCR (Surface Condition Rating)	90				
PCR (Pavement Condition Rating)	90				
<b>Distress Index Values</b>					
Structural Crack Index	N/A				
Transverse Cracking Index	N/A				
Patching Index	N/A				
Rutting Index	N/A				
Roughness Condition Index (RCI)	N/A

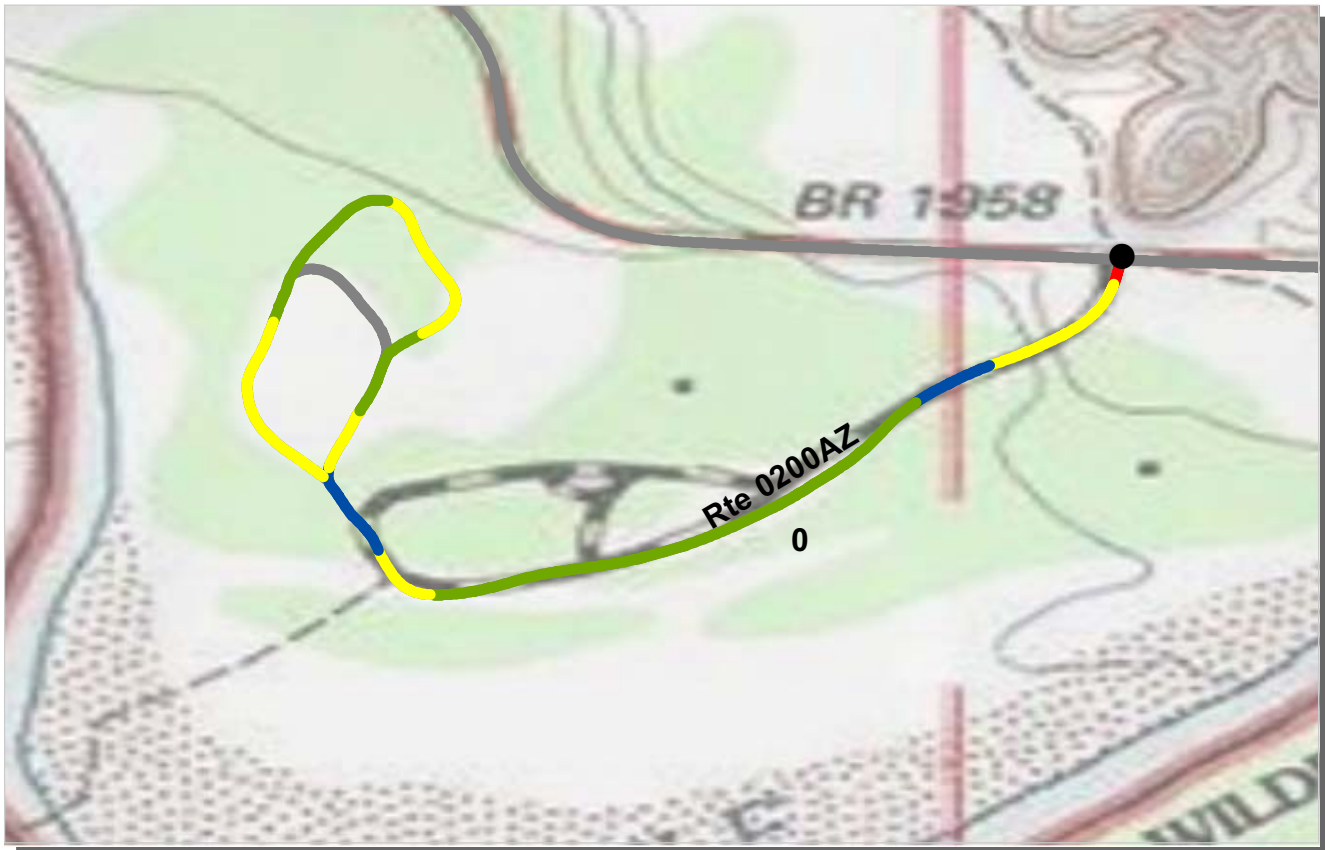
ROUTE: 0200AZ JUNIPER CAMPGROUND LOOP A

<b>Section Number</b>	0				
<b>Section Length (mi)</b>	0.91				
<b>Cross Section Information</b>					
Number of Lanes	2				
Paved Width (ft)	18				
Lane Width (ft)	12				
<b>Roadway Condition Information</b>					
SCR (Surface Condition Rating)	90				
PCR (Pavement Condition Rating)	90				
<b>Distress Index Values</b>					
Structural Crack Index	90				
Transverse Cracking Index	94				
Patching Index	97				
Rutting Index	92				
Roughness Condition Index (RCI)	NC

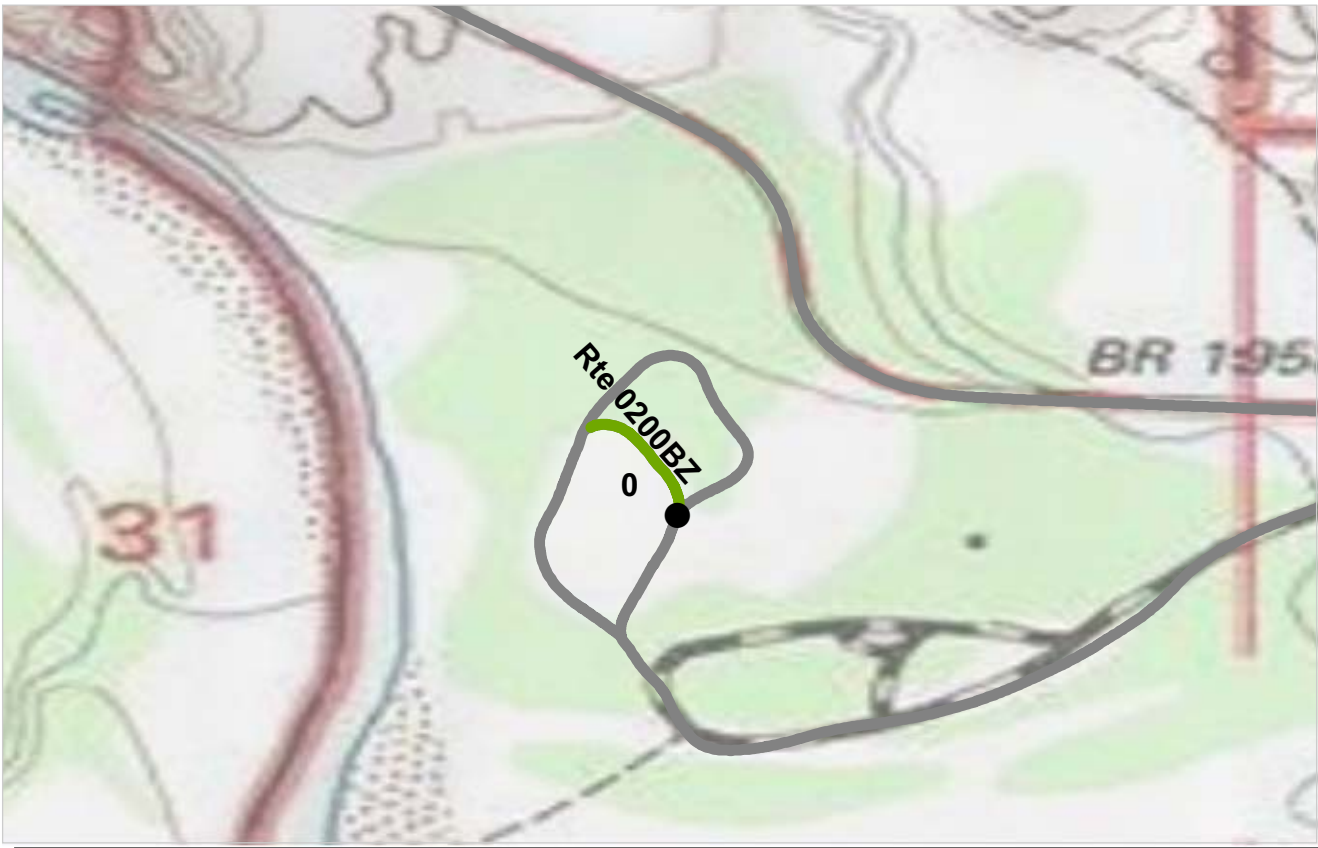
ROUTE: 0200BZ JUNIPER CAMPGROUND CUT THROUGH

<b>Section Number</b>	0				
<b>Section Length (mi)</b>	0.08				
<b>Cross Section Information</b>					
Number of Lanes	1				
Paved Width (ft)	13				
Lane Width (ft)	13				
<b>Roadway Condition Information</b>					
SCR (Surface Condition Rating)	90				
PCR (Pavement Condition Rating)	90				
<b>Distress Index Values</b>					
Structural Crack Index	96				
Transverse Cracking Index	93				
Patching Index	100				
Rutting Index	90				
Roughness Condition Index (RCI)	NC

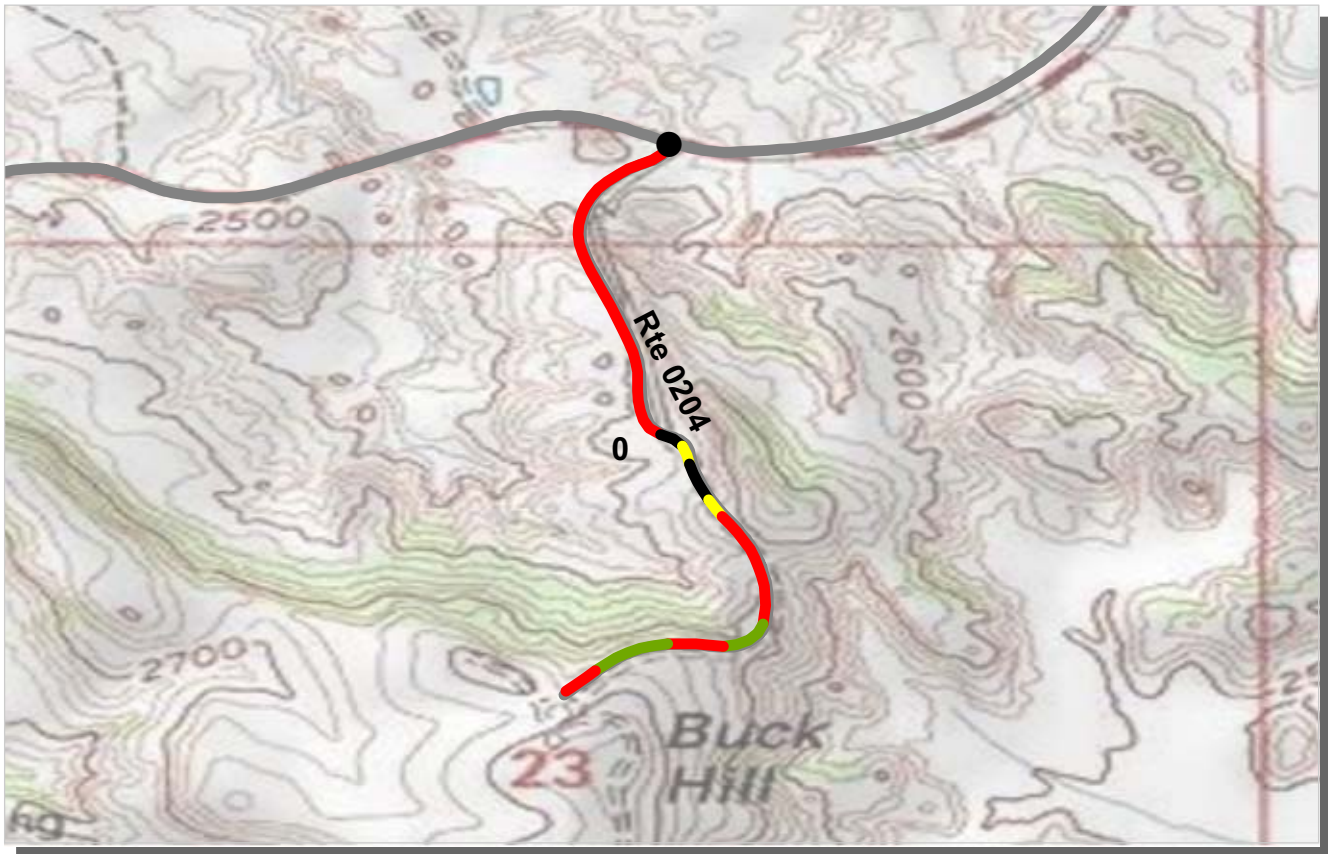
**ROUTE: 0204 BUCK HILL SPUR**

<b>Section Number</b>	0				
<b>Section Length (mi)</b>	0.73				
<b>Cross Section Information</b>					
Number of Lanes	2				
Paved Width (ft)	27				
Lane Width (ft)	12				
<b>Roadway Condition Information</b>					
SCR (Surface Condition Rating)	0				
PCR (Pavement Condition Rating)	0				
<b>Distress Index Values</b>					
Structural Crack Index	0				
Transverse Cracking Index	97				
Patching Index	96				
Rutting Index	65				
Roughness Condition Index (RCI)	NC
