# Road Inventory Program

Road Inventory and Condition Assessment

### **Timpanogos Cave National Monument** TICA - 1550

### **Cycle 5 Report**

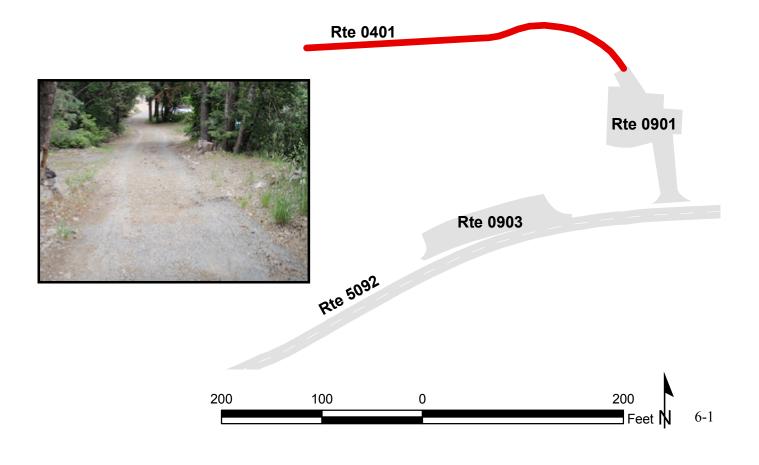
WATER TANK ROAD FROM ROUTE 0901 (RESIDENCE AREA PARKING) TO DEAD END AT WATER TANK

Route	Public /			Lane	Paved Length	Paved Width
Number	NonPublic	Date Visited	Area (sq ft)	Miles *	(mi)	(ft)
0401	NONPUBLIC	6/28/2011	2,587	0.05	0.05	10
Culverts	<b>Drop Inlets</b>	Gates	Curb & Gutter	Curb	PCR	Surface Type
			NO CURB AND			
0	0	0	GUTTER	NO CURB	POOR/45	AS

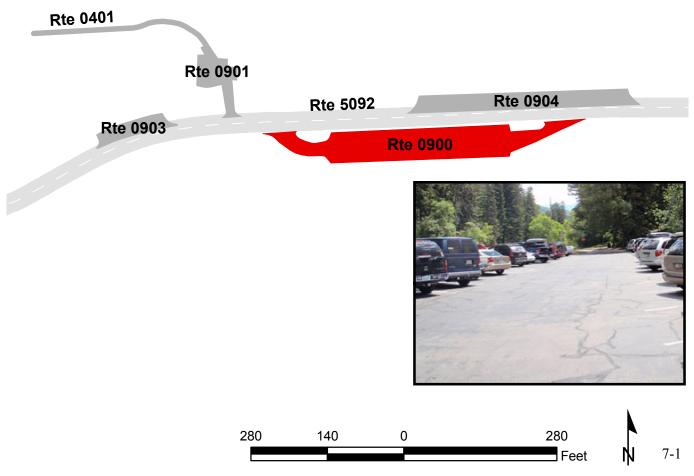
VISITOR CENTER PARKING FROM ROUTE 5092 (STATE ROUTE 92) TO ROUTE 5092 (STATE ROUTE 92)

Route	Public /				
Number	NonPublic	<b>Date Visited</b>	Area (sq ft)	Lane Miles *	Surface Type
0900	PUBLIC	6/28/2011	18,599	0.32	AS
Culverts	<b>Drop Inlets</b>	Gates	Curb & Gutter	Curb	PCR
			NO CURB AND	CONCRETE &	
0	0	0	GUTTER	STONE CURB	POOR/45

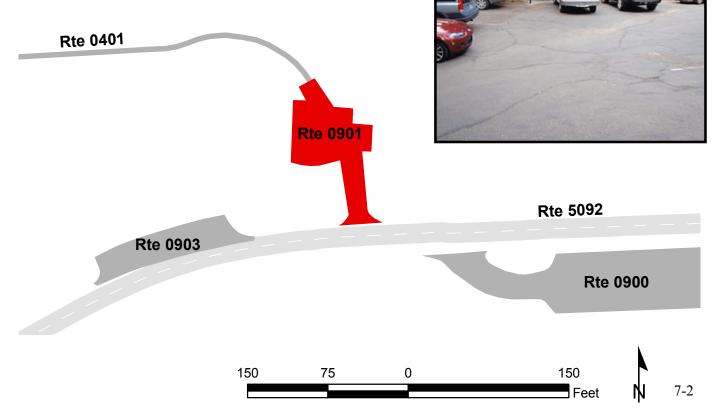
RESIDENCE AREA PARKING FROM ROUTE 5092 (STATE ROUTE 92) TO ROUTE 0401 (WATER TANK ROAD)

Route	Public /				
Number	NonPublic	<b>Date Visited</b>	Area (sq ft)	Lane Miles *	Surface Type
0901	NONPUBLIC	6/28/2011	3,993	0.07	AS
Culverts	<b>Drop Inlets</b>	Gates	Curb & Gutter	Curb	PCR
			NO CURB AND		
0	0	0	GUTTER	STONE CURB	POOR/45

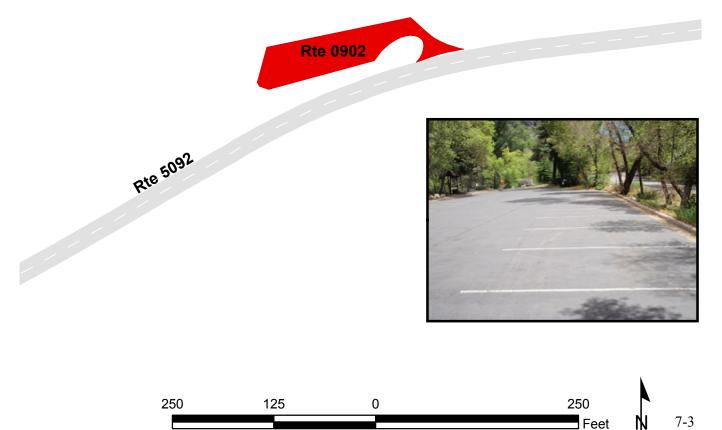
SWINGING BRIDGE PICNIC AREA FROM ROUTE 5092 (STATE ROUTE 92) TO PARKING

Route	Public /				
Number	NonPublic	<b>Date Visited</b>	Area (sq ft)	Lane Miles *	Surface Type
0902	PUBLIC	6/28/2011	6,889	0.12	AS
Culverts	<b>Drop Inlets</b>	Gates	Curb & Gutter	Curb	PCR
			CONCRETE CURB		
0	0	0	AND GUTTER	NO CURB	FAIR/73

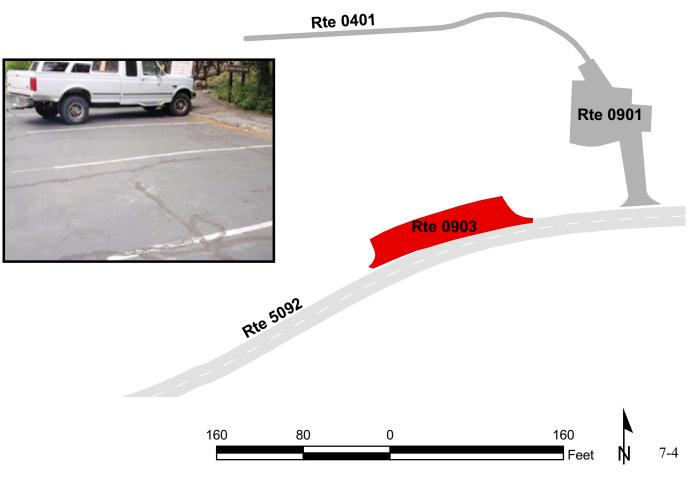
CANYON NATURE TRAIL PARKING ADJACENT TO ROUTE 5092 (STATE ROUTE 92)

Route	Public /				
Number	NonPublic	<b>Date Visited</b>	Area (sq ft)	Lane Miles *	Surface Type
0903	PUBLIC	6/28/2011	2,902	0.05	AS
Culverts	<b>Drop Inlets</b>	Gates	Curb & Gutter	Curb	PCR
			NO CURB AND		
0	0	0	GUTTER	STONE CURB	POOR/45

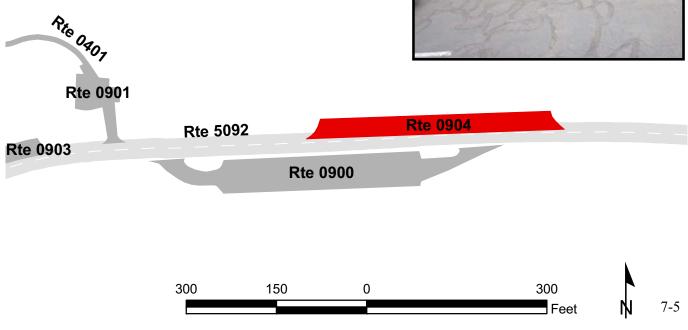
CANYON VIEW PARKING ADJACENT TO ROUTE 5092 (STATE ROUTE 92)

Route	Public /				
Number	NonPublic	<b>Date Visited</b>	Area (sq ft)	Lane Miles *	Surface Type
0904	PUBLIC	6/28/2011	9,658	0.17	AS
Culverts	<b>Drop Inlets</b>	Gates	Curb & Gutter	Curb	PCR
			NO CURB AND		
0	0	0	GUTTER	STONE CURB	POOR/45

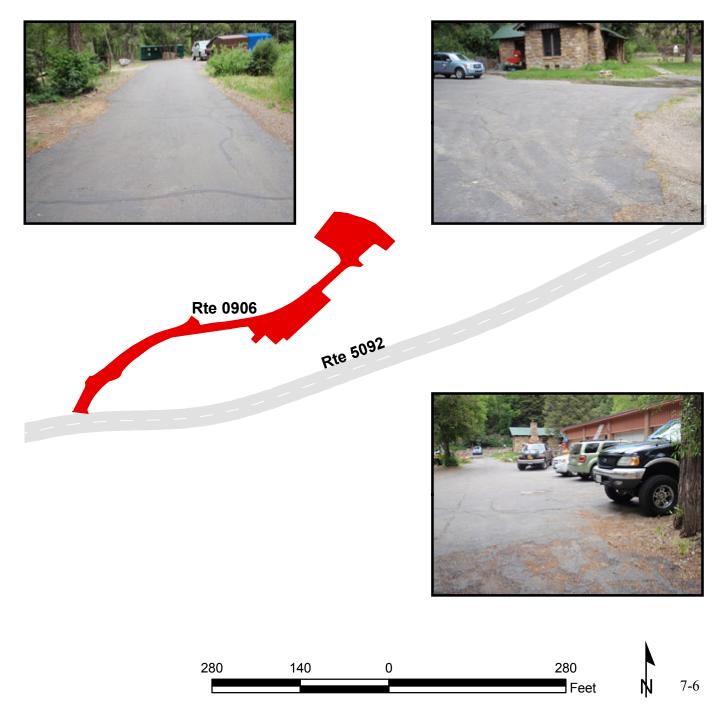
MAINTENANCE FACILITY FROM ROUTE 5092 (STATE ROUTE 92) THROUGH MAINTENANCE FACILITY

Route	Public /				
Number	NonPublic	<b>Date Visited</b>	Area (sq ft)	Lane Miles *	Surface Type
0906	NONPUBLIC	6/28/2011	13,363	0.23	AS
Culverts	<b>Drop Inlets</b>	Gates	Curb & Gutter	Curb	PCR
			NO CURB AND		
1	0	1	GUTTER	NO CURB	FAIR/73
