Federal Lands Highway Road Inventory Program

Road Inventory and Condition Assessment

Tonto National Monument TONT - 8680

Cycle 5 Report

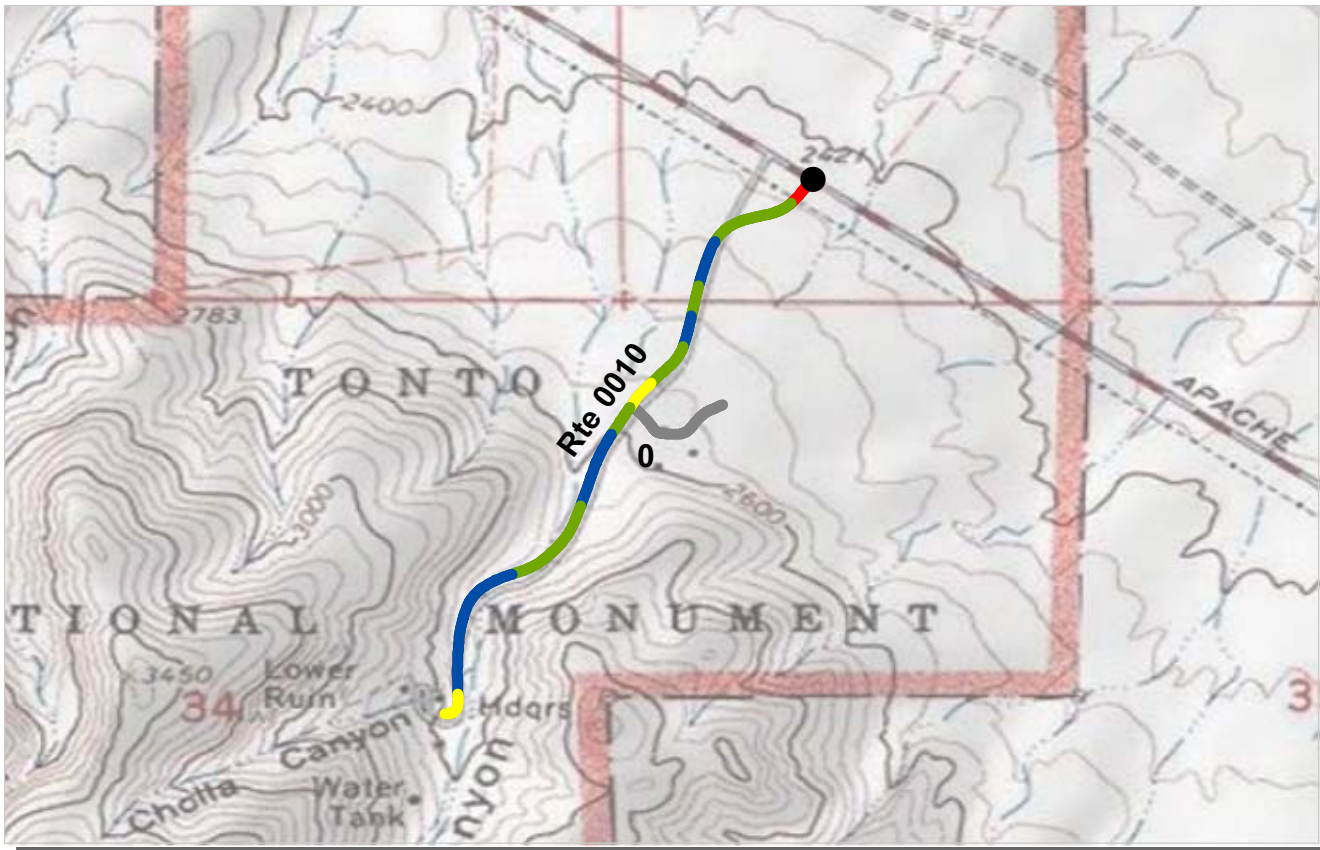
ROUTE: 0010 ENTRANCE ROAD

Section Number	0				
Section Length (mi)	0.85				
Cross Section Information					
Number of Lanes	2				
Paved Width (ft)	25				
Lane Width (ft)	11				
Roadway Condition Information					
SCR (Surface Condition Rating)	95				
PCR (Pavement Condition Rating)	89				
Distress Index Values					
Structural Crack Index	98				
Transverse Cracking Index	99				
Patching Index	100				
Rutting Index	95				
Roughness Condition Index (RCI)	79

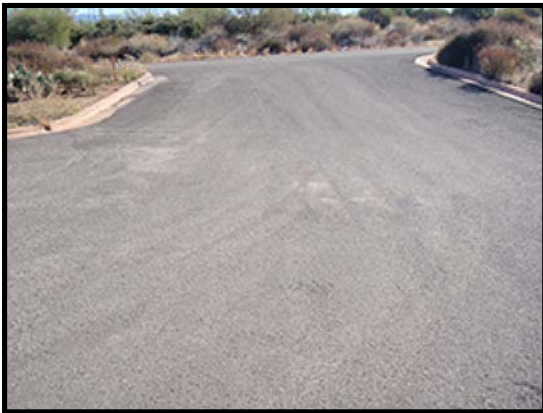
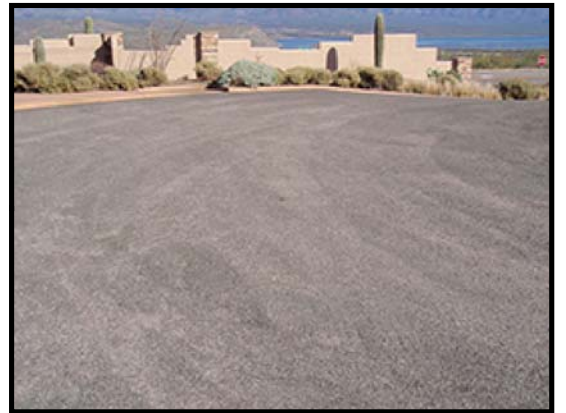
Route Number	Public / NonPublic	Date Visited	Area (sq ft)	Lane Miles *	Surface Type
0200	PUBLIC	12/9/2010	6,437	0.11	AS
Culverts	Drop Inlets	Gates	Curb & Gutter	Curb	PCR
0	0	0	CONCRETE CURB AND GUTTER	NO CURB	GOOD/90

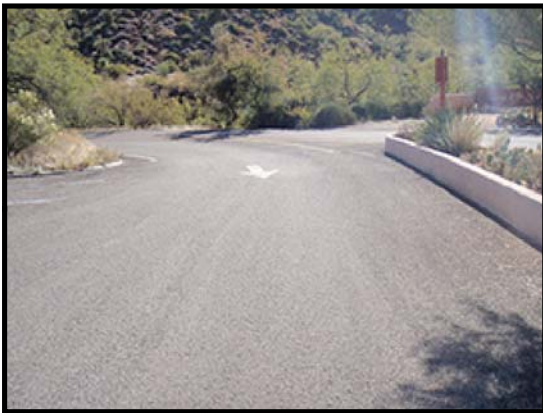
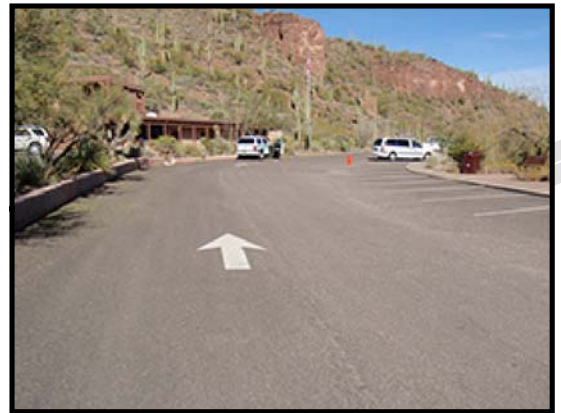
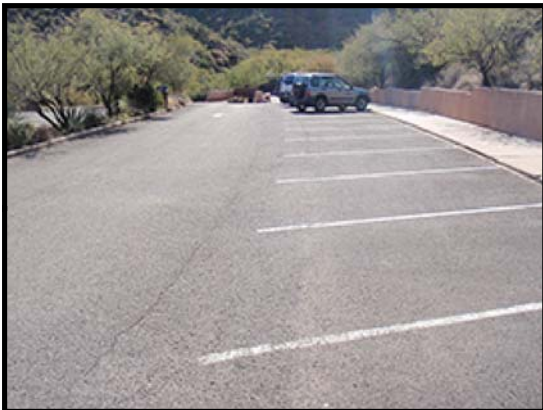
Route Number	Public / NonPublic	Date Visited	Area (sq ft)	Lane Miles *	Surface Type
0900	PUBLIC	12/9/2010	26,379	0.45	AS
Culverts	Drop Inlets	Gates	Curb & Gutter	Curb	PCR
0	0	0	NO CURB AND GUTTER	CONCRETE CURB	GOOD/90

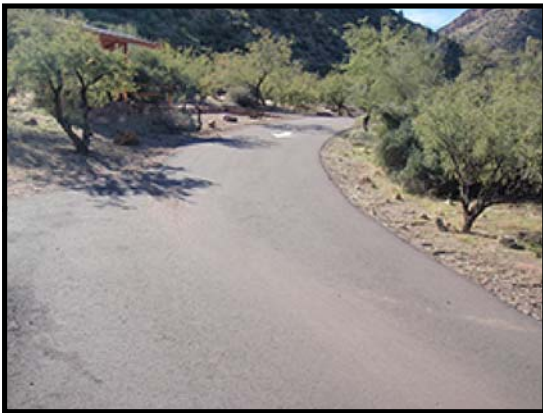
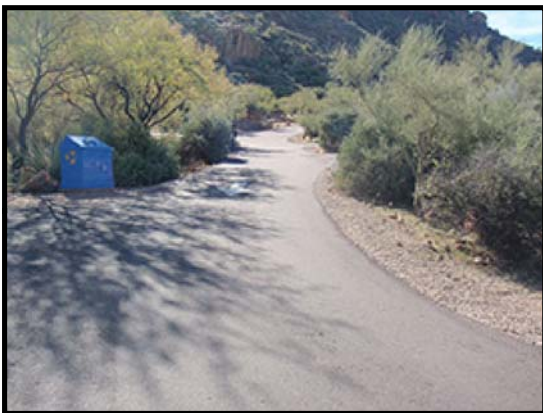
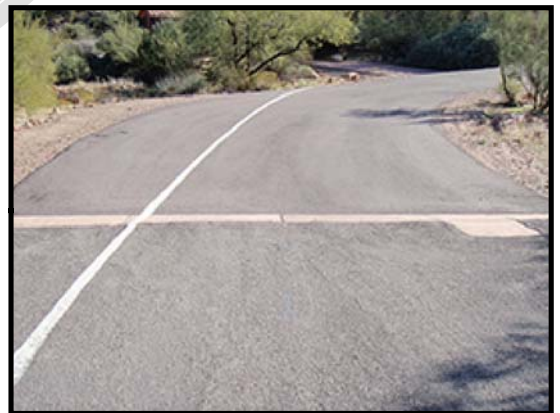
Route 0901

Route Number	Public / NonPublic	Date Visited	Area (sq ft)	Lane Miles *	Surface Type
0901	PUBLIC	12/9/2010	8,797	0.15	AS
Culverts	Drop Inlets	Gates	Curb & Gutter	Curb	PCR
1	0	0	NO CURB AND GUTTER	NO CURB	EXCELLENT/97

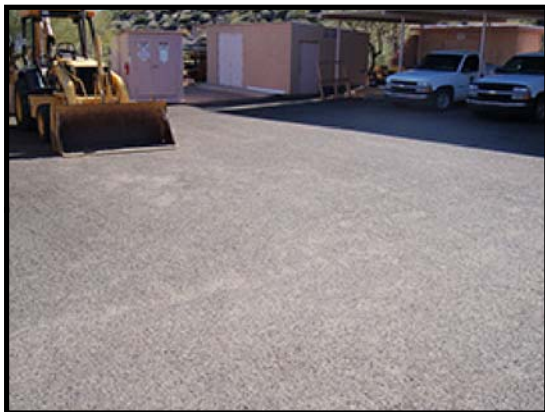
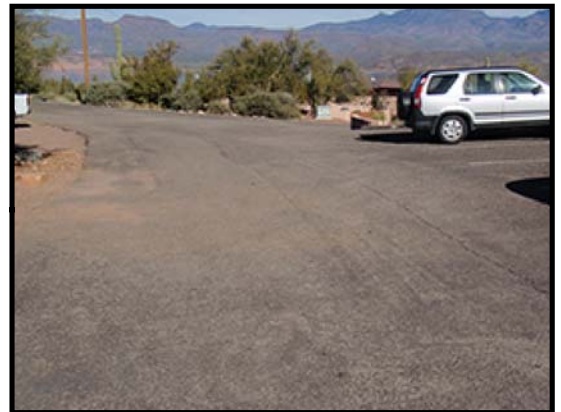
Route 0902

Route Number	Public / NonPublic	Date Visited	Area (sq ft)	Lane Miles *	Surface Type
0902	NONPUBLIC	12/9/2010	9,913	0.17	AS
Culverts	Drop Inlets	Gates	Curb & Gutter	Curb	PCR
0	0	1	NO CURB AND GUTTER	NO CURB	GOOD/90

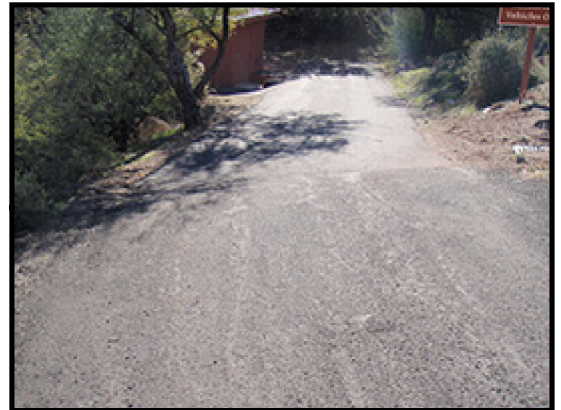
Route 0904

Route Number	Public / NonPublic	Date Visited	Area (sq ft)	Lane Miles *	Surface Type
0904	NONPUBLIC	12/9/2010	1,348	0.02	AS
Culverts	Drop Inlets	Gates	Curb & Gutter	Curb	PCR
0	0	0	NO CURB AND GUTTER	NO CURB	GOOD/90
