# Federal Lands Highway Road Inventory Program

Road Inventory and Condition Assessment

**Tumacacori National Historical Park**

**Cycle 5 Report**

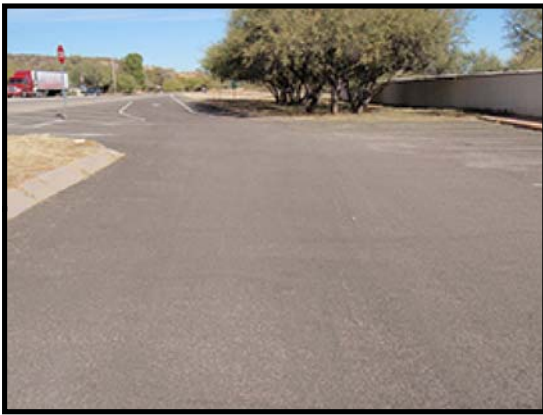
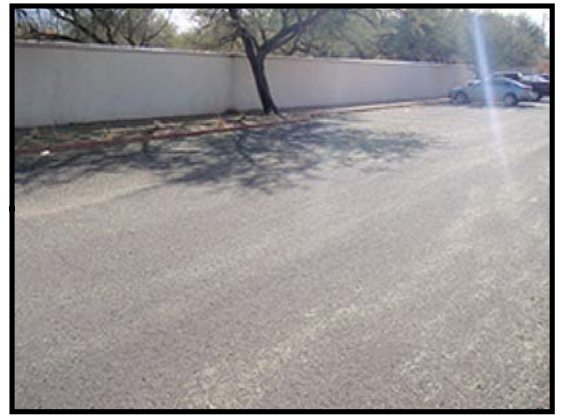
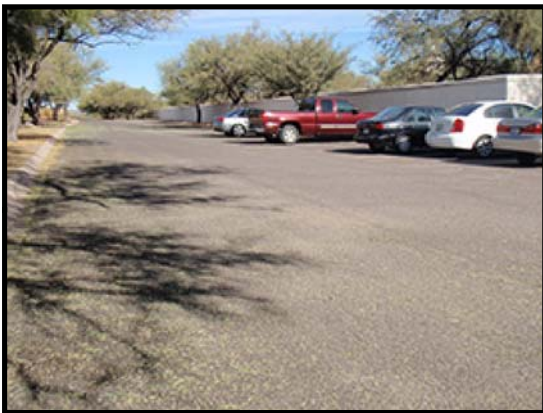
Route Number	Public / NonPublic	Date Visited	Area (sq ft)	Lane Miles *	Surface Type
0900	PUBLIC	12/7/2010	34,048	0.59	AS
Culverts	Drop Inlets	Gates	Curb & Gutter	Curb	PCR
0	0	0	NO CURB AND GUTTER	CONCRETE CURB	FAIR/73

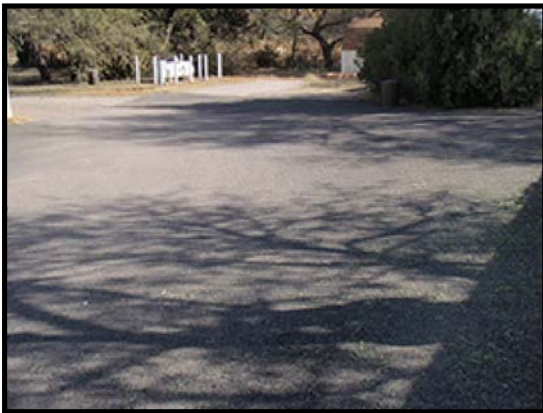
## Route 0901

Route Number	Public / NonPublic	Date Visited	Area (sq ft)	Lane Miles *	Surface Type
0901	NONPUBLIC	12/7/2010	5,620	0.10	AS
Culverts	Drop Inlets	Gates	Curb & Gutter	Curb	PCR
0	0	0	NO CURB AND GUTTER	NO CURB	FAIR/73

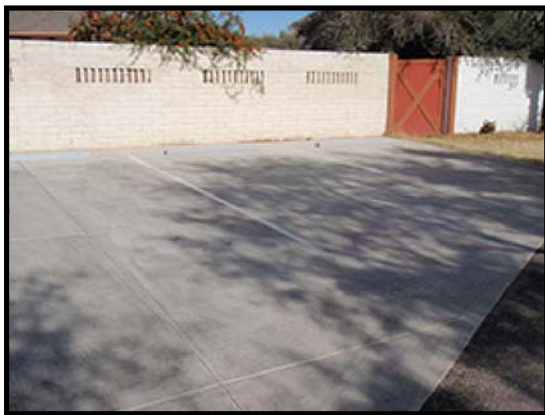
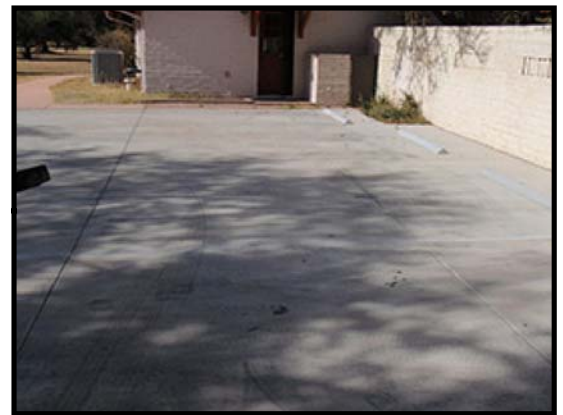
## Route 0903

Route Number	Public / NonPublic	Date Visited	Area (sq ft)	Lane Miles *	Surface Type
0903	NONPUBLIC	12/7/2010	994	0.02	CO
Culverts	Drop Inlets	Gates	Curb & Gutter	Curb	PCR
0	0	0	NO CURB AND GUTTER	NO CURB	EXCELLENT/97
