# Federal Lands Highway Road Inventory Program

Road Inventory and Condition Assessment

## Tuzigoot National Monument TUZI

### Cycle 5 Report

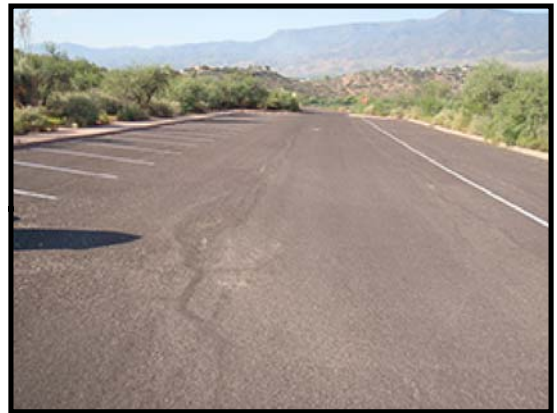
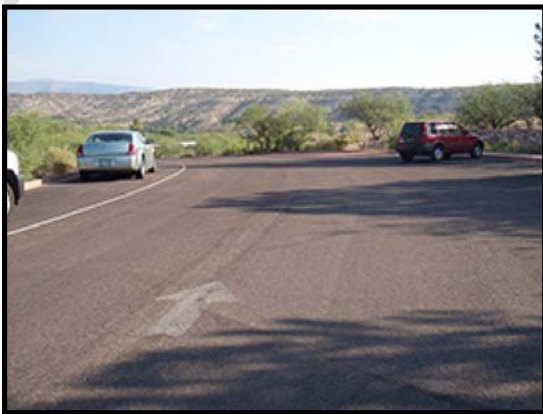
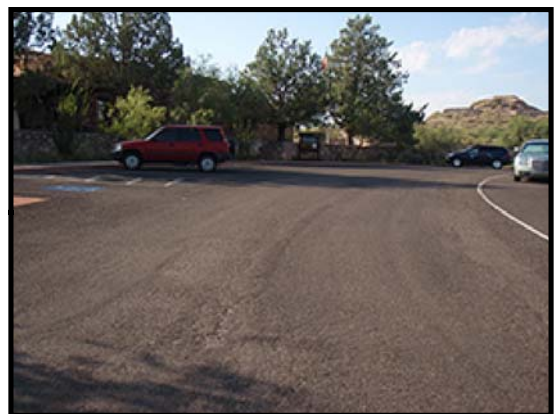
Route Number	Public / NonPublic	Date Visited	Area (sq ft)	Lane Miles *	Surface Type
0900	PUBLIC	8/31/2011	35,396	0.61	AS
Culverts	Drop Inlets	Gates	Curb & Gutter	Curb	PCR
1	5	0	CONCRETE CURB AND GUTTER	NO CURB	GOOD/90

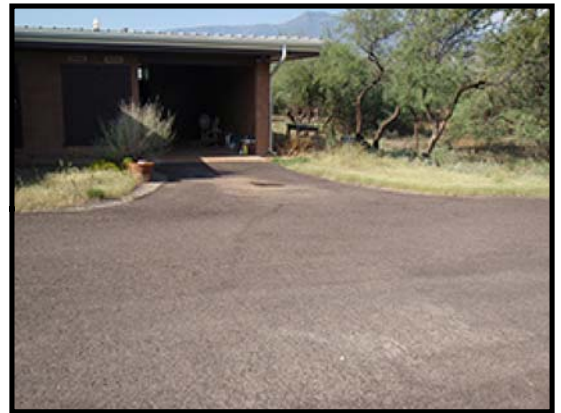
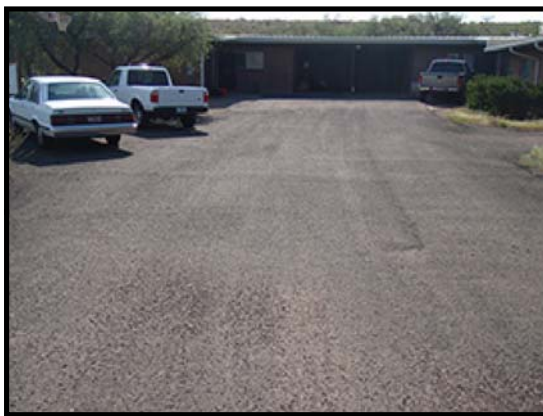
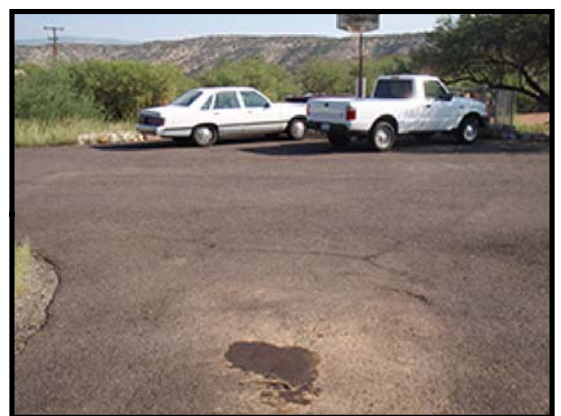
## Route 0901

Route Number	Public / NonPublic	Date Visited	Area (sq ft)	Lane Miles *	Surface Type
0901	PUBLIC	8/31/2011	3,187	0.06	AS
Culverts	Drop Inlets	Gates	Curb & Gutter	Curb	PCR
0	0	0	NO CURB AND GUTTER	STONE CURB	FAIR/73
