Federal Lands Highway Road Inventory Program

Road Inventory and Condition Assessment

Valley Forge National Historical Park VAFO

Cycle 5 Report

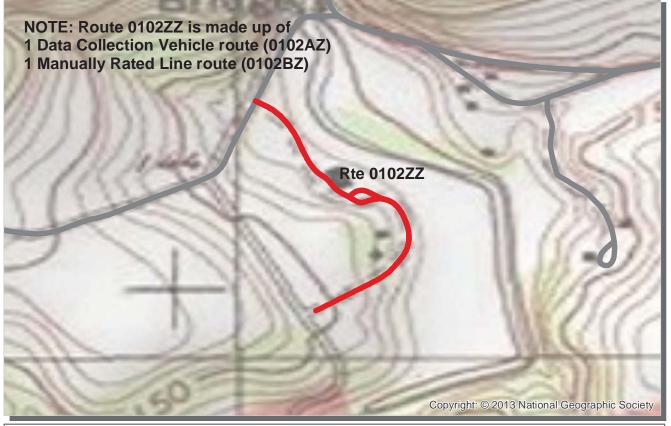
ROUTE: 0102ZZ LIBRARY LANE ROADS

Summary Record				LLECTED:	4/4/2013	
NORTHEAST REGION		TOTAL LENGT		LENGTH:	0.33 Miles	
Section Number						
Section Length (mi)						
Cross Section Information						
Number of Lanes	N/A					
Paved Width (ft)	N/A					
Lane Width (ft)	N/A					
Roadway Condition Information						
SCR (Surface Condition Rating)	0					
PCR (Pavement Condition Rating)	4					
Distress Index Values						
Structural Crack Index	N/A					
Transverse Cracking Index	N/A					
Patching Index	N/A					
Rutting Index	N/A					
Roughness Condition Index (RCI)	N/A

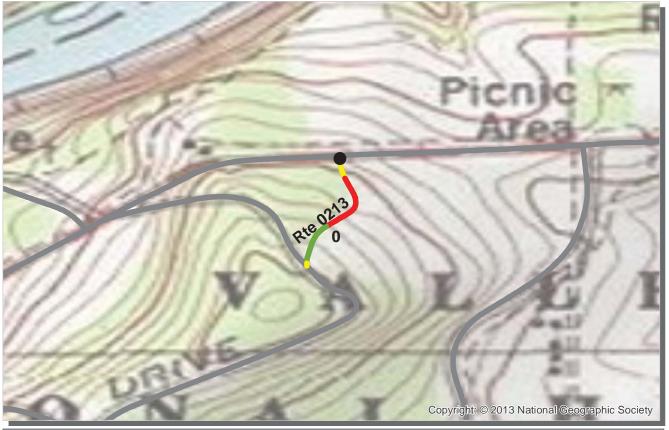
ROUTE: 0213 INNER LINE SPUR VAFO : VALLEY FORGE NATIONAL HISTORICAL PARK

COLLECTED: 4/4/2013 NORTHEAST REGION **TOTAL LENGTH:** 0.12 Miles Section Number 0 Section Length (mi) 0.12 **Cross Section Information** Number of Lanes 2 21 Paved Width (ft) Lane Width (ft) 11 **Roadway Condition Information** SCR (Surface Condition Rating) 18 PCR (Pavement Condition Rating) 18 **Distress Index Values** 18 Structural Crack Index 85 Transverse Cracking Index 95 Patching Index 89 **Rutting Index** NC Roughness Condition Index (RCI)

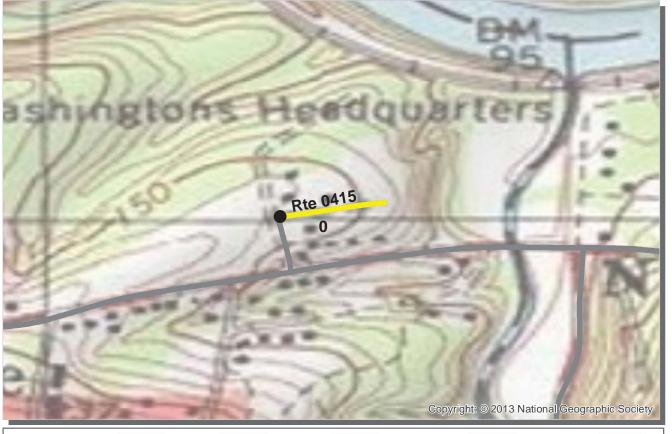
ROUTE: 0415 BRITTAIN LANE VAFO : VALLEY FORGE NATIONAL HISTORICAL PARK

NORTHEAST REGION			LLECTED: LENGTH:	4/4/2013 0.08 Miles
Section Number	0	_		
Section Length (mi)	0.08			
Cross Section Information				
Number of Lanes	1			
Paved Width (ft)	12			
Lane Width (ft)	12			
Roadway Condition Information				
SCR (Surface Condition Rating)	76			
PCR (Pavement Condition Rating)	76			
Distress Index Values				
Structural Crack Index	92			
Transverse Cracking Index	95			
Patching Index	100			
Rutting Index	76			
Roughness Condition Index (RCI)	NC

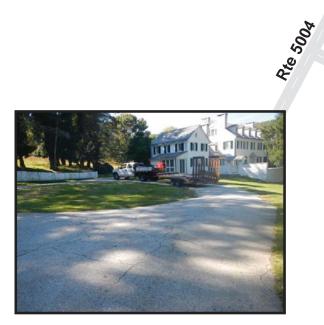
Route	Public /			Lane	Paved Length	Paved Width
Number	NonPublic	Date Visited	Area (sq ft)	Miles *	(mi)	(ft)
0102BZ	PUBLIC	10/1/2012	1,620	0.03	0.03	11.8
Culverts	Drop Inlets	Gates	Curb & Gutter	Curb	PCR	Surface Type
			NO CURB AND			
0	1	0	GUTTER	NO CURB	POOR/45	AS

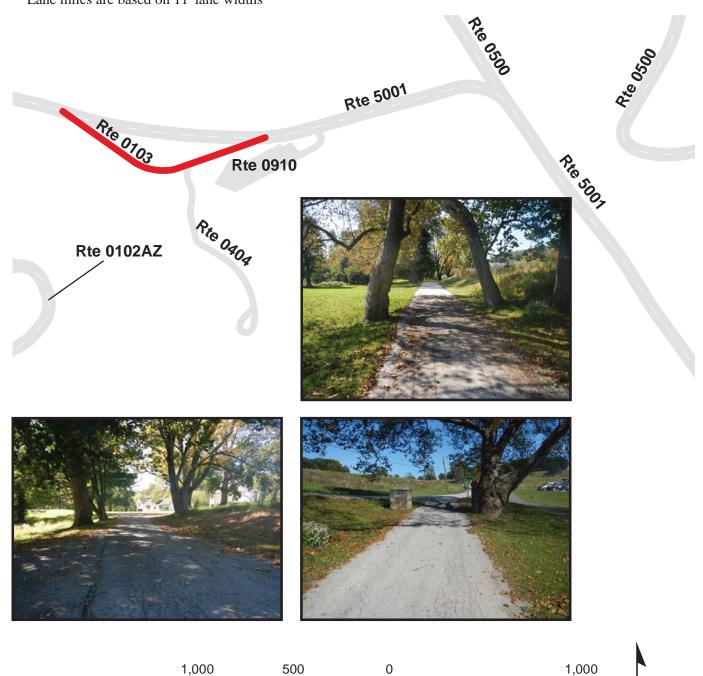
SUPERINTENDENTS RESIDENCE ACCESS ROAD FROM ROUTE 0103 (KNOX'S QUARTERS ACCESS ROAD) TO END OF LOOP

Route	Public /			Lane	Paved Length	Paved Width
Number	NonPublic	Date Visited	Area (sq ft)	Miles *	(mi)	(ft)
0404	NONPUBLIC	10/1/2012	15,449	0.27	0.21	14
Culverts	Drop Inlets	Gates	Curb & Gutter	Curb	PCR	Surface Type
			NO CURB AND	CONCRETE		
0	1	0	GUTTER	CURB	POOR/45	AS

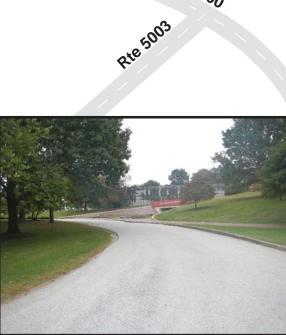
Rte 5000

Route	Public /				
Number	NonPublic	Date Visited	Area (sq ft)	Lane Miles *	Surface Type
0900	PUBLIC	10/2/2012	9,877	0.17	AS
Culverts	Drop Inlets	Gates	Curb & Gutter	Curb	PCR
			NO CURB AND	CONCRETE	
0	2	0	GUTTER	CURB	GOOD/90

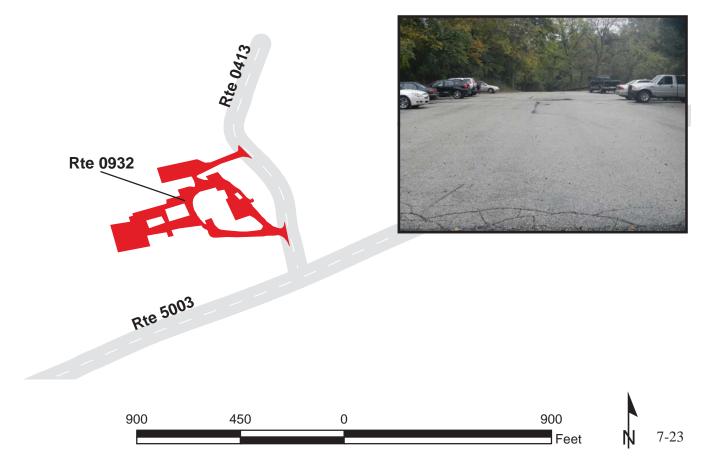
KENNEDY MANSION PARKING FROM ROUTE 5000 (STATE ROUTE 23) TO PARKING

Route	Public /				
Number	NonPublic	Date Visited	Area (sq ft)	Lane Miles *	Surface Type
0933	PUBLIC	10/2/2012	50,213	0.87	AS
Culverts	Drop Inlets	Gates	Curb & Gutter	Curb	PCR
			NO CURB AND		
0	0	0	GUTTER	NO CURB	POOR/45
