Federal Lands Highway Road Inventory Program

Road Inventory and Condition Assessment

Wind Cave National Park
WICA - 1560

Cycle 5 Report

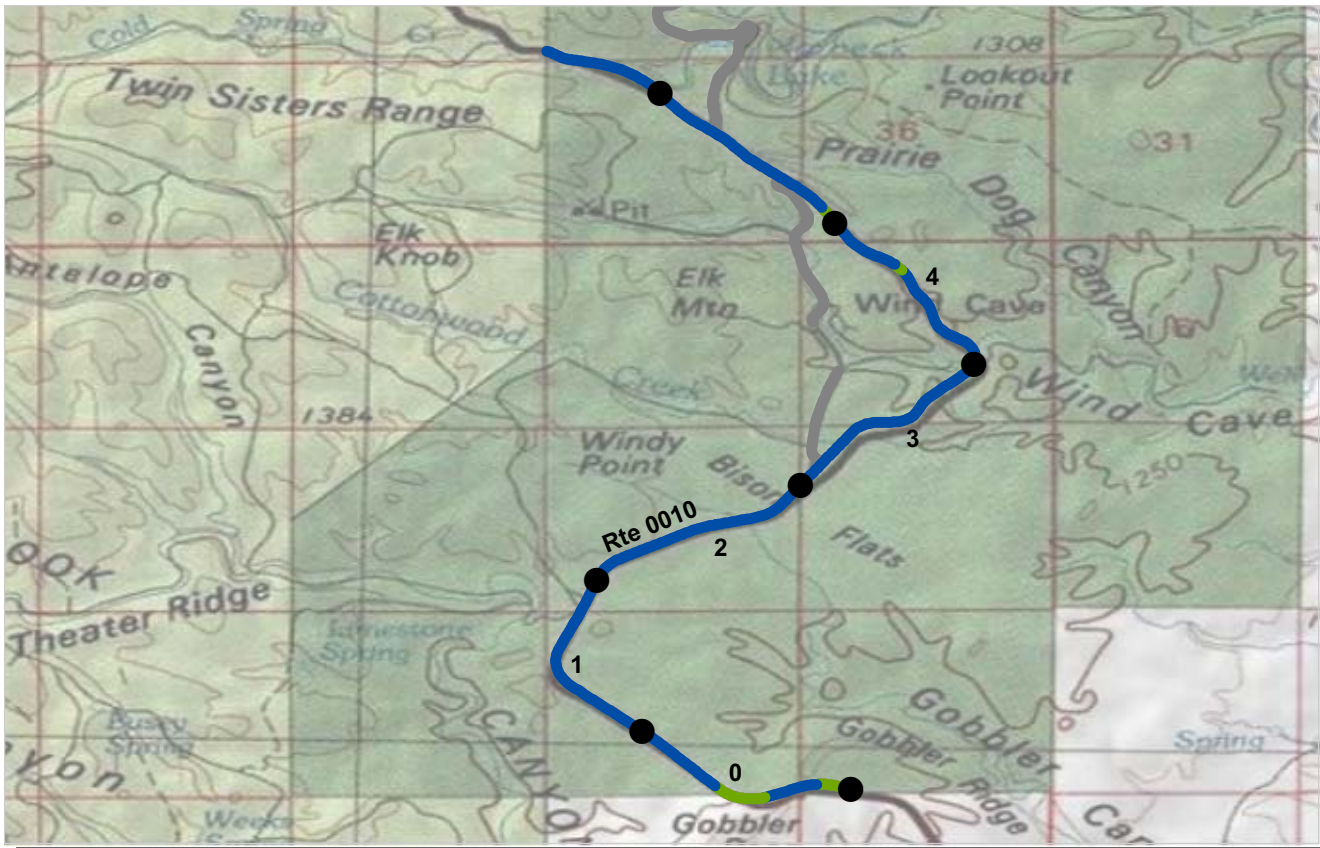
ROUTE: 0010 WIND CAVE HIGHWAY (U.S. 385)

<i>Section Number</i>	0	1	2	3	4
<i>Section Length (mi)</i>	1.00	1.00	1.00	1.00	1.00
<i>Cross Section Information</i>					
Number of Lanes	2	2	2	2	2
Paved Width (ft)	37	33	32	34	34
Lane Width (ft)	11	12	12	12	11
<i>Roadway Condition Information</i>					
SCR (Surface Condition Rating)	NC	99	99	99	97
PCR (Pavement Condition Rating)	95	99	99	99	98
<i>Distress Index Values</i>					
Structural Crack Index	NC	100	100	100	97
Transverse Cracking Index	NC	100	99	99	99
Patching Index	NC	100	100	100	100
Rutting Index	NC	99	100	100	100
Roughness Condition Index (RCI)	95	100	100	100	100

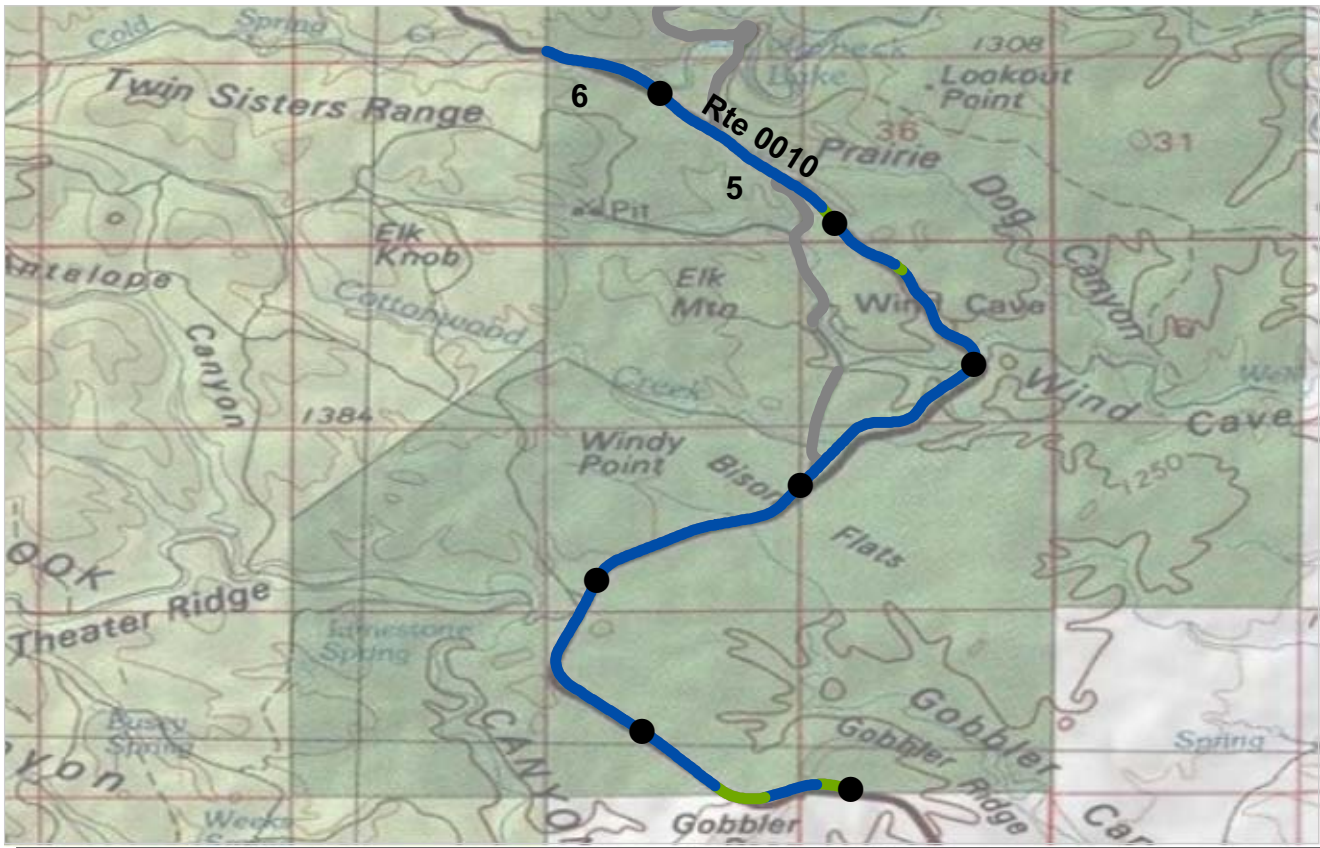
ROUTE: 0010 WIND CAVE HIGHWAY (U.S. 385)

Section Number	5	6			
Section Length (mi)	1.00	0.52			
Cross Section Information					
Number of Lanes	2	2			
Paved Width (ft)	35	31			
Lane Width (ft)	11	11			
Roadway Condition Information					
SCR (Surface Condition Rating)	98	99			
PCR (Pavement Condition Rating)	99	99			
Distress Index Values					
Structural Crack Index	98	100			
Transverse Cracking Index	98	99			
Patching Index	100	100			
Rutting Index	100	99			
Roughness Condition Index (RCI)	100	100

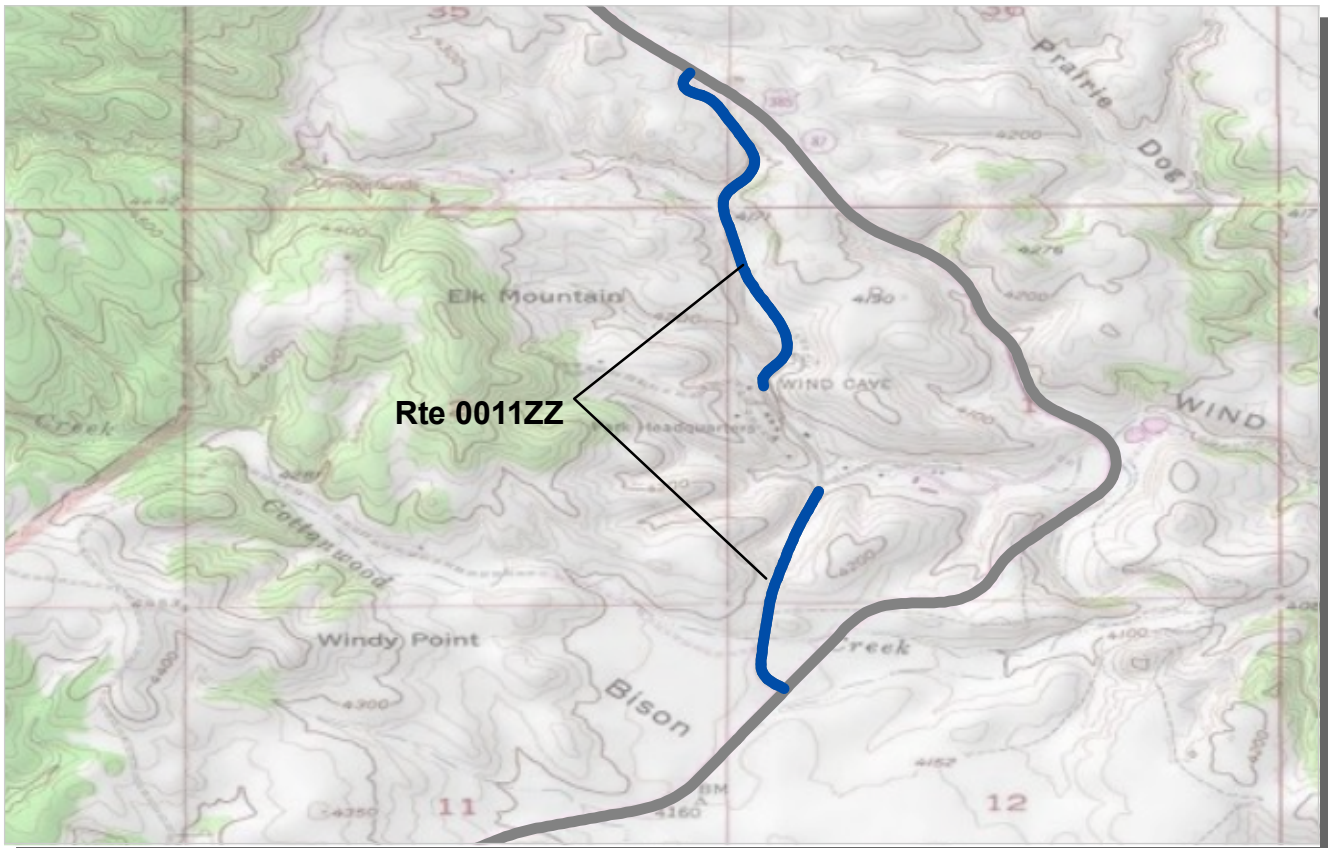
ROUTE: 0011ZZ VISITOR CENTER/CAVE ACCESS ROADS

Section Number					
Section Length (mi)					
Cross Section Information					
Number of Lanes	N/A				
Paved Width (ft)	N/A				
Lane Width (ft)	N/A				
Roadway Condition Information					
SCR (Surface Condition Rating)	99				
PCR (Pavement Condition Rating)	98				
Distress Index Values					
Structural Crack Index	N/A				
Transverse Cracking Index	N/A				
Patching Index	N/A				
Rutting Index	N/A				
Roughness Condition Index (RCI)	N/A

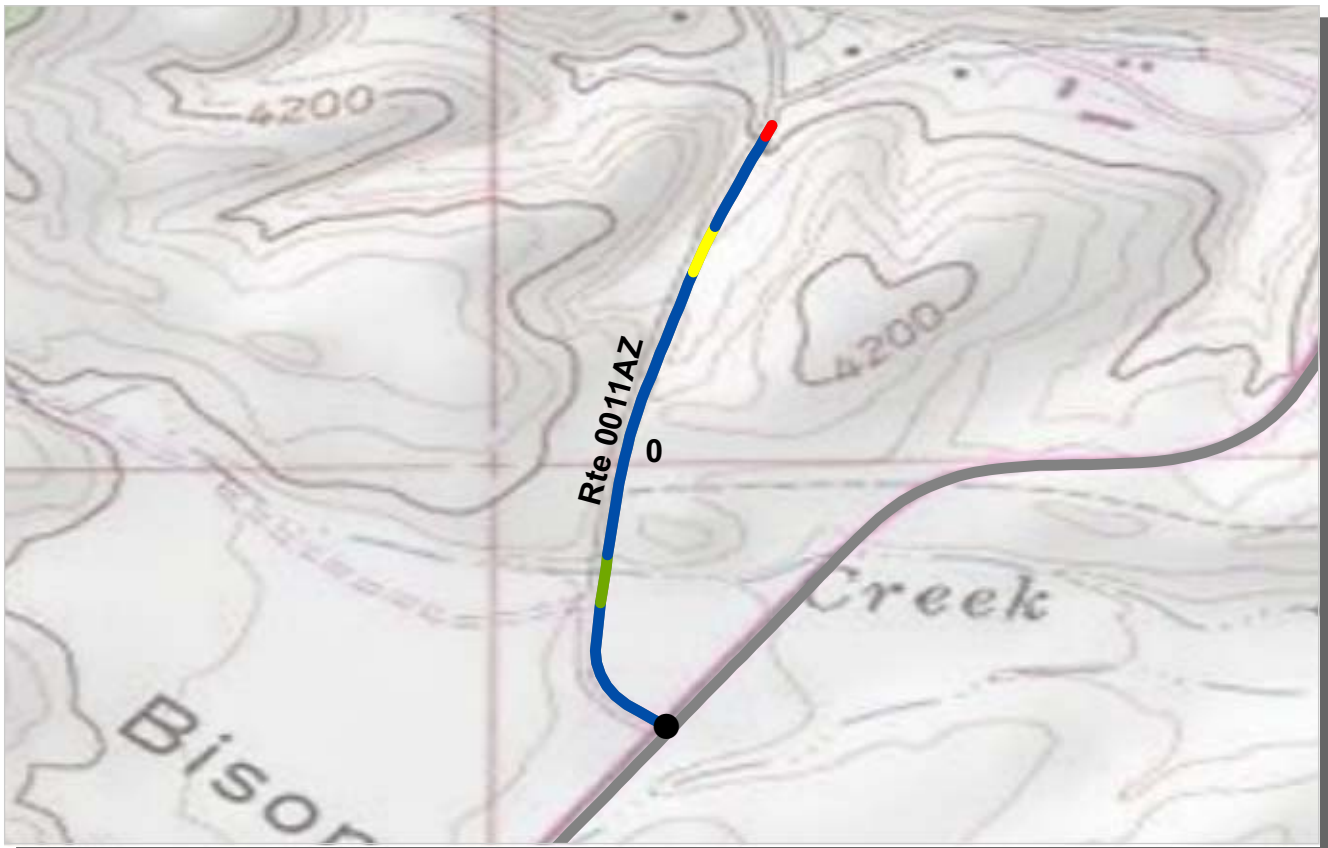
ROUTE: 0011AZ VISITOR CENTER/CAVE ACCESS ROAD A

Section Number	0				
Section Length (mi)	0.53				
Cross Section Information					
Number of Lanes	2				
Paved Width (ft)	23				
Lane Width (ft)	10				
Roadway Condition Information					
SCR (Surface Condition Rating)	96				
PCR (Pavement Condition Rating)	95				
Distress Index Values					
Structural Crack Index	96				
Transverse Cracking Index	100				
Patching Index	100				
Rutting Index	99				
Roughness Condition Index (RCI)	94

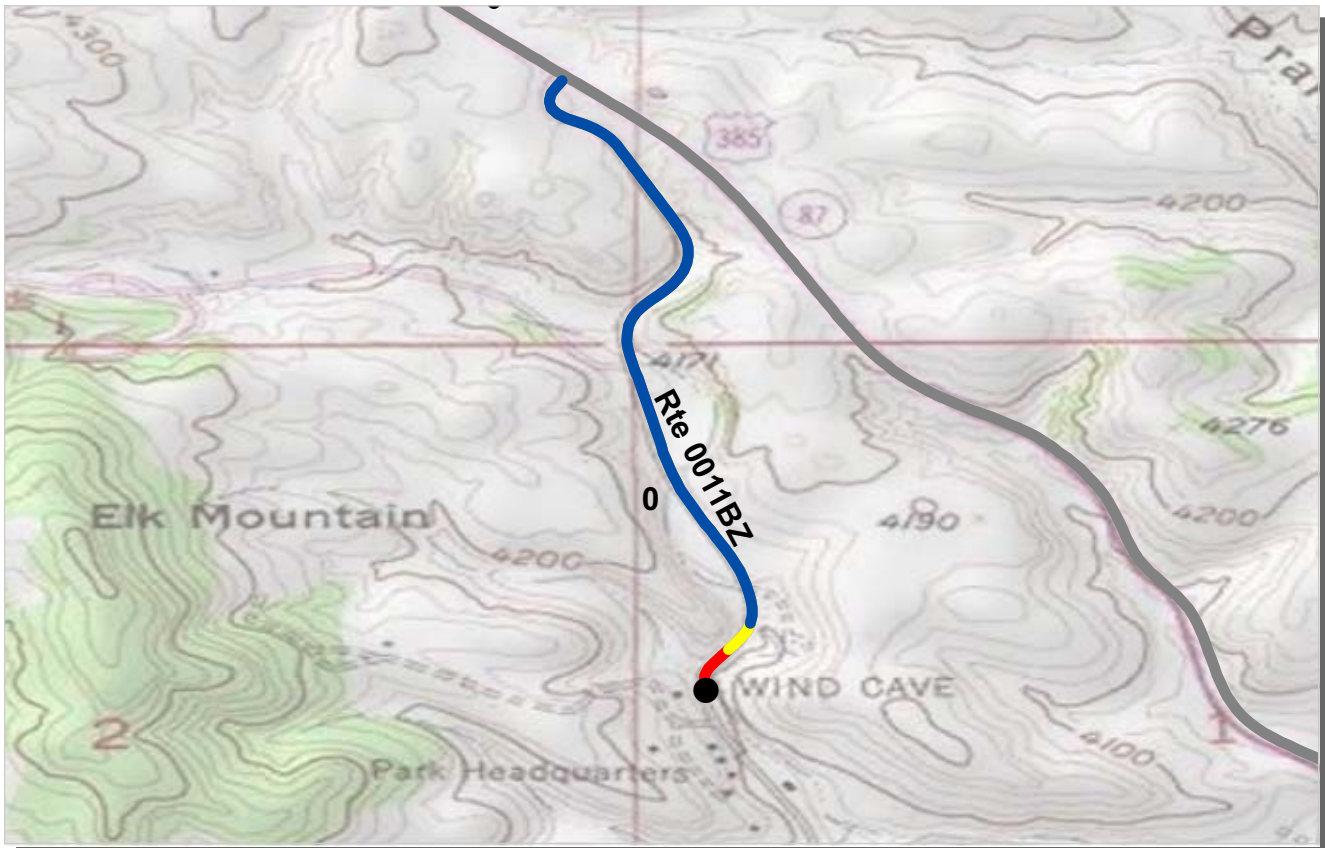
ROUTE: 0011BZ VISITOR CENTER/CAVE ACCESS ROAD B

<i>Section Number</i>	0				
<i>Section Length (mi)</i>	0.90				
<i>Cross Section Information</i>					
Number of Lanes	2				
Paved Width (ft)	24				
Lane Width (ft)	10				
<i>Roadway Condition Information</i>					
SCR (Surface Condition Rating)	100				
PCR (Pavement Condition Rating)	100				
<i>Distress Index Values</i>					
Structural Crack Index	100				
Transverse Cracking Index	100				
Patching Index	100				
Rutting Index	100				
Roughness Condition Index (RCI)	100

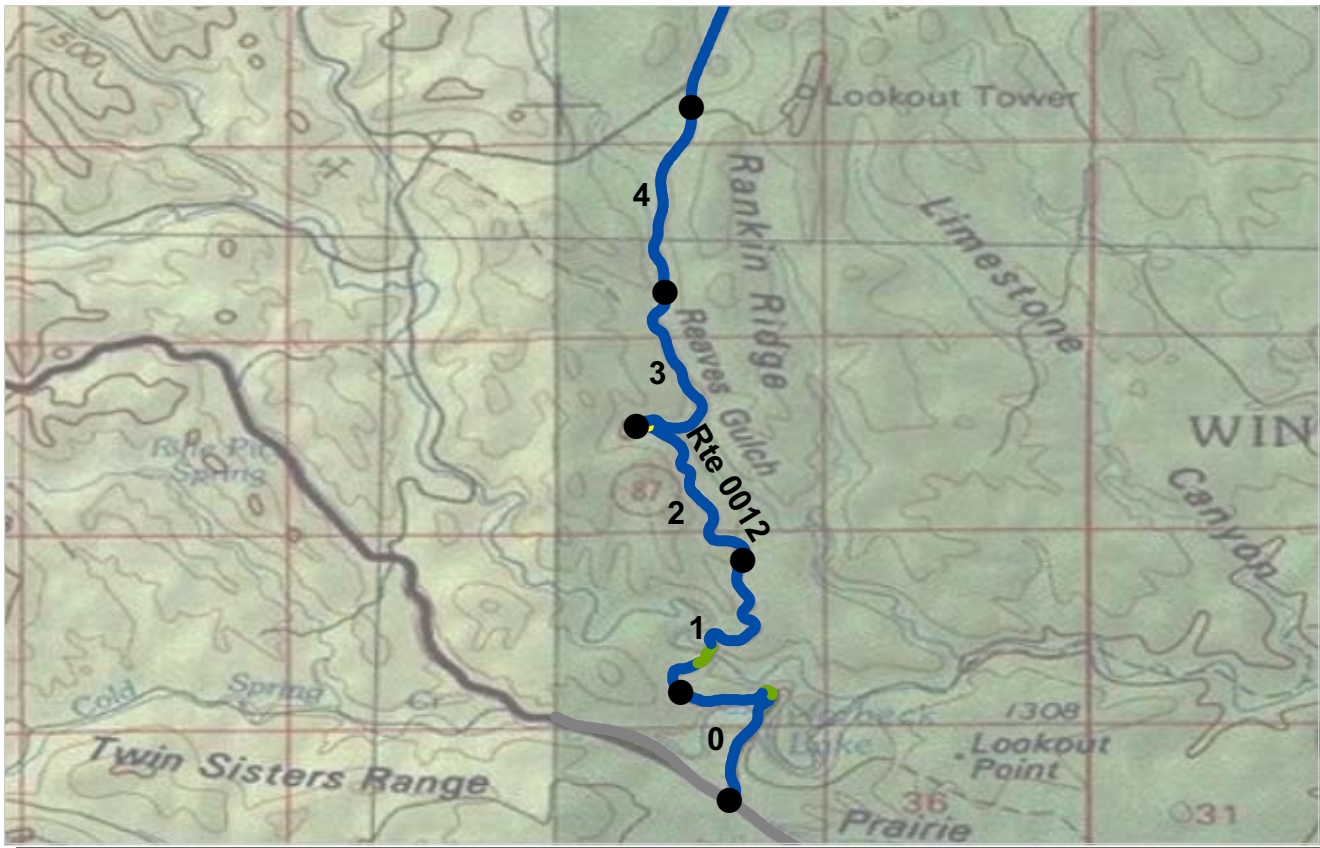
ROUTE: 0012 NORTH ENTRANCE ROAD (STATE HIGHWAY 87)

<i>Section Number</i>	0	1	2	3	4
<i>Section Length (mi)</i>	1.00	1.00	1.00	1.00	1.00
<i>Cross Section Information</i>					
Number of Lanes	2	2	2	2	2
Paved Width (ft)	25	23	24	22	22
Lane Width (ft)	11	9	9	9	9
<i>Roadway Condition Information</i>					
SCR (Surface Condition Rating)	100	99	100	99	99
PCR (Pavement Condition Rating)	100	99	100	99	99
<i>Distress Index Values</i>					
Structural Crack Index	100	100	100	100	99
Transverse Cracking Index	100	100	100	100	100
Patching Index	100	100	100	100	100
Rutting Index	100	99	100	99	100
Roughness Condition Index (RCI)	100	100	100	100	100

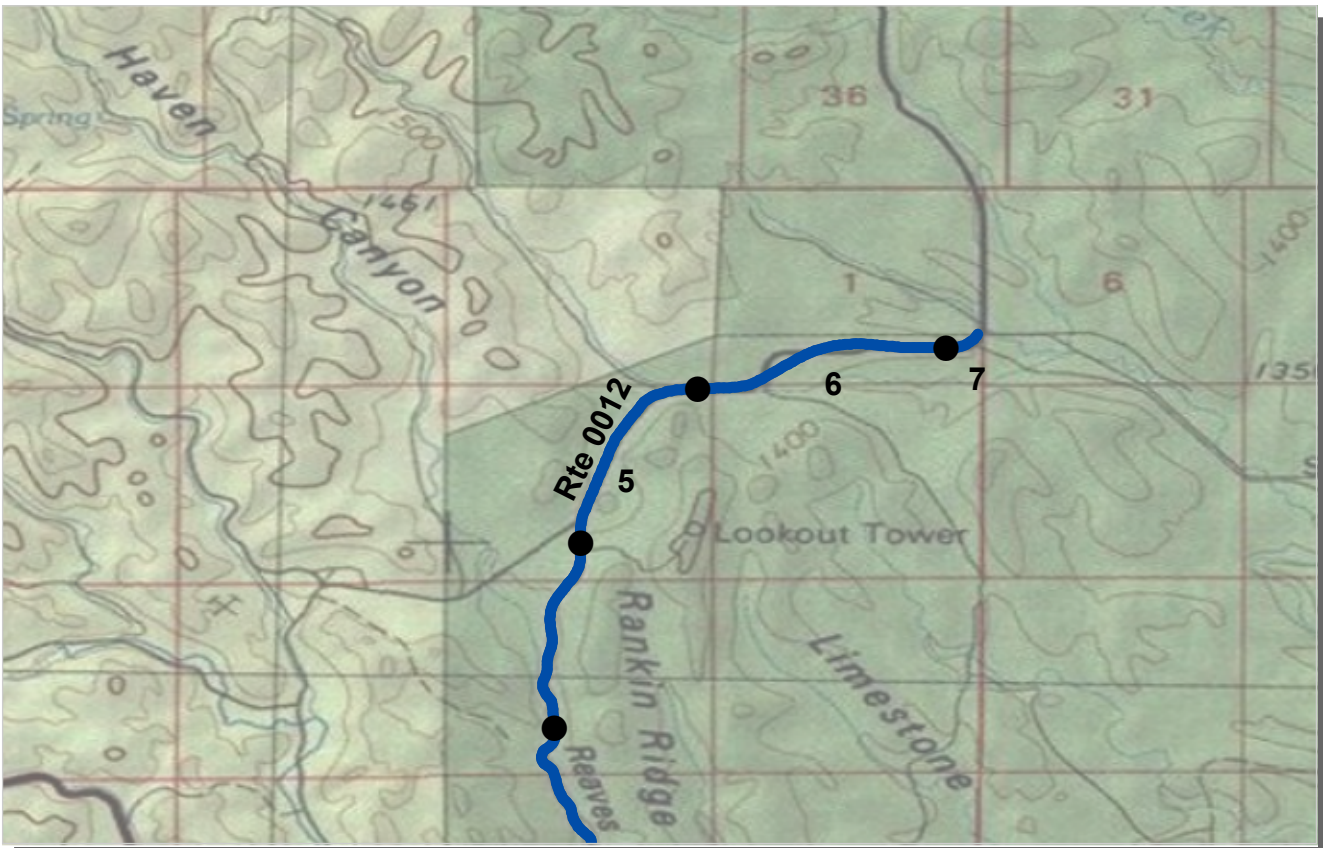
ROUTE: 0012 NORTH ENTRANCE ROAD (STATE HIGHWAY 87)

<i>Section Number</i>	5	6	7		
<i>Section Length (mi)</i>	1.00	1.00	0.15		
<i>Cross Section Information</i>					
Number of Lanes	2	2	2		
Paved Width (ft)	22	22	22		
Lane Width (ft)	9	9	10		
<i>Roadway Condition Information</i>					
SCR (Surface Condition Rating)	100	100	100		
PCR (Pavement Condition Rating)	100	100	100		
<i>Distress Index Values</i>					
Structural Crack Index	100	100	100		
Transverse Cracking Index	100	100	100		
Patching Index	100	100	100		
Rutting Index	100	100	100		
Roughness Condition Index (RCI)	100	100	100

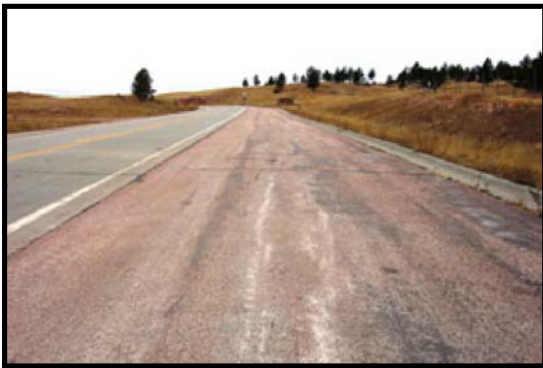
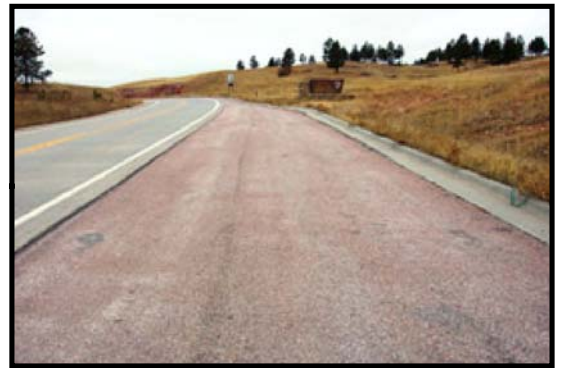
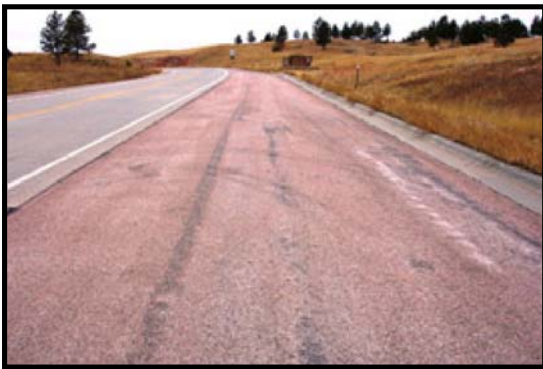
Route 0904E

Route Number	Public / NonPublic	Date Visited	Area (sq ft)	Lane Miles *	Surface Type
0904E	PUBLIC	11/19/2010	6,522	0.11	AS
Culverts	Drop Inlets	Gates	Curb & Gutter	Curb	PCR
0	0	0	CONCRETE CURB AND GUTTER	NO CURB	GOOD/90
