# Federal Lands Highway Road Inventory Program

Road Inventory and Condition Assessment

## Wilson's Creek National Battlefield WICR - 6370

## **Cycle 5 Report**

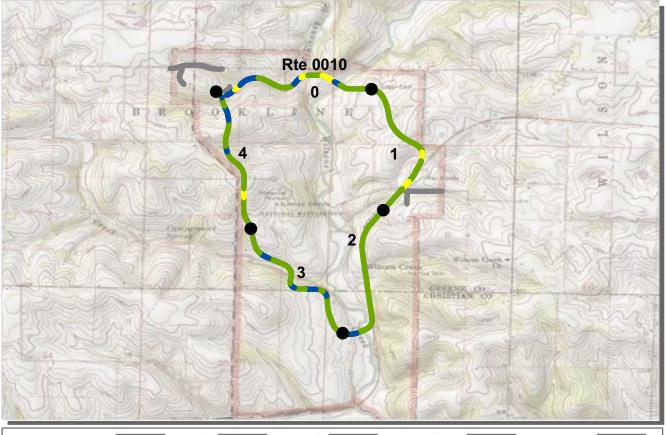
#### ROUTE: 0010 TOUR ROAD WICR : WILSON'S CREEK NATIONAL BATTLEFIELD

MIDWEST REGION			TO	COLLECTED: FAL LENGTH:	12/8/2011 4.95 Miles
Section Number	0	1	2	IAL LENGTH:	4.95 Miles
Section Length (mi)	1.00	1.00	1.00	1.00	0.95
Cross Section Information					
Number of Lanes	1	1	1	1	1
Paved Width (ft)	20	19	19	20	20
Lane Width (ft)	13	12	12	13	12
Roadway Condition Information					
SCR (Surface Condition Rating)	89	82	87	89	86
PCR (Pavement Condition Rating)	90	89	90	92	90
Distress Index Values					
Structural Crack Index	89	82	87	89	86
Transverse Cracking Index	92	88	90	92	95
Patching Index	100	100	100	100	100
Rutting Index	100	99	99	99	100
Roughness Condition Index (RCI)	91	100	95	96	97

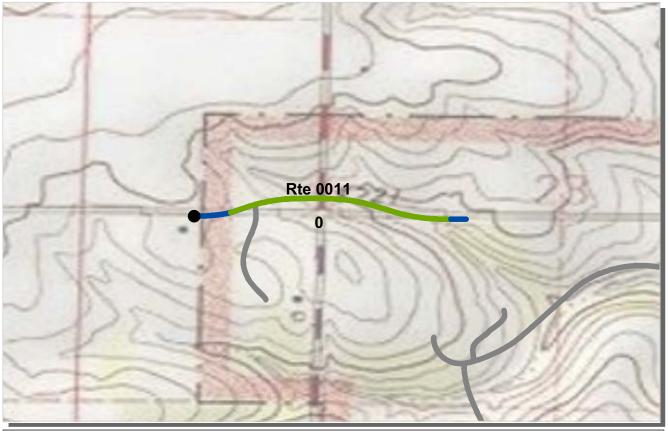
COLLECTED:	12/8/2011
MIDWEST REGION		TOTAL LENGTH:	0.30 Miles
Section Number	0		
Section Length (mi)	0.30		
Cross Section Information			
Number of Lanes	2		
Paved Width (ft)	35		
Lane Width (ft)	13		
Roadway Condition Information			
SCR (Surface Condition Rating)	91		
PCR (Pavement Condition Rating)	91		
Distress Index Values			
Structural Crack Index	91		
Transverse Cracking Index	92		
Patching Index	100		
Rutting Index	97		
Roughness Condition Index (RCI)	NC

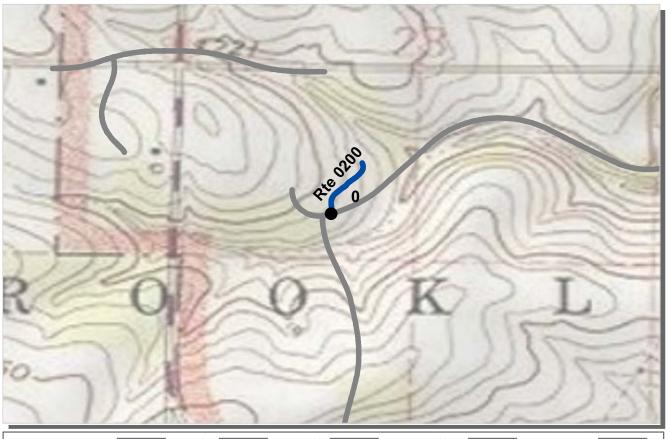
COLLECTED:	12/8/2011	
MIDWEST REGION	TOTAL LENGTH		TOTAL LENGTH:	0.08 Miles	
Section Number	0				
Section Length (mi)	0.08				
Cross Section Information					
Number of Lanes	2				
Paved Width (ft)	23				
Lane Width (ft)	11				
Roadway Condition Information					
SCR (Surface Condition Rating)	99				
PCR (Pavement Condition Rating)	99				
Distress Index Values					
Structural Crack Index	100				
Transverse Cracking Index	99				
Patching Index	100				
Rutting Index	99				
Roughness Condition Index (RCI)	NC

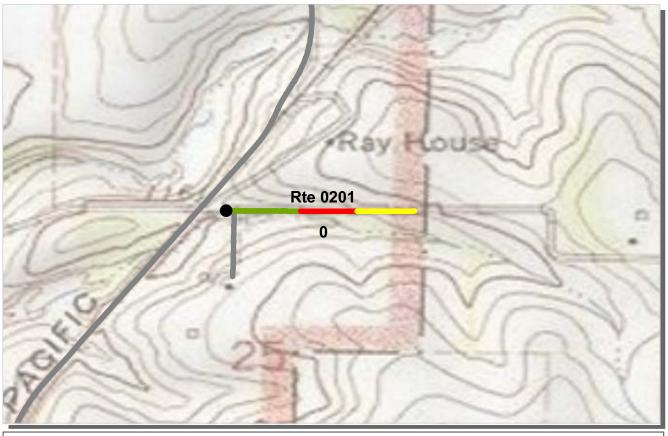
COLLECTED	: 12/8/2011	
MIDWEST REGION	TOTAL LENGTH			0.20 Miles	
Section Number	0				
Section Length (mi)	0.20				
Cross Section Information					
Number of Lanes	2				
Paved Width (ft)	17				
Lane Width (ft)	8				
Roadway Condition Information					
SCR (Surface Condition Rating)	25				
PCR (Pavement Condition Rating)	25				
Distress Index Values					
Structural Crack Index	25				
Transverse Cracking Index	89				
Patching Index	100				
Rutting Index	93				
Roughness Condition Index (RCI)	NC

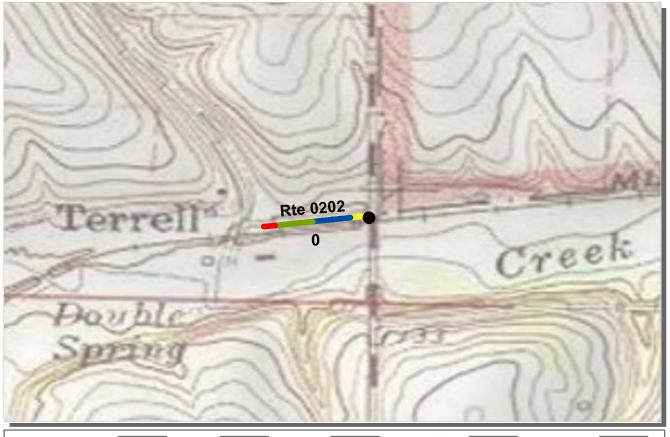
COL	LECTED:	12/8/2011	
MIDWEST REGION		TOTAL LENGTH:			0.11 Miles	
Section Number	0					
Section Length (mi)	0.11					
Cross Section Information						
Number of Lanes	2					
Paved Width (ft)	16					
Lane Width (ft)	8					
Roadway Condition Information						
SCR (Surface Condition Rating)	88					
PCR (Pavement Condition Rating)	88					
Distress Index Values						
Structural Crack Index	93					
Transverse Cracking Index	89					
Patching Index	100					
Rutting Index	88					
Roughness Condition Index (RCI)	NC

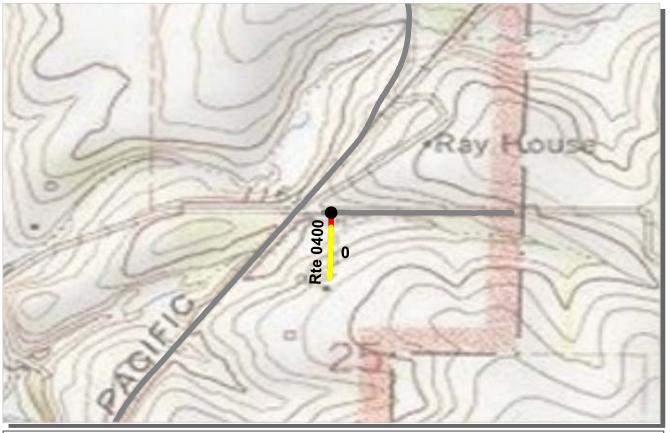
CO	LLECTED:	12/8/2011
MIDWEST REGION	TOTAL LENGTH		LENGTH:	: 0.09 Miles	
Section Number	0				
Section Length (mi)	0.09				
Cross Section Information					
Number of Lanes	2				
Paved Width (ft)	15				
Lane Width (ft)	8				
Roadway Condition Information					
SCR (Surface Condition Rating)	66				
PCR (Pavement Condition Rating)	66				
Distress Index Values					
Structural Crack Index	66				
Transverse Cracking Index	96				
Patching Index	100				
Rutting Index	86				
Roughness Condition Index (RCI)	NC

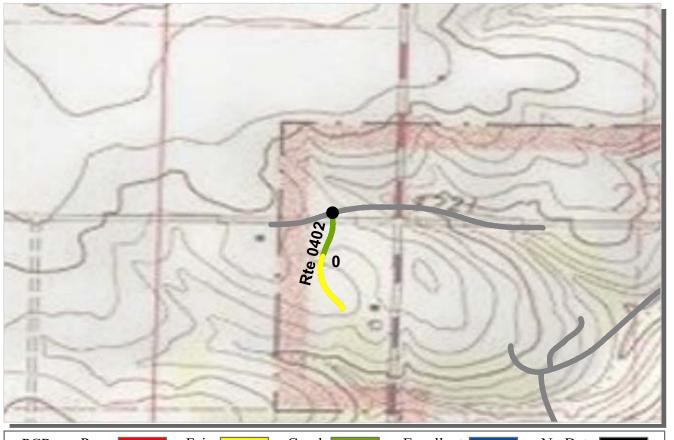
COL	LECTED:	12/8/2011
MIDWEST REGION	TOTAL LENGT		LENGTH:	H: 0.13 Miles	
Section Number	0				
Section Length (mi)	0.13				
Cross Section Information					
Number of Lanes	2				
Paved Width (ft)	26				
Lane Width (ft)	13				
Roadway Condition Information					
SCR (Surface Condition Rating)	92				
PCR (Pavement Condition Rating)	92				
Distress Index Values					
Structural Crack Index	93				
Transverse Cracking Index	92				
Patching Index	100				
Rutting Index	96				
Roughness Condition Index (RCI)	NC
