# Federal Lands Highway Road Inventory Program

Road Inventory and Condition Assessment

## Wolf Trap National Park for the Performing Arts WOTR

### Cycle 5 Report

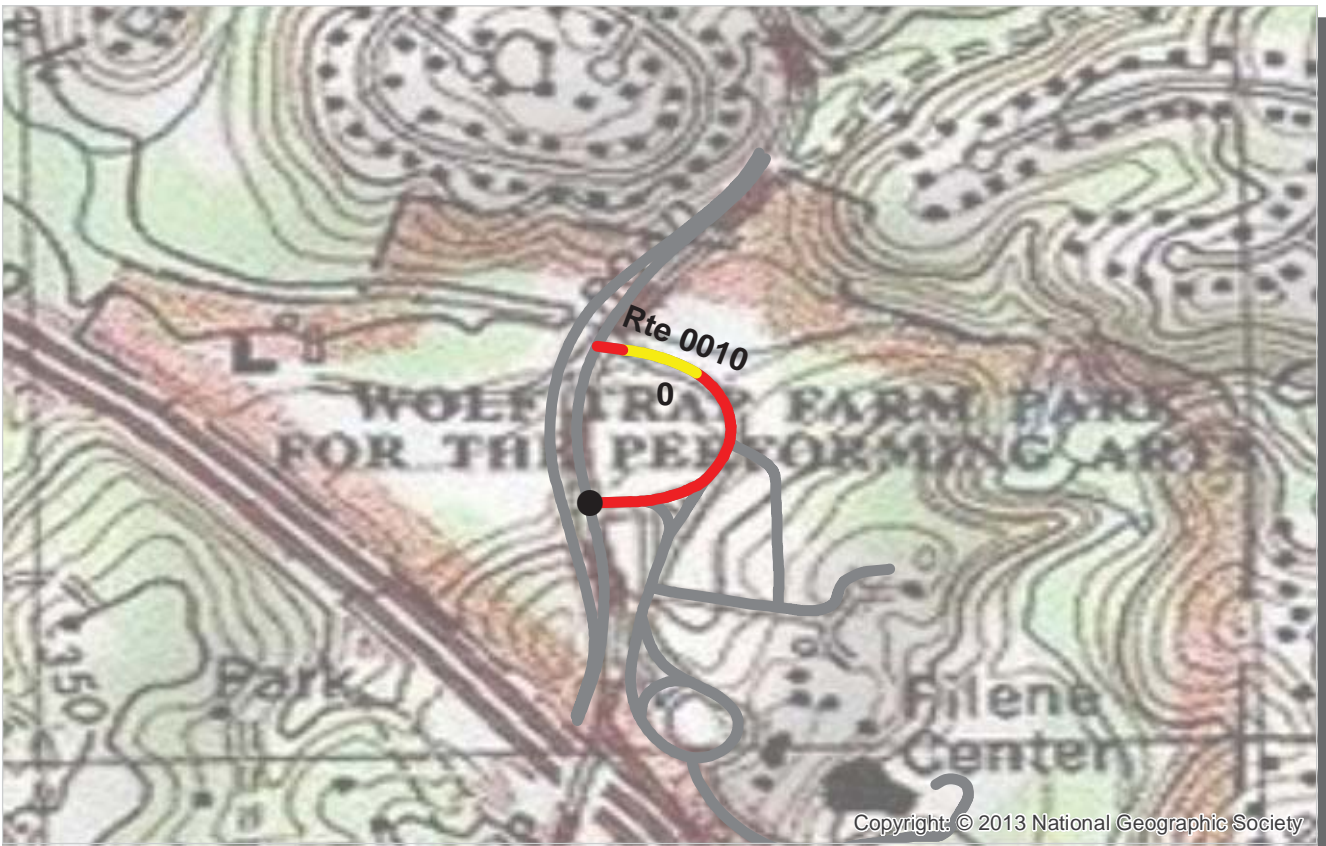
**ROUTE: 0010 EAST LOT ACCESS ROAD**

| SCR (Surface Condition Rating) | 59 | | | | |
| PCR (Pavement Condition Rating) | 59 | | | | |
| Structural Crack Index | 59 | | | | |
| Transverse Cracking Index | 81 | | | | |

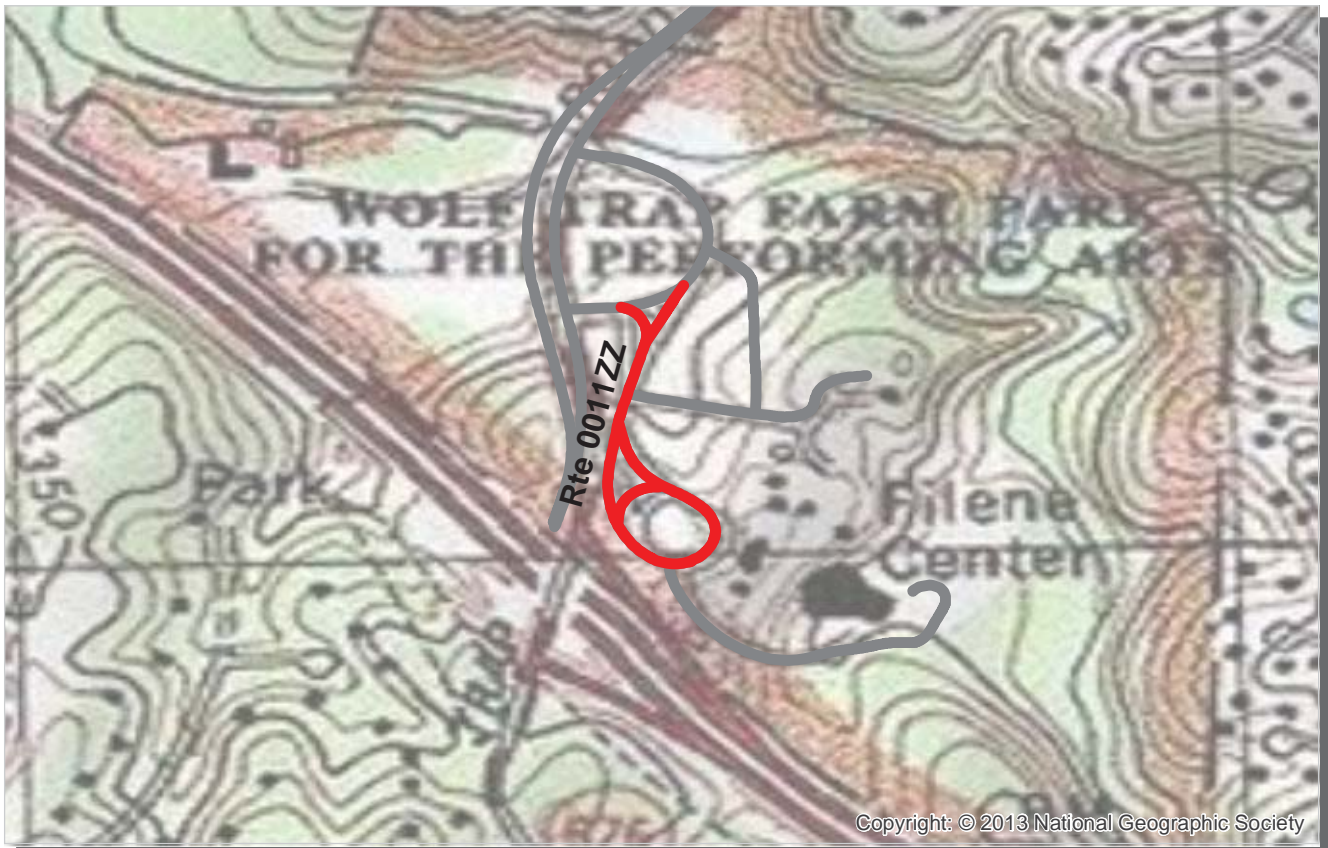
ROUTE: 0011ZZ MAIN CIRCLE ROADS

| SCR (Surface Condition Rating) | 41 | | | | |
| PCR (Pavement Condition Rating) | 41 | | | | |

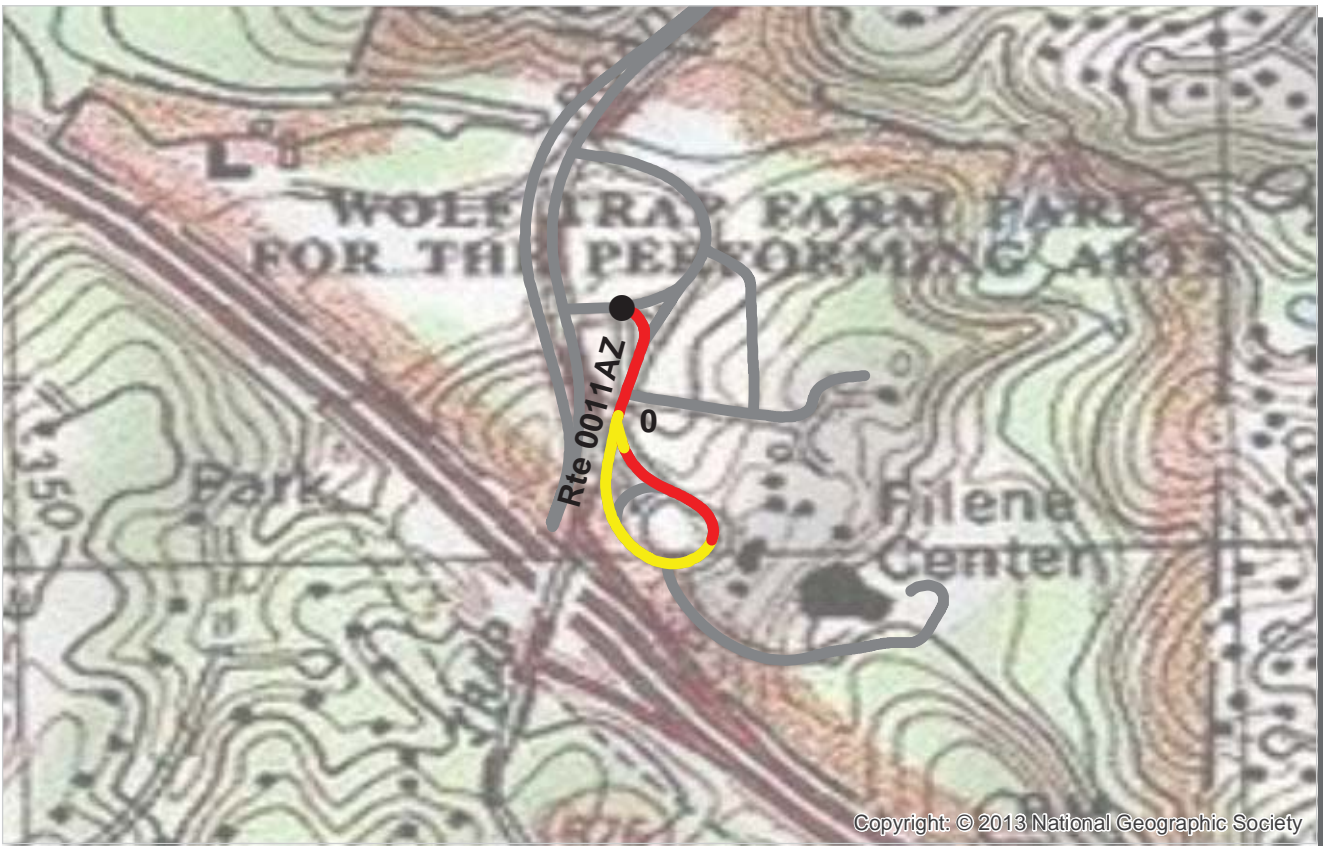
**ROUTE: 0011AZ MAIN CIRCLE ROAD**

| SCR (Surface Condition Rating) | 40 | | | | |
| PCR (Pavement Condition Rating) | 40 | | | | |
| Structural Crack Index | 40 | | | | |
| Transverse Cracking Index | 77 | | | | |

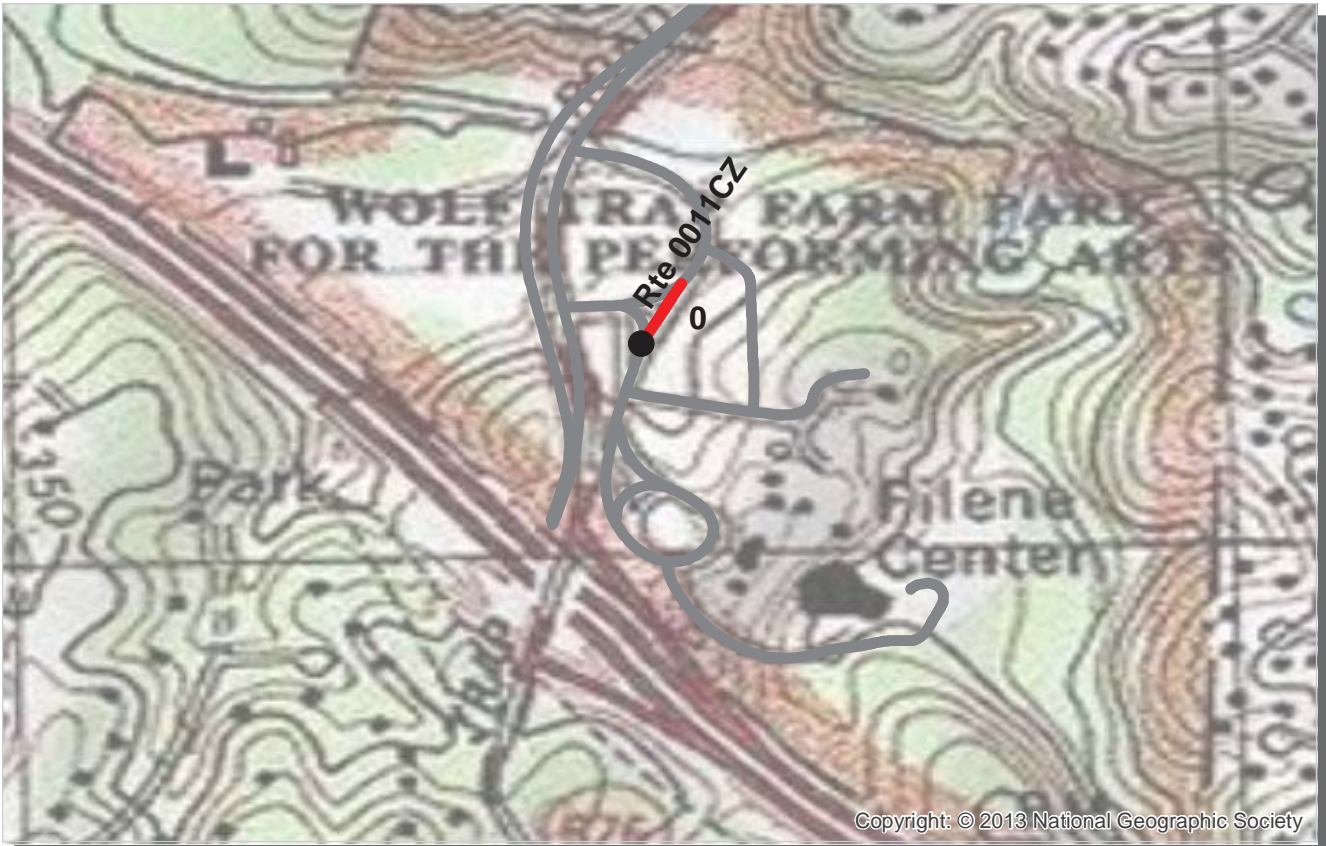
ROUTE: 0011CZ MAIN CIRCLE ROAD SPUR

| SCR (Surface Condition Rating) | 42 | | | | |
| PCR (Pavement Condition Rating) | 42 | | | | |
| Structural Crack Index | 42 | | | | |
| Transverse Cracking Index | 78 | | | | |

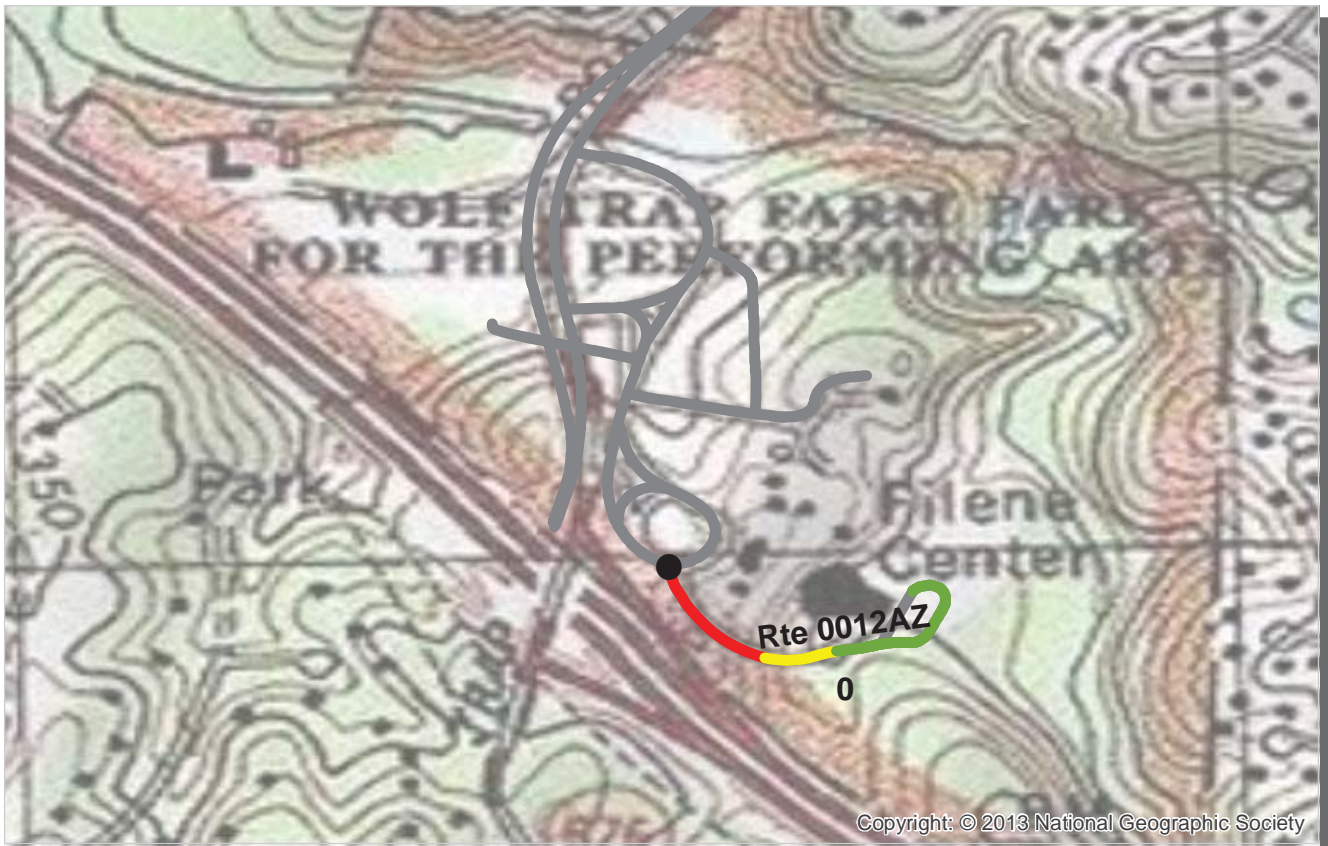
ROUTE: 0012AZ THEATER ROAD

| SCR (Surface Condition Rating) | 69 | | | | |
| PCR (Pavement Condition Rating) | 69 | | | | |
| Structural Crack Index | 69 | | | | |
| Transverse Cracking Index | 89 | | | | |

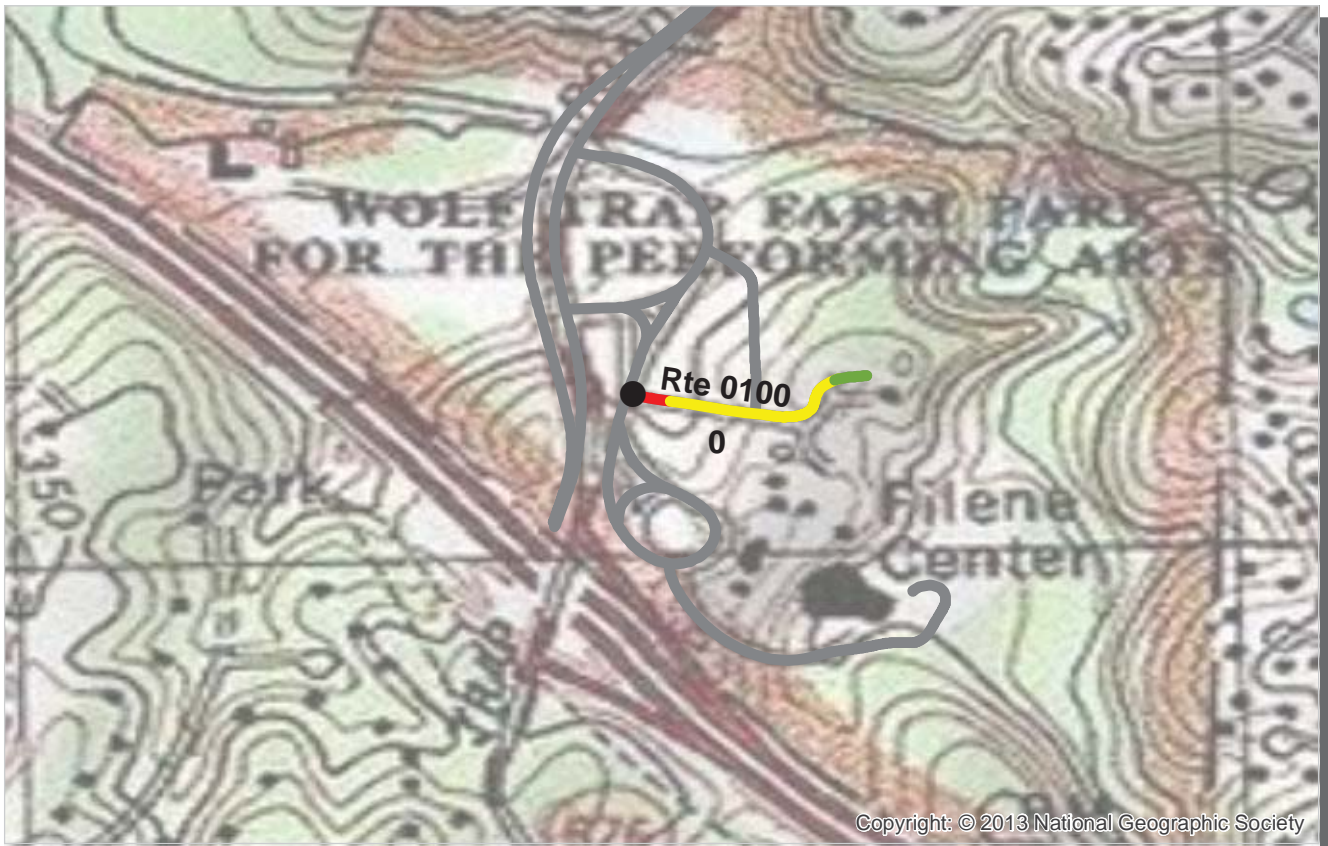
**ROUTE: 0100 BARN ROAD**

| SCR (Surface Condition Rating) | 63 | | | | |
| PCR (Pavement Condition Rating) | 63 | | | | |
| Structural Crack Index | 63 | | | | |
| Transverse Cracking Index | 75 | | | | |

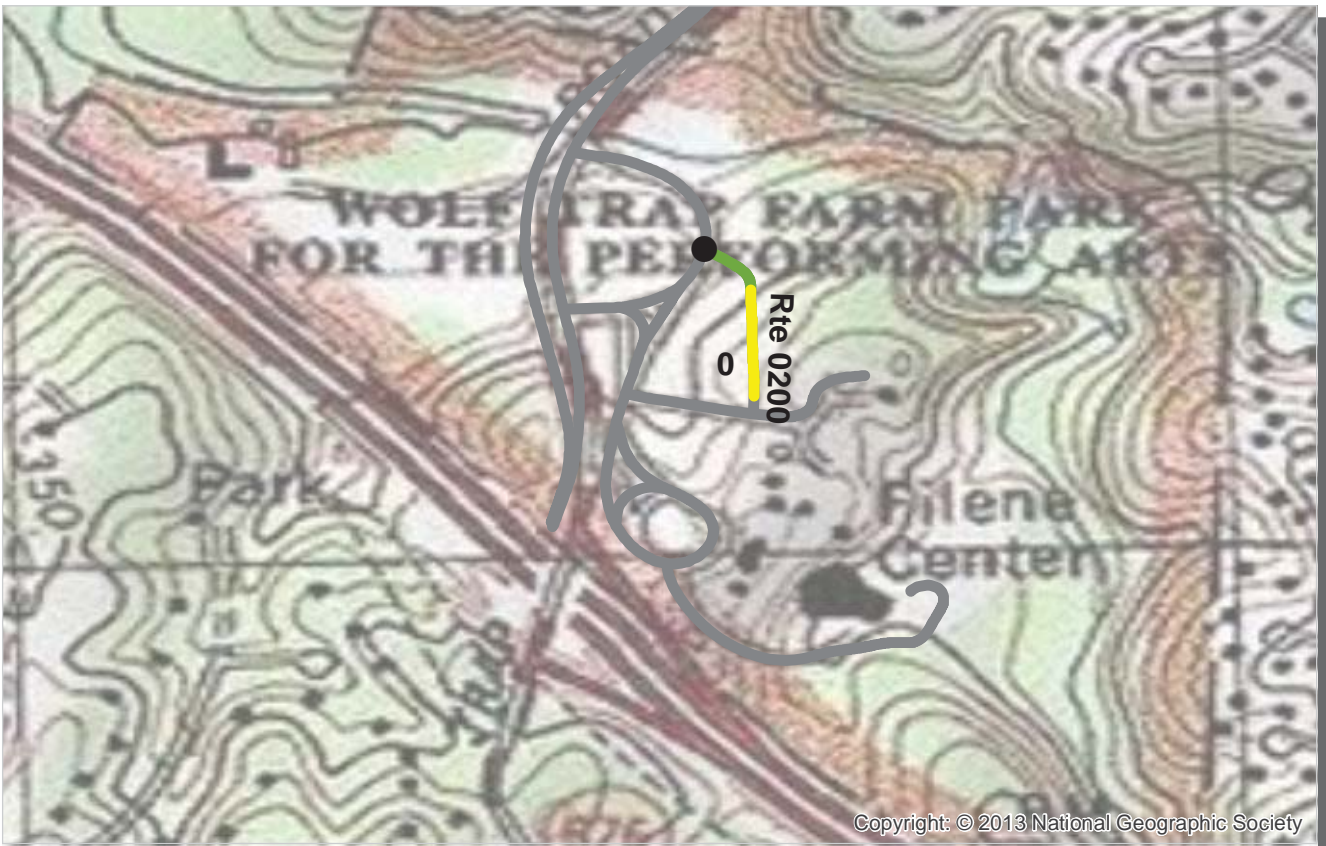
**ROUTE: 0200 GILLS ROAD**

| SCR (Surface Condition Rating) | 84 | | | | |
| PCR (Pavement Condition Rating) | 84 | | | | |
| Structural Crack Index | 98 | | | | |
| Transverse Cracking Index | 84 | | | | |
