Federal Lands Highway Road Inventory Program

Road Inventory and Condition Assessment

Wupatki National Monument WUPA

Cycle 5 Report

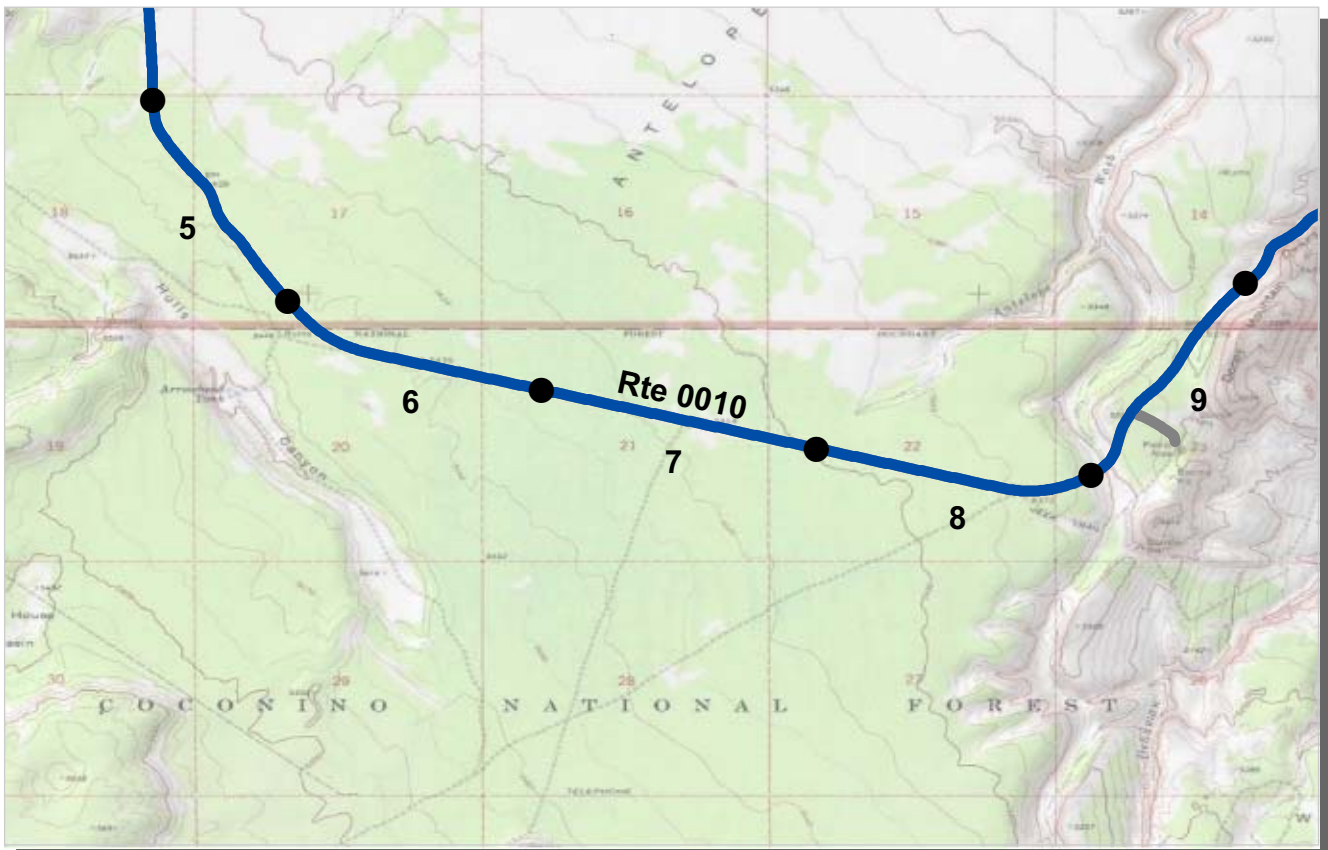
ROUTE: 0010 WUPATKI-SUNSET CRATER SCENIC LOOP ROAD

<i>Section Number</i>	5	6	7	8	9
<i>Section Length (mi)</i>	1.00	1.00	1.00	1.00	1.00
<i>Cross Section Information</i>					
Number of Lanes	2	2	2	2	2
Paved Width (ft)	25	25	25	25	25
Lane Width (ft)	10	10	10	10	10
<i>Roadway Condition Information</i>					
SCR (Surface Condition Rating)	98	98	99	99	100
PCR (Pavement Condition Rating)	99	99	99	99	100
<i>Distress Index Values</i>					
Structural Crack Index	100	100	100	100	100
Transverse Cracking Index	100	100	100	100	100
Patching Index	100	100	100	100	100
Rutting Index	98	98	99	99	100
Roughness Condition Index (RCI)	100	100	100	100	100

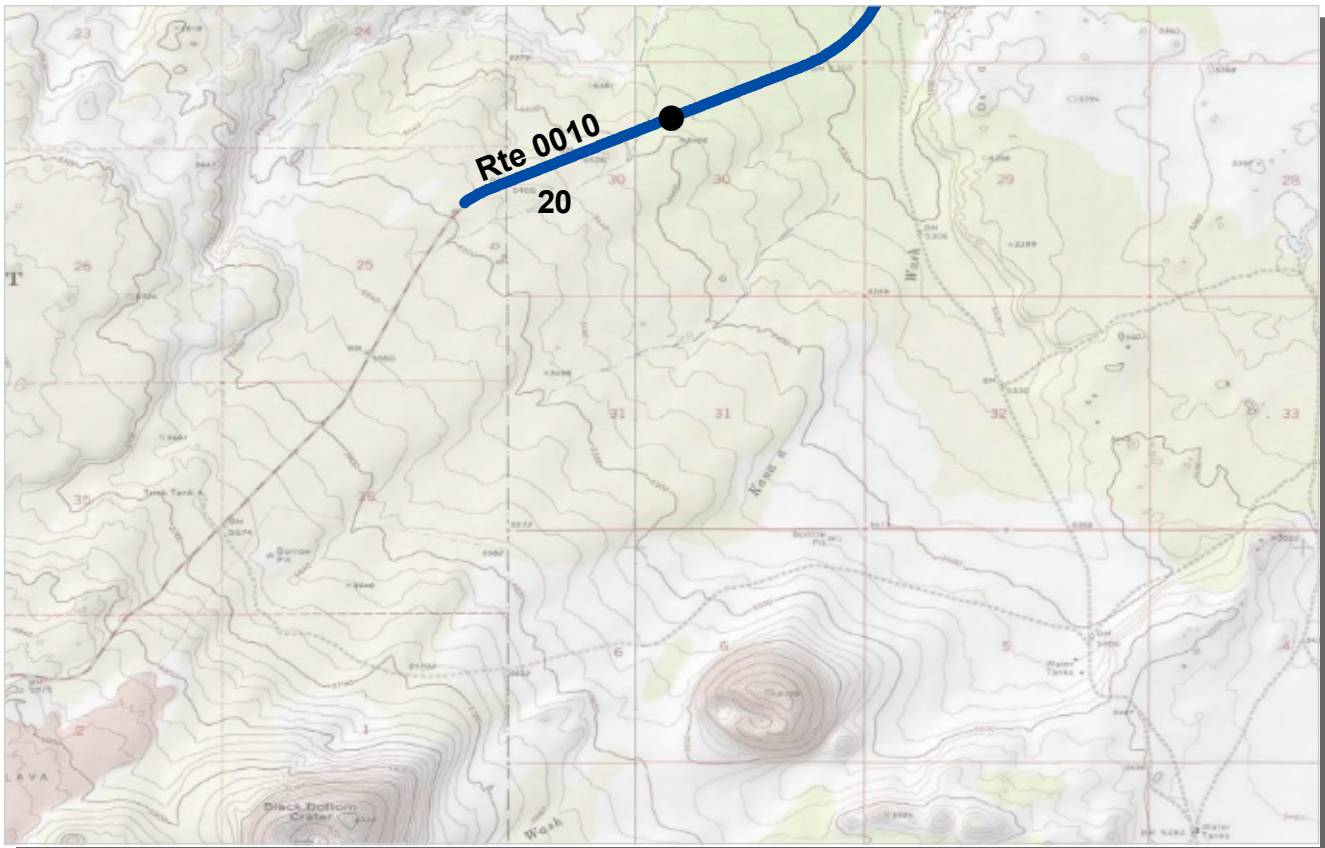
ROUTE: 0010 WUPATKI-SUNSET CRATER SCENIC LOOP ROAD

Section Number	20				
Section Length (mi)	0.82				
Cross Section Information					
Number of Lanes	2				
Paved Width (ft)	26				
Lane Width (ft)	11				
Roadway Condition Information					
SCR (Surface Condition Rating)	100				
PCR (Pavement Condition Rating)	100				
Distress Index Values					
Structural Crack Index	100				
Transverse Cracking Index	100				
Patching Index	100				
Rutting Index	100				
Roughness Condition Index (RCI)	100

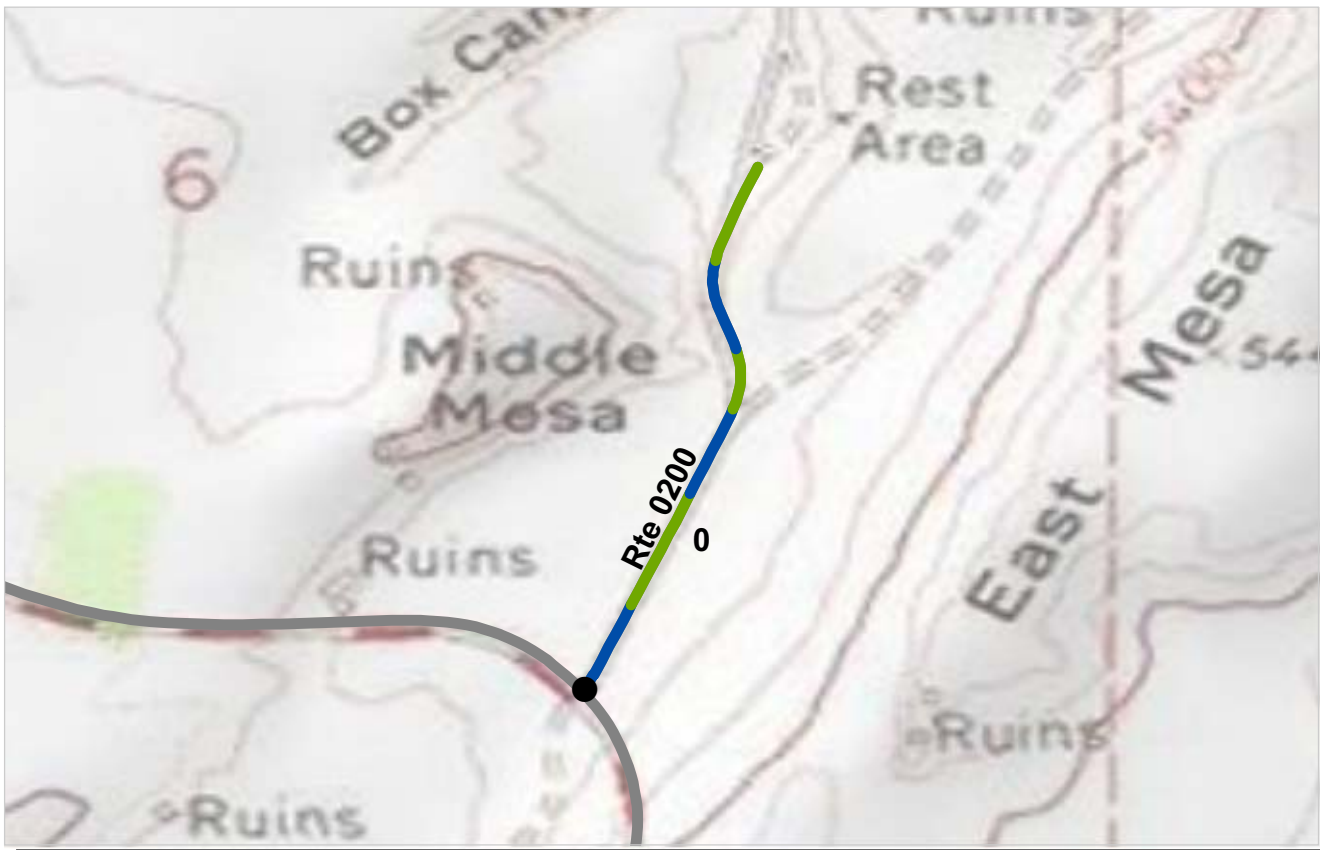
ROUTE: 0200 LOMAKI ROAD

Section Number	0				
Section Length (mi)	0.37				
Cross Section Information					
Number of Lanes	2				
Paved Width (ft)	23				
Lane Width (ft)	10				
Roadway Condition Information					
SCR (Surface Condition Rating)	95				
PCR (Pavement Condition Rating)	95				
Distress Index Values					
Structural Crack Index	99				
Transverse Cracking Index	95				
Patching Index	100				
Rutting Index	97				
Roughness Condition Index (RCI)	NC

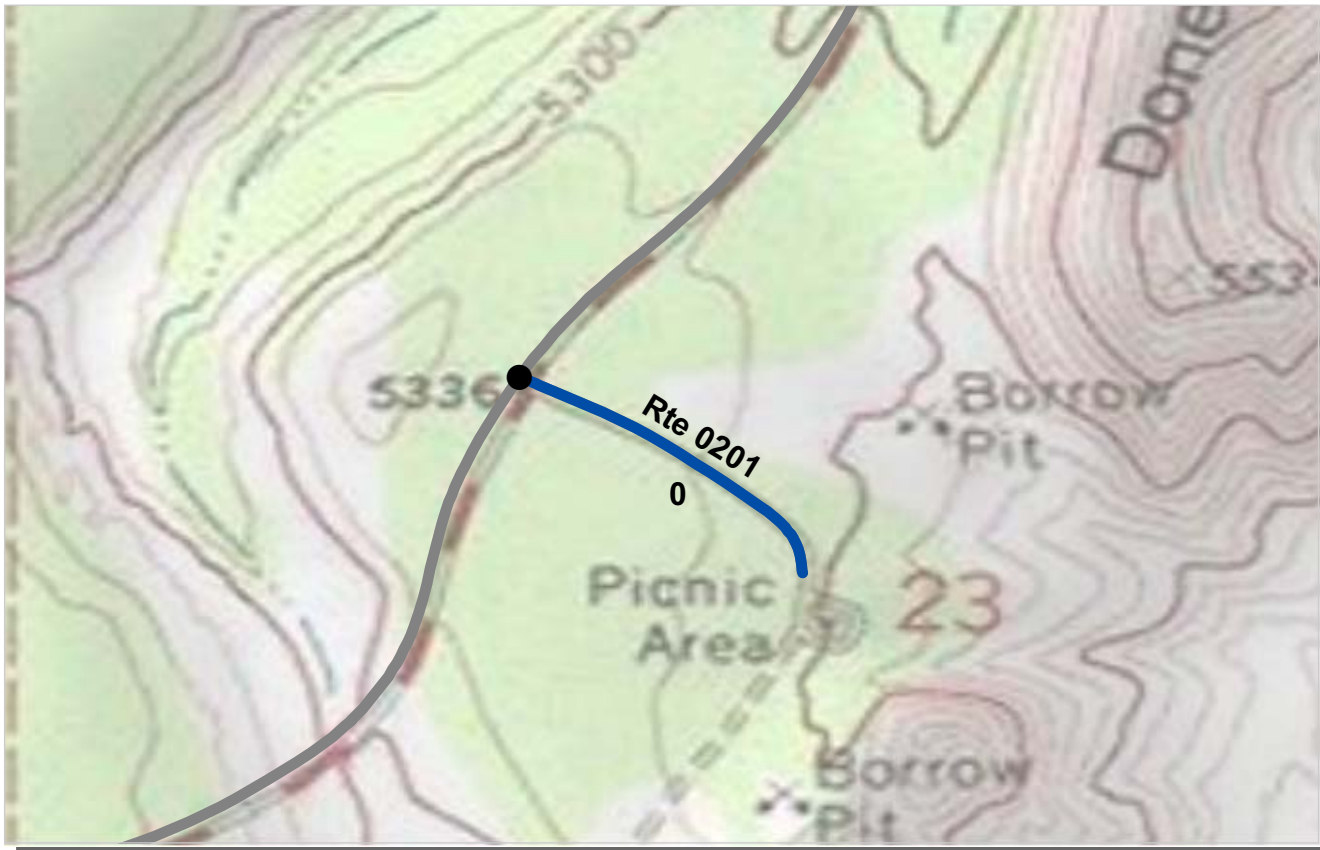
ROUTE: 0201 DONEY CRATER PICNIC AREA ROAD

Section Number	0				
Section Length (mi)	0.21				
Cross Section Information					
Number of Lanes	2				
Paved Width (ft)	21				
Lane Width (ft)	9				
Roadway Condition Information					
SCR (Surface Condition Rating)	99				
PCR (Pavement Condition Rating)	99				
Distress Index Values					
Structural Crack Index	100				
Transverse Cracking Index	100				
Patching Index	100				
Rutting Index	99				
Roughness Condition Index (RCI)	NC

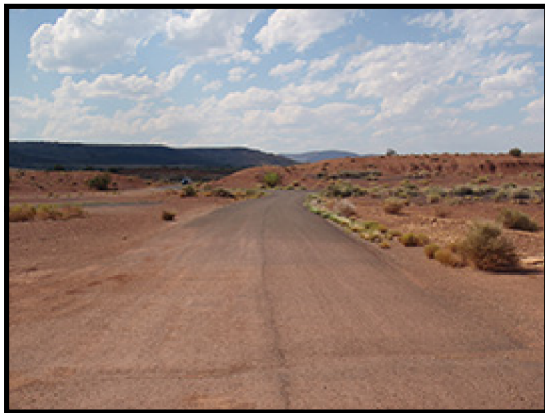
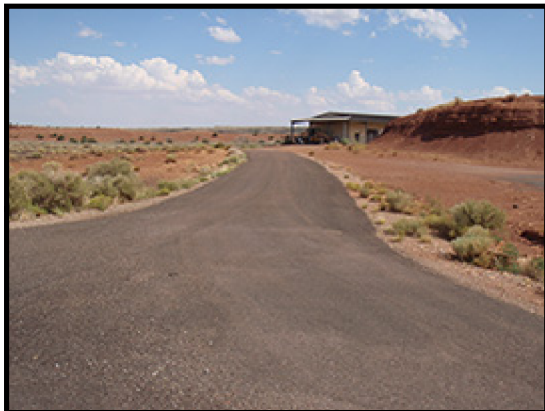
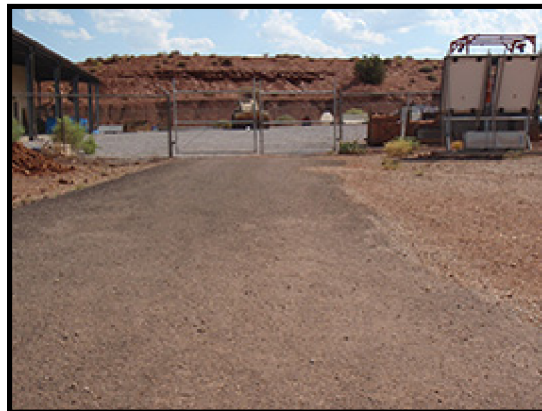
Route Number	Public / NonPublic	Date Visited	Area (sq ft)	Lane Miles *	Surface Type
0409	NONPUBLIC	8/31/2011	11,012	0.19	AS
Culverts	Drop Inlets	Gates	Curb & Gutter	Curb	PCR
1	0	1	NO CURB AND GUTTER	NO CURB	FAIR/73

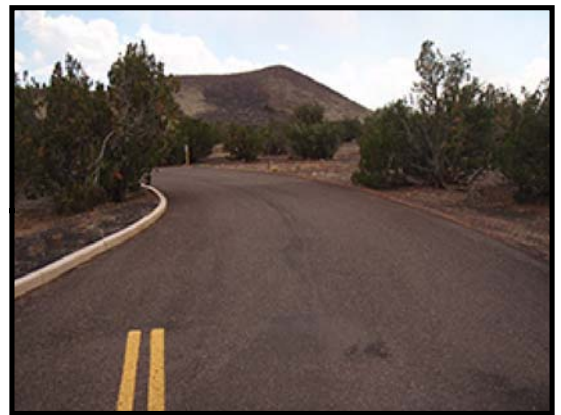
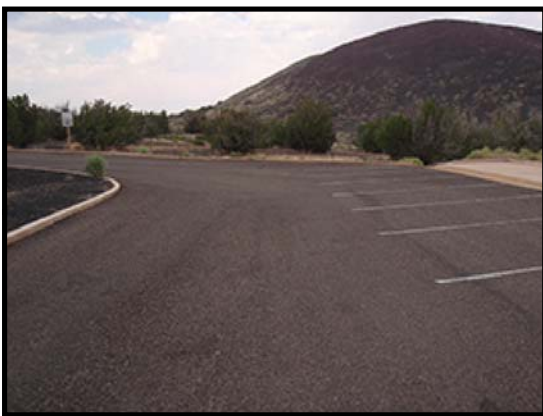
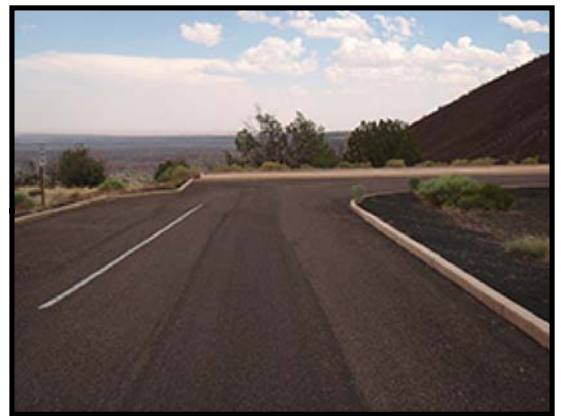
Route Number	Public / NonPublic	Date Visited	Area (sq ft)	Lane Miles *	Surface Type
0903	PUBLIC	8/31/2011	15,462	0.27	AS
Culverts	Drop Inlets	Gates	Curb & Gutter	Curb	PCR
0	0	0	CONCRETE CURB AND GUTTER	CONCRETE CURB	GOOD/90

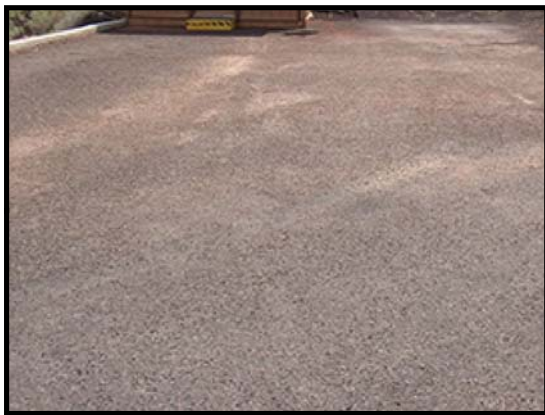
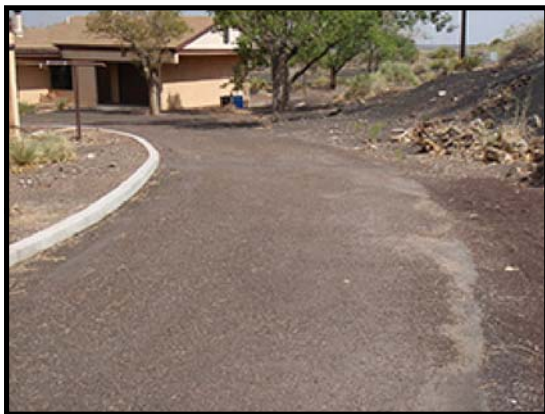
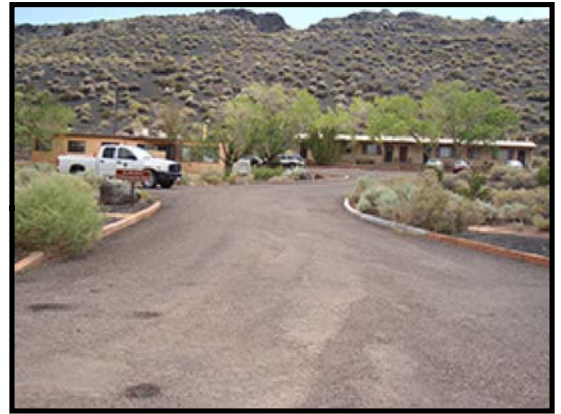
Route 0905

Route Number	Public / NonPublic	Date Visited	Area (sq ft)	Lane Miles *	Surface Type
0905	NONPUBLIC	8/31/2011	16,377	0.28	AS
Culverts	Drop Inlets	Gates	Curb & Gutter	Curb	PCR
0	1	0	CONCRETE CURB AND GUTTER	CONCRETE & STONE CURB	FAIR/73
