Federal Lands Highway Road Inventory Program

Road Inventory and Condition Assessment

Zion National Park ZION

Cycle 5 Report

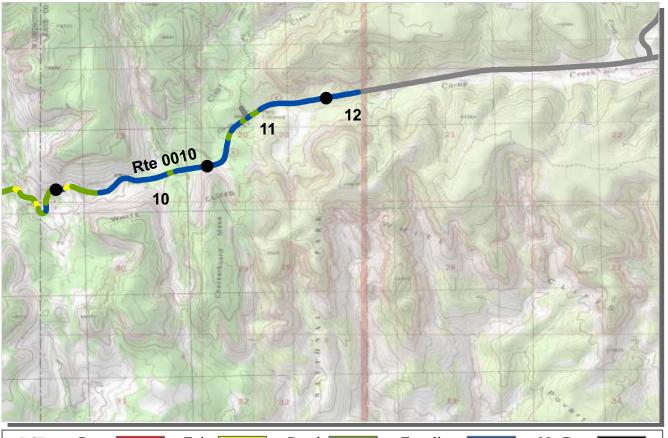
Excellent PCR Poor Fair Good No Da (0 - 60)(61 - 84)(85 - 94)(95 - 100)* If the PCR rating is not available for a section, the SCR rating will be displayed. See appendix for definitions and formulas.

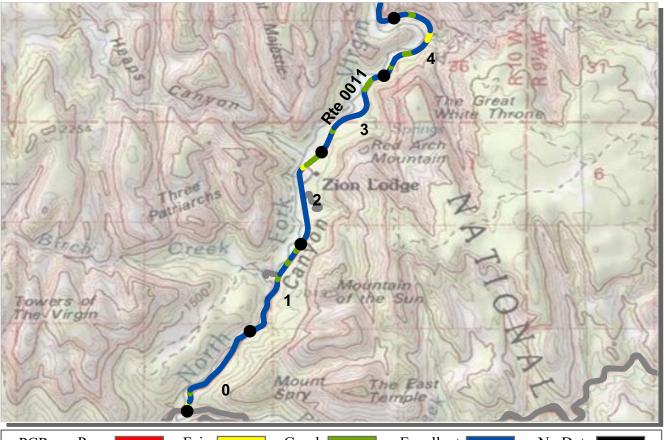
* If the PCR rating is not available for a section, the SCR rating will be displayed. See appendix for definitions and formulas.
 No Data

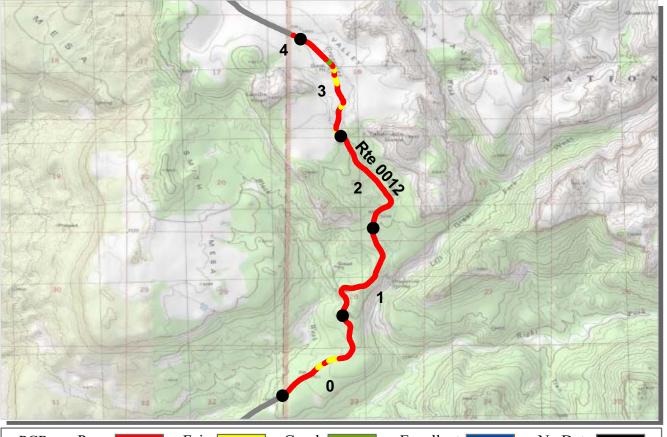
PCR	Poor	Fair Fair	Good	Excellent	No Data
	(0 - 6	60) (61 - 84)	(85 - 94)	(95 - 100))
* If the PCI	R rating is not av	vailable for a section, the	e SCR rating will be dis	played. See appendix for	definitions and formulas.
