# ABLI Cycle 6

## Final Report

### Road Inventory and Condition Assessment of Paved Routes Abraham Lincoln Birthplace National Historical Park

**Report Date: April 2022**

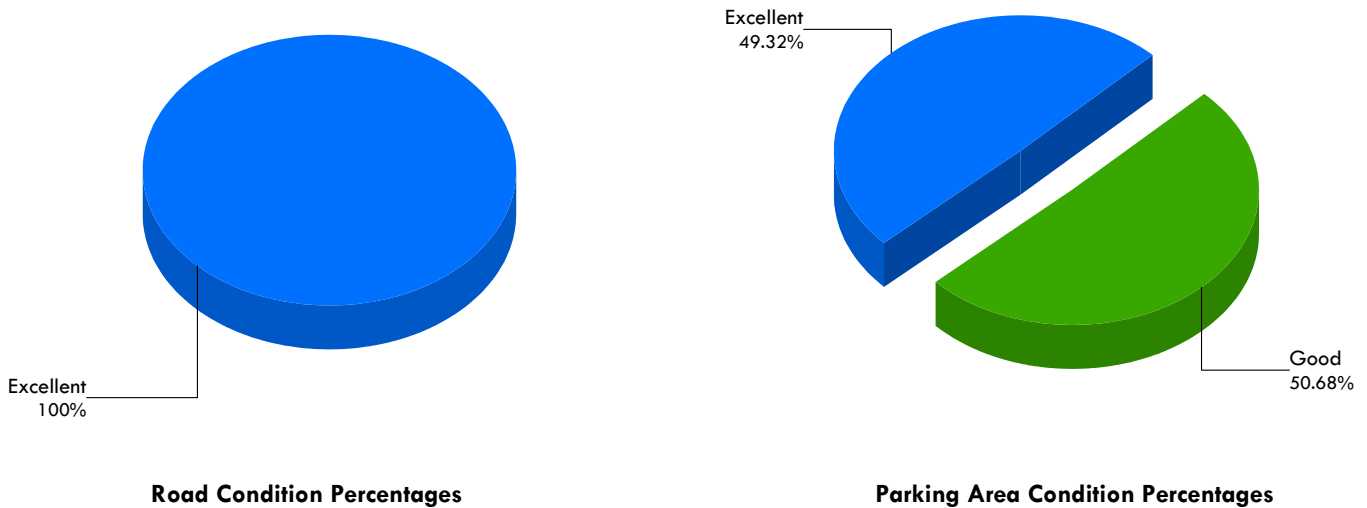
Figure 1: Pavement Condition Rating Breakdown for Paved Roads and Parking Areas

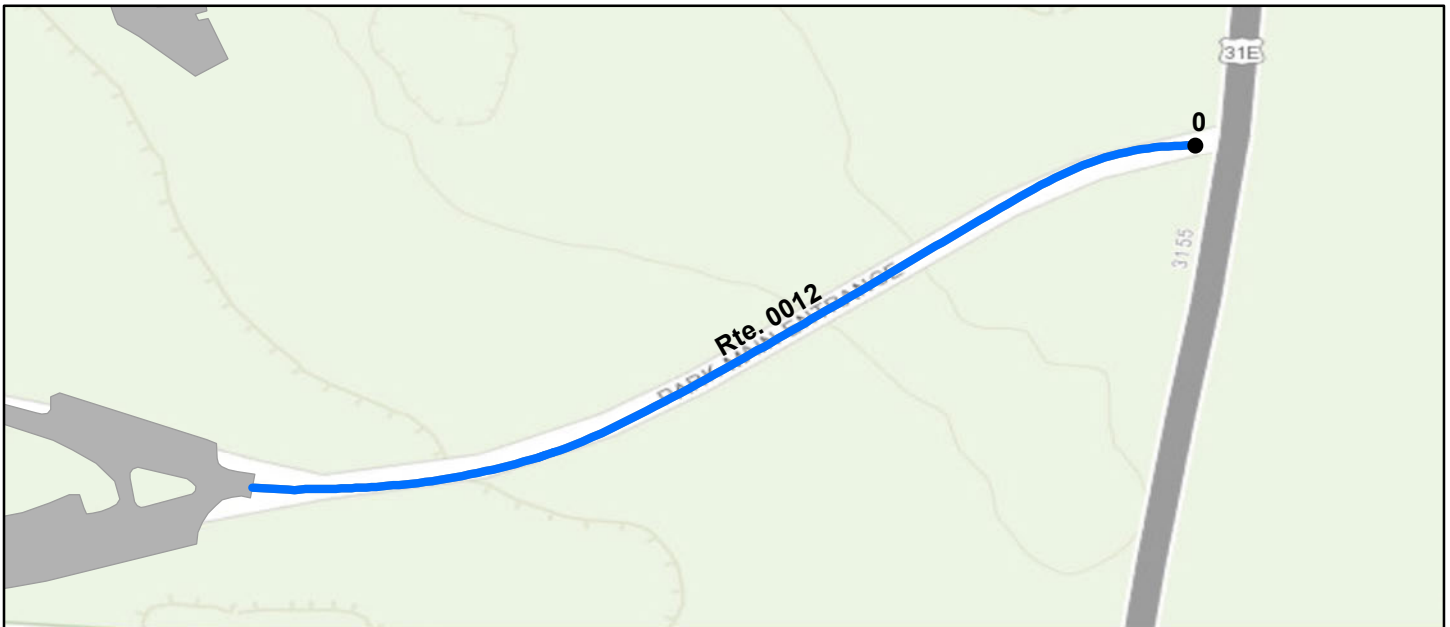
## ROUTE 0012: VISITOR CENTER ENTRANCE ROAD

| Route Condition Legend – Pavement Condition Rating (PCR) | | | | | | |
|---|---|---|---|---|--|--|
| Pavement Condition Rating (PCR) | 99 | 99 | | | | |
| Surface Condition Rating (SCR) | 99 | 99 | | | | |
| Structural Crack Index | 100 | 100 | | | | |

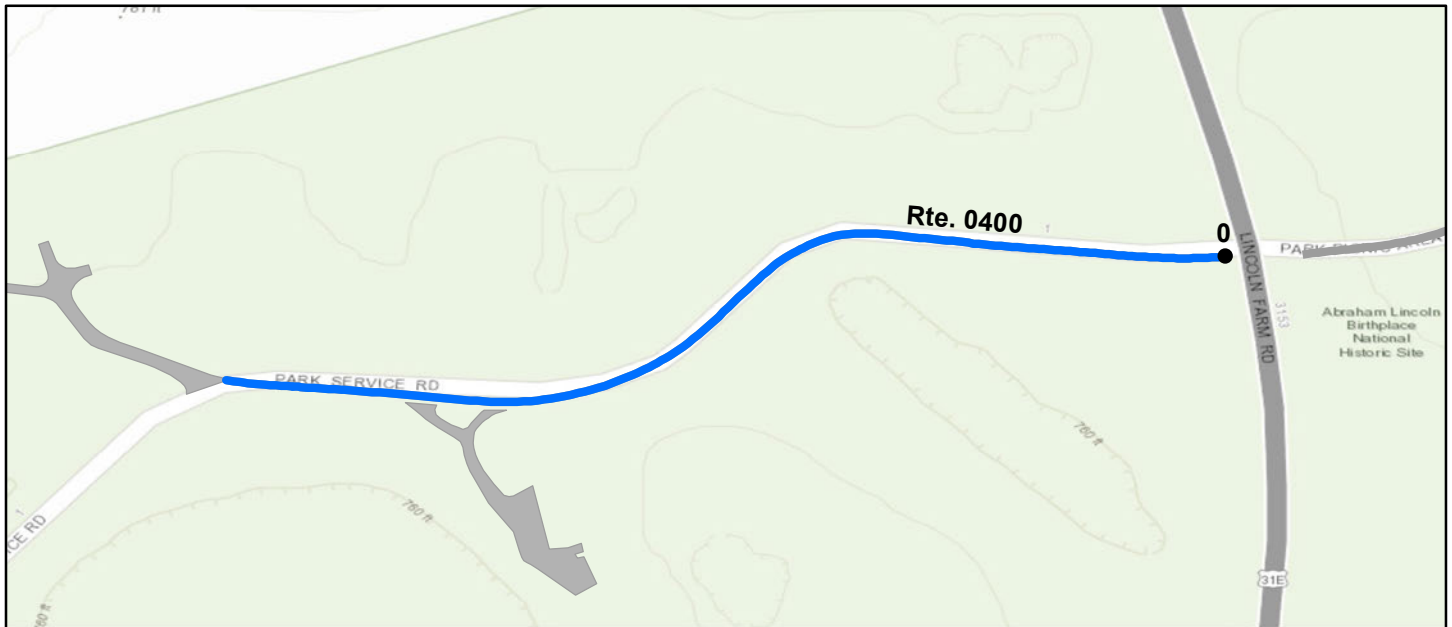
## ROUTE 0400: MAINTENANCE SERVICE ROAD

| Pavement Condition Rating (PCR) | 99 | 99 | | | | |
| Surface Condition Rating (SCR) | 99 | 99 | | | | |
| Structural Crack Index | 100 | 100 | | | | |
