# AGFO Cycle 6

## Final Report

### Road Inventory and Condition Assessment of Paved Routes Agate Fossil Beds National Monument

Report Date: December 2017

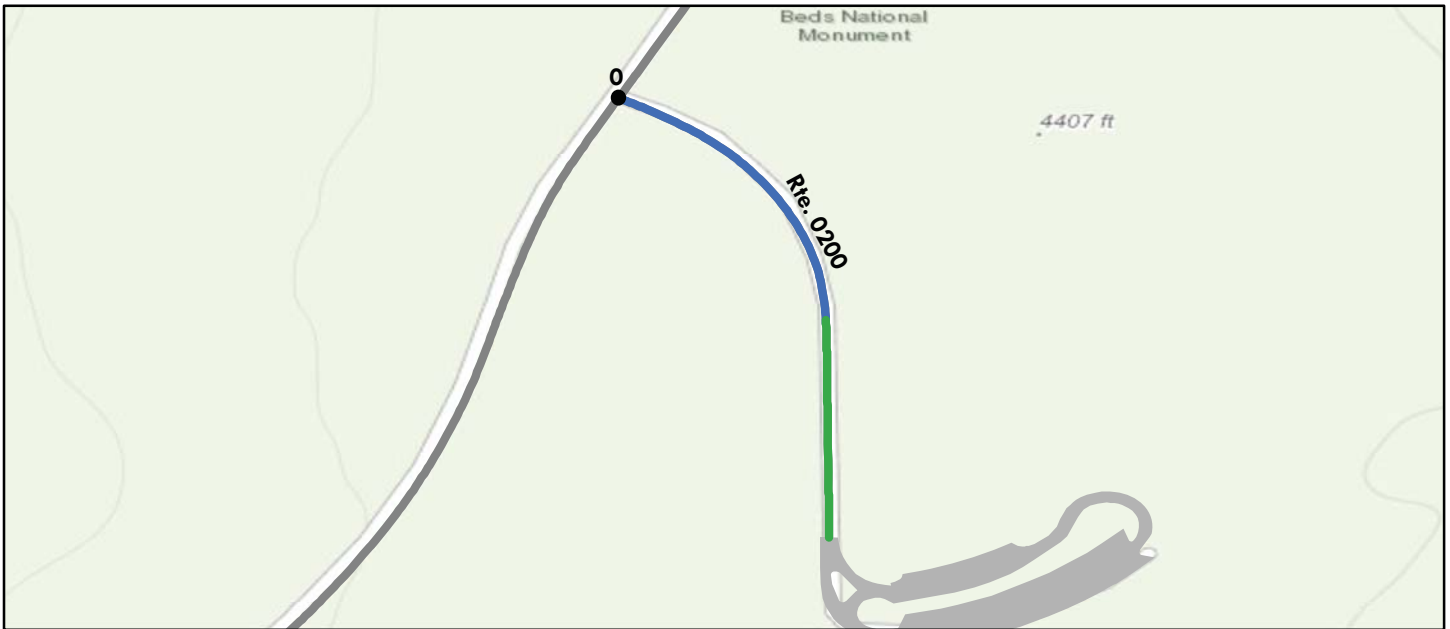
## ROUTE 0200: HEADQUARTERS ACCESS ROAD

Route Condition Legend – Pavement Condition Rating (PCR)						
Poor (0 - 60)	Fair (61- 84)	Good (85 - 94)	Excellent (95 - 100)	Not Rated		
See Appendix for definitions and formulas						
<b>Inspection Date:</b> 7/17/2017	<b>Beginning Section MP</b>	0				
<b>Paved Length (Miles):</b> 0.17	<b>Section Length (MI)</b>	0.17				
<b>Surface Type:</b> ASPHALT	<b>Route Summary</b>					
<b>Roadway Condition Information</b>						
Pavement Condition Rating (PCR)	96	96				
Surface Condition Rating (SCR)	96	96				
Roughness Condition Index (RCI)	N/A	N/A				
<b>Distress Index Values</b>						
Structural Crack Index	99	99				
Alligator Crack Index	100	100				
Longitudinal Crack Index	99	99				
Transverse Cracking Index	96	96				
Patching Index	100	100				
Rutting Index	96	96				
International Roughness Index (IRI)	N/A	N/A				
<b>Lane &amp; Width Information</b>						
Number of Lanes	2	2				
Paved Width (ft)	24.1	24.1				
Lane Width (ft)	11.1	11.1

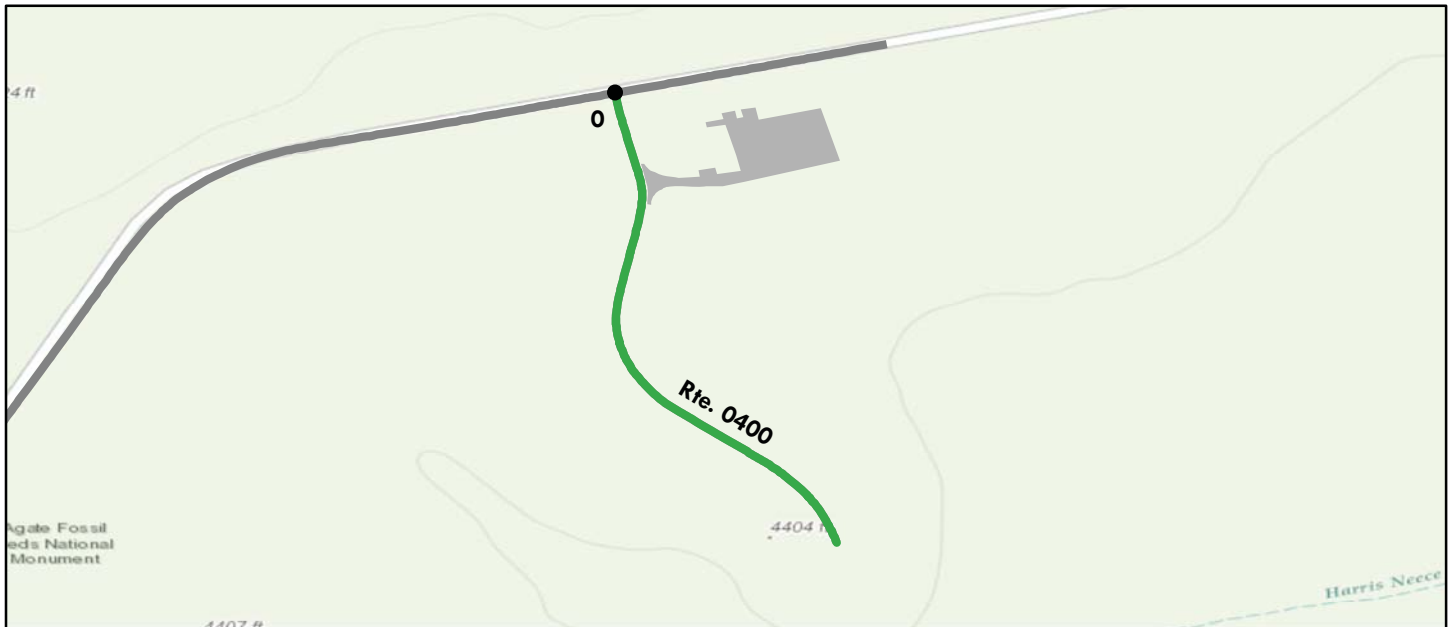
## ROUTE 0400: HOUSING ACCESS ROAD

Route Condition Legend – Pavement Condition Rating (PCR)						
Poor (0 - 60)	Fair (61- 84)	Good (85 - 94)	Excellent (95 - 100)	Not Rated		
See Appendix for definitions and formulas						
<b>Inspection Date:</b> 7/17/2017	<b>Beginning Section MP</b>	0				
<b>Paved Length (Miles):</b> 0.22	<b>Section Length (MI)</b>	0.22				
<b>Surface Type:</b> CONCRETE	<b>Route Summary</b>					
<b>Roadway Condition Information</b>						
Pavement Condition Rating (PCR)	90	90				
Surface Condition Rating (SCR)	N/A	N/A				
Roughness Condition Index (RCI)	N/A	N/A				
<b>Distress Index Values</b>						
Structural Crack Index	N/A	N/A				
Alligator Crack Index	N/A	N/A				
Longitudinal Crack Index	N/A	N/A				
Transverse Cracking Index	N/A	N/A				
Patching Index	N/A	N/A				
Rutting Index	N/A	N/A				
International Roughness Index (IRI)	N/A	N/A				
<b>Lane &amp; Width Information</b>						
Number of Lanes	2	2				
Paved Width (ft)	18.6	18.6

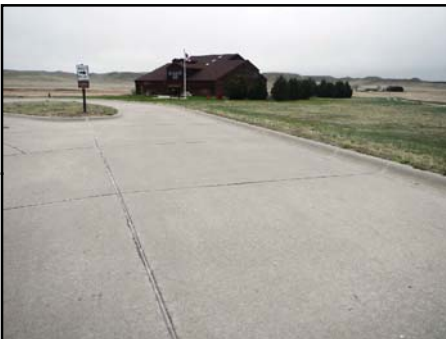
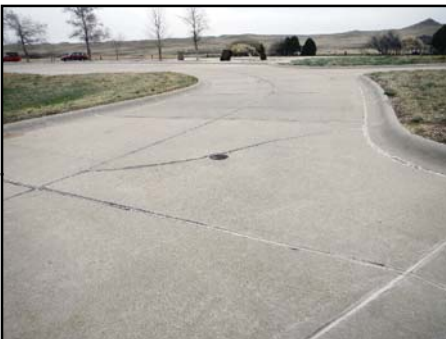
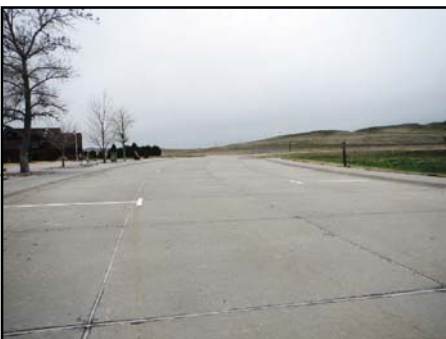
Inspection Date	FMSS Number	User Access	Surface Type
4/25/2017	60131	PUBLIC	CONCRETE
Area (Sq. Ft.)	Lane Miles (11' Widths)	Curb Reveal (Inches)	Curb Recommendation
42,004	0.723	7	DO NOTHING
Curb Type		Curb & Gutter Type	
CONCRETE		NO CURB AND GUTTER	
Pavement Recommendation		Condition Rating / PCR	
PREVENTIVE MAINTENANCE		GOOD / 90

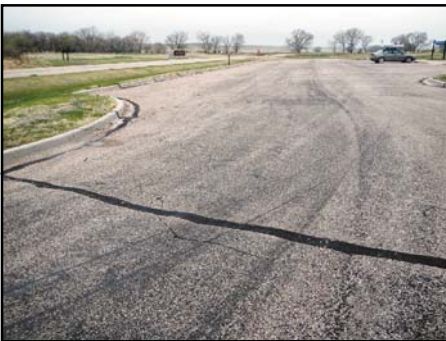
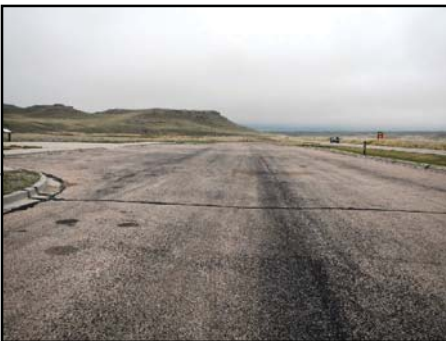
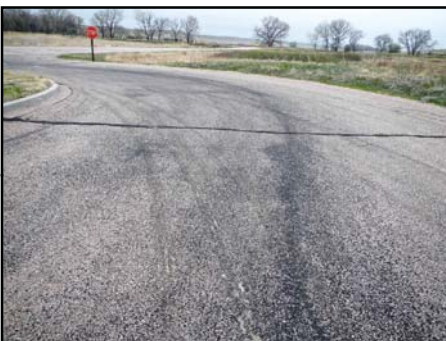
## ROUTE 0901: DAEMONELIX PARKING

Inspection Date	FMSS Number	User Access	Surface Type
4/25/2017	60132	PUBLIC	ASPHALT
Area (Sq. Ft.)	Lane Miles (11' Widths)	Curb Reveal (Inches)	Curb Recommendation
15,905	0.274	NOT APPLICABLE	DO NOTHING
Curb Type		Curb & Gutter Type	
NO CURB		CONCRETE	
Pavement Recommendation		Condition Rating / PCR	
PREVENTIVE MAINTENANCE		GOOD / 90

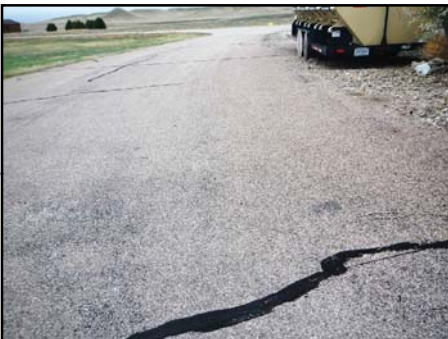
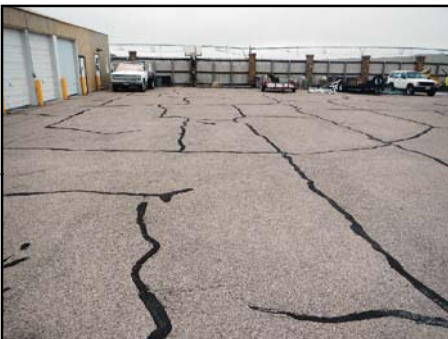
## ROUTE 0902: MAINTENANCE AREA PARKING

Inspection Date	FMSS Number	User Access	Surface Type
4/25/2017	31338	NONPUBLIC	ASPHALT
Area (Sq. Ft.)	Lane Miles (11' Widths)	Curb Reveal (Inches)	Curb Recommendation
25,838	0.445	NOT APPLICABLE	NOT APPLICABLE
Curb Type		Curb & Gutter Type	
NO CURB		NO CURB AND GUTTER	
Pavement Recommendation		Condition Rating / PCR	
HEAVY 3R TREATMENTS		POOR / 53

Note: Parking area consists of multiple surface types: 1 part Asphalt at 22,790 square feet; 3 parts Concrete at 3,048 square feet.
