ALPO Cycle 6

Final Report

Road Inventory and Condition Assessment of Paved Routes Allegheny Portage Railroad National Historic Site

Report Date: September 2021

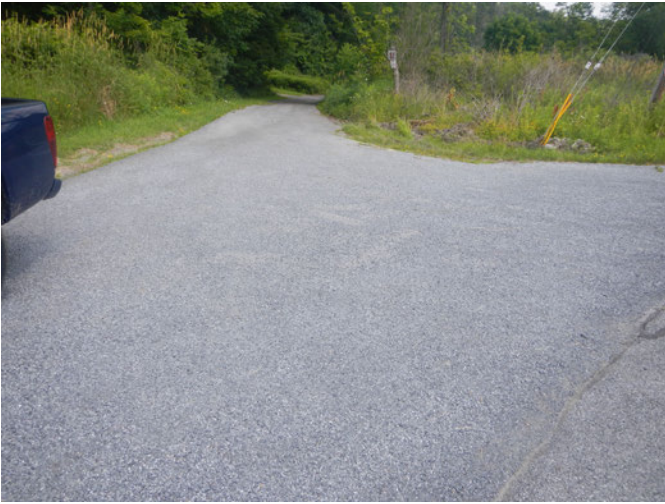
ALPO_0402_0.000.JPG

Inspection Date: 6/28/2019	Beginning Section MP	0.00				
Paved Length (Miles): 0.19	Section Length (MI)	0.19				
Surface Type: ASPHALT	Route Summary					
Roadway Condition Information						
Pavement Condition Rating (PCR)	90	90				
Surface Condition Rating (SCR)	90	90				
Roughness Condition Index (RCI)	N/A	N/A				
Distress Index Values						
Structural Crack Index	N/A	N/A				
Alligator Crack Index	90	90				
Longitudinal Crack Index	90	90				
Transverse Cracking Index	90	90				
Patching Index	97	97				
Rutting Index	90	90				
International Roughness Index (IRI)	N/A	N/A				
Lane & Width Information						
Number of Lanes	1	1				
Paved Width (ft)	10	10				
Lane Width (ft)	10	10

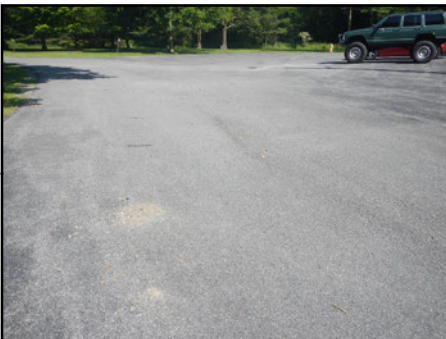
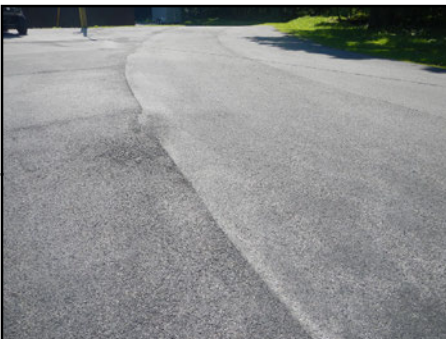
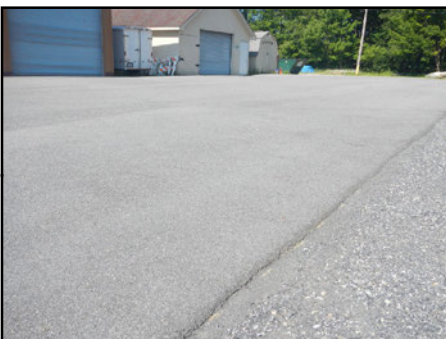
ROUTE 0901: MAINTENANCE PARKING

Inspection Date	FMSS Number	User Access	Surface Type
6/28/2019	16304	NONPUBLIC	ASPHALT
Area (Sq. Ft.)	Lane Miles (11' Widths)	Curb Reveal (Inches)	Curb Recommendation
38,121	0.656	NOT APPLICABLE	NOT APPLICABLE
Curb Type		Curb & Gutter Type	
NO CURB		NO CURB AND GUTTER	
Pavement Recommendation		Condition Rating / PCR	
LIGHT 3R TREATMENTS		FAIR / 73

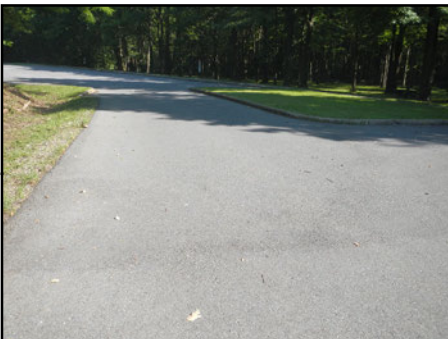
ROUTE 0903: SUMMIT PICNIC AREA PARKING

Inspection Date	FMSS Number	User Access	Surface Type
6/28/2019	16282	PUBLIC	ASPHALT
Area (Sq. Ft.)	Lane Miles (11' Widths)	Curb Reveal (Inches)	Curb Recommendation
42,126	0.725	6	MODERATE REPAIR
Curb Type		Curb & Gutter Type	
CONCRETE		NO CURB AND GUTTER	
Pavement Recommendation		Condition Rating / PCR	
PREVENTIVE MAINTENANCE		GOOD / 90

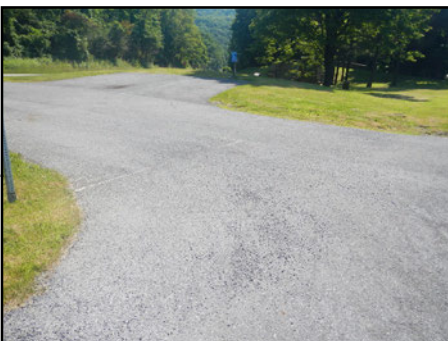
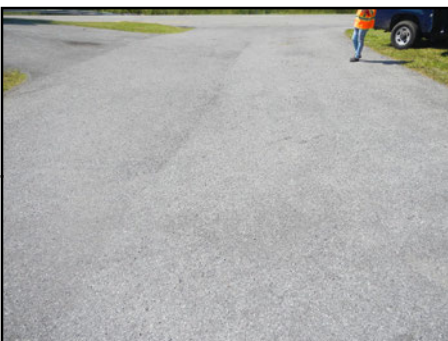
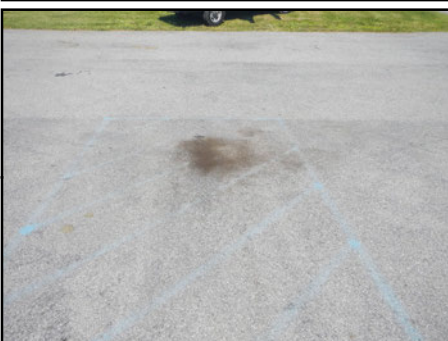
ROUTE 0904: SKEW ARCH BRIDGE PARKING

Inspection Date	FMSS Number	User Access	Surface Type
6/28/2019	236932	PUBLIC	ASPHALT
Area (Sq. Ft.)	Lane Miles (11' Widths)	Curb Reveal (Inches)	Curb Recommendation
2,432	0.042	NOT APPLICABLE	NOT APPLICABLE
Curb Type		Curb & Gutter Type	
NO CURB		NO CURB AND GUTTER	
Pavement Recommendation		Condition Rating / PCR	
LIGHT 3R TREATMENTS		FAIR / 73

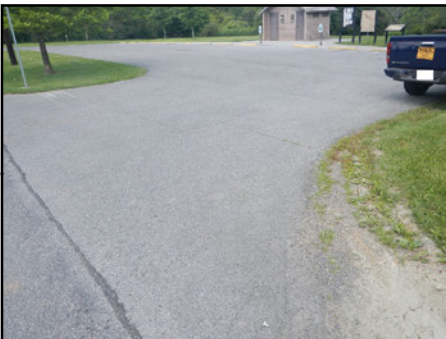
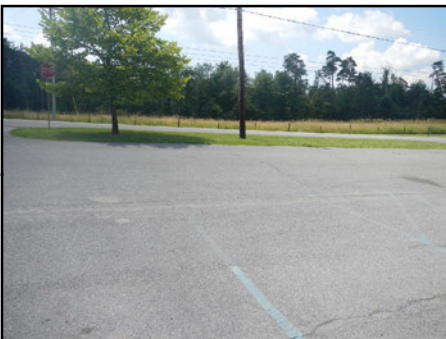
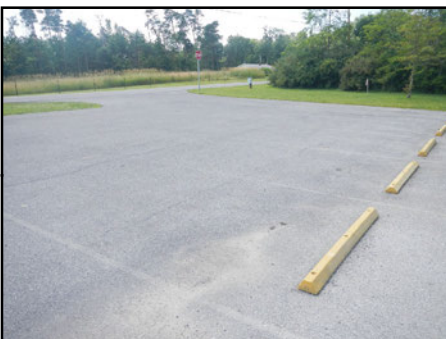
ROUTE 0905: 6-10 COMFORT STATION PARKING

Inspection Date	FMSS Number	User Access	Surface Type
6/28/2019	236934	PUBLIC	ASPHALT
Area (Sq. Ft.)	Lane Miles (11' Widths)	Curb Reveal (Inches)	Curb Recommendation
7,295	0.126	NOT APPLICABLE	NOT APPLICABLE
Curb Type		Curb & Gutter Type	
NO CURB		NO CURB AND GUTTER	
Pavement Recommendation		Condition Rating / PCR	
HEAVY 3R TREATMENTS		POOR / 53

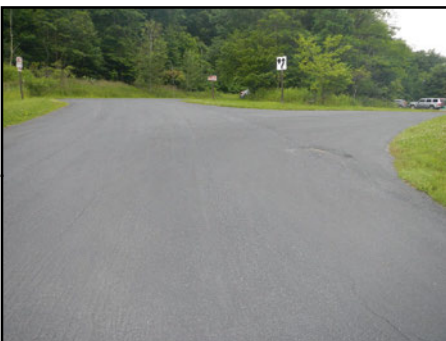
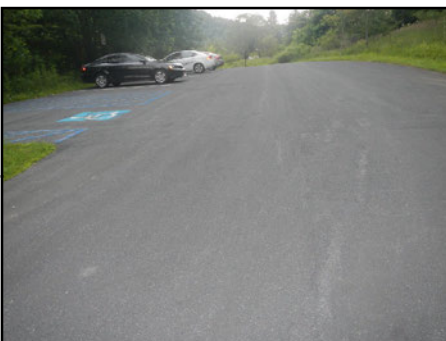
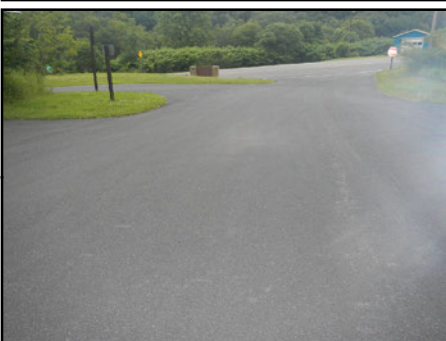
ROUTE 0906: STAPLE BEND PARKING

Inspection Date	FMSS Number	User Access	Surface Type
6/28/2019	16255	PUBLIC	ASPHALT
Area (Sq. Ft.)	Lane Miles (11' Widths)	Curb Reveal (Inches)	Curb Recommendation
16,777	0.289	6	DO NOTHING
Curb Type		Curb & Gutter Type	
STONE		NO CURB AND GUTTER	
Pavement Recommendation		Condition Rating / PCR	
PREVENTIVE MAINTENANCE		GOOD / 90

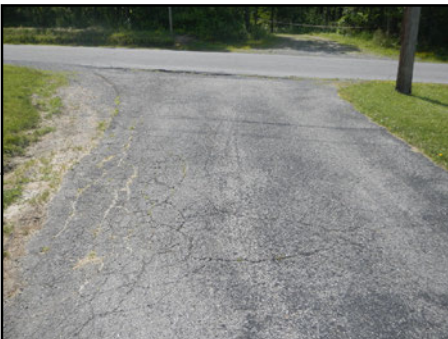
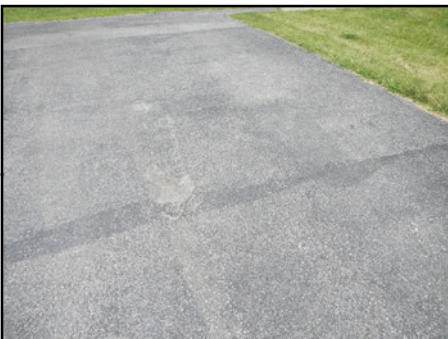
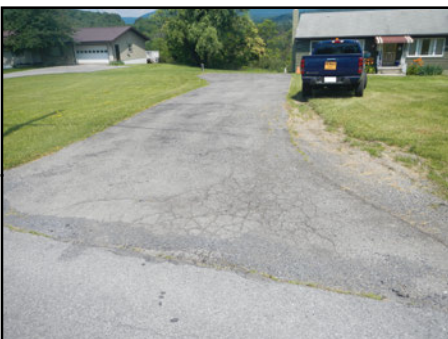
ROUTE 0907: RANGER STATION PARKING

Inspection Date	FMSS Number	User Access	Surface Type
6/28/2019		NONPUBLIC	ASPHALT
Area (Sq. Ft.)	Lane Miles (11' Widths)	Curb Reveal (Inches)	Curb Recommendation
1,712	0.029	NOT APPLICABLE	NOT APPLICABLE
Curb Type		Curb & Gutter Type	
NO CURB		NO CURB AND GUTTER	
Pavement Recommendation		Condition Rating / PCR	
LIGHT 3R TREATMENTS		FAIR / 73

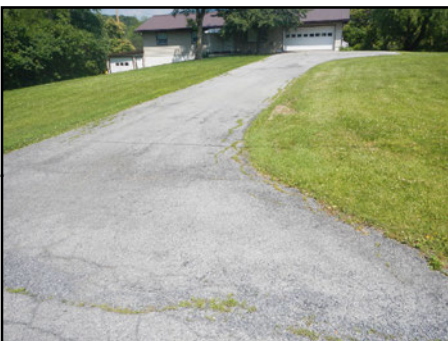
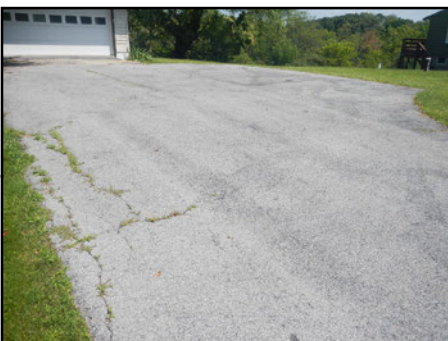
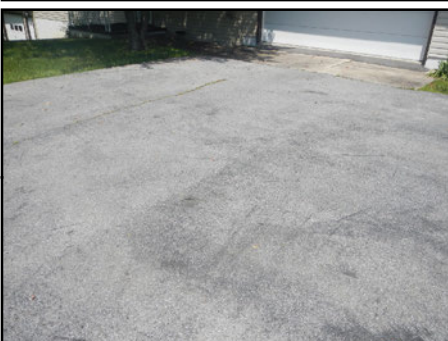
ROUTE 0908: SEASONAL QUARTERS PARKING

Inspection Date	FMSS Number	User Access	Surface Type
6/28/2019		NONPUBLIC	ASPHALT
Area (Sq. Ft.)	Lane Miles (11' Widths)	Curb Reveal (Inches)	Curb Recommendation
2,132	0.037	NOT APPLICABLE	NOT APPLICABLE
Curb Type		Curb & Gutter Type	
NO CURB		NO CURB AND GUTTER	
Pavement Recommendation		Condition Rating / PCR	
LIGHT 3R TREATMENTS		FAIR / 73

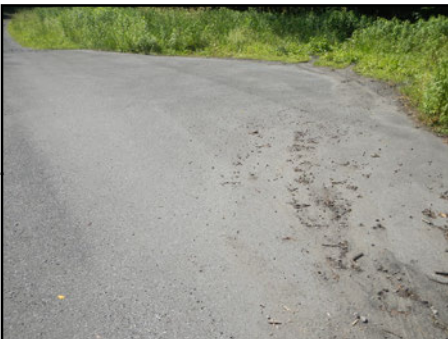
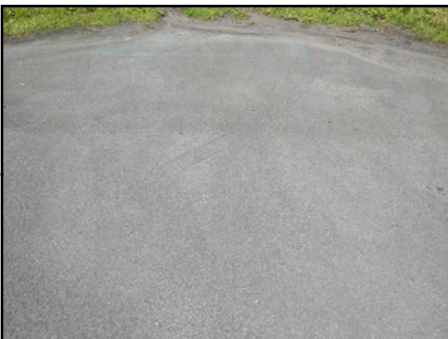
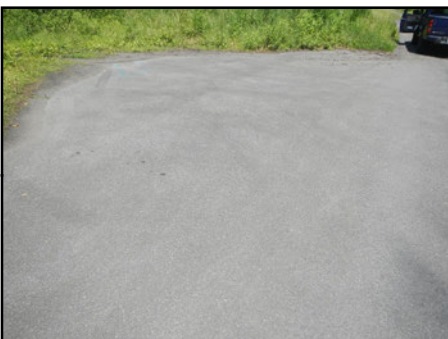
ROUTE 0909: HANDICAP PARKING

Inspection Date	FMSS Number	User Access	Surface Type
6/28/2019		PUBLIC	ASPHALT
Area (Sq. Ft.)	Lane Miles (11' Widths)	Curb Reveal (Inches)	Curb Recommendation
409	0.007	NOT APPLICABLE	NOT APPLICABLE
Curb Type		Curb & Gutter Type	
NO CURB		NO CURB AND GUTTER	
Pavement Recommendation		Condition Rating / PCR	
PREVENTIVE MAINTENANCE		GOOD / 90
