Final Report

Road Inventory and Condition Assessment of Paved Routes Andersonville National Historic Site

**Federal Highway Administration
Eastern Federal Lands Highway Division
Road Inventory Program (RIP)**

Report Date: October 2021

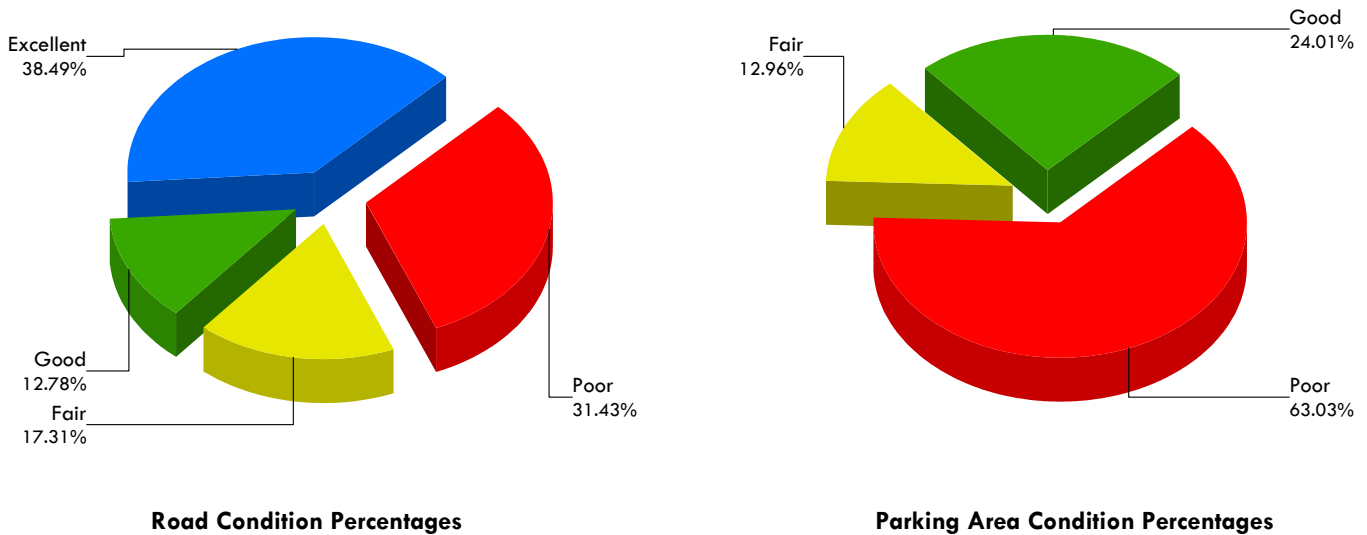
Figure 1: Pavement Condition Rating Breakdown for Paved Roads and Parking Areas

Parkwide Condition Percentages

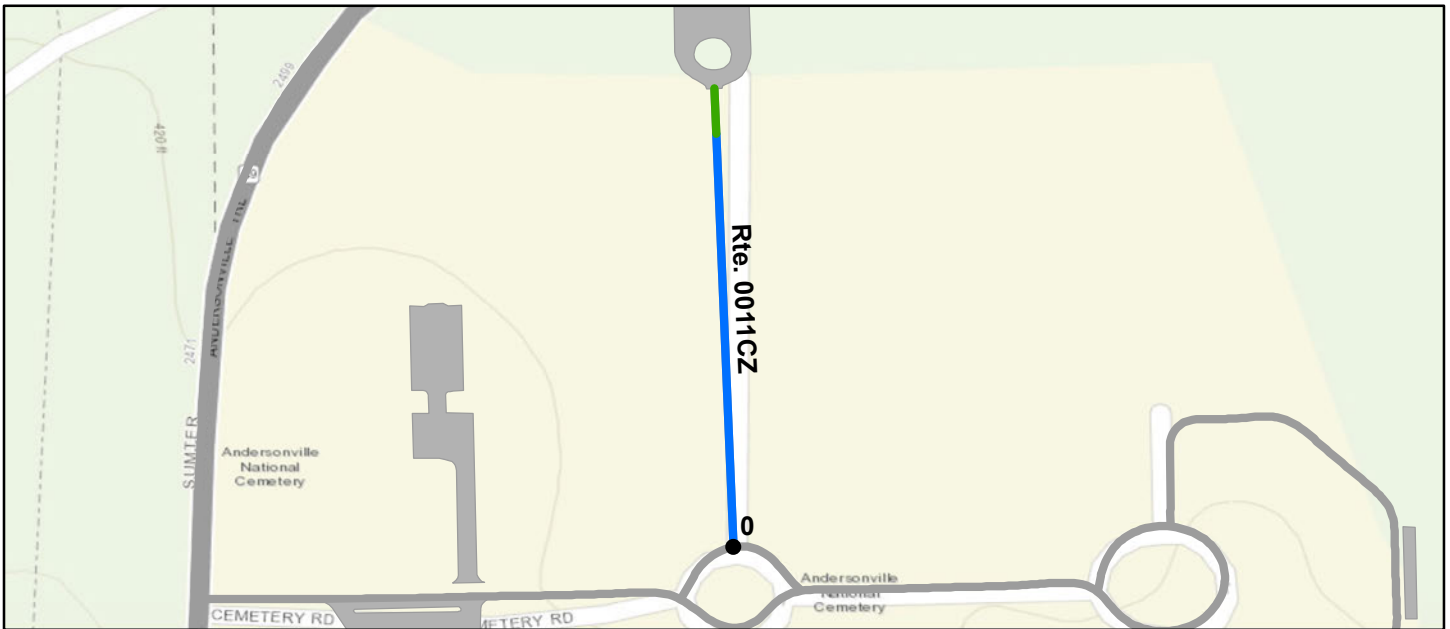
Inspection Date: 2/7/2021	Beginning Section MP	0				
Paved Length (Miles): 0.11	Section Length (MI)	0.11				
Surface Type: ASPHALT	Route Summary					
Roadway Condition Information						
Pavement Condition Rating (PCR)	95	95				
Surface Condition Rating (SCR)	95	95				
Roughness Condition Index (RCI)	N/A	N/A				
Distress Index Values						
Structural Crack Index	98	98				
Alligator Crack Index	100	100				
Longitudinal Crack Index	98	98				
Transverse Cracking Index	95	95				
Patching Index	100	100				
Rutting Index	100	100				
International Roughness Index (IRI)	N/A	N/A				
Lane & Width Information						
Number of Lanes	2	2				
Paved Width (ft)	19.7	19.7				
Lane Width (ft)	9.8	9.8

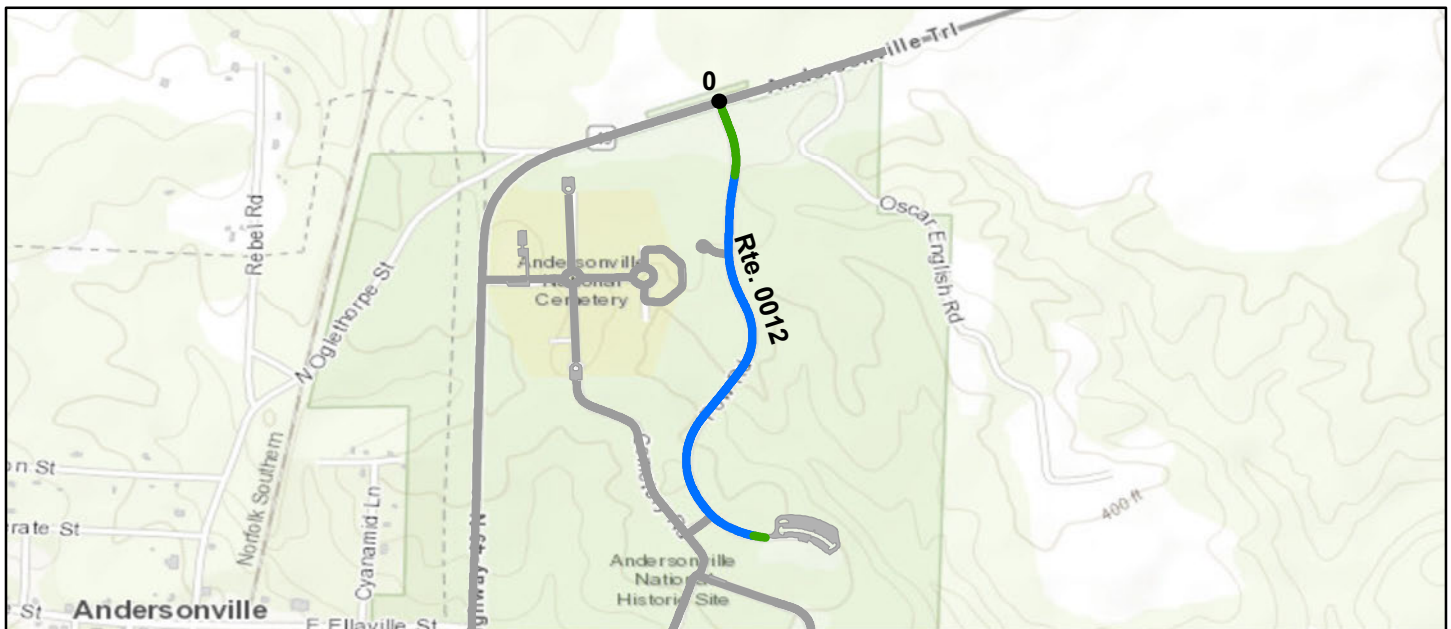
ROUTE 0012: P.O.W. ROAD

Inspection Date: 2/7/2021	Beginning Section MP	0				
Paved Length (Miles): 0.71	Section Length (MI)	0.71				
Surface Type: ASPHALT	Route Summary					
Roadway Condition Information						
Pavement Condition Rating (PCR)	97	97				
Surface Condition Rating (SCR)	95	95				
Roughness Condition Index (RCI)	100	100				
Distress Index Values						
Structural Crack Index	100	100				
Alligator Crack Index	100	100				
Longitudinal Crack Index	100	100				
Transverse Cracking Index	95	95				
Patching Index	100	100				
Rutting Index	100	100				
International Roughness Index (IRI)	100	100				
Lane & Width Information						
Number of Lanes	2	2				
Paved Width (ft)	23.2	23.2				
Lane Width (ft)	11.1	11.1

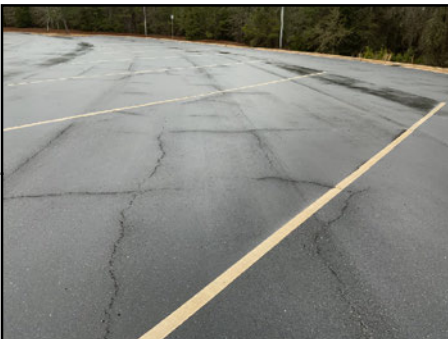
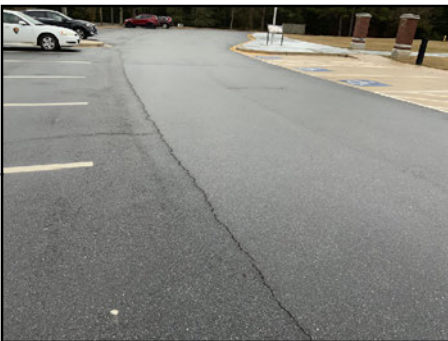
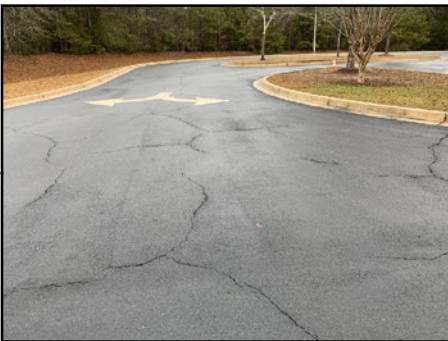
Inspection Date	FMSS Number	User Access	Surface Type
2/6/2021	80636	PUBLIC	ASPHALT
Area (Sq. Ft.)	Lane Miles (11' Widths)	Curb Reveal (Inches)	Curb Recommendation
66,318	1.142	NOT APPLICABLE	DO NOTHING
Curb Type		Curb & Gutter Type	
NO CURB		CONCRETE	
Pavement Recommendation		Condition Rating / PCR	
HEAVY 3R TREATMENTS		POOR / 53

Multiple Surface Types: Asphalt = 65,058 sq ft; Concrete = 1,260 sq ft.

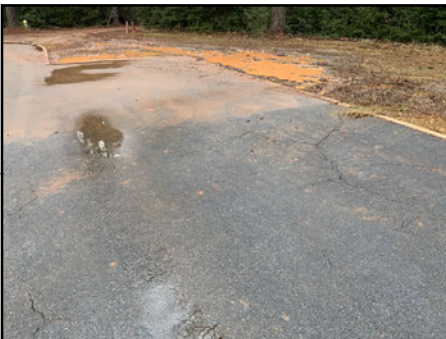
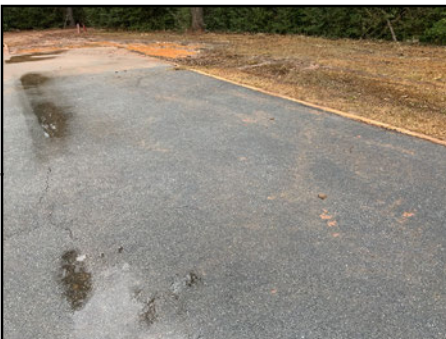
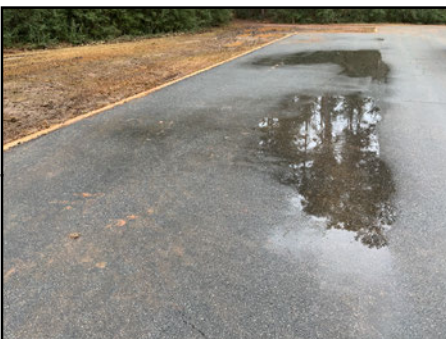
ROUTE 0902: ROSTRUM PARKING

Inspection Date	FMSS Number	User Access	Surface Type
2/6/2021	80638	PUBLIC	ASPHALT
Area (Sq. Ft.)	Lane Miles (11' Widths)	Curb Reveal (Inches)	Curb Recommendation
1,561	0.027	0	LIGHT REPAIR
Curb Type		Curb & Gutter Type	
CONCRETE		NO CURB AND GUTTER	
Pavement Recommendation		Condition Rating / PCR	
PREVENTIVE MAINTENANCE		GOOD / 90

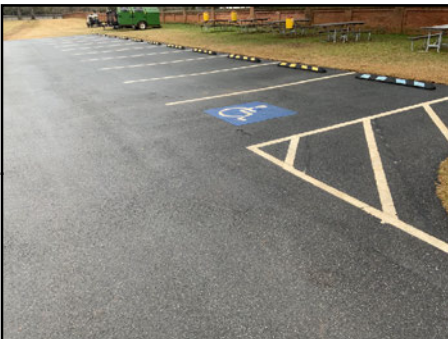
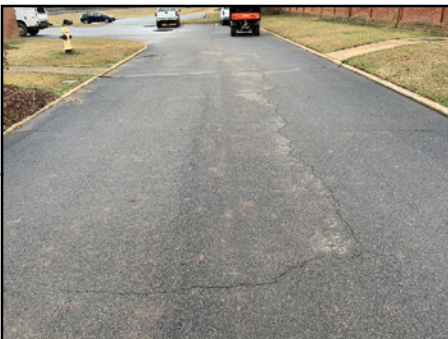
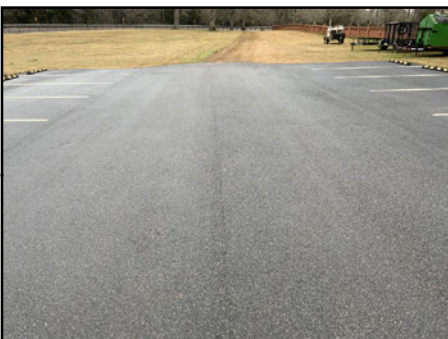
ROUTE 0903: EMPLOYEE PARKING

Inspection Date	FMSS Number	User Access	Surface Type
2/6/2021	80639	NONPUBLIC	ASPHALT
Area (Sq. Ft.)	Lane Miles (11' Widths)	Curb Reveal (Inches)	Curb Recommendation
14,182	0.244	2	LIGHT REPAIR
Curb Type		Curb & Gutter Type	
CONCRETE		NO CURB AND GUTTER	
Pavement Recommendation		Condition Rating / PCR	
PREVENTIVE MAINTENANCE		GOOD / 90

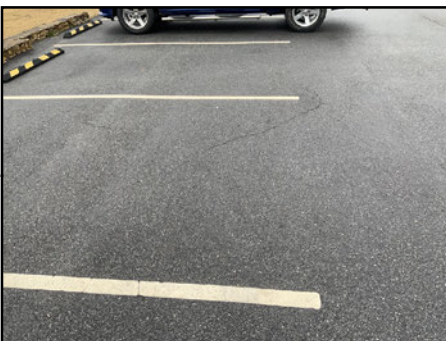
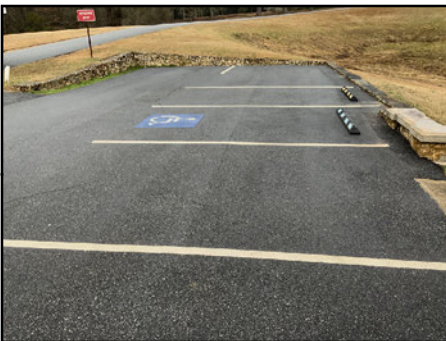
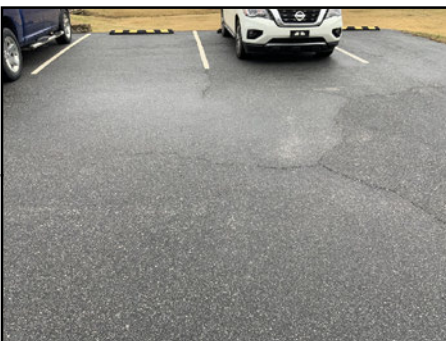
ROUTE 0907: SPRING HOUSE PARKING

Route No.	FMSS No.	Route Name	User Access	Surf. Type	Area (Sq. Ft.)	Pavement Condition Rating (PCR)	<u>Asphalt Surface Distresses</u>					<u>Concrete Surface Distresses</u>						
							Alligator Cracking	Longitudinal / Transverse Cracking	Rutting / Distortions	Potholes / Patching	HMA Patching	Surface Raveling / Bleeding	Joint Faulting	Slab Cracking	Joint Distresses	Delamination / Pop-Outs	Potholes / Patching	
ANDE-0901	80636	P.O.W. MUSEUM PARKING	PUBLIC	AS	66,318	53	90	53	97	97	97	97						
ANDE-0902	80638	ROSTRUM PARKING	PUBLIC	AS	1,561	90	90	90	97	97	97	97						
ANDE-0903	80639	EMPLOYEE PARKING	NONPUBLIC	AS	14,182	90	90	90	97	97	97	90						
ANDE-0904	80640	CURATORIAL BUILDING PARKING	PUBLIC	AS	6,782	73	73	90	97	97	97	97						
ANDE-0905	80642	NORTH CEMETERY PARKING	PUBLIC	AS	8,771	73	73	90	97	97	97	90						
ANDE-0906	80644	SOUTH CEMETERY PARKING	PUBLIC	AS	9,037	90	97	90	97	97	97	90						
ANDE-0907	80646	SPRING HOUSE PARKING	PUBLIC	AS	4,050	90	97	90	97	97	97	90

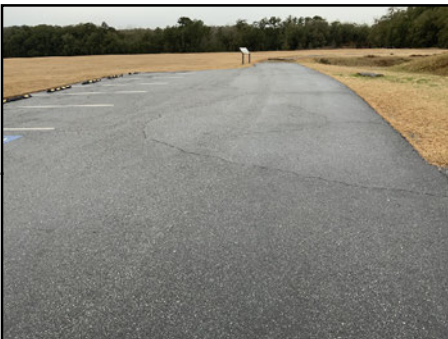
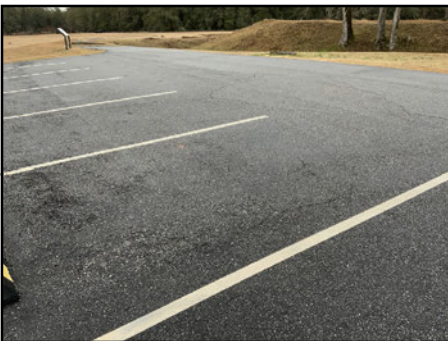
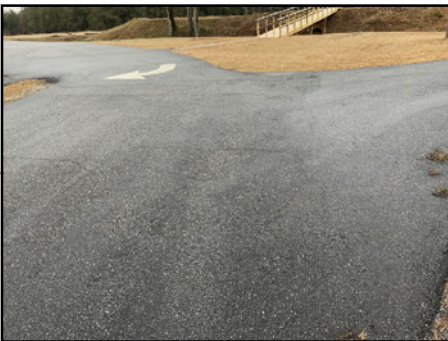
ROUTE 0908: STAR FORT PARKING

ANDE-0908	80648	STAR FORT PARKING	PUBLIC	AS	6,236	53	90	53	97	97	97	73						
ANDE-0911	80653	PRISON PARKING	PUBLIC	AS	3,103	53	97	53	97	97	97	90
