Final Report

Road Inventory and Condition Assessment of Paved Routes Antietam National Battlefield

**Federal Lands Highway
Road Inventory Program**

Report Date: January 2019

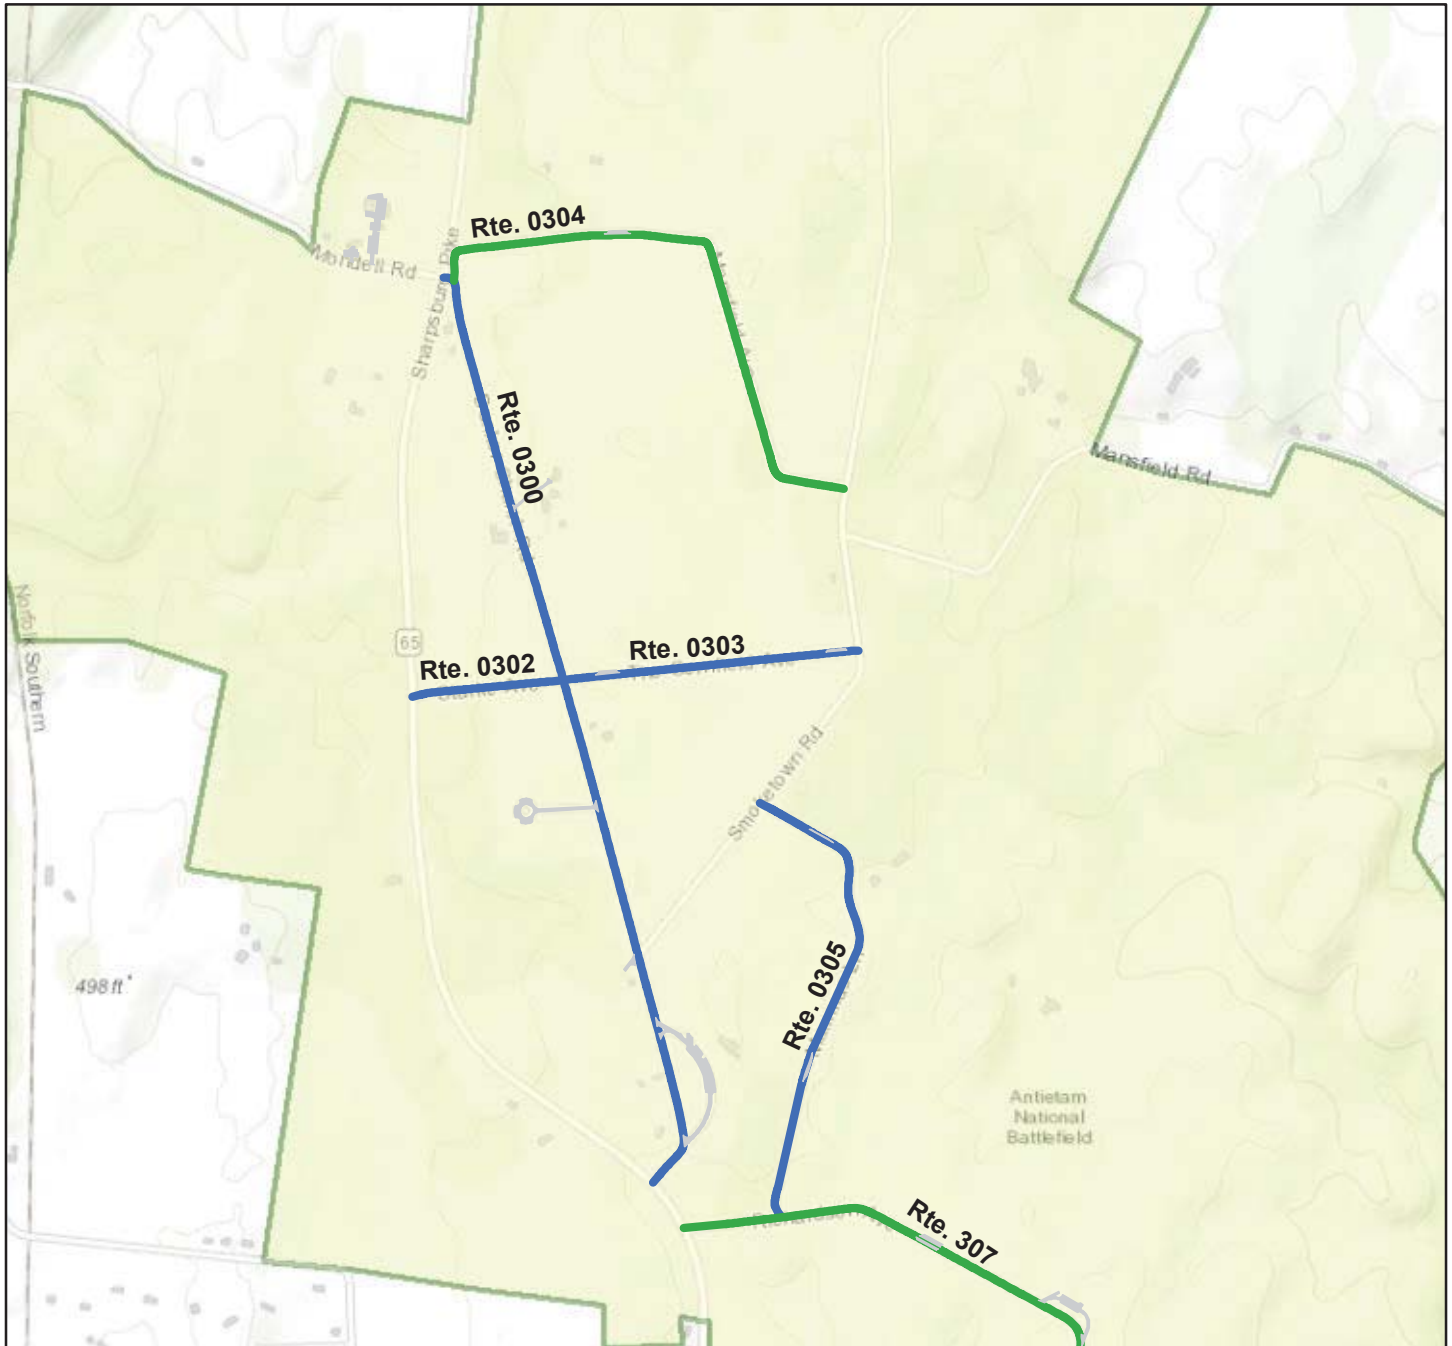
Area Map 1

Colors on map represent condition scores at 1-mile intervals. See Appendix for definitions and formulas

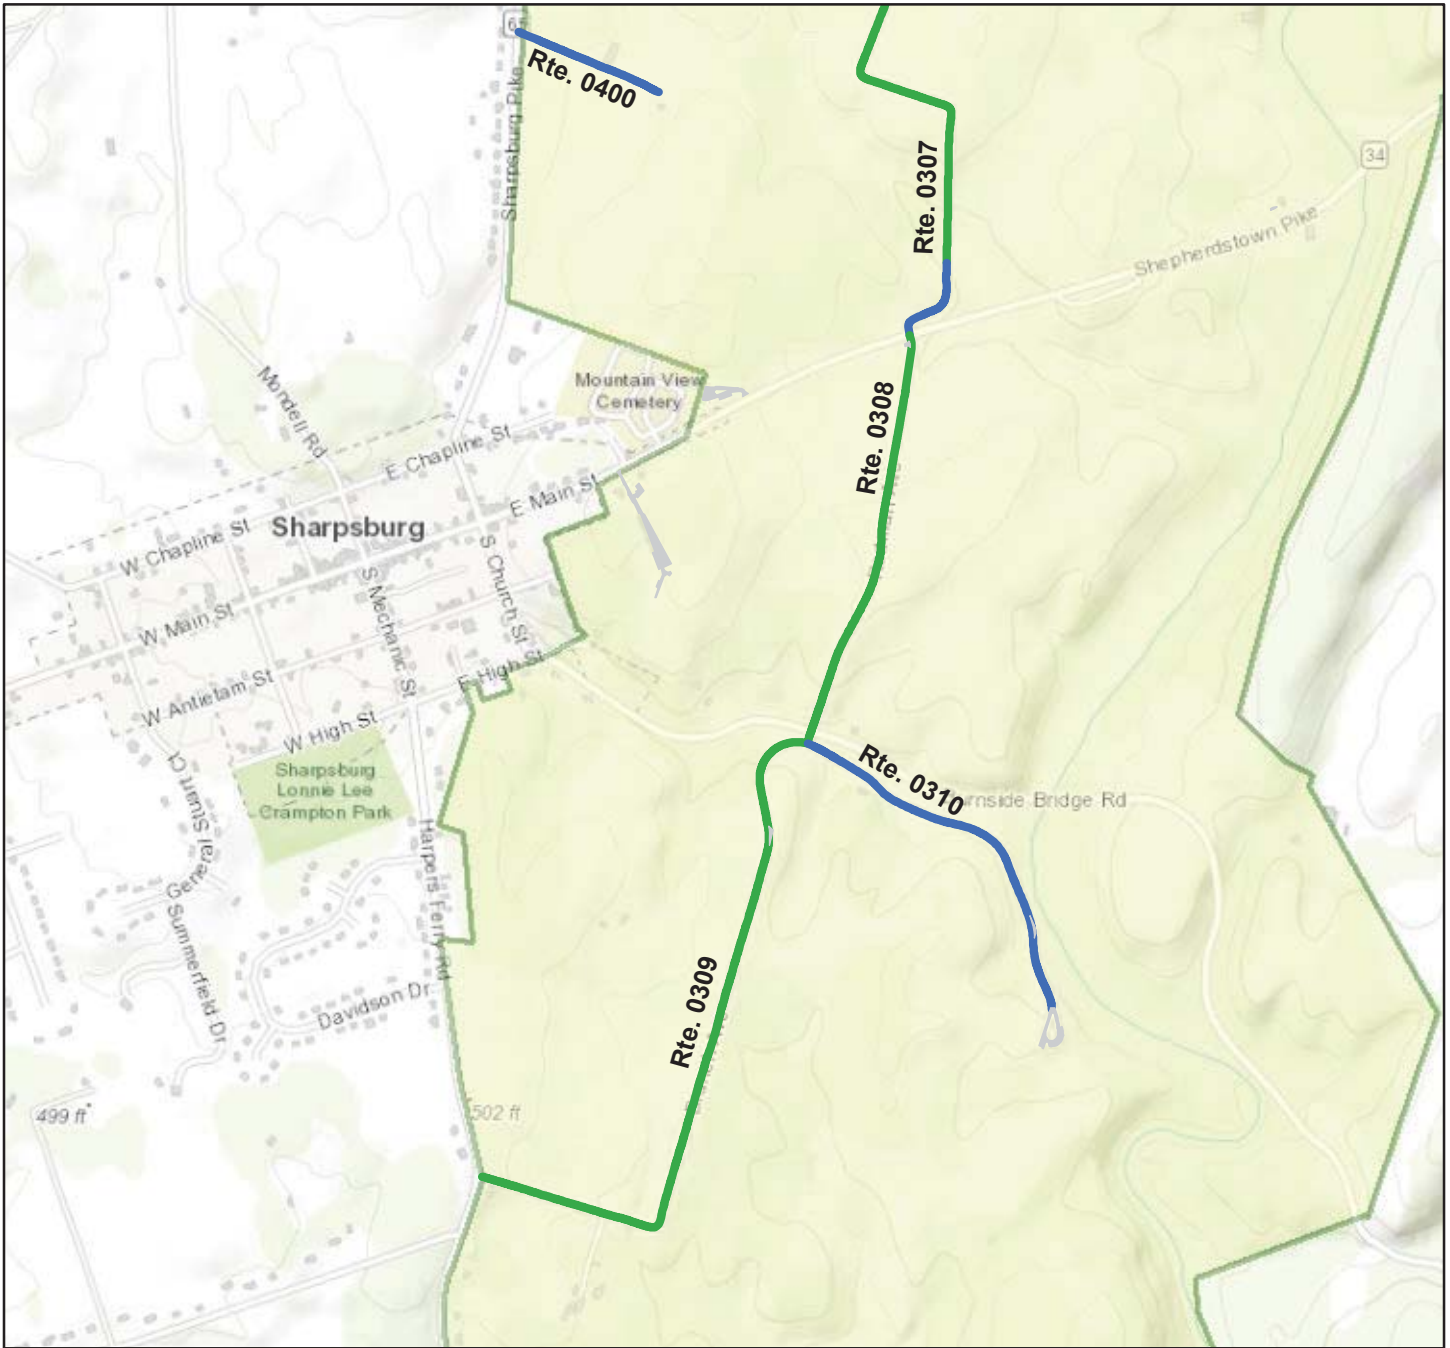
Area Map 2

Colors on map represent condition scores at 1-mile intervals. See Appendix for definitions and formulas
 Only Data Collection Vehicle and Manually Rated Roads are displayed

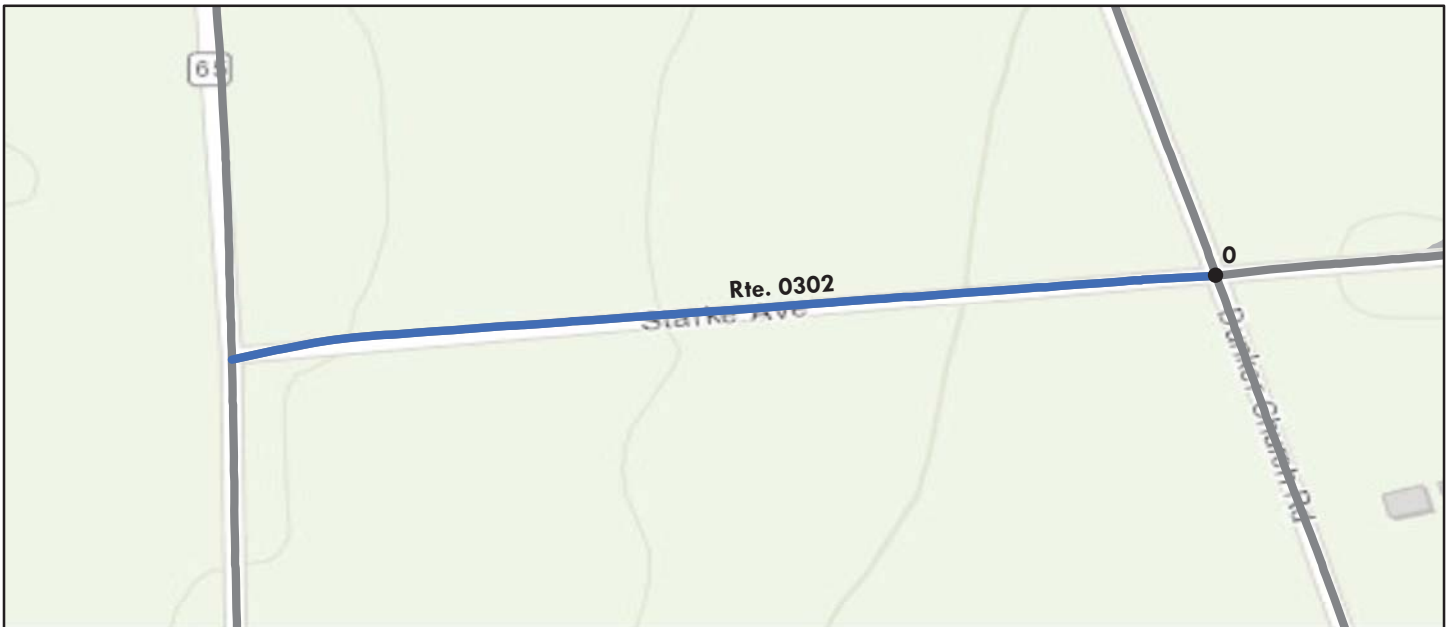
Data Collection Vehicle (DCV) Rating

Colors on map represent condition scores at 0.10-mile intervals. See Appendix for definitions and formulas.

Inspection Date: 3/26/2018	Beginning Section MP	0				
Paved Length (Miles): 0.18	Section Length (MI)	0.18				
Surface Type: ASPHALT	Route Summary					
Roadway Condition Information						
Pavement Condition Rating (PCR)	98	98				
Surface Condition Rating (SCR)	98	98				
Roughness Condition Index (RCI)	N/A	N/A				
Distress Index Values						
Structural Crack Index	100	100				
Alligator Crack Index	100	100				
Longitudinal Crack Index	100	100				
Transverse Cracking Index	98	98				
Patching Index	100	100				
Rutting Index	100	100				
International Roughness Index (IRI)	N/A	N/A				
Lane & Width Information						
Number of Lanes	2	2				
Paved Width (ft)	17.8	17.8				
Lane Width (ft)	8.4	8.4

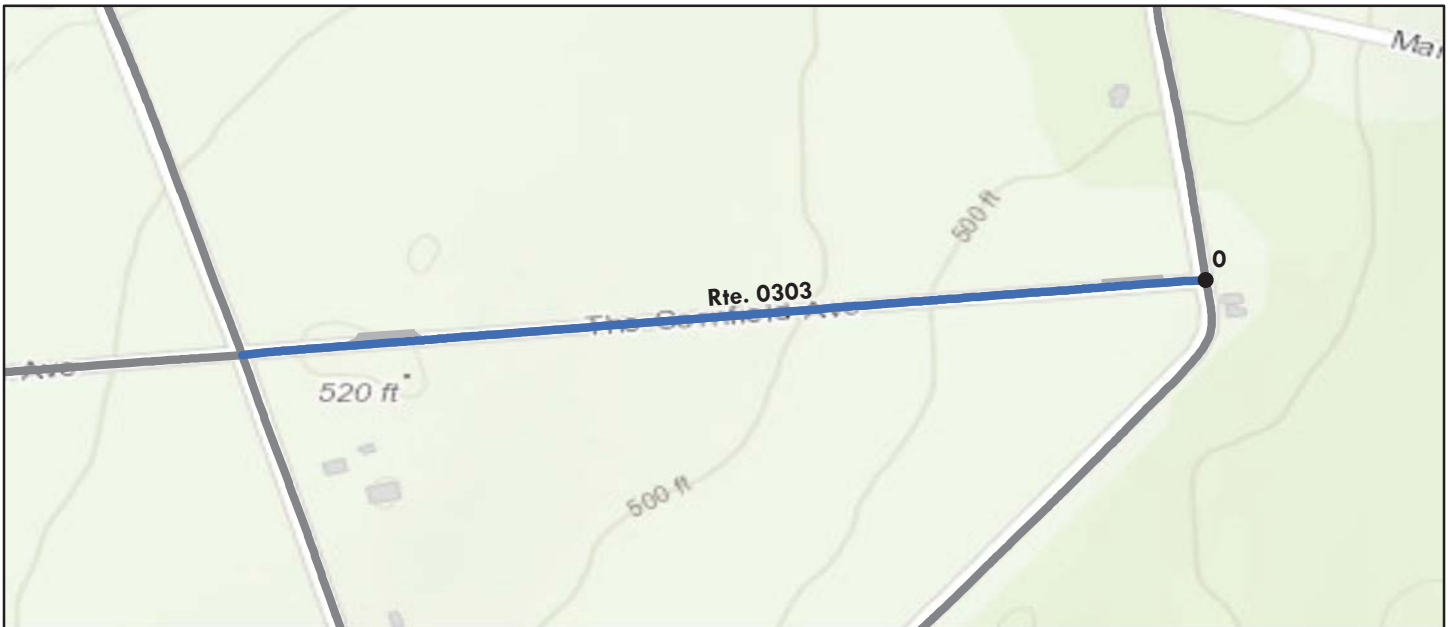
Data Collection Vehicle (DCV) Rating

Colors on map represent condition scores at 0.10-mile intervals. See Appendix for definitions and formulas.

Inspection Date: 3/26/2018	Beginning Section MP	0				
Paved Length (Miles): 0.36	Section Length (MI)	0.36				
Surface Type: ASPHALT	Route Summary					
Roadway Condition Information						
Pavement Condition Rating (PCR)	100	100				
Surface Condition Rating (SCR)	100	100				
Roughness Condition Index (RCI)	N/A	N/A				
Distress Index Values						
Structural Crack Index	100	100				
Alligator Crack Index	100	100				
Longitudinal Crack Index	100	100				
Transverse Cracking Index	100	100				
Patching Index	100	100				
Rutting Index	100	100				
International Roughness Index (IRI)	N/A	N/A				
Lane & Width Information						
Number of Lanes	2	2				
Paved Width (ft)	17.5	17.5				
Lane Width (ft)	9.1	9.1

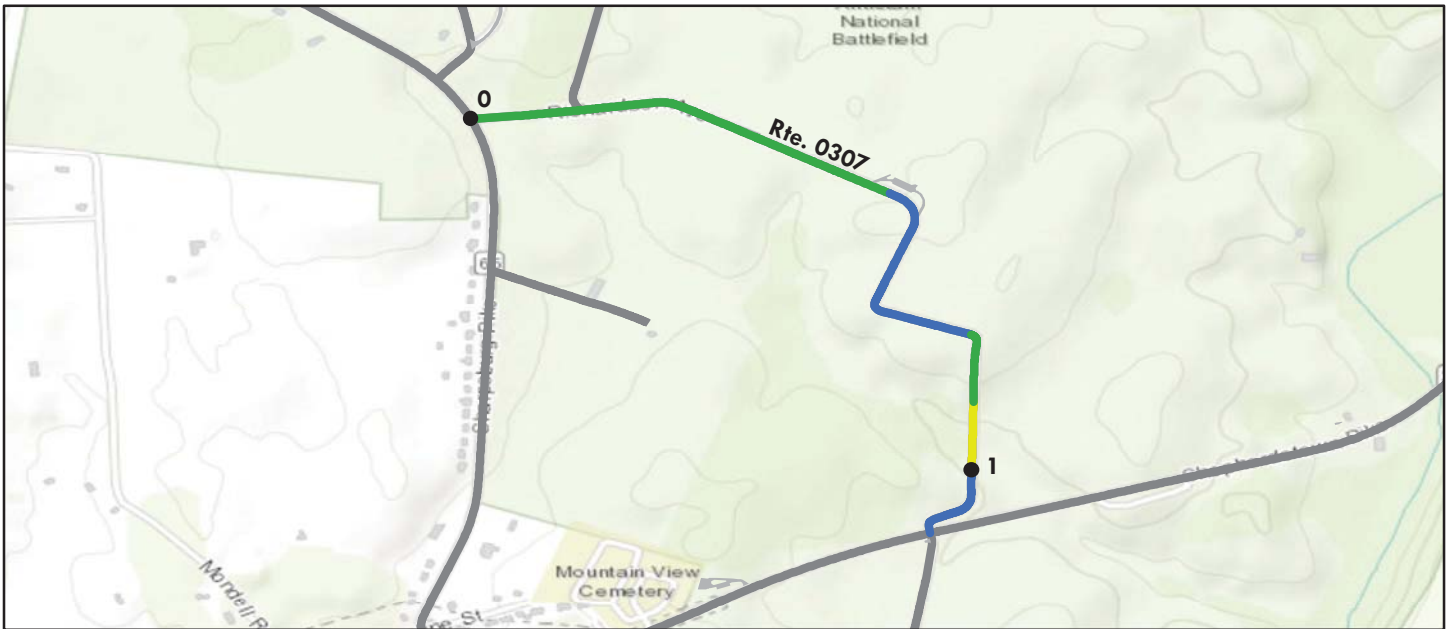
Data Collection Vehicle (DCV) Rating

Colors on map represent condition scores at 0.10-mile intervals. See Appendix for definitions and formulas.

Inspection Date:	3/26/2018	Beginning Section MP	0	1			
Paved Length (Miles):	1.11	Section Length (MI)	1	0.11			
Surface Type:	ASPHALT	Route Summary					
Roadway Condition Information							
Pavement Condition Rating (PCR)	91	91	100				
Surface Condition Rating (SCR)	99	99	100				
Roughness Condition Index (RCI)	80	80	N/A				
Distress Index Values							
Structural Crack Index	100	100	100				
Alligator Crack Index	100	100	100				
Longitudinal Crack Index	100	100	100				
Transverse Cracking Index	100	100	100				
Patching Index	100	100	100				
Rutting Index	99	99	100				
International Roughness Index (IRI)	168	170	N/A				
Lane & Width Information							
Number of Lanes	2	2	1				
Paved Width (ft)	17.5	17.7	16.1				
Lane Width (ft)	12.2	11.7	16.1

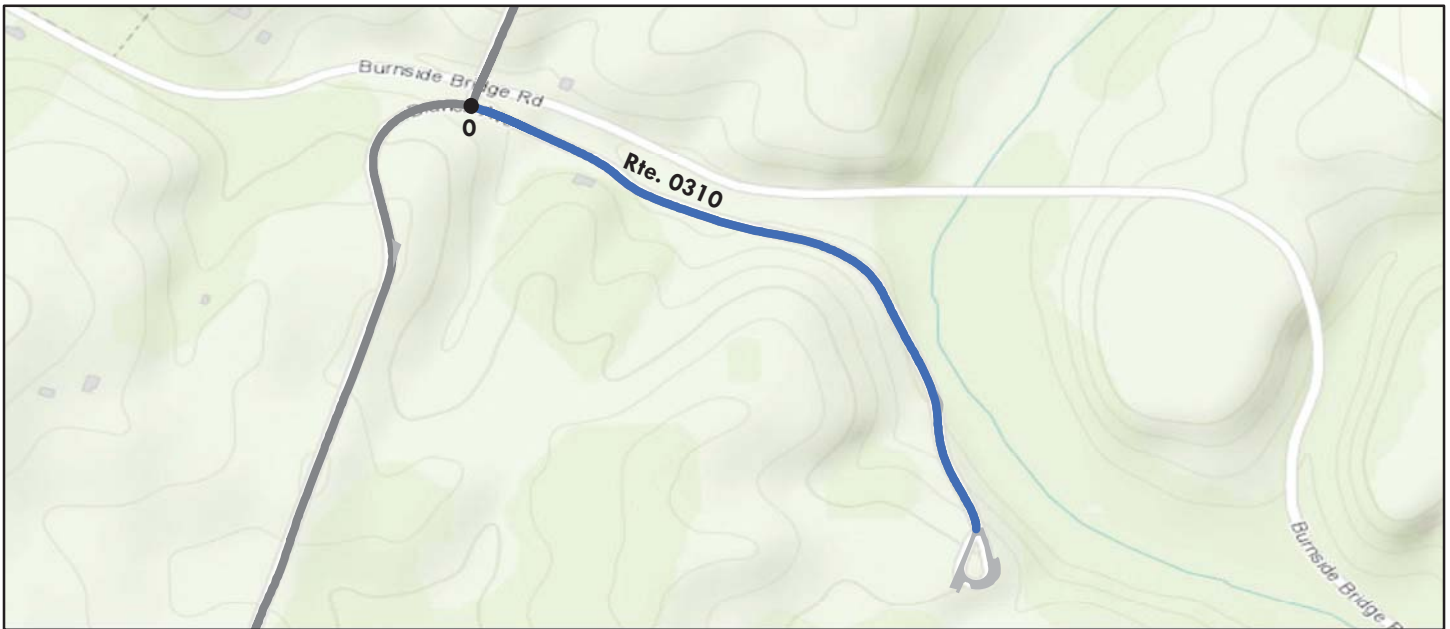
Data Collection Vehicle (DCV) Rating

Route Condition Legend – Pavement Condition Rating (PCR)						
Poor (0 - 60)	Fair (61- 84)	Good (85 - 94)	Excellent (95 - 100)	Not Rated		
Colors on map represent condition scores at 0.10-mile intervals. See Appendix for definitions and formulas.						
Inspection Date:	3/26/2018	Beginning Section MP	0			
Paved Length (Miles):	0.49	Section Length (MI)	0.49			
Surface Type:	ASPHALT	Route Summary				
Roadway Condition Information						
Pavement Condition Rating (PCR)	99	99				
Surface Condition Rating (SCR)	99	99				
Roughness Condition Index (RCI)	N/A	N/A				
Distress Index Values						
Structural Crack Index	100	100				
Alligator Crack Index	100	100				
Longitudinal Crack Index	100	100				
Transverse Cracking Index	100	100				
Patching Index	100	100				
Rutting Index	99	99				
International Roughness Index (IRI)	N/A	N/A				
Lane & Width Information						
Number of Lanes	2	2				
Paved Width (ft)	18.8	18.8				
Lane Width (ft)	9.3	9.3

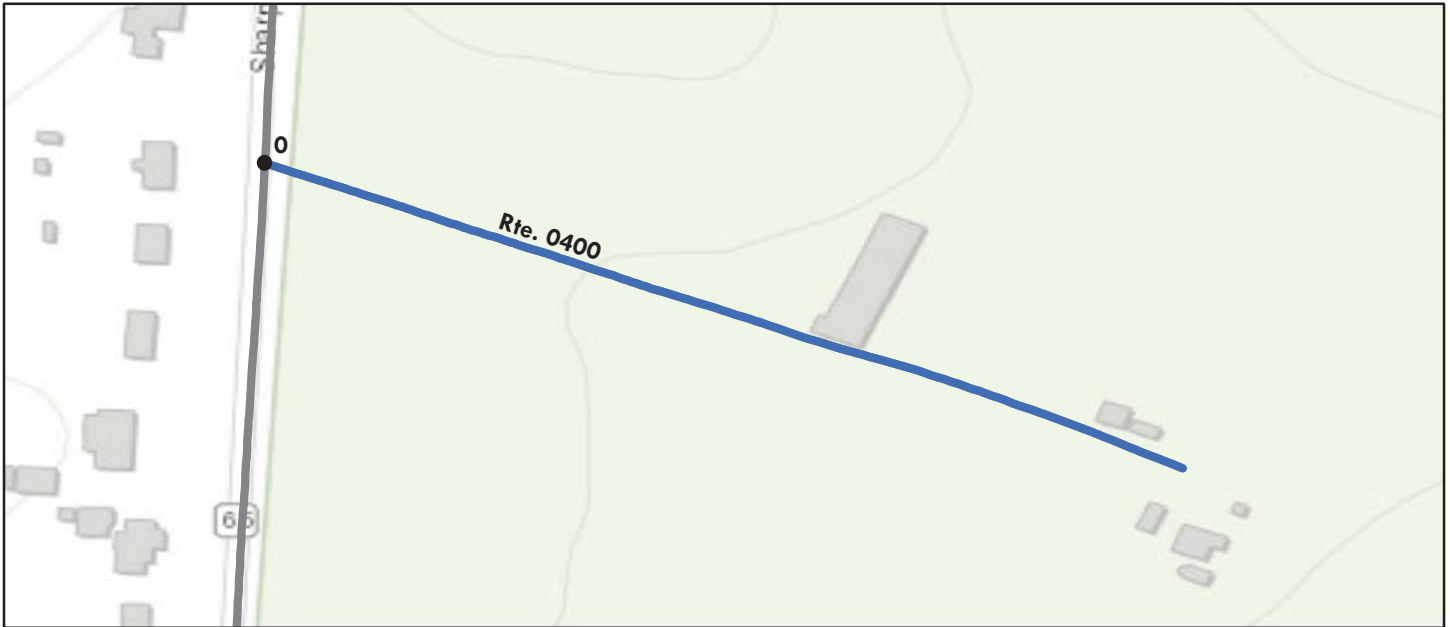
Data Collection Vehicle (DCV) Rating

Route Condition Legend – Pavement Condition Rating (PCR)						
Poor (0 - 60)	Fair (61- 84)	Good (85 - 94)	Excellent (95 - 100)	Not Rated		
Colors on map represent condition scores at 0.10-mile intervals. See Appendix for definitions and formulas.						
Inspection Date: 3/26/2018	Beginning Section MP	0				
Paved Length (Miles): 0.19	Section Length (MI)	0.19				
Surface Type: ASPHALT	Route Summary					
Roadway Condition Information						
Pavement Condition Rating (PCR)	98	98				
Surface Condition Rating (SCR)	98	98				
Roughness Condition Index (RCI)	N/A	N/A				
Distress Index Values						
Structural Crack Index	100	100				
Alligator Crack Index	100	100				
Longitudinal Crack Index	100	100				
Transverse Cracking Index	98	98				
Patching Index	100	100				
Rutting Index	100	100				
International Roughness Index (IRI)	N/A	N/A				
Lane & Width Information						
Number of Lanes	1	1				
Paved Width (ft)	14.1	14.1
