# APCO Cycle 6

## Final Report

### Road Inventory and Condition Assessment of Paved Routes Appomattox Court House National Historical Park

**Report Date: September 2020**

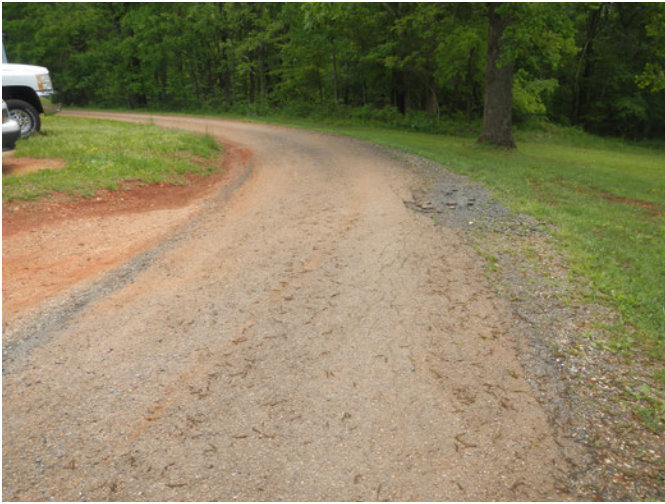
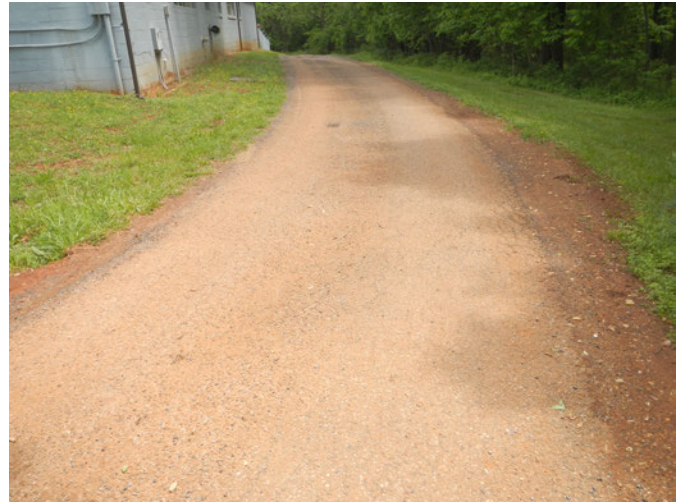
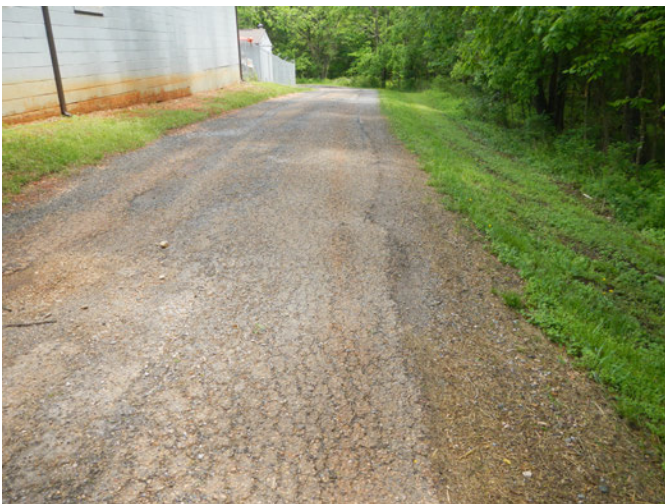
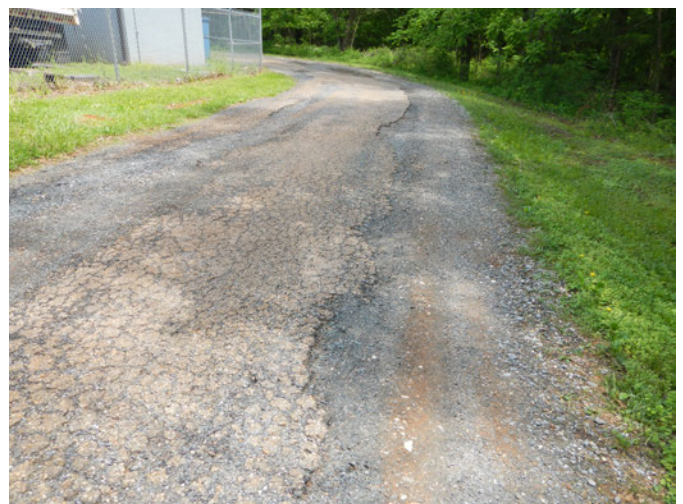
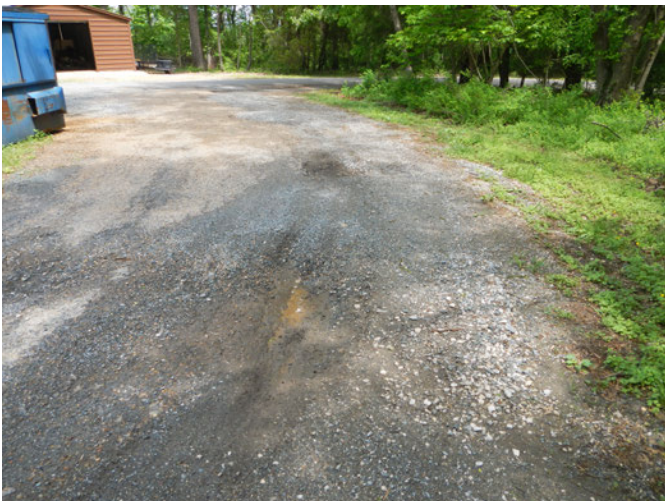
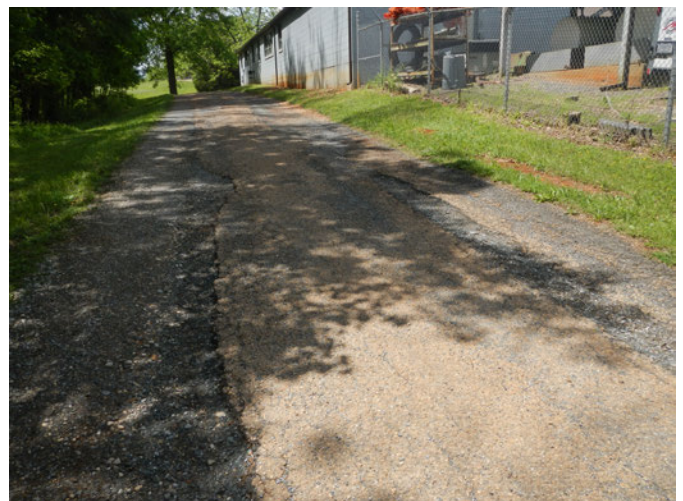
## ROUTE 0408: MAINTENANCE AREA BYPASS ROAD

Route Condition Legend – Pavement Condition Rating (PCR)						
Poor (0 - 60)	Fair (61- 84)	Good (85 - 94)	Excellent (95 - 100)	Not Rated		
See Appendix for definitions and formulas						
<b>Inspection Date:</b> 5/6/2019	<b>Beginning Section MP</b>	0.00				
<b>Paved Length (Miles):</b> 0.07	<b>Section Length (MI)</b>	0.07				
<b>Surface Type:</b> ASPHALT	<b>Route Summary</b>					
<b>Roadway Condition Information</b>						
Pavement Condition Rating (PCR)	30	30				
Surface Condition Rating (SCR)	30	30				
Roughness Condition Index (RCI)	N/A	N/A				
<b>Distress Index Values</b>						
Structural Crack Index	N/A	N/A				
Alligator Crack Index	30	30				
Longitudinal Crack Index	97	97				
Transverse Cracking Index	97	97				
Patching Index	97	97				
Rutting Index	73	73				
International Roughness Index (IRI)	N/A	N/A				
<b>Lane &amp; Width Information</b>						
Number of Lanes	1	1				
Paved Width (ft)	12	12				
Lane Width (ft)	12	12

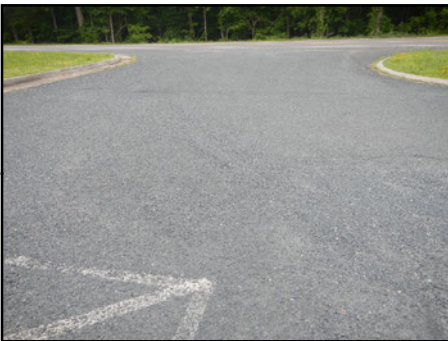
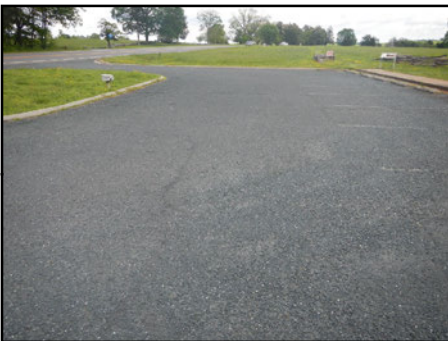
## ROUTE 0901: NORTH CAROLINA MONUMENT PARKING

Inspection Date	FMSS Number	User Access	Surface Type
5/6/2019	30568	PUBLIC	ASPHALT
Area (Sq. Ft.)	Lane Miles (11' Widths)	Curb Reveal (Inches)	Curb Recommendation
7,926	0.136	3	DO NOTHING
Curb Type		Curb & Gutter Type	
CONCRETE		CONCRETE	
Pavement Recommendation		Condition Rating / PCR	
PREVENTIVE MAINTENANCE		GOOD / 90

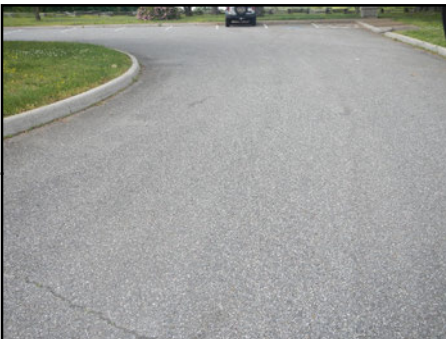
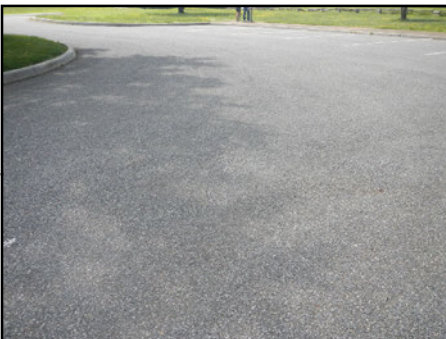
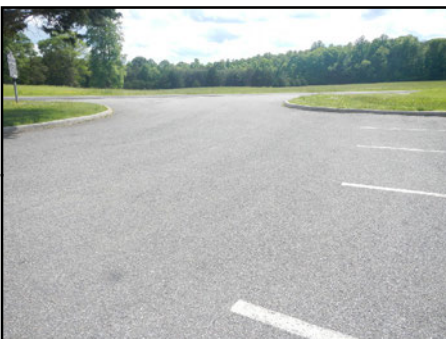
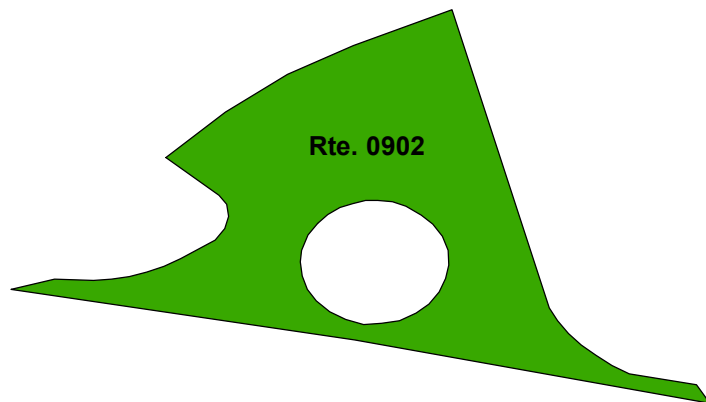
## ROUTE 0902: CONFEDERATE CEMETERY PARKING

Inspection Date	FMSS Number	User Access	Surface Type
5/6/2019	30570	PUBLIC	ASPHALT
Area (Sq. Ft.)	Lane Miles (11' Widths)	Curb Reveal (Inches)	Curb Recommendation
7,593	0.131	5	DO NOTHING
Curb Type		Curb & Gutter Type	
CONCRETE		NO CURB AND GUTTER	
Pavement Recommendation		Condition Rating / PCR	
PREVENTIVE MAINTENANCE		GOOD / 90

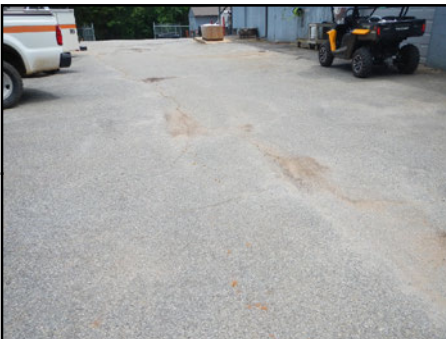
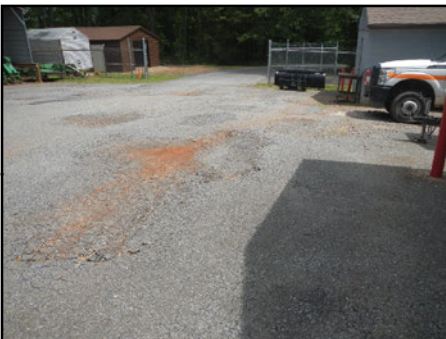
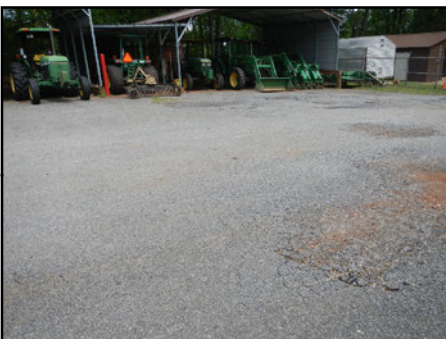
## ROUTE 0903: MAINTENANCE AREA

Inspection Date	FMSS Number	User Access	Surface Type
5/6/2019	51617	NONPUBLIC	ASPHALT
Area (Sq. Ft.)	Lane Miles (11' Widths)	Curb Reveal (Inches)	Curb Recommendation
12,113	0.209	NOT APPLICABLE	NOT APPLICABLE
Curb Type		Curb & Gutter Type	
NO CURB		NO CURB AND GUTTER	
Pavement Recommendation		Condition Rating / PCR	
HEAVY 3R TREATMENTS		POOR / 53

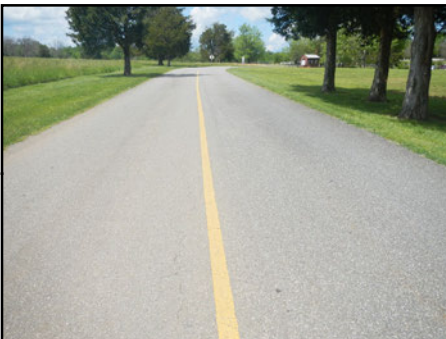
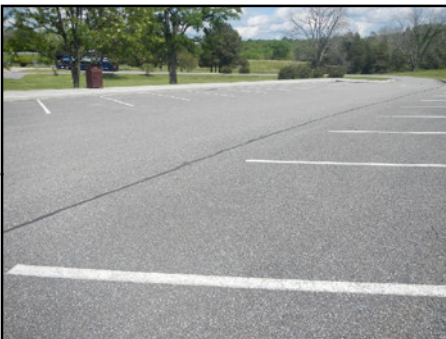
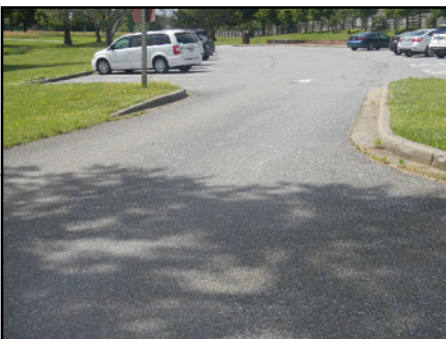
## ROUTE 0904: VILLAGE AREA PARKING

Inspection Date	FMSS Number	User Access	Surface Type
5/6/2019	30554	PUBLIC	ASPHALT
Area (Sq. Ft.)	Lane Miles (11' Widths)	Curb Reveal (Inches)	Curb Recommendation
49,475	0.852	NOT APPLICABLE	DO NOTHING
Curb Type		Curb & Gutter Type	
NO CURB		CONCRETE	
Pavement Recommendation		Condition Rating / PCR	
PREVENTIVE MAINTENANCE		GOOD / 90

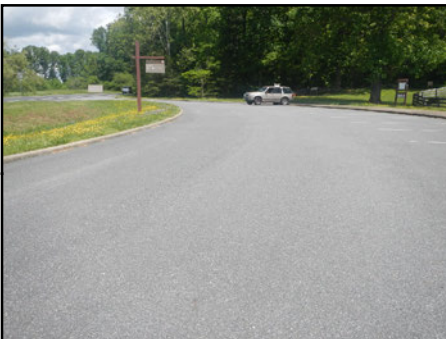
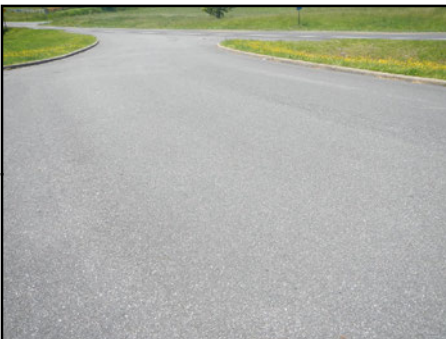
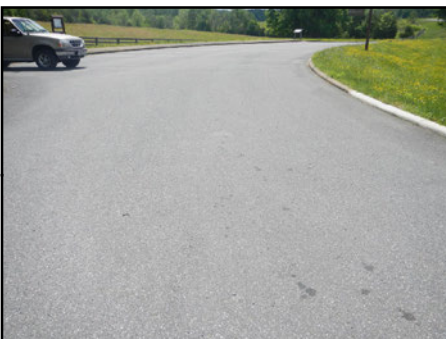
## ROUTE 0905: LEE'S HEADQUARTERS PARKING

Inspection Date	FMSS Number	User Access	Surface Type
5/6/2019	30562	PUBLIC	ASPHALT
Area (Sq. Ft.)	Lane Miles (11' Widths)	Curb Reveal (Inches)	Curb Recommendation
9,284	0.16	3	DO NOTHING
Curb Type		Curb & Gutter Type	
CONCRETE		NO CURB AND GUTTER	
Pavement Recommendation		Condition Rating / PCR	
PREVENTIVE MAINTENANCE		GOOD / 90

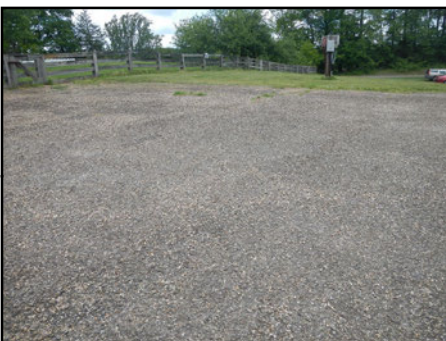
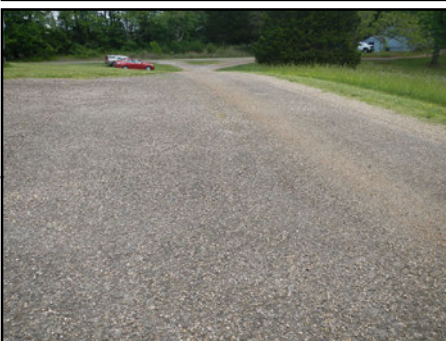
## ROUTE 0906: PEERS HOUSE DRIVEWAY/PARKING

Inspection Date	FMSS Number	User Access	Surface Type
5/6/2019	26866	NONPUBLIC	ASPHALT
Area (Sq. Ft.)	Lane Miles (11' Widths)	Curb Reveal (Inches)	Curb Recommendation
4,426	0.076	NOT APPLICABLE	NOT APPLICABLE
Curb Type		Curb & Gutter Type	
NO CURB		NO CURB AND GUTTER	
Pavement Recommendation		Condition Rating / PCR	
LIGHT 3R TREATMENTS		FAIR / 73
