# AZRU Cycle 6

## Final Report

### Road Inventory and Condition Assessment of Paved Routes Aztec Ruins National Monument

**Report Date: March 2017**

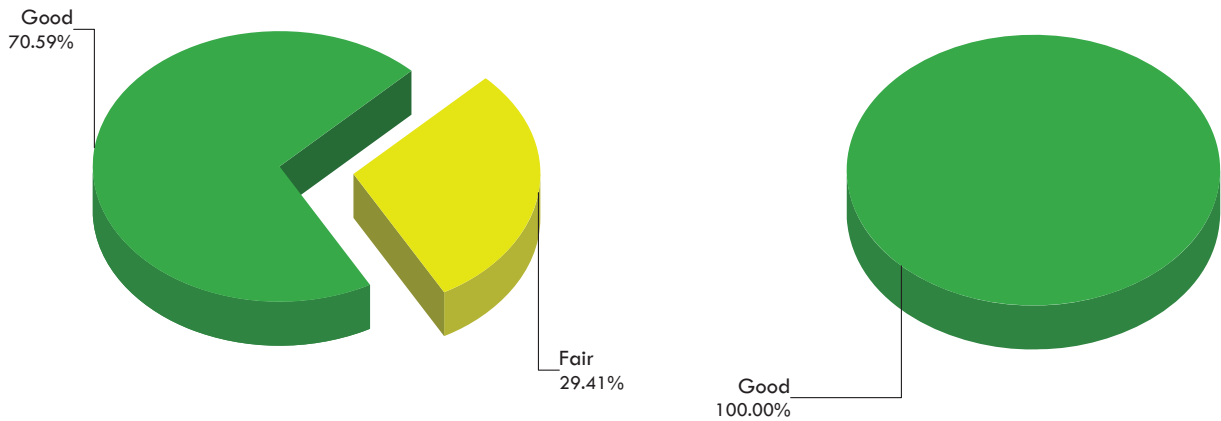
Figure 1: Pavement Condition Rating Breakdown for Paved Roads and Parking Areas

**Road Condition Percentages**

**Parking Area Condition Percentages**

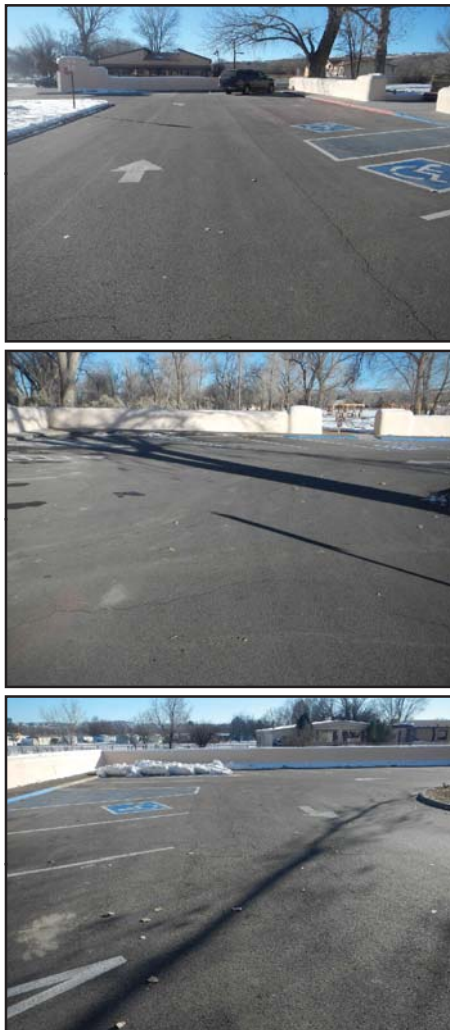
Inspection Date	FMSS Number	User Access	Surface Type
1/14/2016	79469	PUBLIC	ASPHALT
Area (Sq. Ft.)	Lane Miles (11' Widths)	Curb Reveal (Inches)	Curb Recommendation
18,400	0.317	6	DO NOTHING
Curb Type		Curb & Gutter Type	
CONCRETE		CONCRETE	
Pavement Recommendation		Condition Rating / PCR	
PREVENTIVE MAINTENANCE		GOOD / 90

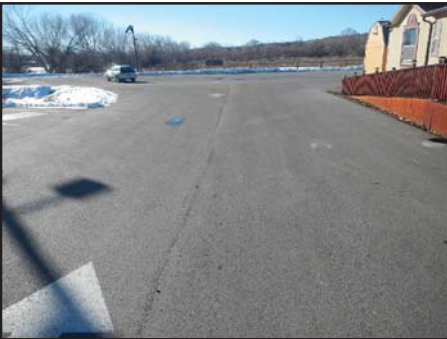
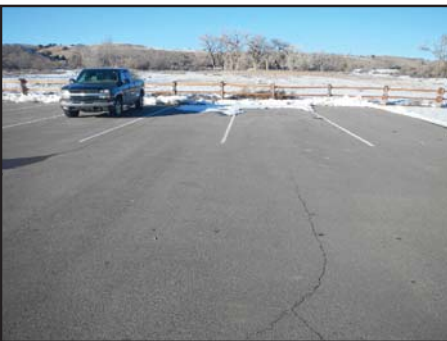
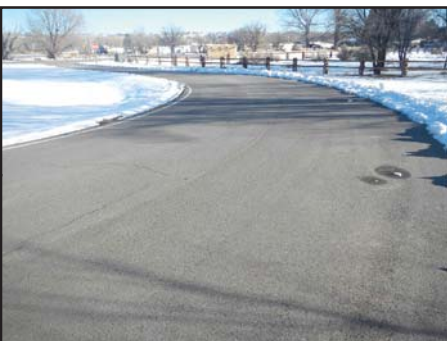
## ROUTE 0901: WESTERN PARKING LOT

Inspection Date	FMSS Number	User Access	Surface Type
1/14/2016	79471	PUBLIC	ASPHALT
Area (Sq. Ft.)	Lane Miles (11' Widths)	Curb Reveal (Inches)	Curb Recommendation
33,713	0.58	NOT APPLICABLE	NOT APPLICABLE
Curb Type		Curb & Gutter Type	
NO CURB		NO CURB AND GUTTER	
Pavement Recommendation		Condition Rating / PCR	
PREVENTIVE MAINTENANCE		GOOD / 90

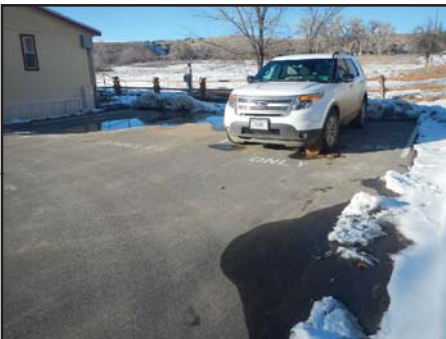
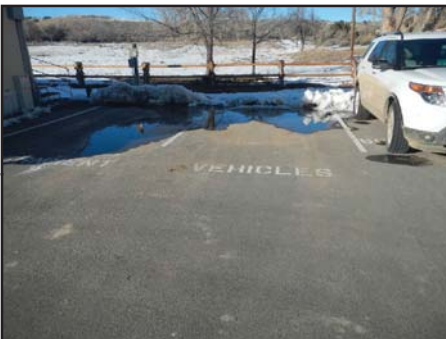
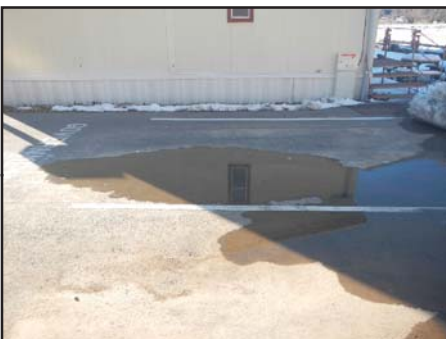
## ROUTE 0902: GOVERNMENT PARKING

Inspection Date	FMSS Number	User Access	Surface Type
1/14/2016	236346	NONPUBLIC	ASPHALT
Area (Sq. Ft.)	Lane Miles (11' Widths)	Curb Reveal (Inches)	Curb Recommendation
852	0.015	NOT APPLICABLE	NOT APPLICABLE
Curb Type		Curb & Gutter Type	
NO CURB		NO CURB AND GUTTER	
Pavement Recommendation		Condition Rating / PCR	
PREVENTIVE MAINTENANCE		GOOD / 90

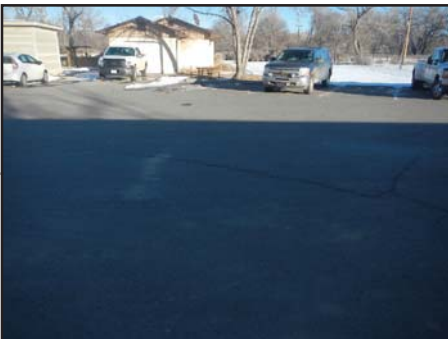
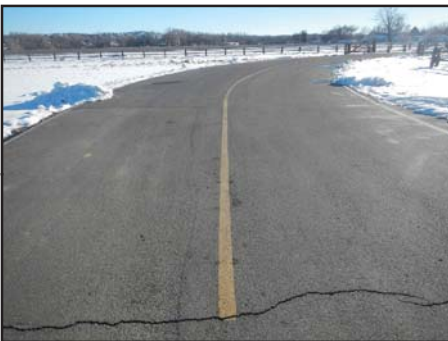
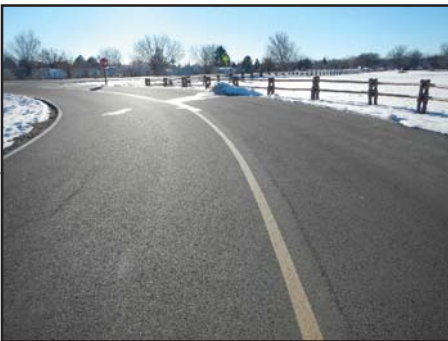
## ROUTE 0904: MAINTENANCE PARKING

Inspection Date	FMSS Number	User Access	Surface Type
1/14/2016	79716	NONPUBLIC	ASPHALT
Area (Sq. Ft.)	Lane Miles (11' Widths)	Curb Reveal (Inches)	Curb Recommendation
15,201	0.262	NOT APPLICABLE	NOT APPLICABLE
Curb Type		Curb & Gutter Type	
NO CURB		NO CURB AND GUTTER	
Pavement Recommendation		Condition Rating / PCR	
PREVENTIVE MAINTENANCE		GOOD / 90

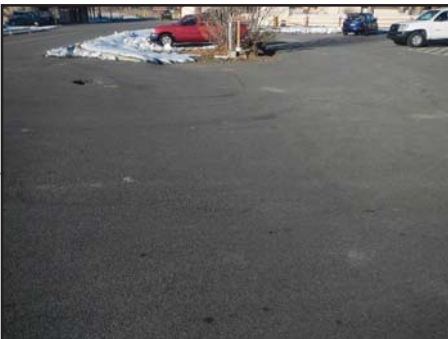
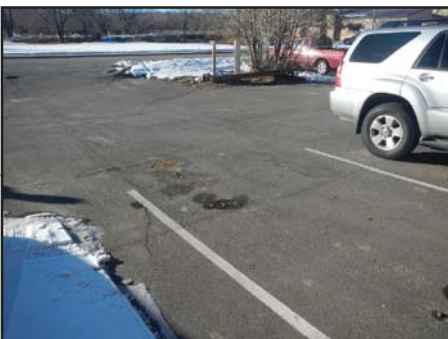
## ROUTE 0905: CULTURAL RESOURCES DIVISION PARKING

Inspection Date	FMSS Number	User Access	Surface Type
1/14/2016	236347	NONPUBLIC	ASPHALT
Area (Sq. Ft.)	Lane Miles (11' Widths)	Curb Reveal (Inches)	Curb Recommendation
7,057	0.122	NOT APPLICABLE	DO NOTHING
Curb Type		Curb & Gutter Type	
NO CURB		CONCRETE	
Pavement Recommendation		Condition Rating / PCR	
PREVENTIVE MAINTENANCE		GOOD / 90

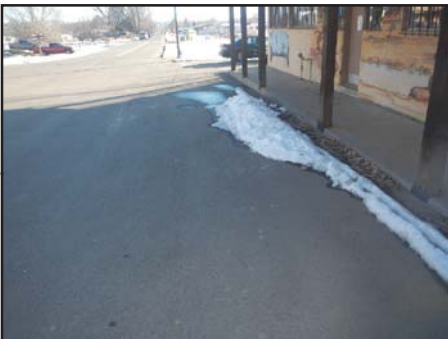
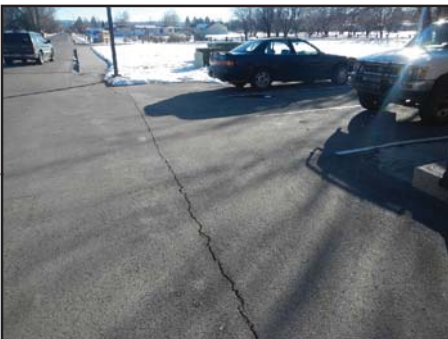
## ROUTE 0906: VISITOR CENTER LOT 2 PARKING

Inspection Date	FMSS Number	User Access	Surface Type
1/14/2016	237560	PUBLIC	ASPHALT
Area (Sq. Ft.)	Lane Miles (11' Widths)	Curb Reveal (Inches)	Curb Recommendation
1,143	0.02	NOT APPLICABLE	NOT APPLICABLE
Curb Type		Curb & Gutter Type	
NO CURB		NO CURB AND GUTTER	
Pavement Recommendation		Condition Rating / PCR	
PREVENTIVE MAINTENANCE		GOOD / 90
