BAWA Cycle 6

Final Report

Road Inventory and Condition Assessment of Paved Routes Baltimore - Washington Parkway

Part of the National Capital Parks - East

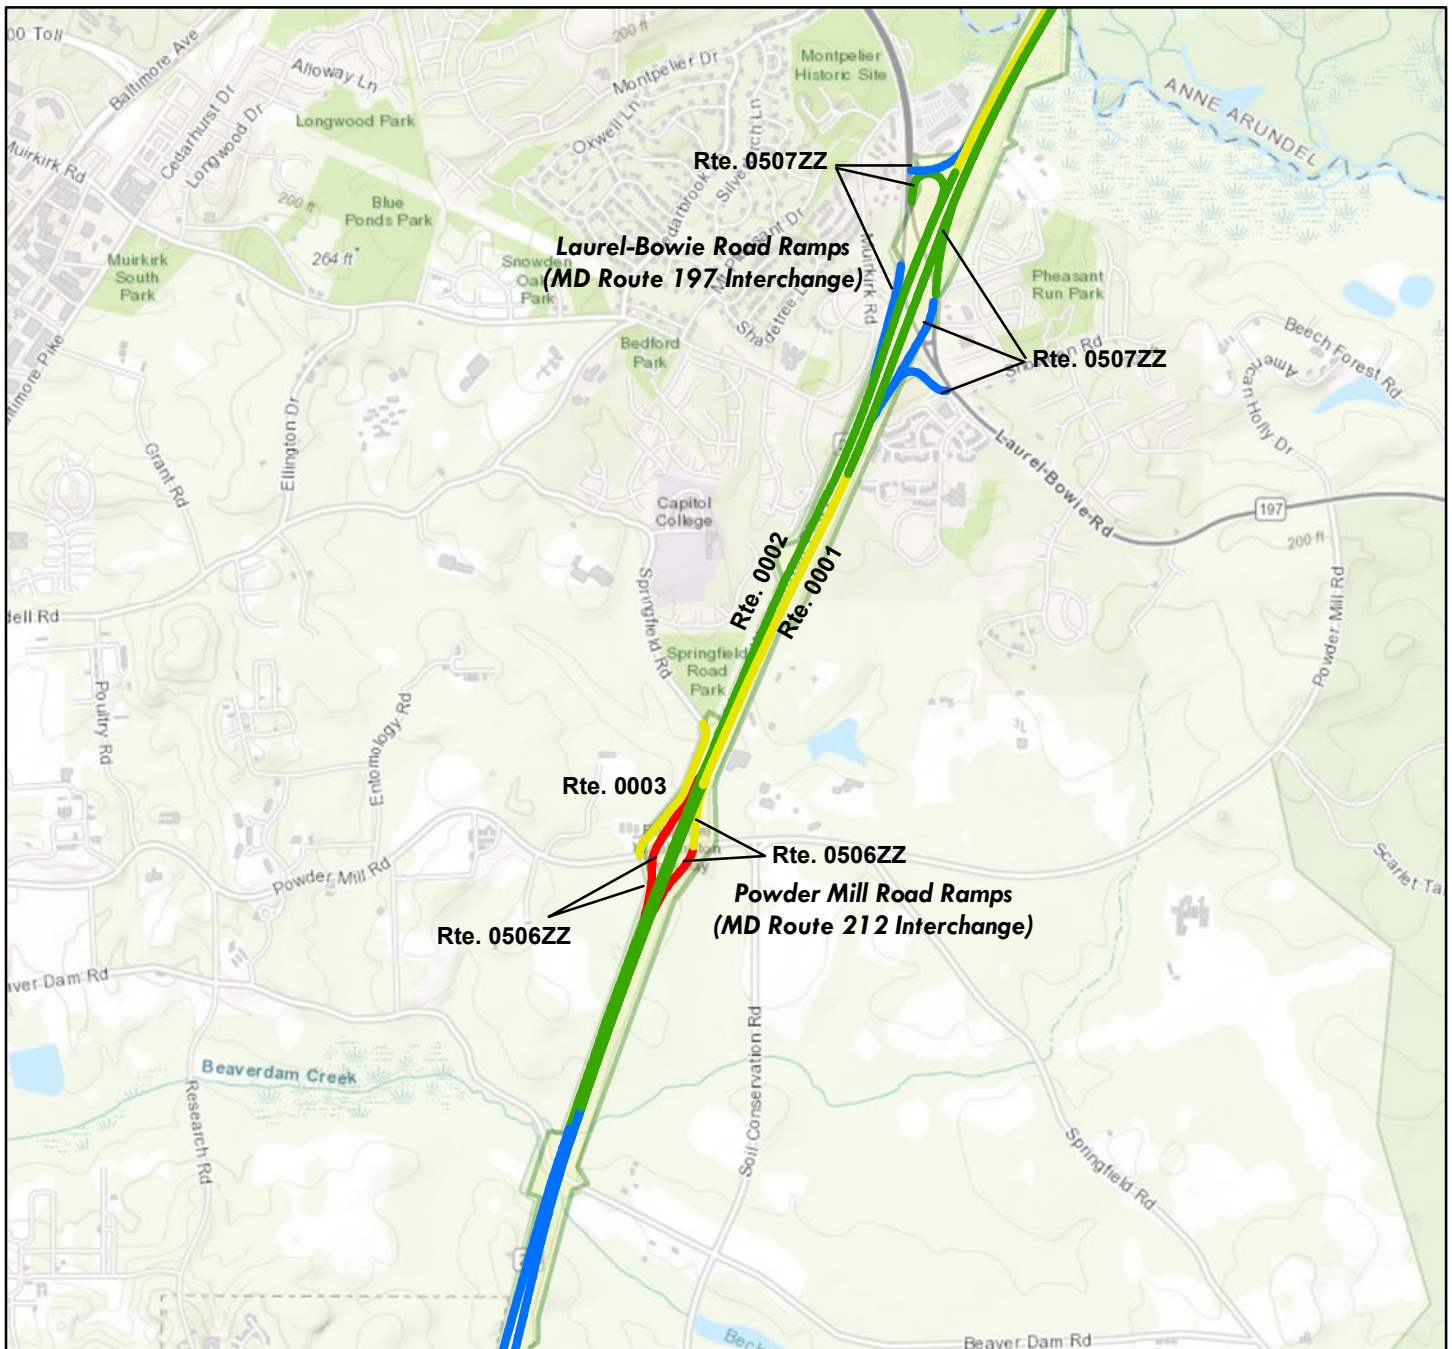
Area Map 3

Colors on map represent condition scores at 1-mile intervals. See Appendix for definitions and formulas

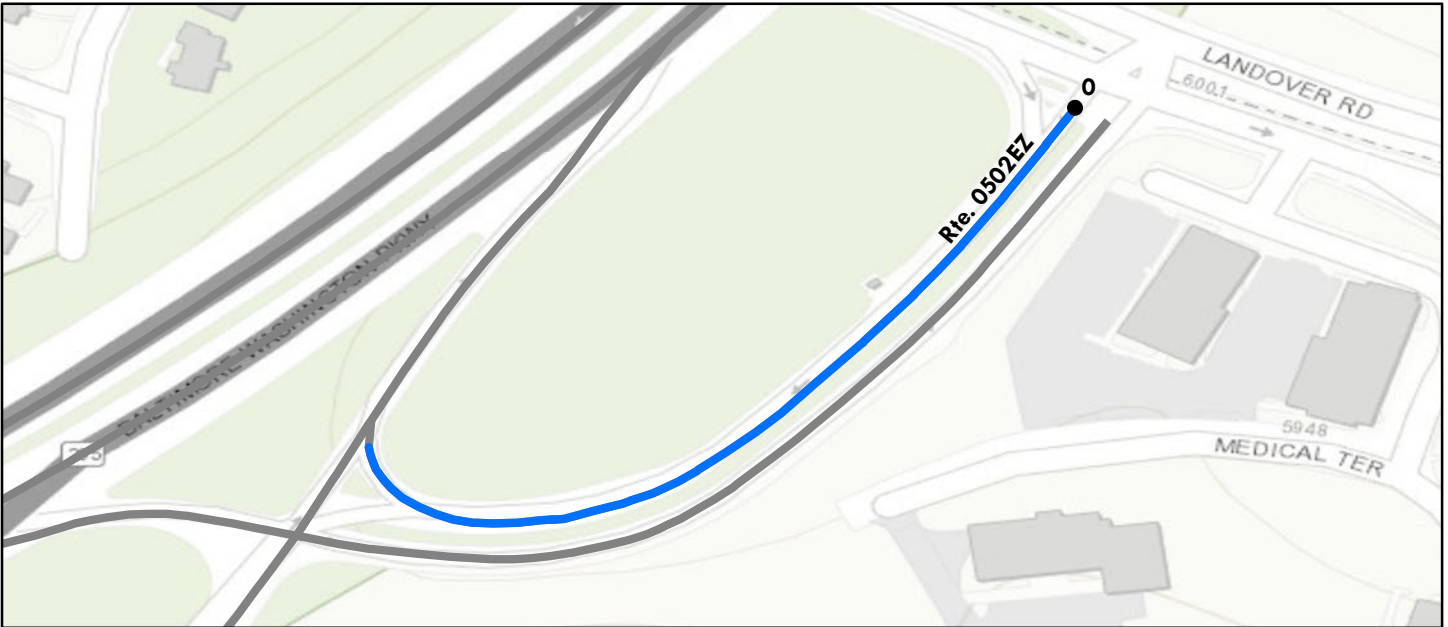
ROUTE 0502EZ: RAMP FROM ROUTE 202 TO RAMP FROM HOSPITAL DRIVE

Route Condition Legend – Pavement Condition Rating (PCR)						
Poor (0 - 60)		Fair (61- 84)		Good (85 - 94)		Excellent (95 - 100)
						Not Rated
Colors on map represent condition scores at 0.10-mile intervals. See Appendix for definitions and formulas.						
Inspection Date:	6/9/2018	Beginning Section MP	0			
Paved Length (Miles):	0.13	Section Length (MI)	0.13			
Surface Type:	ASPHALT	Route Summary				
Roadway Condition Information						
Pavement Condition Rating (PCR)	99	99				
Surface Condition Rating (SCR)	99	99				
Roughness Condition Index (RCI)	N/A	N/A				
Distress Index Values						
Structural Crack Index	100	100				
Alligator Crack Index	100	100				
Longitudinal Crack Index	100	100				
Transverse Cracking Index	100	100				
Patching Index	100	100				
Rutting Index	99	99				
International Roughness Index (IRI)	N/A	N/A				
Lane & Width Information						
Number of Lanes	1	1				
Paved Width (ft)	20.9	20.9

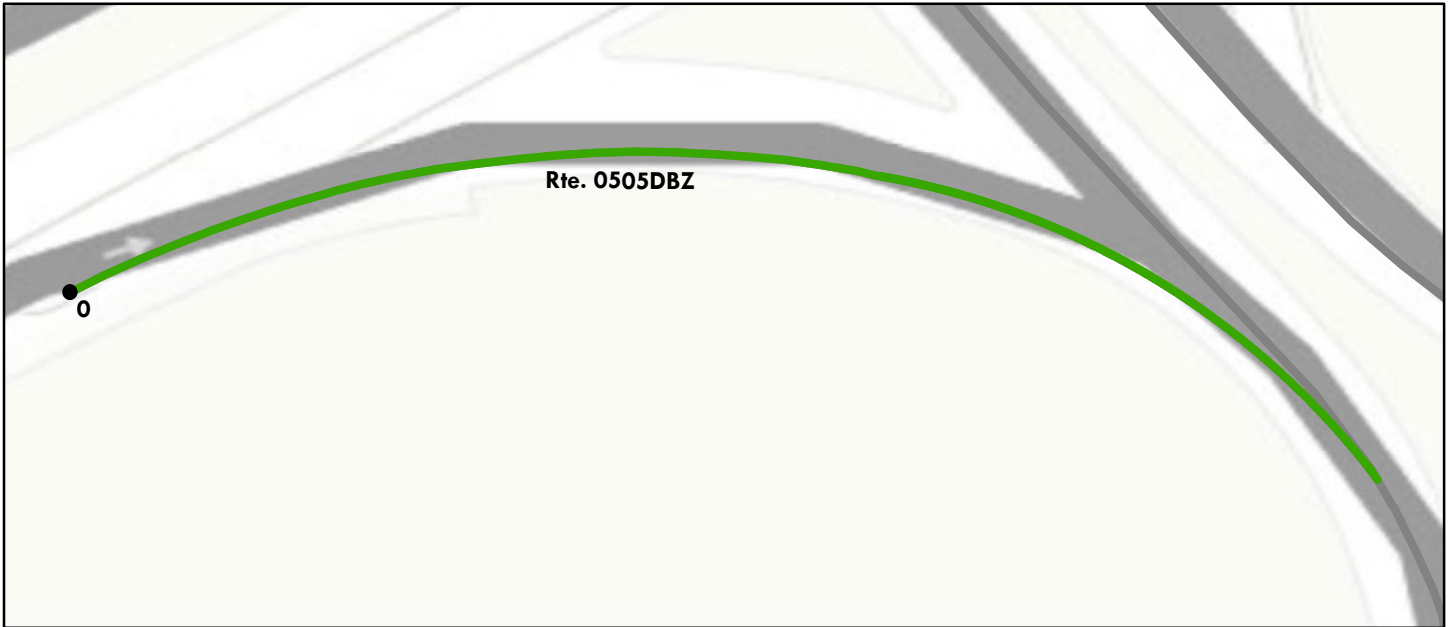
ROUTE 0505DBZ: RAMP FROM SOUTHWAY TO S/B BW PARKWAY

Route Condition Legend – Pavement Condition Rating (PCR)						
Poor (0 - 60)	Fair (61- 84)	Good (85 - 94)	Excellent (95 - 100)	Not Rated		
Colors on map represent condition scores at 0.10-mile intervals. See Appendix for definitions and formulas.						
Inspection Date: 6/8/2018	Beginning Section MP	0				
Paved Length (Miles): 0.03	Section Length (MI)	0.03				
Surface Type: ASPHALT	Route Summary					
Roadway Condition Information						
Pavement Condition Rating (PCR)	88	88				
Surface Condition Rating (SCR)	88	88				
Roughness Condition Index (RCI)	N/A	N/A				
Distress Index Values						
Structural Crack Index	88	88				
Alligator Crack Index	100	100				
Longitudinal Crack Index	88	88				
Transverse Cracking Index	99	99				
Patching Index	100	100				
Rutting Index	99	99				
International Roughness Index (IRI)	N/A	N/A				
Lane & Width Information						
Number of Lanes	1	1				
Paved Width (ft)	23.3	23.3				
Lane Width (ft)	22.7	22.7

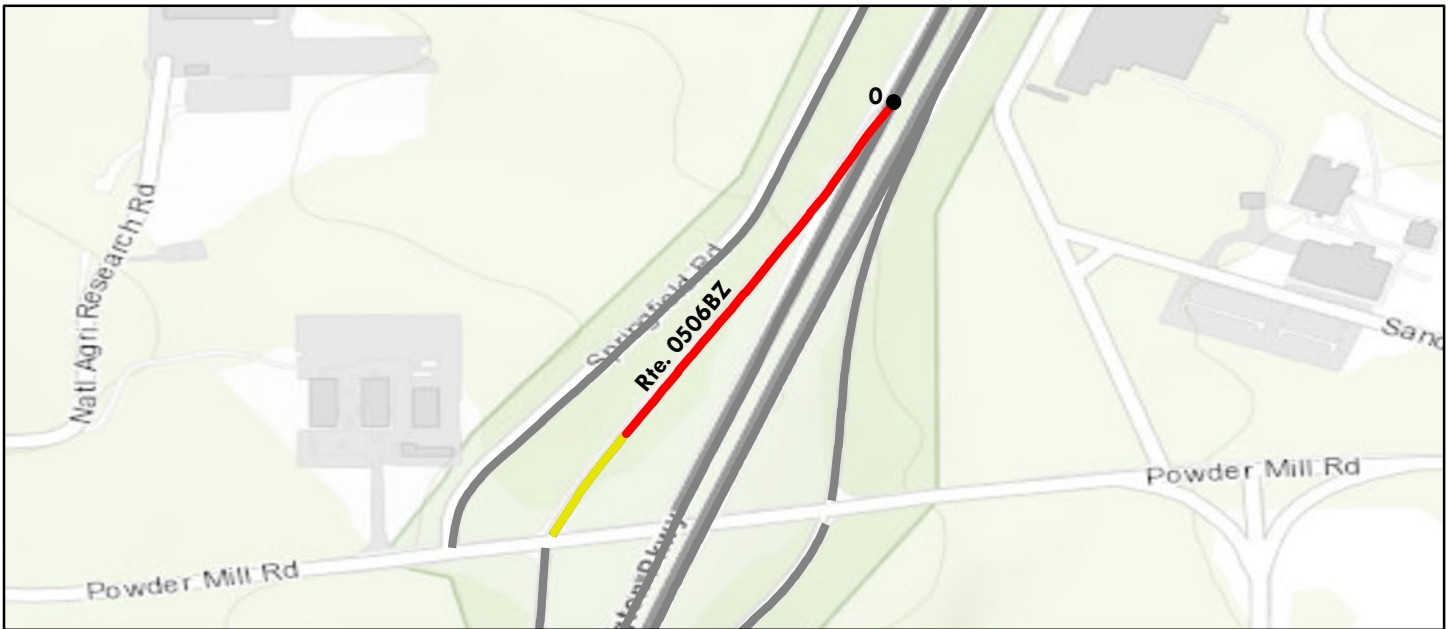
ROUTE 0506BZ: S/B BW PARKWAY RAMP TO POWDER MILL ROAD (ROUTE 212)

Route Condition Legend – Pavement Condition Rating (PCR)							
Poor (0 - 60)		Fair (61- 84)		Good (85 - 94)		Excellent (95 - 100)	Not Rated
Colors on map represent condition scores at 0.10-mile intervals. See Appendix for definitions and formulas.							
Inspection Date:	6/9/2018	Beginning Section MP	0				
Paved Length (Miles):	0.26	Section Length (MI)	0.26				
Surface Type:	ASPHALT	Route Summary					
Roadway Condition Information							
Pavement Condition Rating (PCR)	5	5					
Surface Condition Rating (SCR)	5	5					
Roughness Condition Index (RCI)	N/A	N/A					
Distress Index Values							
Structural Crack Index	5	5					
Alligator Crack Index	100	100					
Longitudinal Crack Index	5	5					
Transverse Cracking Index	74	74					
Patching Index	100	100					
Rutting Index	98	98					
International Roughness Index (IRI)	N/A	N/A					
Lane & Width Information							
Number of Lanes	1	1					
Paved Width (ft)	23	23

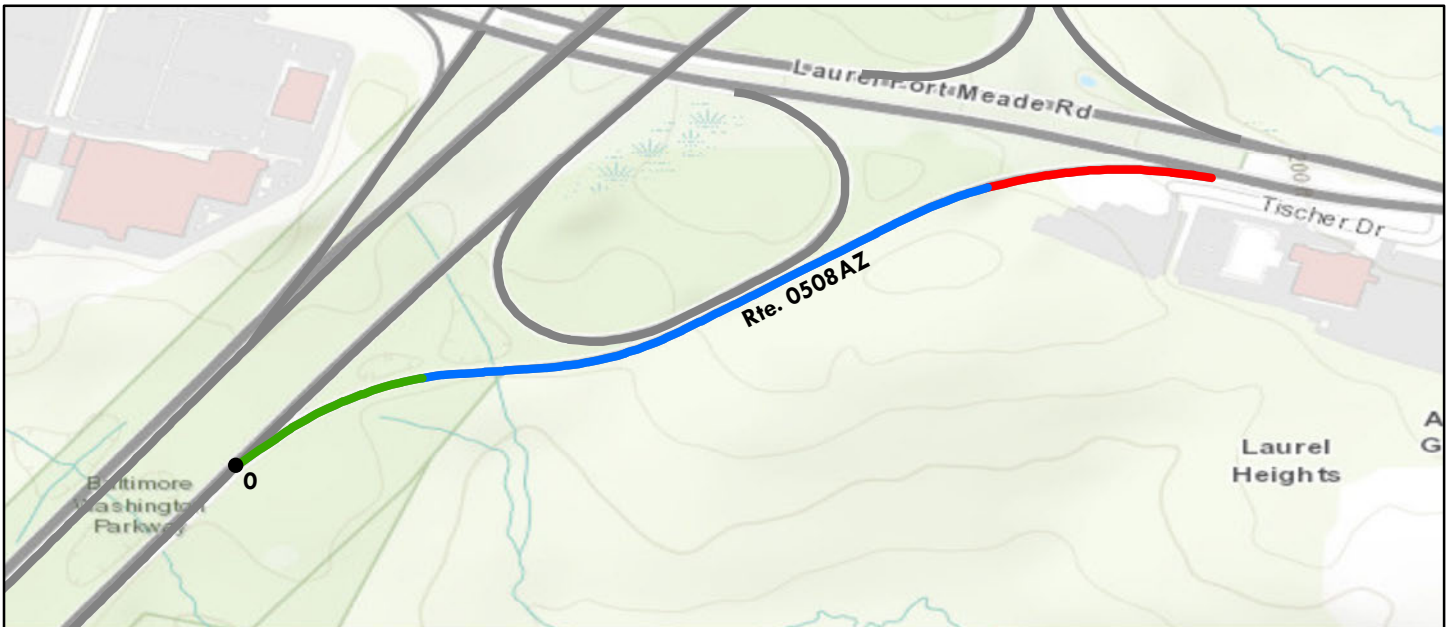
ROUTE 0508AZ: N/B BW PARKWAY RAMP TO E/B ROUTE 198

Route Condition Legend – Pavement Condition Rating (PCR)						
Poor (0 - 60)	Fair (61- 84)	Good (85 - 94)	Excellent (95 - 100)	Not Rated		
Colors on map represent condition scores at 0.10-mile intervals. See Appendix for definitions and formulas.						
Inspection Date: 6/9/2018	Beginning Section MP	0				
Paved Length (Miles): 0.51	Section Length (MI)	0.51				
Surface Type: ASPHALT	Route Summary					
Roadway Condition Information						
Pavement Condition Rating (PCR)	86	86				
Surface Condition Rating (SCR)	78	78				
Roughness Condition Index (RCI)	98	98				
Distress Index Values						
Structural Crack Index	78	78				
Alligator Crack Index	100	100				
Longitudinal Crack Index	78	78				
Transverse Cracking Index	86	86				
Patching Index	100	100				
Rutting Index	99	99				
International Roughness Index (IRI)	119	119				
Lane & Width Information						
Number of Lanes	1	1				
Paved Width (ft)	17.6	17.6				
Lane Width (ft)	14.5	14.5

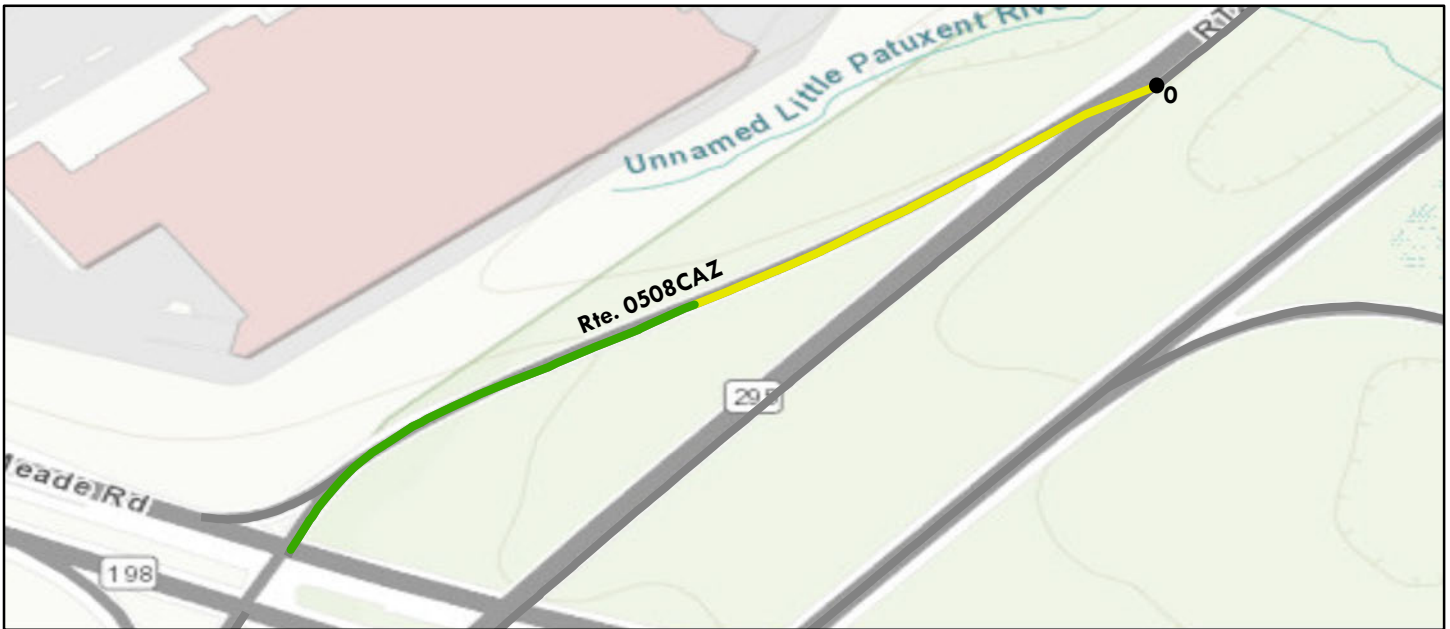
ROUTE 0508CAZ: S/B BW PARKWAY RAMP TO MD HIGHWAY 198 (EB AND WB)

Route Condition Legend – Pavement Condition Rating (PCR)						
Poor (0 - 60)	Fair (61- 84)	Good (85 - 94)	Excellent (95 - 100)	Not Rated		
Colors on map represent condition scores at 0.10-mile intervals. See Appendix for definitions and formulas.						
Inspection Date: 6/9/2018	Beginning Section MP	0				
Paved Length (Miles): 0.2	Section Length (MI)	0.2				
Surface Type: ASPHALT	Route Summary					
Roadway Condition Information						
Pavement Condition Rating (PCR)	81	81				
Surface Condition Rating (SCR)	81	81				
Roughness Condition Index (RCI)	N/A	N/A				
Distress Index Values						
Structural Crack Index	81	81				
Alligator Crack Index	100	100				
Longitudinal Crack Index	81	81				
Transverse Cracking Index	95	95				
Patching Index	100	100				
Rutting Index	99	99				
International Roughness Index (IRI)	N/A	N/A				
Lane & Width Information						
Number of Lanes	1	1				
Paved Width (ft)	18.6	18.6				
Lane Width (ft)	16.5	16.5

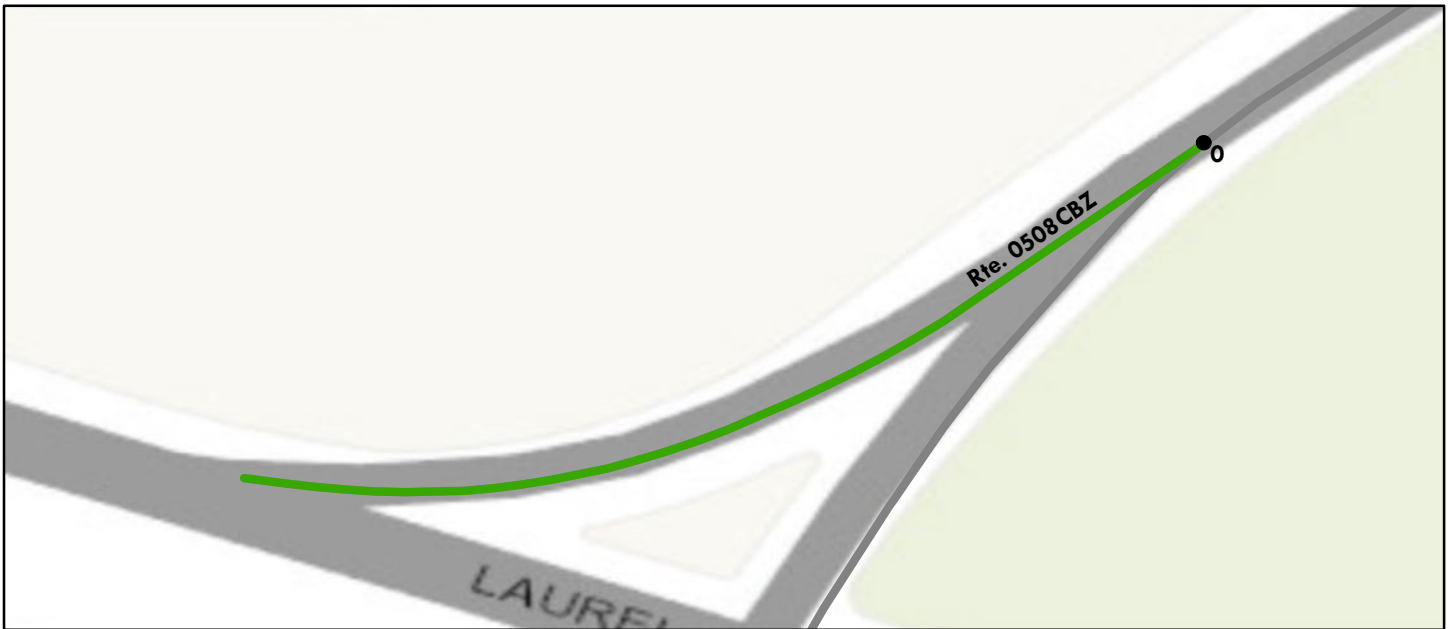
ROUTE 0508CBZ: S/B BW PARKWAY RAMP TO HIGHWAY 198 (WB)

Route Condition Legend – Pavement Condition Rating (PCR)						
Poor (0 - 60)	Fair (61- 84)	Good (85 - 94)	Excellent (95 - 100)	Not Rated		
Colors on map represent condition scores at 0.10-mile intervals. See Appendix for definitions and formulas.						
Inspection Date: 6/9/2018	Beginning Section MP	0				
Paved Length (Miles): 0.03	Section Length (MI)	0.03				
Surface Type: ASPHALT	Route Summary					
Roadway Condition Information						
Pavement Condition Rating (PCR)	90	90				
Surface Condition Rating (SCR)	90	90				
Roughness Condition Index (RCI)	N/A	N/A				
Distress Index Values						
Structural Crack Index	90	90				
Alligator Crack Index	100	100				
Longitudinal Crack Index	90	90				
Transverse Cracking Index	94	94				
Patching Index	100	100				
Rutting Index	93	93				
International Roughness Index (IRI)	N/A	N/A				
Lane & Width Information						
Number of Lanes	1	1				
Paved Width (ft)	19.8	19.8				
Lane Width (ft)	18	18

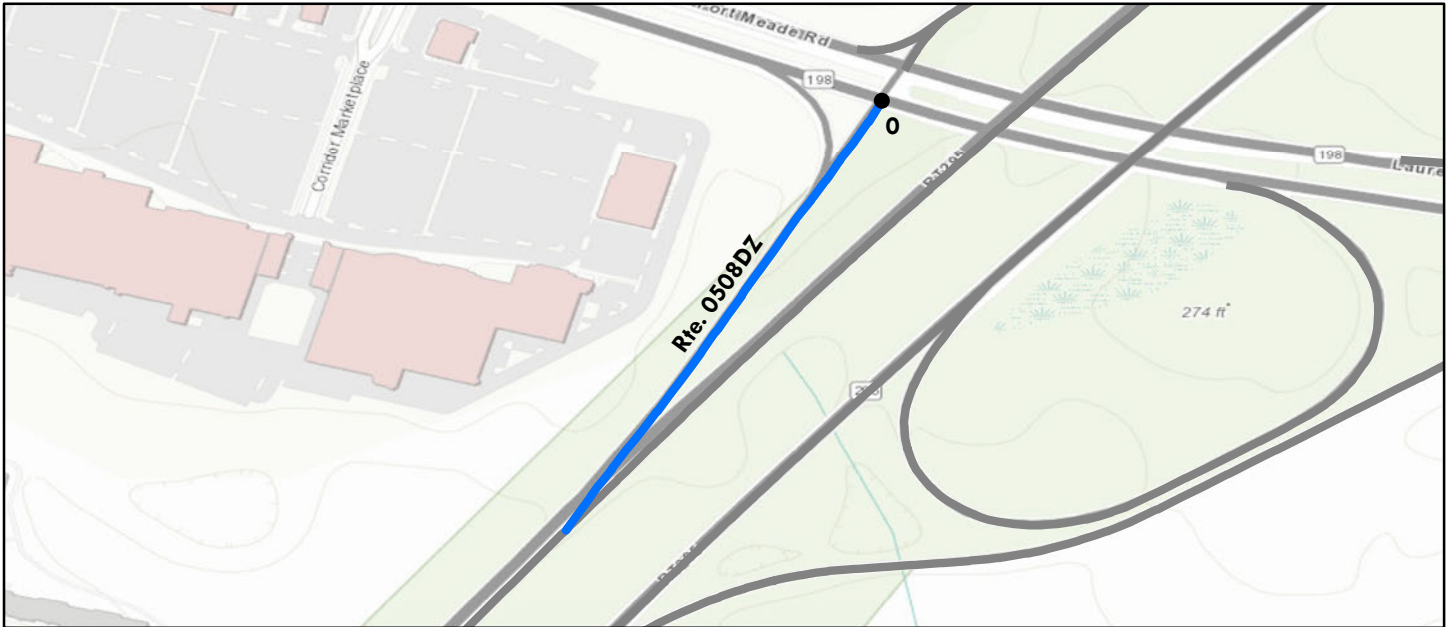
ROUTE 0508DZ: RAMP FROM ROUTE 198 TO S/B BW PARKWAY

Route Condition Legend – Pavement Condition Rating (PCR)						
Poor (0 - 60)	Fair (61- 84)	Good (85 - 94)	Excellent (95 - 100)	Not Rated		
Colors on map represent condition scores at 0.10-mile intervals. See Appendix for definitions and formulas.						
Inspection Date: 6/9/2018	Beginning Section MP	0				
Paved Length (Miles): 0.21	Section Length (MI)	0.21				
Surface Type: ASPHALT	Route Summary					
Roadway Condition Information						
Pavement Condition Rating (PCR)	98	98				
Surface Condition Rating (SCR)	98	98				
Roughness Condition Index (RCI)	N/A	N/A				
Distress Index Values						
Structural Crack Index	98	98				
Alligator Crack Index	100	100				
Longitudinal Crack Index	98	98				
Transverse Cracking Index	99	99				
Patching Index	100	100				
Rutting Index	99	99				
International Roughness Index (IRI)	N/A	N/A				
Lane & Width Information						
Number of Lanes	1	1				
Paved Width (ft)	16.7	16.7				
Lane Width (ft)	14.1	14.1

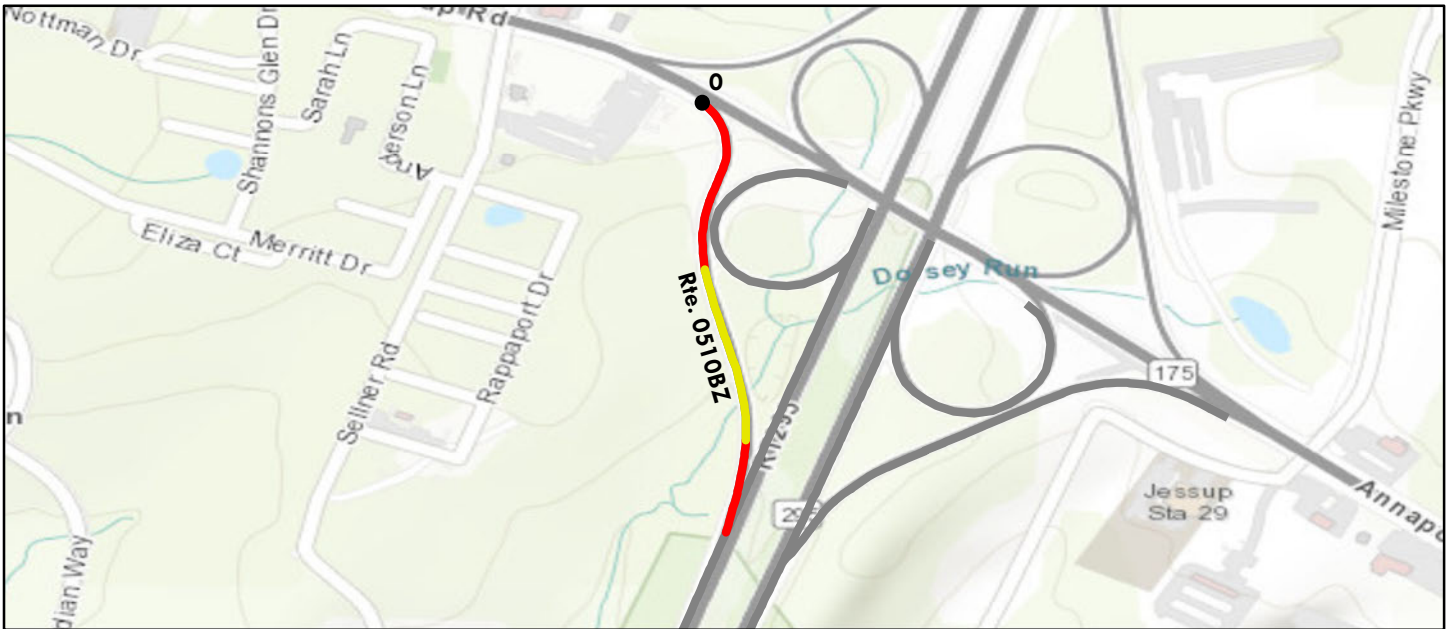
ROUTE 0510BZ: S/B BW PARKWAY RAMP FROM MD HIGHWAY 175

Route Condition Legend – Pavement Condition Rating (PCR)										
Poor (0 - 60)		Fair (61- 84)		Good (85 - 94)		Excellent (95 - 100)		Not Rated		
Colors on map represent condition scores at 0.10-mile intervals. See Appendix for definitions and formulas.										
Inspection Date:	6/9/2018	Beginning Section MP	0							
Paved Length (Miles):	0.25	Section Length (MI)	0.25							
Surface Type:	ASPHALT	Route Summary								
Roadway Condition Information										
Pavement Condition Rating (PCR)		18	18							
Surface Condition Rating (SCR)		18	18							
Roughness Condition Index (RCI)		N/A	N/A							
Distress Index Values										
Structural Crack Index		18	18							
Alligator Crack Index		99	99							
Longitudinal Crack Index		19	19							
Transverse Cracking Index		46	46							
Patching Index		100	100							
Rutting Index		97	97							
International Roughness Index (IRI)		N/A	N/A							
Lane & Width Information

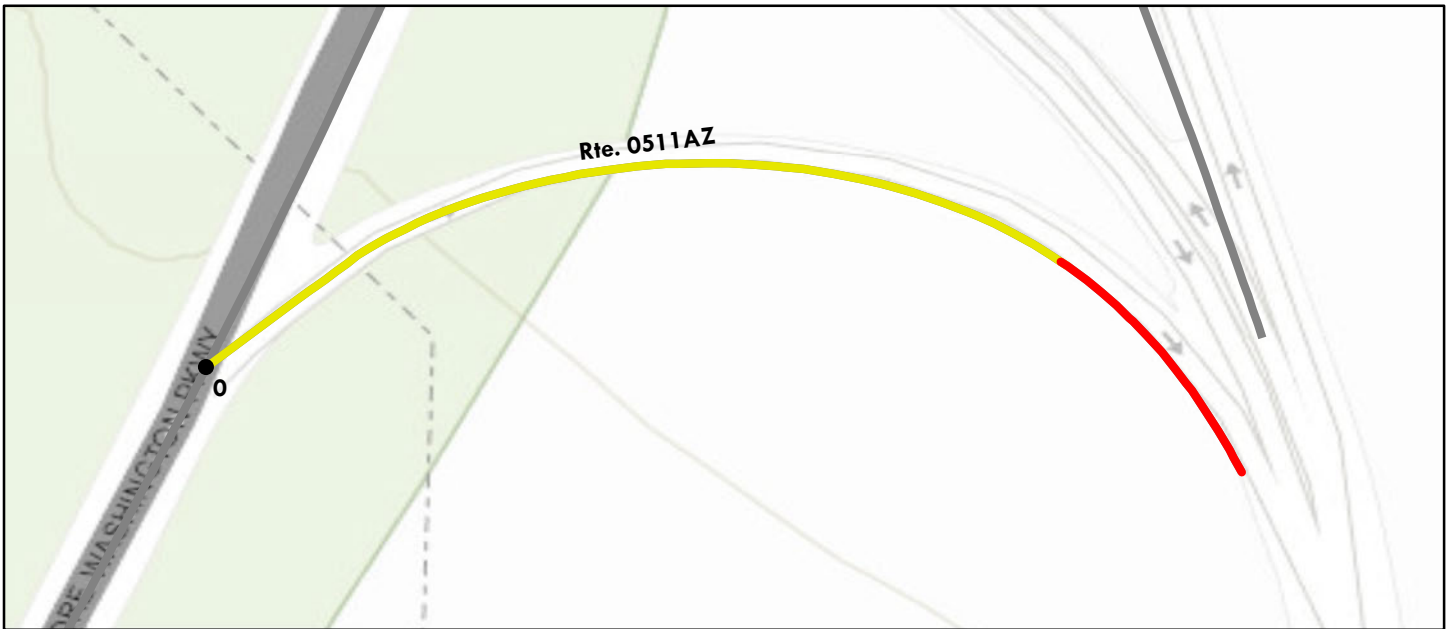
ROUTE 0511AZ: N/B BW PARKWAY RAMP TO NASA

Route Condition Legend – Pavement Condition Rating (PCR)										
Poor (0 - 60)		Fair (61- 84)		Good (85 - 94)		Excellent (95 - 100)		Not Rated		
Colors on map represent condition scores at 0.10-mile intervals. See Appendix for definitions and formulas.										
Inspection Date: 6/8/2018		Beginning Section MP		0						
Paved Length (Miles): 0.13		Section Length (MI)		0.13						
Surface Type: ASPHALT		Route Summary								
Roadway Condition Information										
Pavement Condition Rating (PCR)		70		70						
Surface Condition Rating (SCR)		70		70						
Roughness Condition Index (RCI)		N/A		N/A						
Distress Index Values										
Structural Crack Index		70		70						
Alligator Crack Index		100		100						
Longitudinal Crack Index		70		70						
Transverse Cracking Index		92		92						
Patching Index		99		99						
Rutting Index		99		99						
International Roughness Index (IRI)		N/A		N/A						
Lane & Width Information

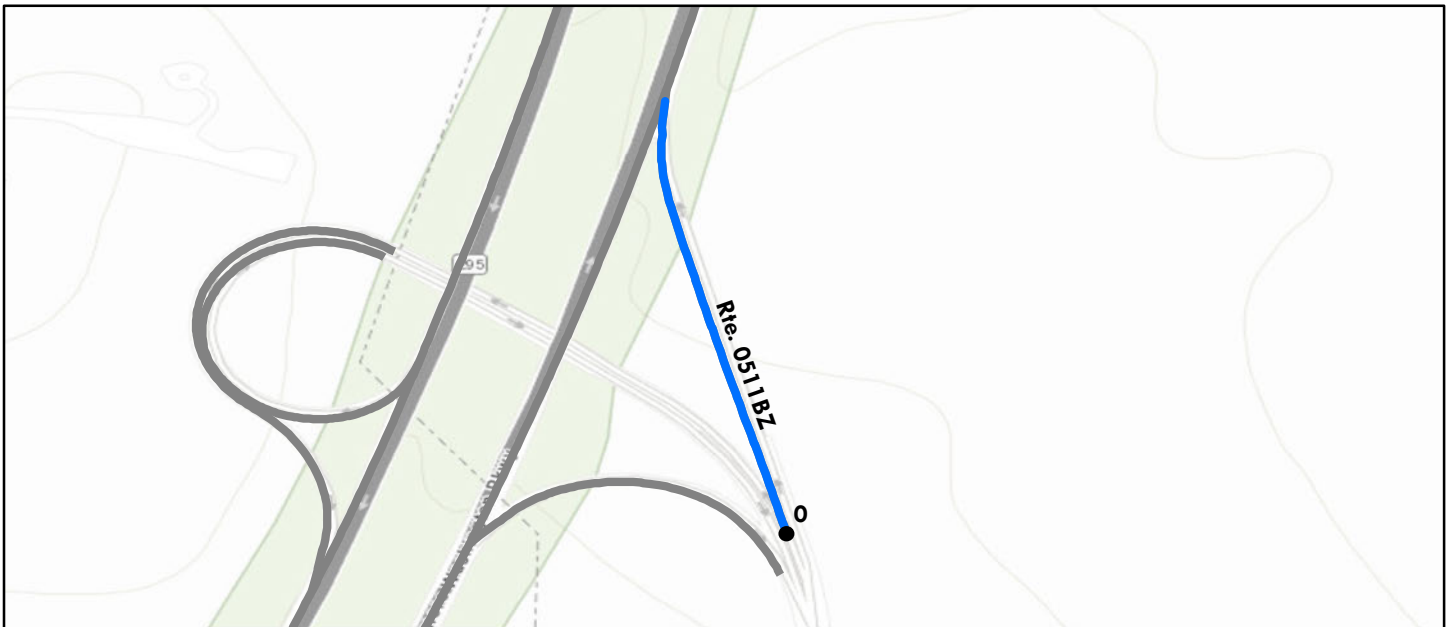
ROUTE 0511BZ: NASA RAMP TO N/B BW PARKWAY

Colors on map represent condition scores at 0.10-mile intervals. See Appendix for definitions and formulas.

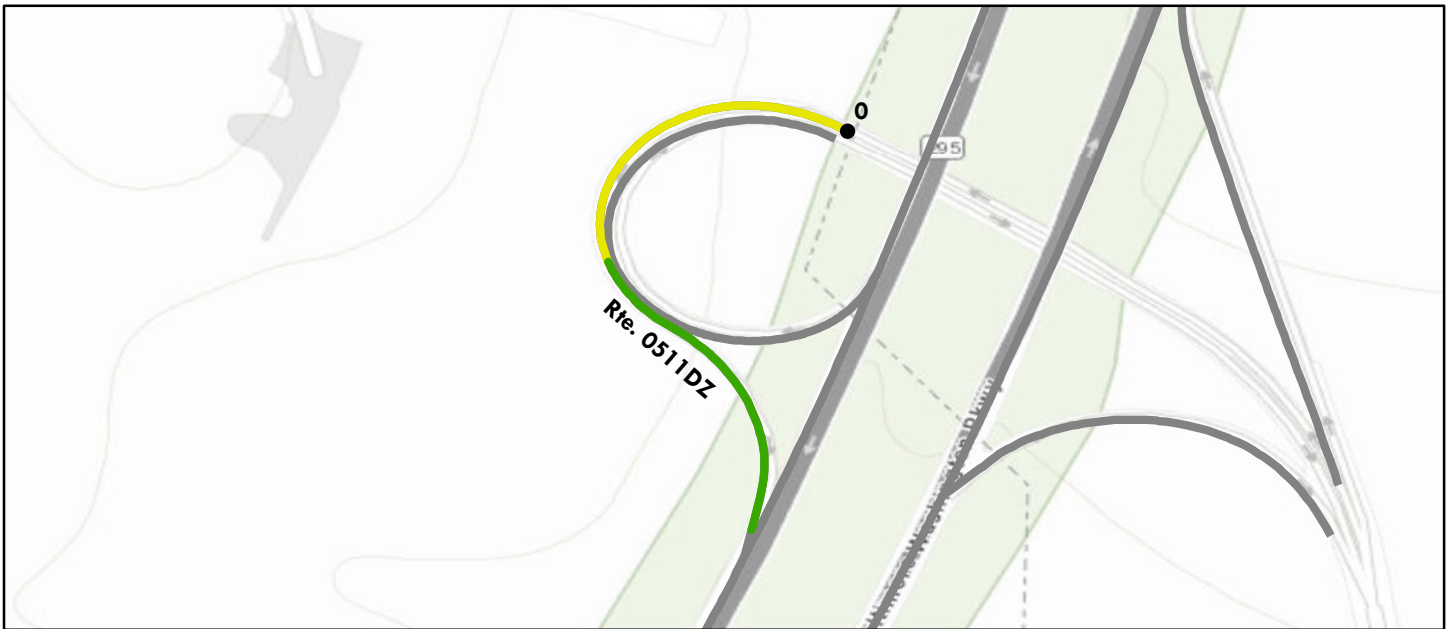
ROUTE 0511DZ: NASA RAMP TO S/B BW PARKWAY

Inspection Date: 6/8/2018	Beginning Section MP	0				
Paved Length (Miles): 0.2	Section Length (MI)	0.2				
Surface Type: ASPHALT	Route Summary					
Roadway Condition Information						
Pavement Condition Rating (PCR)	88	88				
Surface Condition Rating (SCR)	88	88				
Roughness Condition Index (RCI)	N/A	N/A				
Distress Index Values						
Structural Crack Index	88	88				
Alligator Crack Index	100	100				
Longitudinal Crack Index	88	88				
Transverse Cracking Index	95	95				
Patching Index	99	99				
Rutting Index	98	98				
International Roughness Index (IRI)	N/A	N/A				
Lane & Width Information						
Number of Lanes	1	1				
Paved Width (ft)	16	16				
Lane Width (ft)	14.2	14.2
