Road Inventory and Condition Assessment of Paved Routes Biscayne National Park

**Federal Lands Highway
Road Inventory Program**

**Federal Highway Administration
Eastern Federal Lands Highway Division
Road Inventory Program (RIP)**

Report Date: March 2020

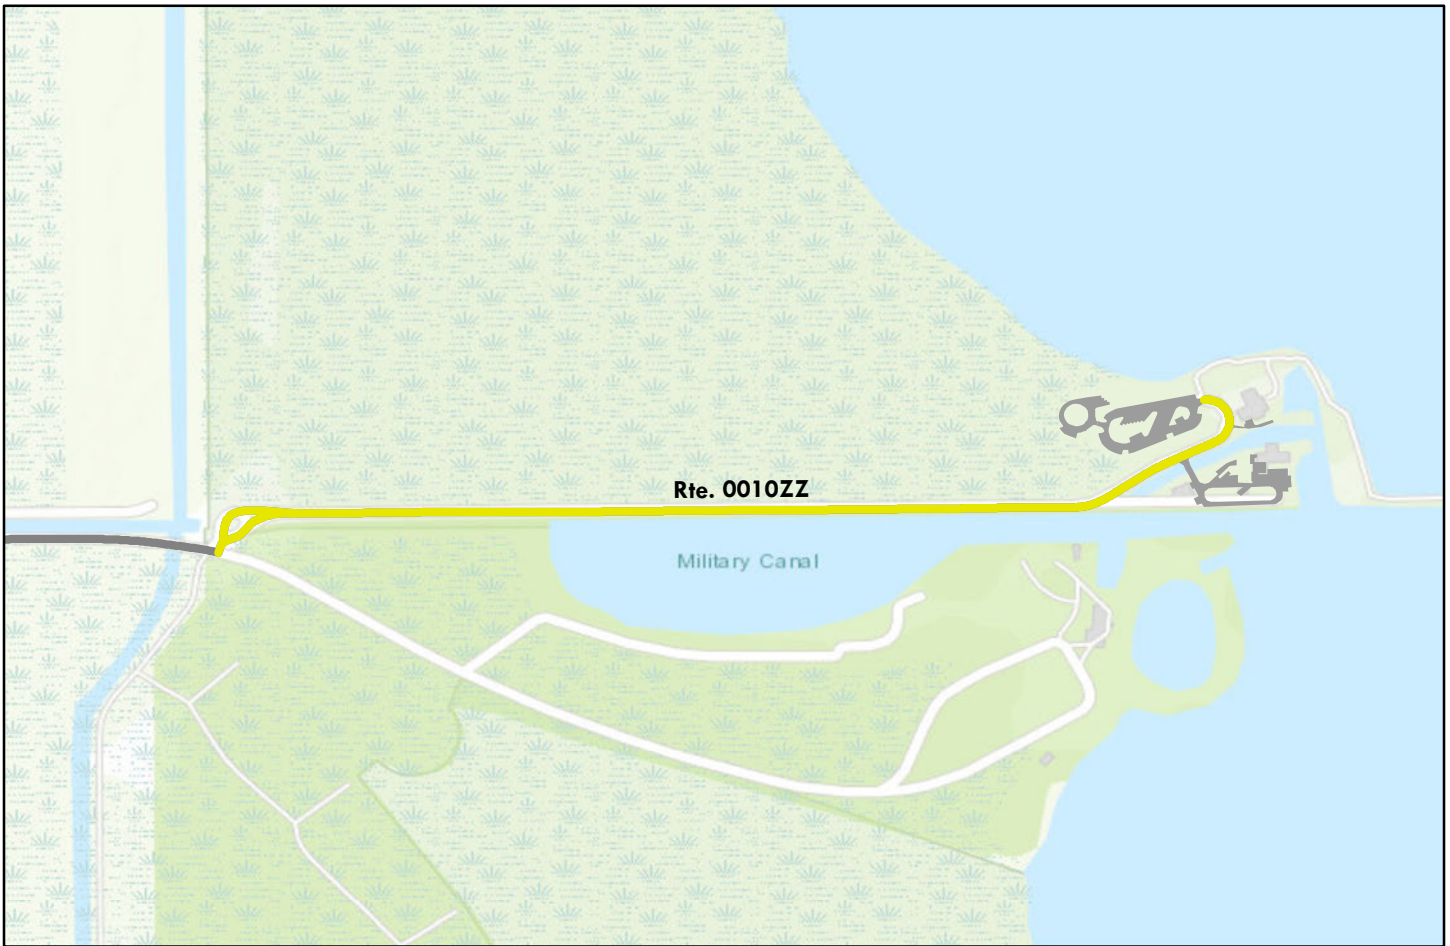
ROUTE 0010ZZ: ENTRANCE ROAD AND EXIT SPUR

Note: The weighted average summary PCR value is calculated from only the sections of road where the PCR was collected. The overall PCR for the summary route may not reflect individual subcomponent ratings.

Route Condition Legend – Pavement Condition Rating (PCR)						
Poor (0 - 60)	Fair (61- 84)	Good (85 - 94)	Excellent (95 - 100)	Not Rated		
See Appendix for definitions and formulas						
Inspection Date:	4/5/2019					
Paved Length (Miles):	0.83					
Surface Type:	ASPHALT	Route Summary				
Roadway Condition Information						
Pavement Condition Rating (PCR)	81					
Lane & Width Information						
Number of Lanes	2					
Paved Width (ft)	21.5					
Lane Width (ft)	10.3

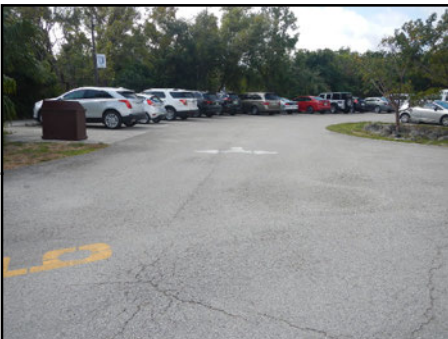
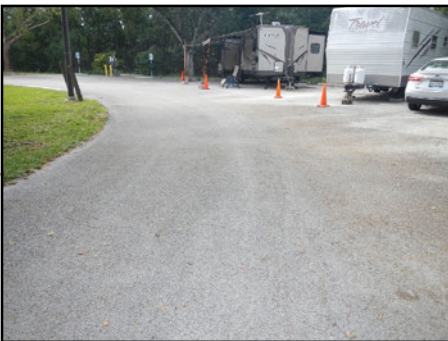
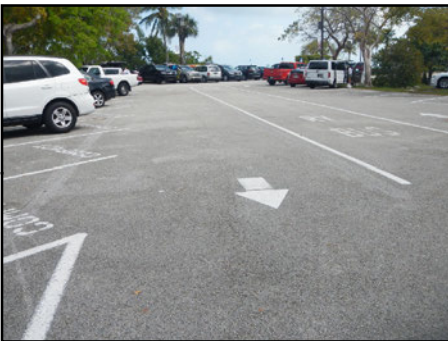
Inspection Date	FMSS Number	User Access	Surface Type
3/14/2019	5341	PUBLIC	ASPHALT
Area (Sq. Ft.)	Lane Miles (11' Widths)	Curb Reveal (Inches)	Curb Recommendation
45,222	0.779	NOT APPLICABLE	NOT APPLICABLE
Curb Type		Curb & Gutter Type	
NO CURB		NO CURB AND GUTTER	
Pavement Recommendation		Condition Rating / PCR	
LIGHT 3R TREATMENTS		FAIR / 73

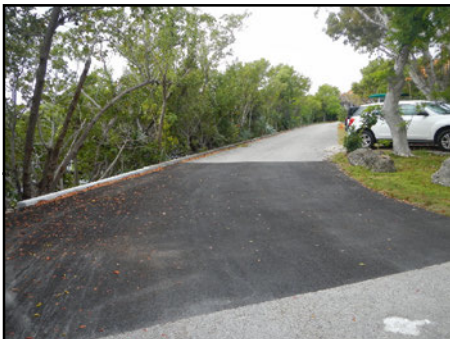
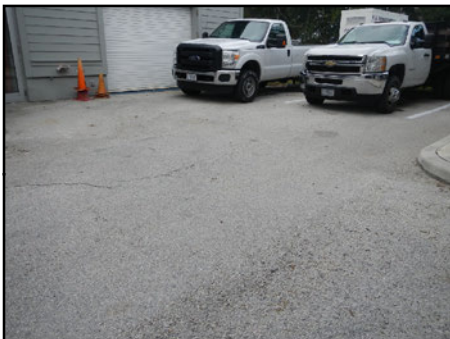
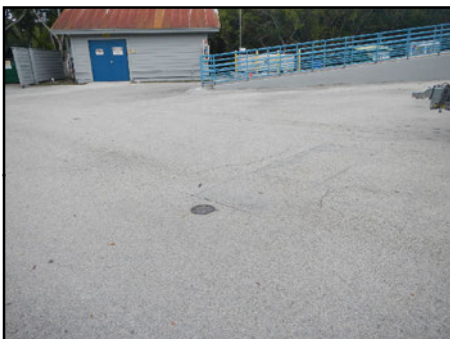
ROUTE 0901A: HEADQUARTERS PARKING PAVED

Inspection Date	FMSS Number	User Access	Surface Type
3/14/2019	5340	NONPUBLIC	ASPHALT
Area (Sq. Ft.)	Lane Miles (11' Widths)	Curb Reveal (Inches)	Curb Recommendation
35,001	0.603	5	DO NOTHING
Curb Type		Curb & Gutter Type	
CONCRETE		NO CURB AND GUTTER	
Pavement Recommendation		Condition Rating / PCR	
PREVENTIVE MAINTENANCE		GOOD / 90

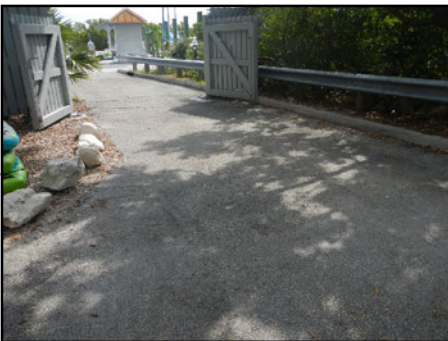
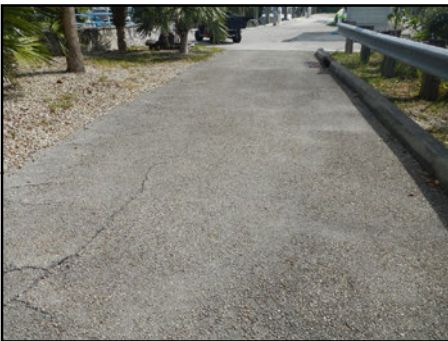
ROUTE 0902: DOCK ACCESS PARKING

Inspection Date	FMSS Number	User Access	Surface Type
3/14/2019	102420	NONPUBLIC	ASPHALT
Area (Sq. Ft.)	Lane Miles (11' Widths)	Curb Reveal (Inches)	Curb Recommendation
2,446	0.042	5	DO NOTHING
Curb Type		Curb & Gutter Type	
CONCRETE		NO CURB AND GUTTER	
Pavement Recommendation		Condition Rating / PCR	
LIGHT 3R TREATMENTS		FAIR / 73

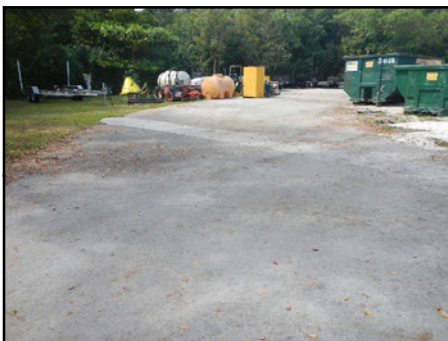
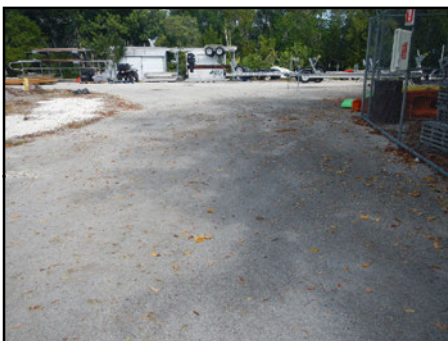
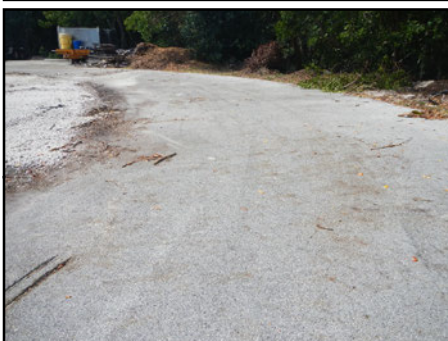
ROUTE 0903: BONEYARD PARKING

Inspection Date	FMSS Number	User Access	Surface Type
3/14/2019	102423	NONPUBLIC	ASPHALT
Area (Sq. Ft.)	Lane Miles (11' Widths)	Curb Reveal (Inches)	Curb Recommendation
12,805	0.22	NOT APPLICABLE	NOT APPLICABLE
Curb Type		Curb & Gutter Type	
NO CURB		NO CURB AND GUTTER	
Pavement Recommendation		Condition Rating / PCR	
LIGHT 3R TREATMENTS		FAIR / 73
