# BISO Cycle 6

## Final Report

### Road Inventory and Condition Assessment of Paved Routes Big South Fork National River and Recreation Area

**Report Date: June 2022**

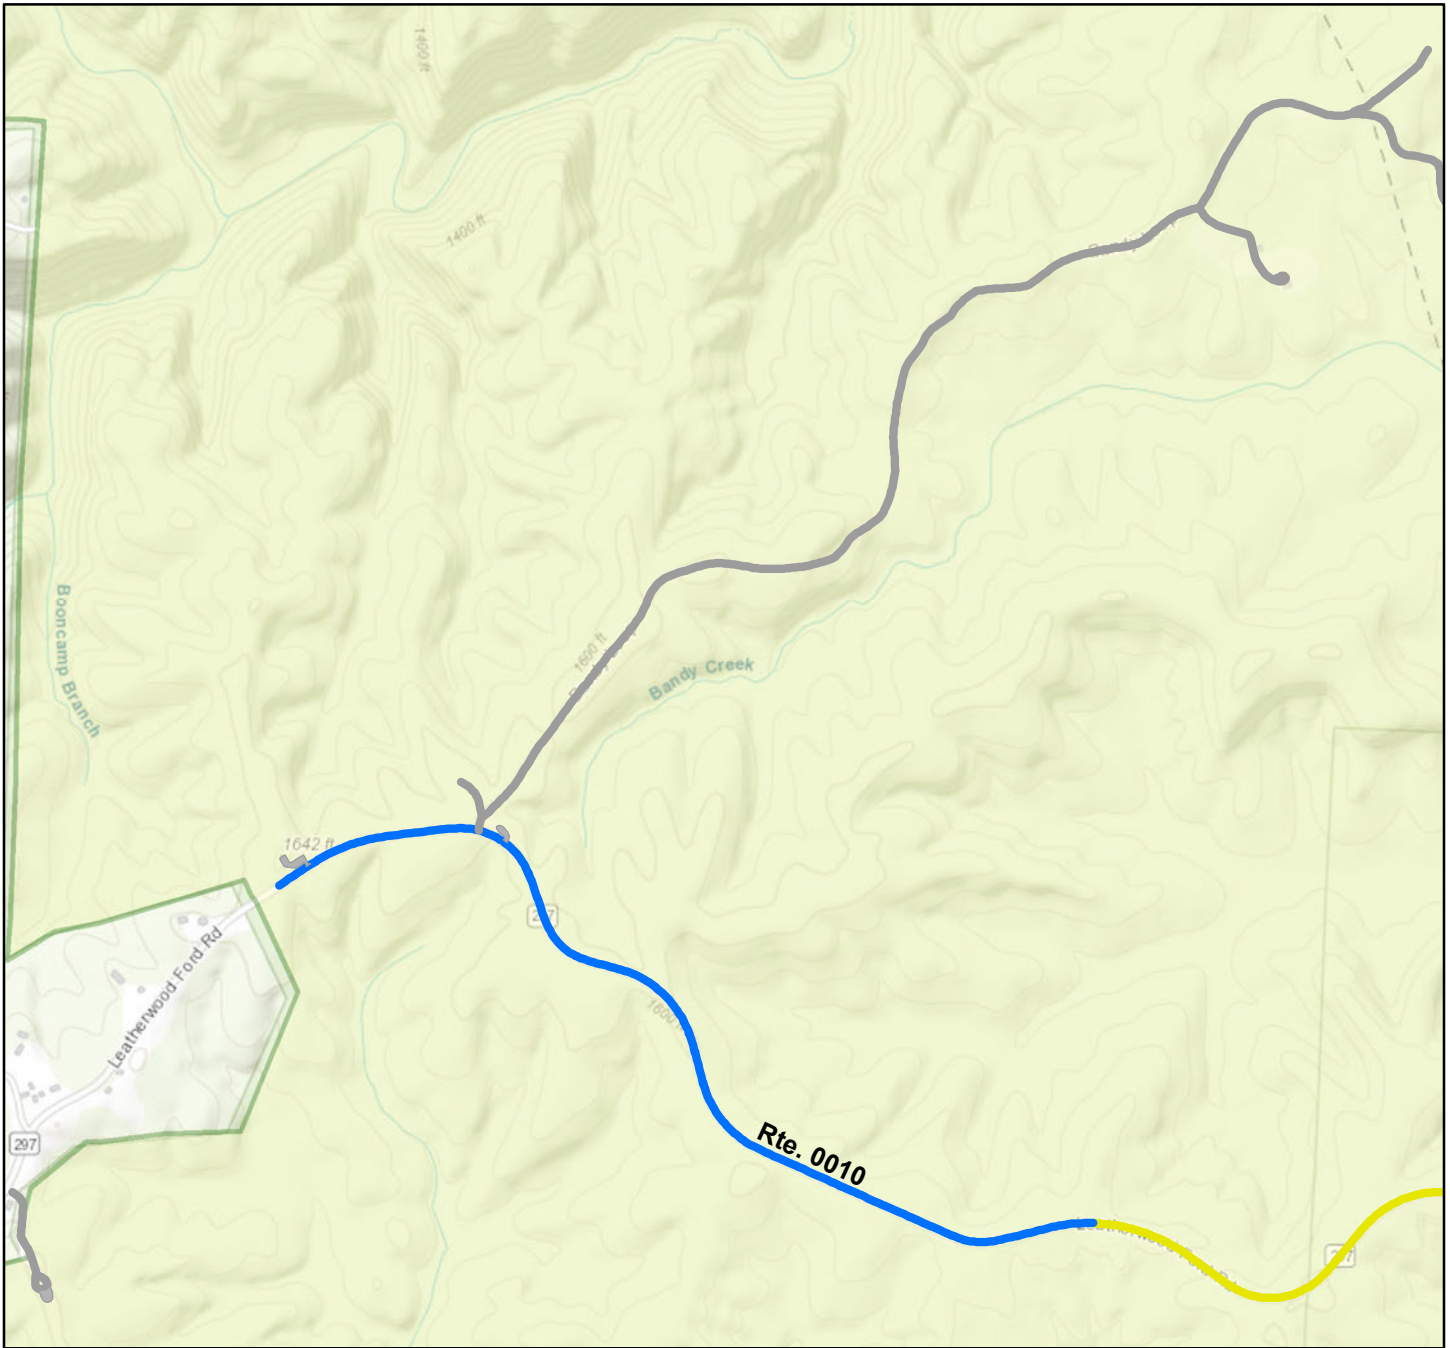
Colors on map represent condition scores at 1-mile intervals. See Appendix for definitions and formulas  
Only Data Collection Vehicle and Manually Rated Roads are displayed

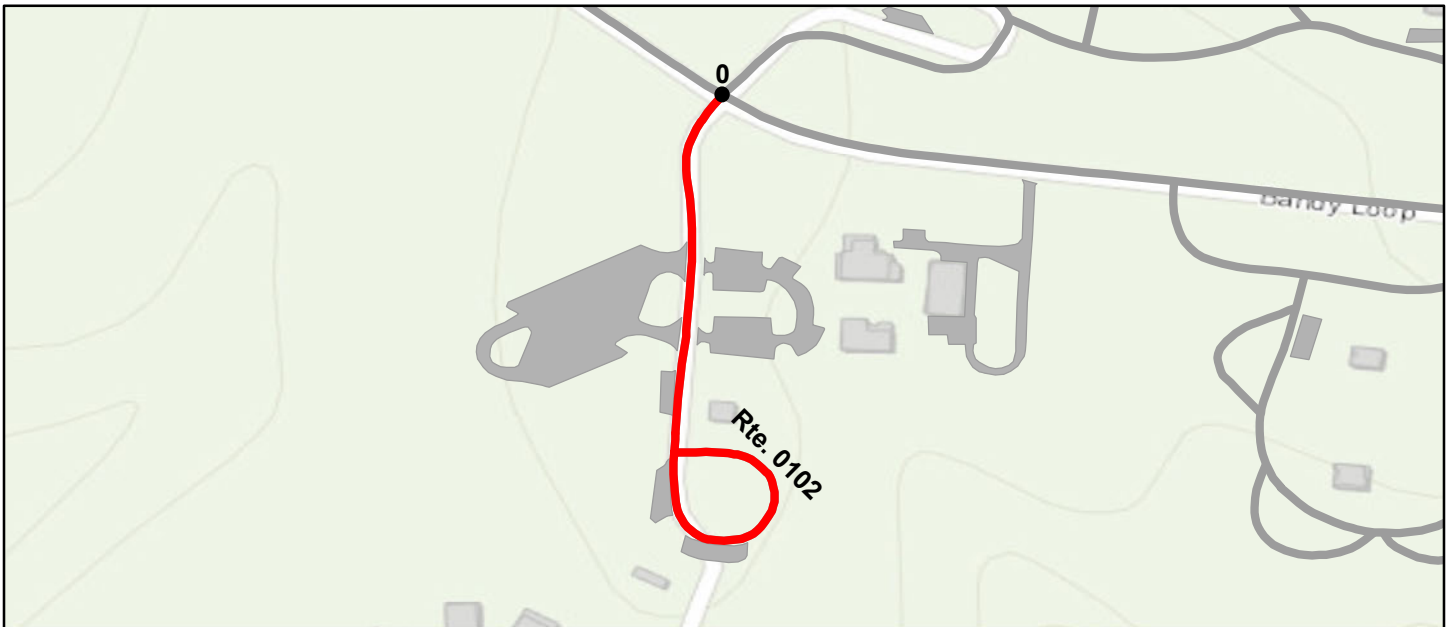
## ROUTE 0102: STABLE ROAD

Route Condition Legend – Pavement Condition Rating (PCR)						
Poor (0 - 60)	Fair (61- 84)	Good (85 - 94)	Excellent (95 - 100)	Not Rated		
Colors on map represent condition scores at 0.10-mile intervals. See Appendix for definitions and formulas.						
<b>Inspection Date:</b> 7/15/2021	<b>Beginning Section MP</b>	0				
<b>Paved Length (Miles):</b> 0.18	<b>Section Length (MI)</b>	0.18				
<b>Surface Type:</b> ASPHALT	<b>Route Summary</b>					
<b>Roadway Condition Information</b>						
Pavement Condition Rating (PCR)	32	32				
Surface Condition Rating (SCR)	32	32				
Roughness Condition Index (RCI)	N/A	N/A				
<b>Distress Index Values</b>						
Structural Crack Index	76	76				
Alligator Crack Index	100	100				
Longitudinal Crack Index	76	76				
Transverse Cracking Index	32	32				
Patching Index	100	100				
Rutting Index	95	95				
International Roughness Index (IRI)	N/A	N/A				
<b>Lane &amp; Width Information</b>

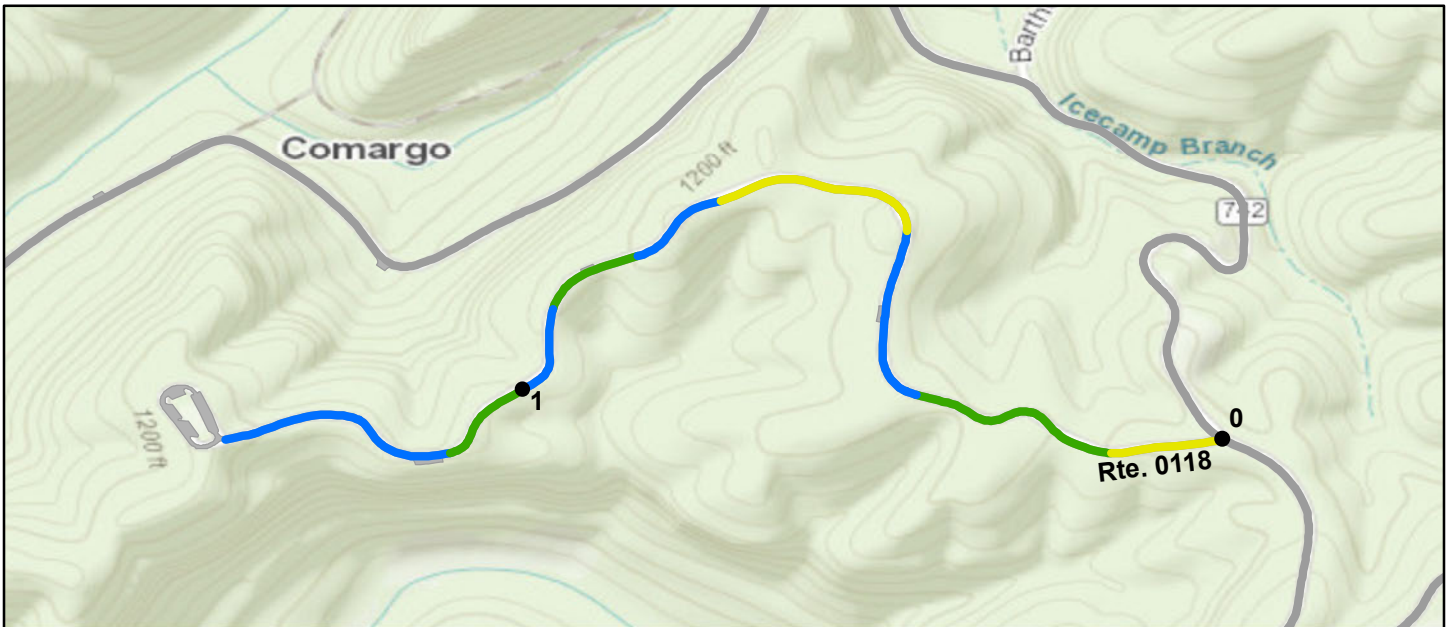
## ROUTE 0118: BLUE HERON OVERLOOK ROAD

Route Condition Legend – Pavement Condition Rating (PCR)						
Poor (0 - 60)	Fair (61- 84)	Good (85 - 94)	Excellent (95 - 100)	Not Rated		
Colors on map represent condition scores at 0.10-mile intervals. See Appendix for definitions and formulas.						
<b>Inspection Date:</b> 7/20/2021	<b>Beginning Section MP</b>	0	1			
<b>Paved Length (Miles):</b> 1.33	<b>Section Length (MI)</b>	1	0.33			
<b>Surface Type:</b> ASPHALT	<b>Route Summary</b>					
<b>Roadway Condition Information</b>						
Pavement Condition Rating (PCR)	92	90	98			
Surface Condition Rating (SCR)	92	89	99			
Roughness Condition Index (RCI)	93	92	96			
<b>Distress Index Values</b>						
Structural Crack Index	92	89	100			
Alligator Crack Index	100	100	100			
Longitudinal Crack Index	92	89	100			
Transverse Cracking Index	98	98	99			
Patching Index	100	100	100			
Rutting Index	100	99	100			
International Roughness Index (IRI)	133	136	125			
<b>Lane &amp; Width Information</b>

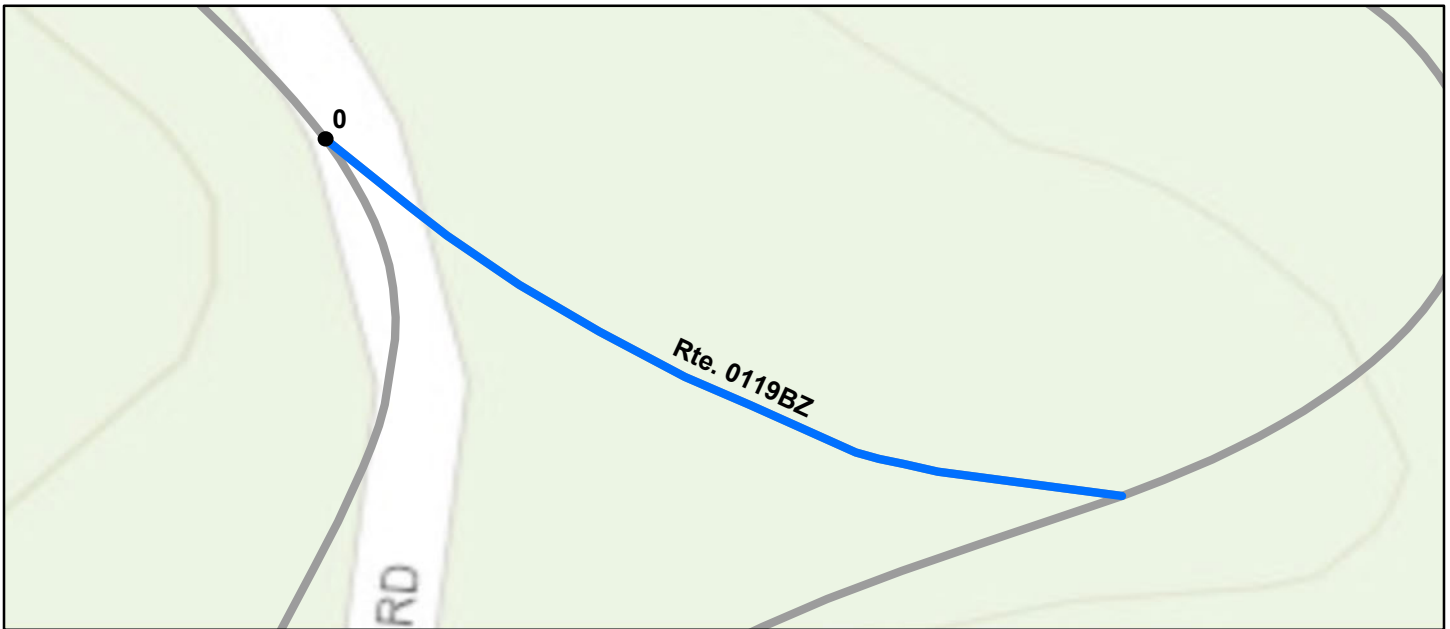
Subcomponent of Route BISO-0119ZZ

Route Condition Legend – Pavement Condition Rating (PCR)							
Poor (0 - 60)		Fair (61- 84)		Good (85 - 94)		Excellent (95 - 100)	Not Rated
Colors on map represent condition scores at 0.10-mile intervals. See Appendix for definitions and formulas.							
<b>Inspection Date:</b>	7/20/2021	<b>Beginning Section MP</b>	0				
<b>Paved Length (Miles):</b>	0.03	<b>Section Length (MI)</b>	0.03				
<b>Surface Type:</b>	ASPHALT	<b>Route Summary</b>					
<b>Roadway Condition Information</b>							
Pavement Condition Rating (PCR)	96	96					
Surface Condition Rating (SCR)	96	96					
Roughness Condition Index (RCI)	N/A	N/A					
<b>Distress Index Values</b>							
Structural Crack Index	100	100					
Alligator Crack Index	100	100					
Longitudinal Crack Index	100	100					
Transverse Cracking Index	100	100					
Patching Index	100	100					
Rutting Index	96	96					
International Roughness Index (IRI)	N/A	N/A					
<b>Lane &amp; Width Information</b>

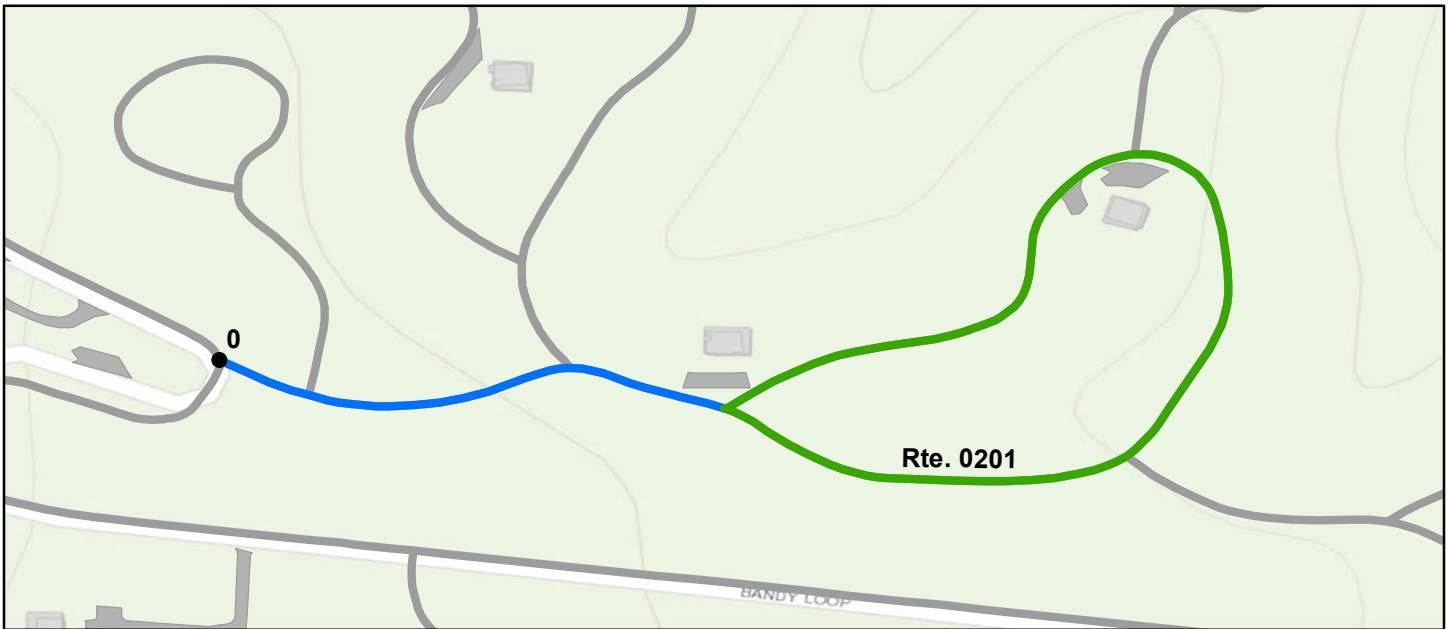
## ROUTE 0201: BANDY CREEK CAMPGROUND AREAS B C AND D ACCESS ROAD

<b>Route Condition Legend – Pavement Condition Rating (PCR)</b>						
<b>Poor (0 - 60)</b>	<b>Fair (61- 84)</b>	<b>Good (85 - 94)</b>	<b>Excellent (95 - 100)</b>	<b>Not Rated</b>		
Colors on map represent condition scores at 0.10-mile intervals. See Appendix for definitions and formulas.						
<b>Inspection Date:</b> 7/15/2021	<b>Beginning Section MP</b>	0				
<b>Paved Length (Miles):</b> 0.38	<b>Section Length (MI)</b>	0.38				
<b>Surface Type:</b> ASPHALT	<b>Route Summary</b>					
<b>Roadway Condition Information</b>						
Pavement Condition Rating (PCR)	92	92				
Surface Condition Rating (SCR)	92	92				
Roughness Condition Index (RCI)	N/A	N/A				
<b>Distress Index Values</b>						
Structural Crack Index	97	97				
Alligator Crack Index	100	100				
Longitudinal Crack Index	97	97				
Transverse Cracking Index	92	92				
Patching Index	100	100				
Rutting Index	100	100				
International Roughness Index (IRI)	N/A	N/A

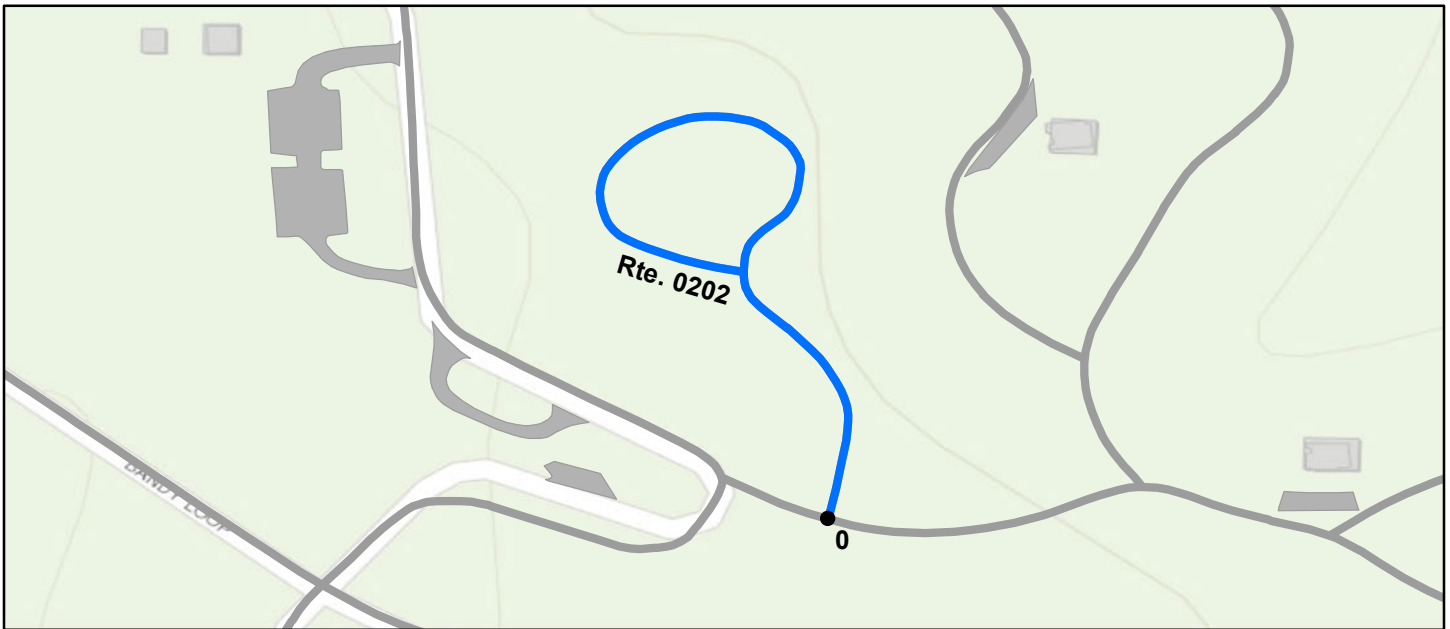
## ROUTE 0202: BANDY CREEK CAMPGROUND AREA B ACCESS ROAD

Route Condition Legend – Pavement Condition Rating (PCR)						
Poor (0 - 60)	Fair (61- 84)	Good (85 - 94)	Excellent (95 - 100)	Not Rated		
Colors on map represent condition scores at 0.10-mile intervals. See Appendix for definitions and formulas.						
<b>Inspection Date:</b> 7/15/2021	<b>Beginning Section MP</b>	0				
<b>Paved Length (Miles):</b> 0.15	<b>Section Length (MI)</b>	0.15				
<b>Surface Type:</b> ASPHALT	<b>Route Summary</b>					
<b>Roadway Condition Information</b>						
Pavement Condition Rating (PCR)	96	96				
Surface Condition Rating (SCR)	96	96				
Roughness Condition Index (RCI)	N/A	N/A				
<b>Distress Index Values</b>						
Structural Crack Index	98	98				
Alligator Crack Index	100	100				
Longitudinal Crack Index	98	98				
Transverse Cracking Index	96	96				
Patching Index	100	100				
Rutting Index	98	98				
International Roughness Index (IRI)	N/A	N/A				
<b>Lane &amp; Width Information</b>

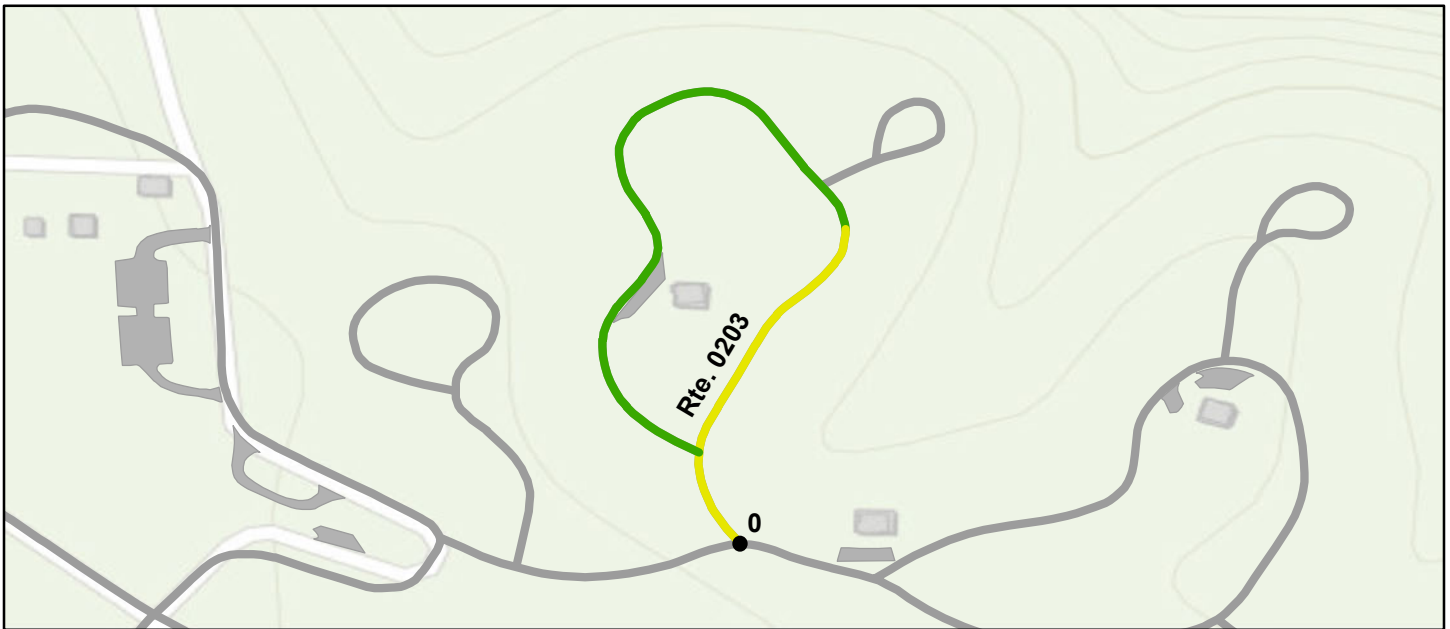
## ROUTE 0203: BANDY CREEK CAMPGROUND AREA C ACCESS ROAD

Route Condition Legend – Pavement Condition Rating (PCR)						
Poor (0 - 60)	Fair (61- 84)	Good (85 - 94)	Excellent (95 - 100)	Not Rated		
Colors on map represent condition scores at 0.10-mile intervals. See Appendix for definitions and formulas.						
<b>Inspection Date:</b> 7/15/2021	<b>Beginning Section MP</b>	0				
<b>Paved Length (Miles):</b> 0.28	<b>Section Length (MI)</b>	0.28				
<b>Surface Type:</b> ASPHALT	<b>Route Summary</b>					
<b>Roadway Condition Information</b>						
Pavement Condition Rating (PCR)	89	89				
Surface Condition Rating (SCR)	89	89				
Roughness Condition Index (RCI)	N/A	N/A				
<b>Distress Index Values</b>						
Structural Crack Index	96	96				
Alligator Crack Index	100	100				
Longitudinal Crack Index	96	96				
Transverse Cracking Index	89	89				
Patching Index	100	100				
Rutting Index	97	97				
International Roughness Index (IRI)	N/A	N/A				
<b>Lane &amp; Width Information</b>

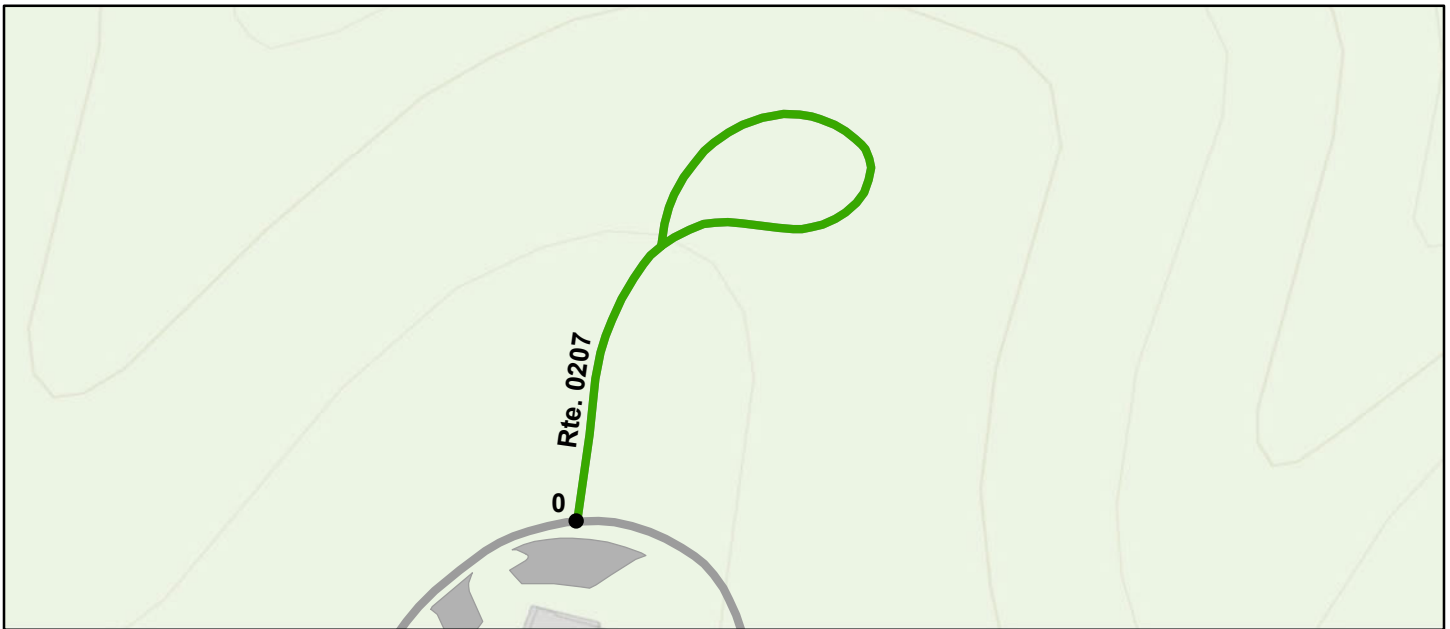
## ROUTE 0207: BANDY CREEK CAMPGROUND AREA D LOOP 2 ROAD

Route Condition Legend – Pavement Condition Rating (PCR)						
Poor (0 - 60)	Fair (61- 84)	Good (85 - 94)	Excellent (95 - 100)	Not Rated		
Colors on map represent condition scores at 0.10-mile intervals. See Appendix for definitions and formulas.						
<b>Inspection Date:</b> 7/15/2021	<b>Beginning Section MP</b>	0				
<b>Paved Length (Miles):</b> 0.08	<b>Section Length (MI)</b>	0.08				
<b>Surface Type:</b> ASPHALT	<b>Route Summary</b>					
<b>Roadway Condition Information</b>						
Pavement Condition Rating (PCR)	90	90				
Surface Condition Rating (SCR)	90	90				
Roughness Condition Index (RCI)	N/A	N/A				
<b>Distress Index Values</b>						
Structural Crack Index	100	100				
Alligator Crack Index	100	100				
Longitudinal Crack Index	100	100				
Transverse Cracking Index	90	90				
Patching Index	100	100				
Rutting Index	100	100				
International Roughness Index (IRI)	N/A	N/A				
<b>Lane &amp; Width Information</b>

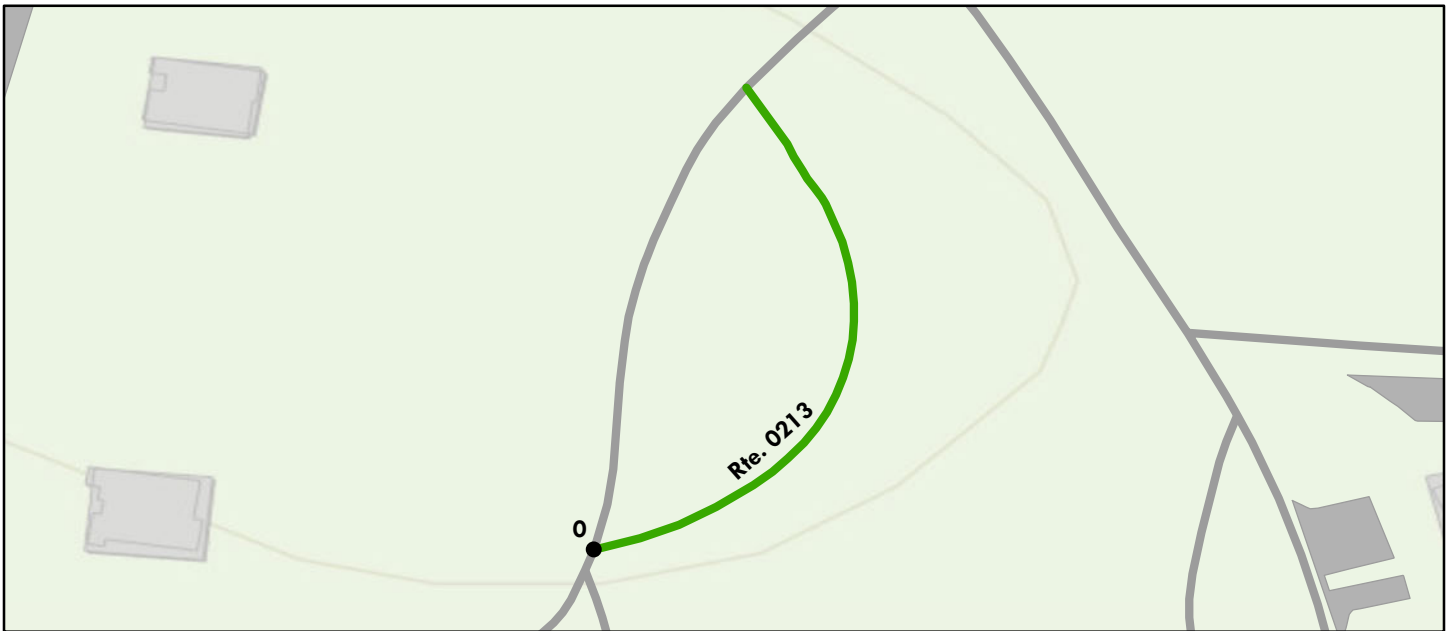
## ROUTE 0213: BANDY CREEK CAMPGROUND AREA E LOOP PULLOUT 4

Route Condition Legend – Pavement Condition Rating (PCR)						
Poor (0 - 60)	Fair (61- 84)	Good (85 - 94)	Excellent (95 - 100)	Not Rated		
See Appendix for definitions and formulas						
<b>Inspection Date:</b> 6/17/2021	<b>Beginning Section MP</b>	0.00				
<b>Paved Length (Miles):</b> 0.05	<b>Section Length (MI)</b>	0.05				
<b>Surface Type:</b> ASPHALT	<b>Route Summary</b>					
<b>Roadway Condition Information</b>						
Pavement Condition Rating (PCR)	90	90				
Surface Condition Rating (SCR)	90	90				
Roughness Condition Index (RCI)	N/A	N/A				
<b>Distress Index Values</b>						
Structural Crack Index	N/A	N/A				
Alligator Crack Index	97	97				
Longitudinal Crack Index	97	97				
Transverse Cracking Index	90	90				
Patching Index	97	97				
Rutting Index	97	97				
International Roughness Index (IRI)	N/A	N/A				
<b>Lane &amp; Width Information</b>						
Number of Lanes	1	1				
Paved Width (ft)	12.1	12.1				
Lane Width (ft)	12.1	12.1

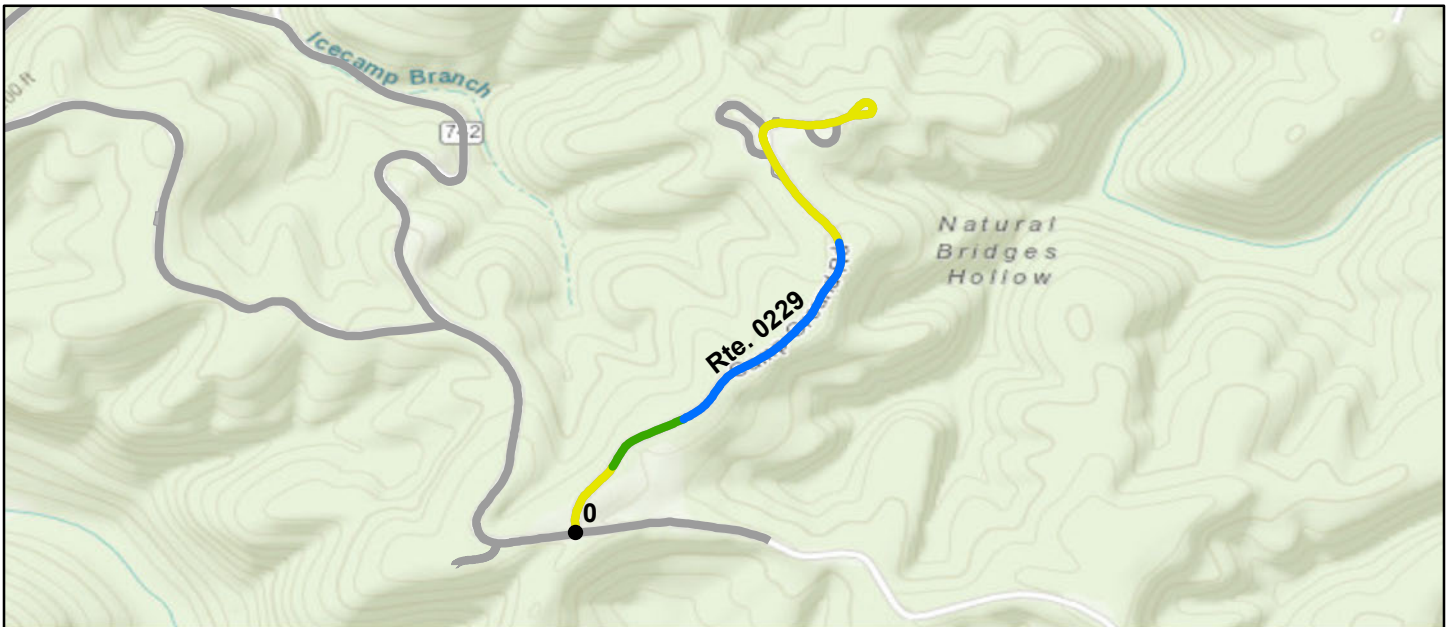
## ROUTE 0229: BLUE HERON CAMPGROUND ROAD

Route Condition Legend – Pavement Condition Rating (PCR)						
Poor (0 - 60)	Fair (61- 84)	Good (85 - 94)	Excellent (95 - 100)	Not Rated		
Colors on map represent condition scores at 0.10-mile intervals. See Appendix for definitions and formulas.						
<b>Inspection Date:</b> 7/20/2021	<b>Beginning Section MP</b>	0				
<b>Paved Length (Miles):</b> 0.83	<b>Section Length (MI)</b>	0.83				
<b>Surface Type:</b> ASPHALT	<b>Route Summary</b>					
<b>Roadway Condition Information</b>						
Pavement Condition Rating (PCR)	84	84				
Surface Condition Rating (SCR)	84	84				
Roughness Condition Index (RCI)	N/A	N/A				
<b>Distress Index Values</b>						
Structural Crack Index	96	96				
Alligator Crack Index	100	100				
Longitudinal Crack Index	96	96				
Transverse Cracking Index	84	84				
Patching Index	100	100				
Rutting Index	100	100				
International Roughness Index (IRI)	N/A	N/A				
<b>Lane &amp; Width Information</b>

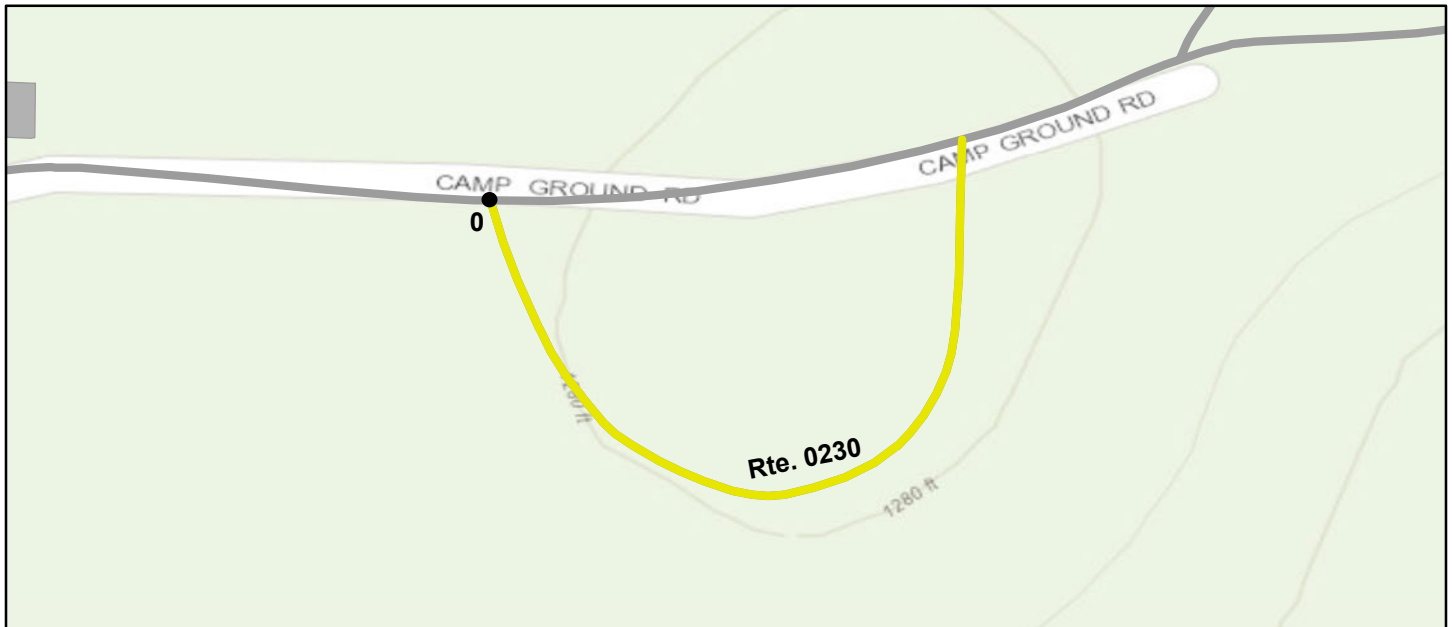
## ROUTE 0230: BLUE HERON CAMPGROUND LOOP 1

Colors on map represent condition scores at 0.10-mile intervals. See Appendix for definitions and formulas.

<b>Inspection Date:</b> 7/20/2021	<b>Beginning Section MP</b>	0				
<b>Paved Length (Miles):</b> 0.06	<b>Section Length (MI)</b>	0.06				
<b>Surface Type:</b> ASPHALT	<b>Route Summary</b>					
<b>Roadway Condition Information</b>						
Pavement Condition Rating (PCR)	71	71				
Surface Condition Rating (SCR)	71	71				
Roughness Condition Index (RCI)	N/A	N/A				
<b>Distress Index Values</b>						
Structural Crack Index	96	96				
Alligator Crack Index	100	100				
Longitudinal Crack Index	96	96				
Transverse Cracking Index	71	71				
Patching Index	100	100				
Rutting Index	97	97				
International Roughness Index (IRI)	N/A	N/A				
<b>Lane &amp; Width Information</b>						
Number of Lanes	1	1				
Paved Width (ft)	14.2	14.2				
Lane Width (ft)	14.2	14.2

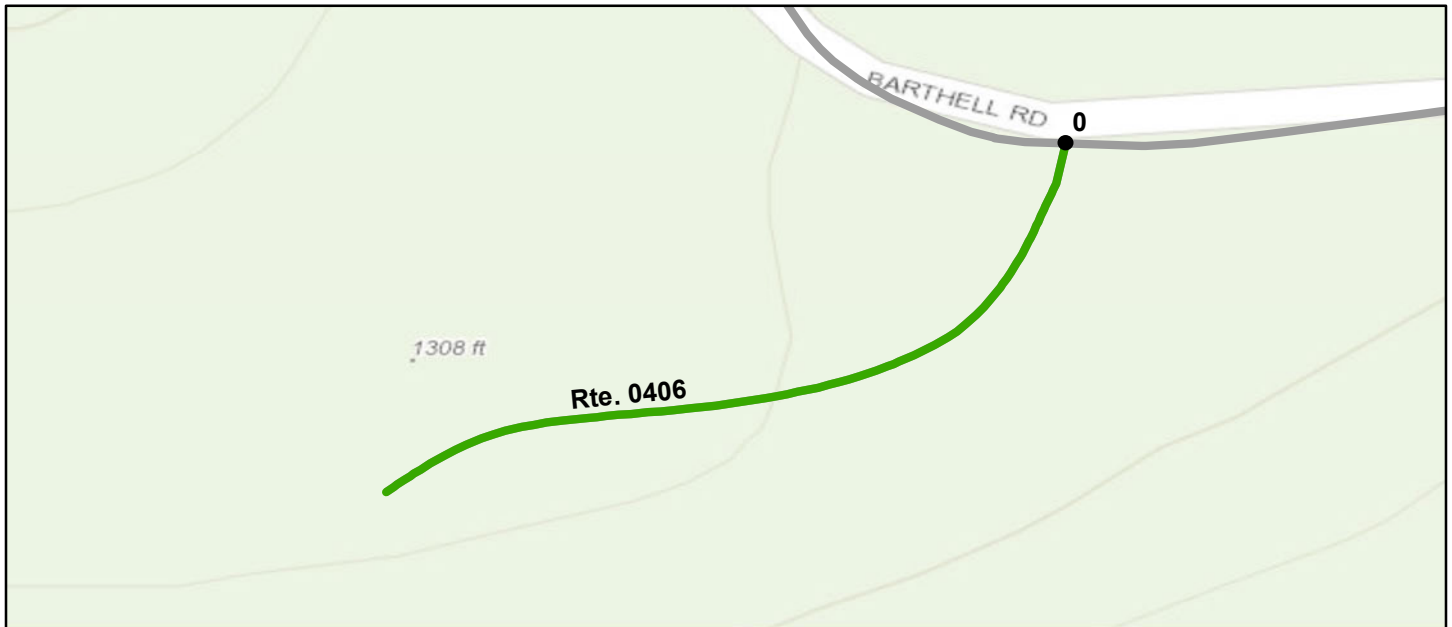
## ROUTE 0406: BLUE HERON RESIDENCE ACCESS ROAD

Colors on map represent condition scores at 0.10-mile intervals. See Appendix for definitions and formulas.

<b>Inspection Date:</b> 7/20/2021	<b>Beginning Section MP</b>	0				
<b>Paved Length (Miles):</b> 0.06	<b>Section Length (MI)</b>	0.06				
<b>Surface Type:</b> ASPHALT	<b>Route Summary</b>					
<b>Roadway Condition Information</b>						
Pavement Condition Rating (PCR)	94	94				
Surface Condition Rating (SCR)	94	94				
Roughness Condition Index (RCI)	N/A	N/A				
<b>Distress Index Values</b>						
Structural Crack Index	95	95				
Alligator Crack Index	100	100				
Longitudinal Crack Index	95	95				
Transverse Cracking Index	95	95				
Patching Index	100	100				
Rutting Index	94	94				
International Roughness Index (IRI)	N/A	N/A				
<b>Lane &amp; Width Information</b>						
Number of Lanes	1	1				
Paved Width (ft)	13.3	13.3				
Lane Width (ft)	13.3	13.3

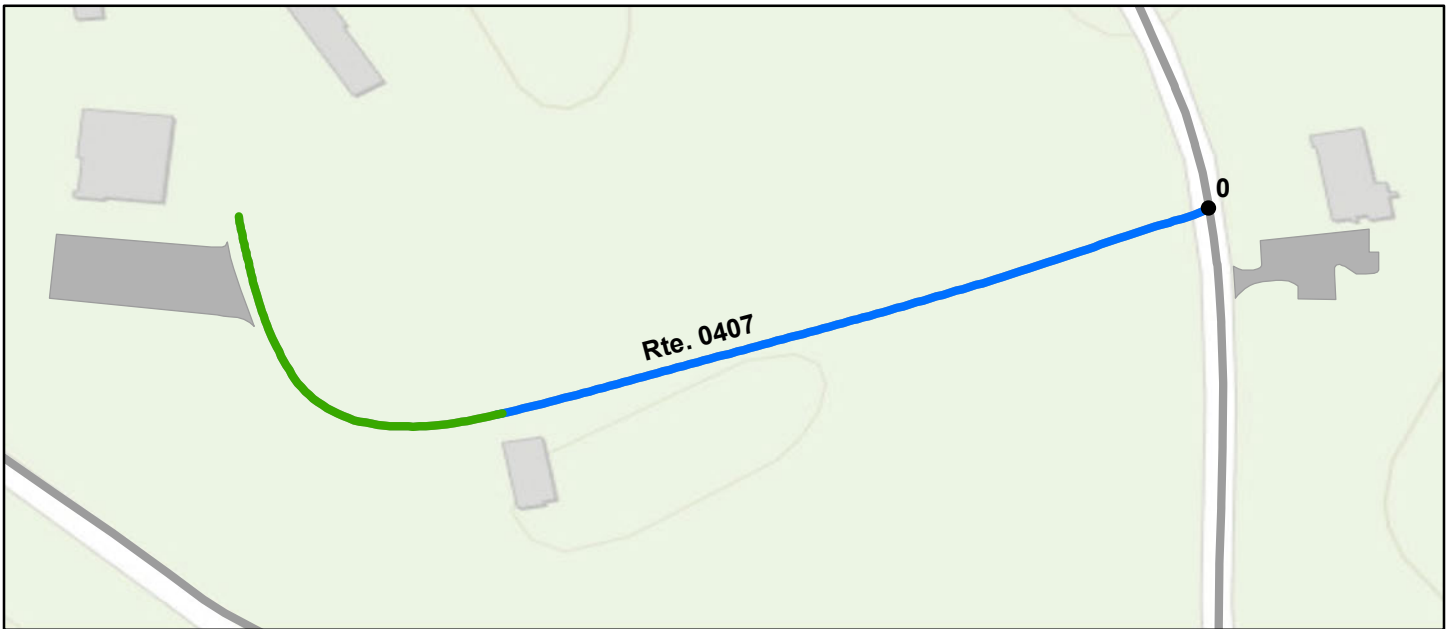
## ROUTE 0407: EAST RIM MAINTENANCE AREA ROAD

Route Condition Legend – Pavement Condition Rating (PCR)						
Poor (0 - 60)	Fair (61- 84)	Good (85 - 94)	Excellent (95 - 100)	Not Rated		
Colors on map represent condition scores at 0.10-mile intervals. See Appendix for definitions and formulas.						
<b>Inspection Date:</b> 7/15/2021	<b>Beginning Section MP</b>	0				
<b>Paved Length (Miles):</b> 0.16	<b>Section Length (MI)</b>	0.16				
<b>Surface Type:</b> ASPHALT	<b>Route Summary</b>					
<b>Roadway Condition Information</b>						
Pavement Condition Rating (PCR)	94	94				
Surface Condition Rating (SCR)	94	94				
Roughness Condition Index (RCI)	N/A	N/A				
<b>Distress Index Values</b>						
Structural Crack Index	100	100				
Alligator Crack Index	100	100				
Longitudinal Crack Index	100	100				
Transverse Cracking Index	100	100				
Patching Index	100	100				
Rutting Index	94	94				
International Roughness Index (IRI)	N/A	N/A				
<b>Lane &amp; Width Information</b>

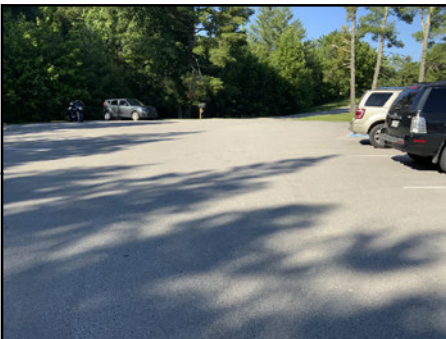
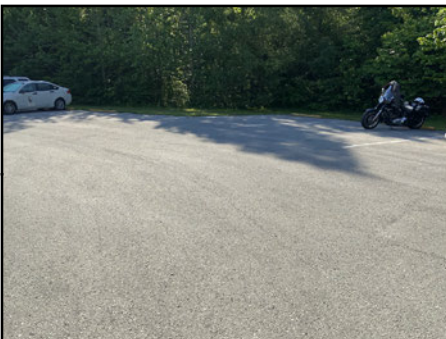
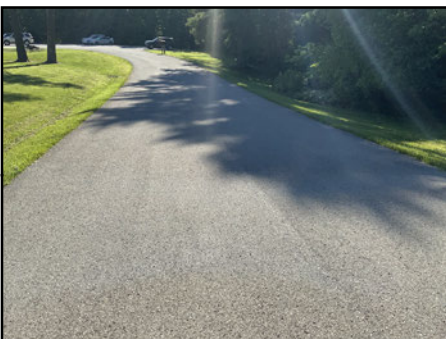
## ROUTE 0913: EAST RIM OVERLOOK PARKING

Inspection Date	FMSS Number	User Access	Surface Type
6/17/2021	56850	PUBLIC	ASPHALT
Area (Sq. Ft.)	Lane Miles (11' Widths)	Curb Reveal (Inches)	Curb Recommendation
14,592	0.251	4	LIGHT REPAIR
Curb Type		Curb & Gutter Type	
CONCRETE		CONCRETE	
Pavement Recommendation		Condition Rating / PCR	
LIGHT 3R TREATMENTS		FAIR / 73

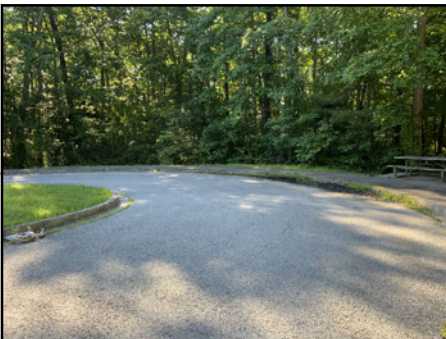
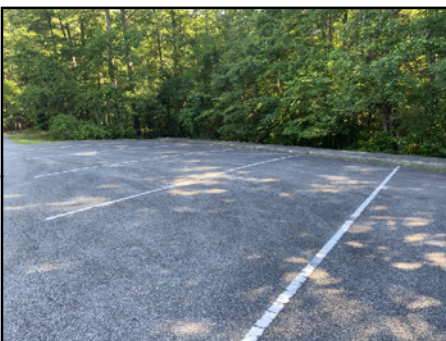
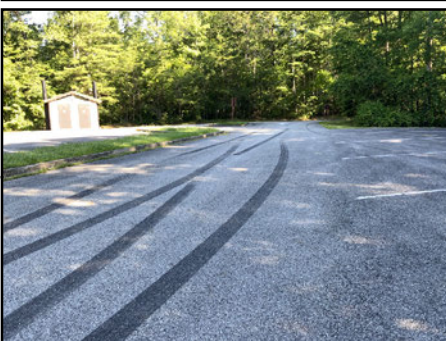
## ROUTE 0914: SUNSET TRAILHEAD PARKING

Inspection Date	FMSS Number	User Access	Surface Type
6/17/2021	56846	PUBLIC	ASPHALT
Area (Sq. Ft.)	Lane Miles (11' Widths)	Curb Reveal (Inches)	Curb Recommendation
2,185	0.038	NOT APPLICABLE	NOT APPLICABLE
Curb Type		Curb & Gutter Type	
NO CURB		NO CURB AND GUTTER	
Pavement Recommendation		Condition Rating / PCR	
LIGHT 3R TREATMENTS		FAIR / 73

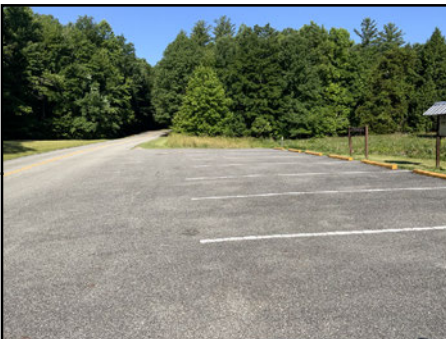
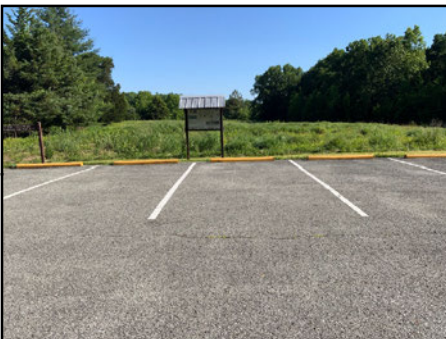
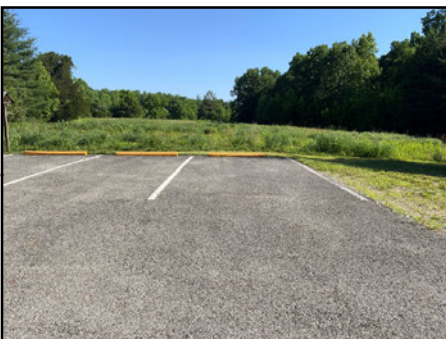
## ROUTE 0916: FACILITY MANAGEMENT AREA PARKING

Inspection Date	FMSS Number	User Access	Surface Type
6/17/2021	53255	NONPUBLIC	ASPHALT
Area (Sq. Ft.)	Lane Miles (11' Widths)	Curb Reveal (Inches)	Curb Recommendation
7,531	0.13	NOT APPLICABLE	NOT APPLICABLE
Curb Type		Curb & Gutter Type	
NO CURB		NO CURB AND GUTTER	
Pavement Recommendation		Condition Rating / PCR	
RECONSTRUCTION		POOR / 30

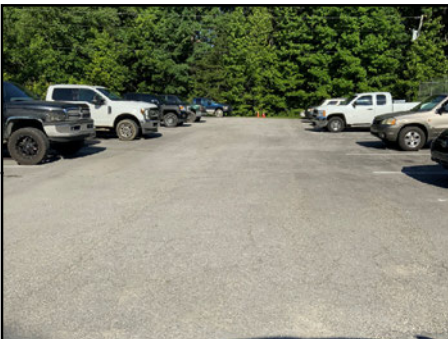
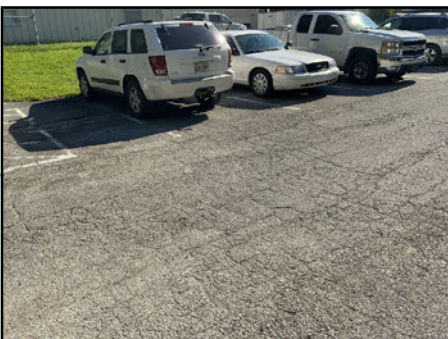
## ROUTE 0925: BREWSTER BRIDGE TRAILHEAD PARKING

Inspection Date	FMSS Number	User Access	Surface Type
6/18/2021	55689	PUBLIC	ASPHALT
Area (Sq. Ft.)	Lane Miles (11' Widths)	Curb Reveal (Inches)	Curb Recommendation
35,672	0.614	NOT APPLICABLE	NOT APPLICABLE
Curb Type		Curb & Gutter Type	
NO CURB		NO CURB AND GUTTER	
Pavement Recommendation		Condition Rating / PCR	
PREVENTIVE MAINTENANCE		GOOD / 90

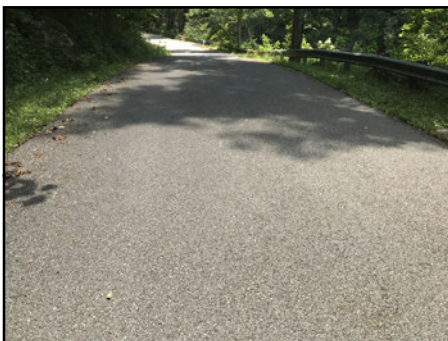
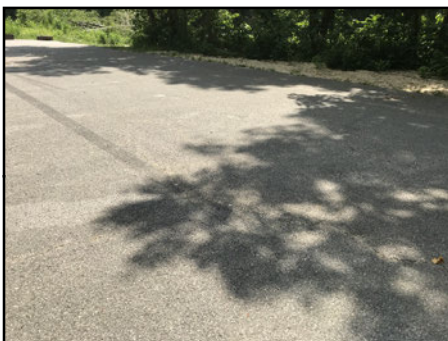
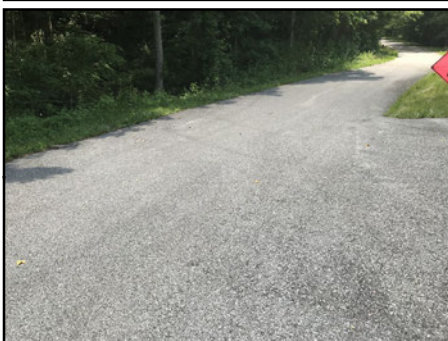
## ROUTE 0926: HONEY CREEK OVERLOOK PARKING

Inspection Date	FMSS Number	User Access	Surface Type
6/18/2021	55795	PUBLIC	ASPHALT
Area (Sq. Ft.)	Lane Miles (11' Widths)	Curb Reveal (Inches)	Curb Recommendation
7,879	0.136	NOT APPLICABLE	NOT APPLICABLE
Curb Type		Curb & Gutter Type	
NO CURB		NO CURB AND GUTTER	
Pavement Recommendation		Condition Rating / PCR	
LIGHT 3R TREATMENTS		FAIR / 73

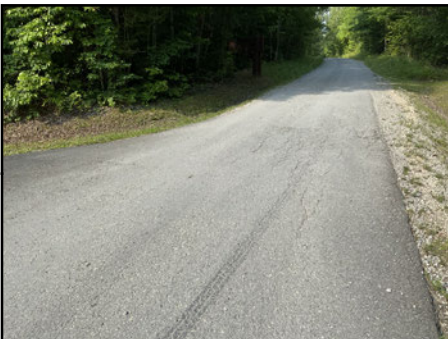
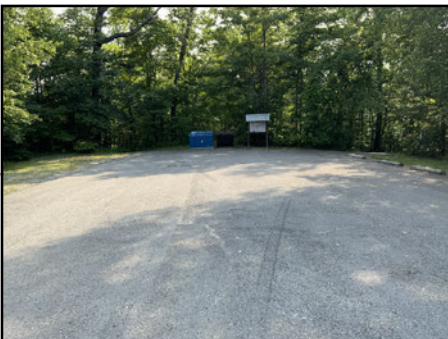
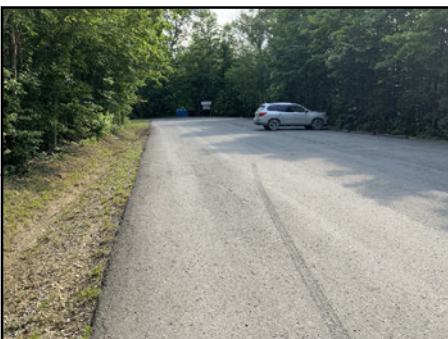
## ROUTE 0934: ROARING PAUNCH CREEK PARKING

Inspection Date	FMSS Number	User Access	Surface Type
6/19/2021	54045	PUBLIC	ASPHALT
Area (Sq. Ft.)	Lane Miles (11' Widths)	Curb Reveal (Inches)	Curb Recommendation
2,295	0.04	NOT APPLICABLE	NOT APPLICABLE
Curb Type		Curb & Gutter Type	
NO CURB		NO CURB AND GUTTER	
Pavement Recommendation		Condition Rating / PCR	
PREVENTIVE MAINTENANCE		GOOD / 90

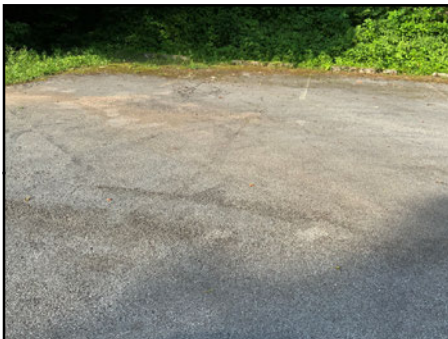
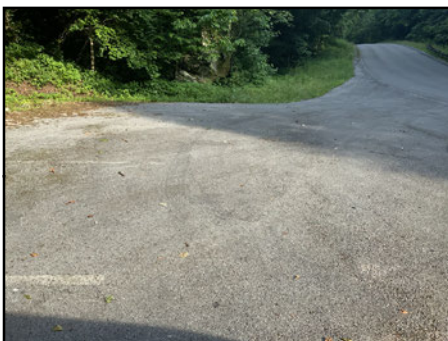
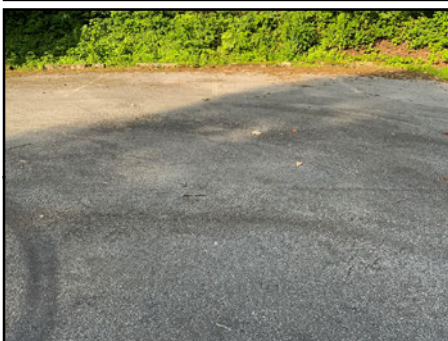
## ROUTE 0935: MINE 18 PARKING

Inspection Date	FMSS Number	User Access	Surface Type
6/19/2021	54043	PUBLIC	ASPHALT
Area (Sq. Ft.)	Lane Miles (11' Widths)	Curb Reveal (Inches)	Curb Recommendation
69,971	1.205	5	MODERATE REPAIR
Curb Type		Curb & Gutter Type	
WOOD		NO CURB AND GUTTER	
Pavement Recommendation		Condition Rating / PCR	
HEAVY 3R TREATMENTS		POOR / 53

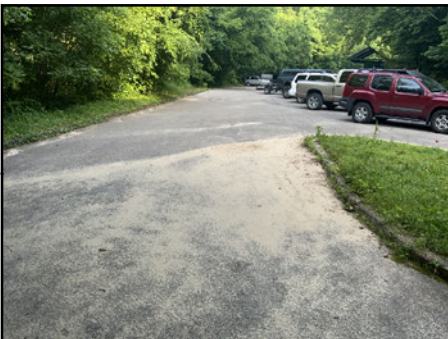
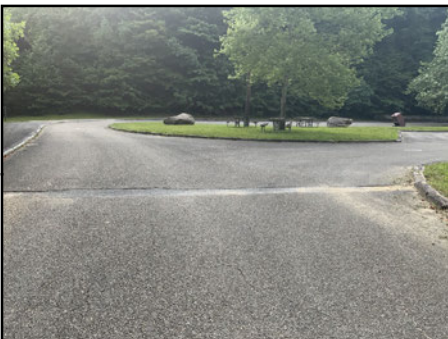
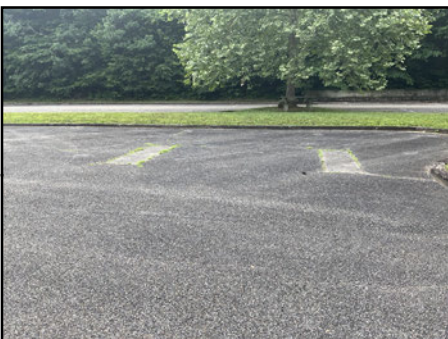
## ROUTE 0936: BLUE HERON OVERLOOK PARKING

Inspection Date	FMSS Number	User Access	Surface Type
6/19/2021	56679	PUBLIC	ASPHALT
Area (Sq. Ft.)	Lane Miles (11' Widths)	Curb Reveal (Inches)	Curb Recommendation
37,653	0.648	2	MODERATE REPAIR
Curb Type		Curb & Gutter Type	
WOOD		NO CURB AND GUTTER	
Pavement Recommendation		Condition Rating / PCR	
PREVENTIVE MAINTENANCE		GOOD / 90

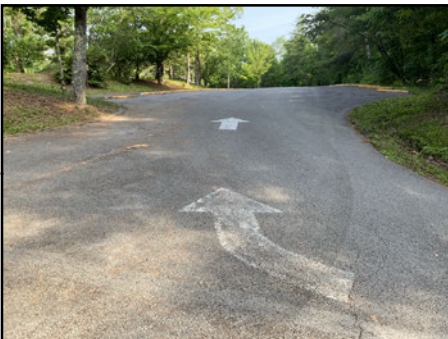
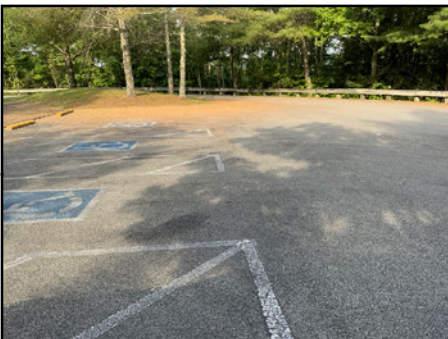
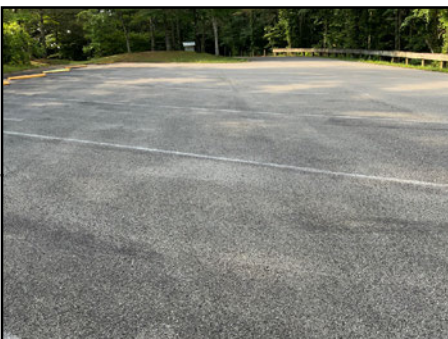
## ROUTE 0938: YAHOO FALLS TRAILHEAD PARKING

Inspection Date	FMSS Number	User Access	Surface Type
6/19/2021	60443	PUBLIC	ASPHALT
Area (Sq. Ft.)	Lane Miles (11' Widths)	Curb Reveal (Inches)	Curb Recommendation
3,086	0.053	NOT APPLICABLE	NOT APPLICABLE
Curb Type		Curb & Gutter Type	
NO CURB		NO CURB AND GUTTER	
Pavement Recommendation		Condition Rating / PCR	
PREVENTIVE MAINTENANCE		GOOD / 90

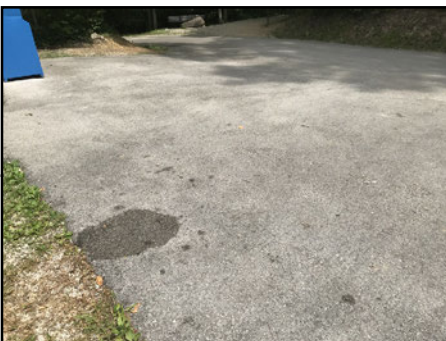
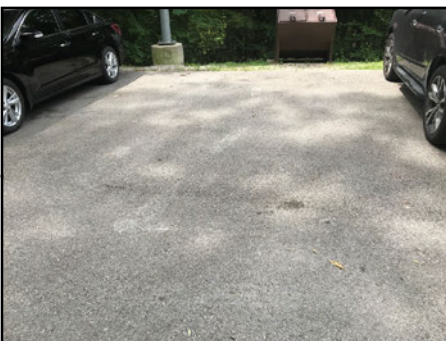
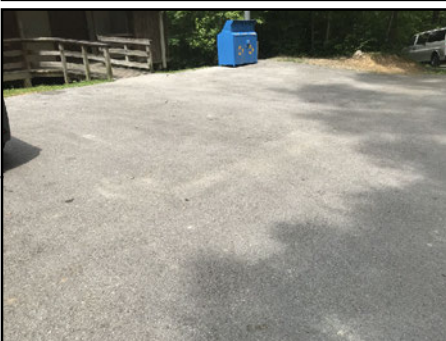
## ROUTE 0939: TENNESSEE RANGER STATION PARKING

Inspection Date	FMSS Number	User Access	Surface Type
6/17/2021	53258	NONPUBLIC	ASPHALT
Area (Sq. Ft.)	Lane Miles (11' Widths)	Curb Reveal (Inches)	Curb Recommendation
3,646	0.063	NOT APPLICABLE	NOT APPLICABLE
Curb Type		Curb & Gutter Type	
NO CURB		NO CURB AND GUTTER	
Pavement Recommendation		Condition Rating / PCR	
PREVENTIVE MAINTENANCE		GOOD / 90

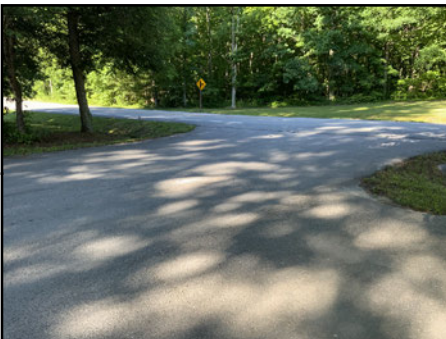
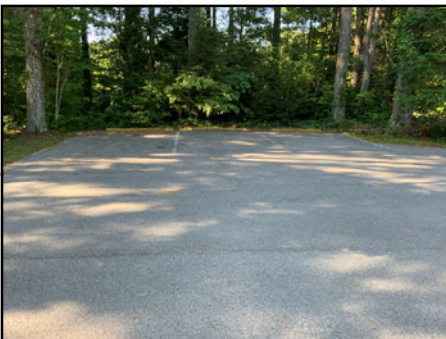
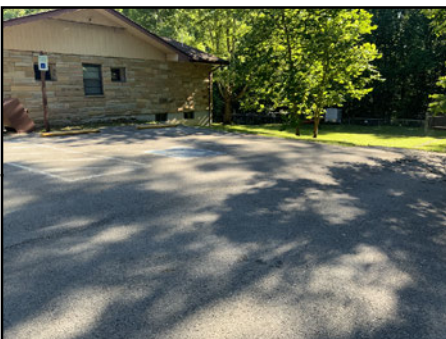
## ROUTE 0940ZZ: BANDY CREEK CAMPGROUND LOOP A COMFORT STATION B131 PARKING

Inspection Date	FMSS Number	User Access	Surface Type
6/17/2021	53580	PUBLIC	ASPHALT
Area (Sq. Ft.)	Lane Miles (11' Widths)	Condition Rating / PCR	
1,934	0.033	SUMMARY / 90

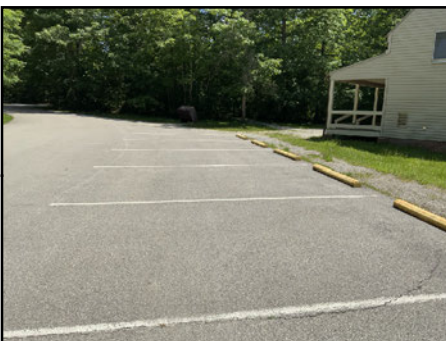
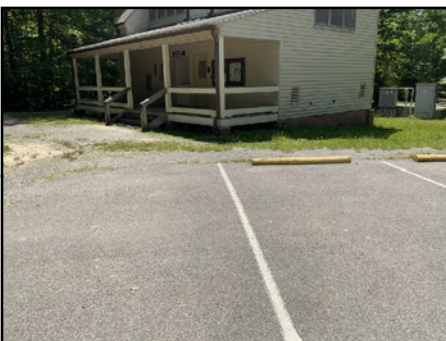
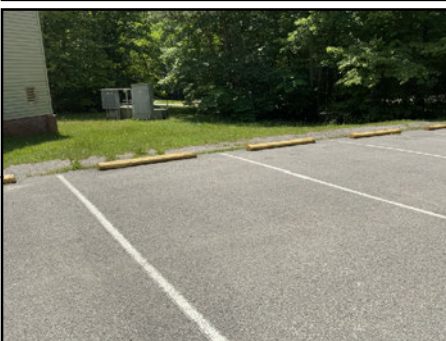
ROUTE 0942ZZ: BANDY CREEK CAMPGROUND LOOP D COMFORT STATION B127 PARKING

Inspection Date	FMSS Number	User Access	Surface Type
6/17/2021	53602	PUBLIC	ASPHALT
Area (Sq. Ft.)	Lane Miles (11' Widths)	Condition Rating / PCR	
2,201	0.038	SUMMARY / 90
