# BISO Cycle 6

## Final Report

### Road Inventory and Condition Assessment of Paved Routes Big South Fork National River and Recreation Area

**Report Date: June 2022**

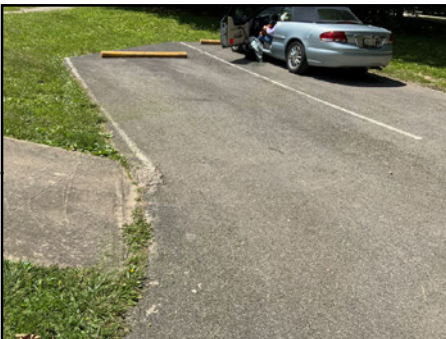
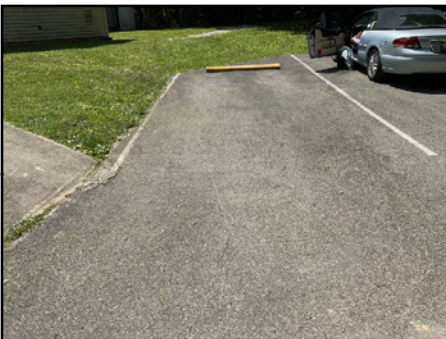
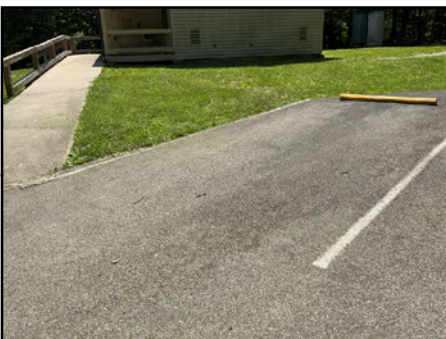
## ROUTE 0942BZ: BANDY CREEK CAMPGROUND LOOP D COMFORT STATION B127 PARKING B

Inspection Date	FMSS Number	User Access	Surface Type
6/17/2021	53602	PUBLIC	ASPHALT
Area (Sq. Ft.)	Lane Miles (11' Widths)	Curb Reveal (Inches)	Curb Recommendation
636	0.011	NOT APPLICABLE	NOT APPLICABLE
Curb Type		Curb & Gutter Type	
NO CURB		NO CURB AND GUTTER	
Pavement Recommendation		Condition Rating / PCR	
PREVENTIVE MAINTENANCE		GOOD / 90

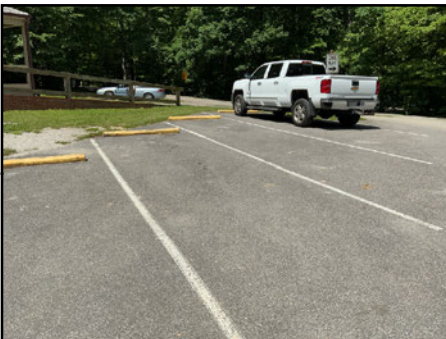
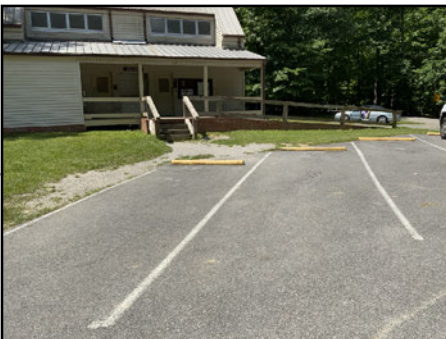
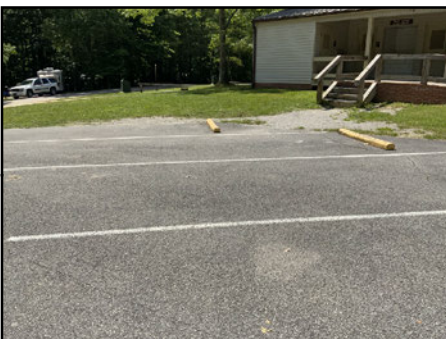
ROUTE 0943: BANDY CREEK CAMPGROUND LOOP D COMFORT STATION B128 PARKING

Inspection Date	FMSS Number	User Access	Surface Type
6/17/2021	53602	PUBLIC	ASPHALT
Area (Sq. Ft.)	Lane Miles (11' Widths)	Curb Reveal (Inches)	Curb Recommendation
1,565	0.027	NOT APPLICABLE	NOT APPLICABLE
Curb Type		Curb & Gutter Type	
NO CURB		NO CURB AND GUTTER	
Pavement Recommendation		Condition Rating / PCR	
PREVENTIVE MAINTENANCE		GOOD / 90

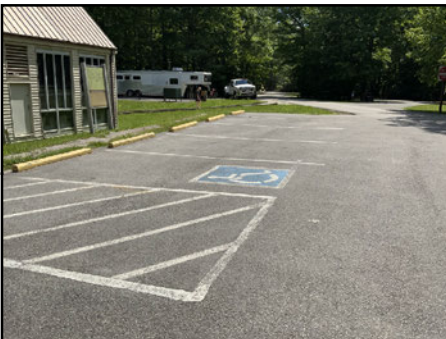
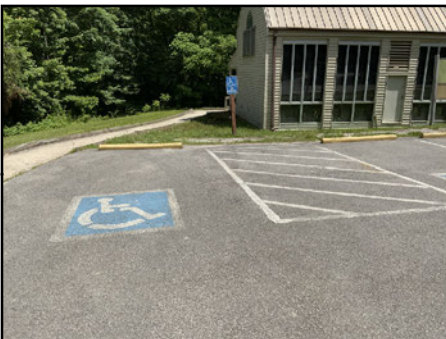
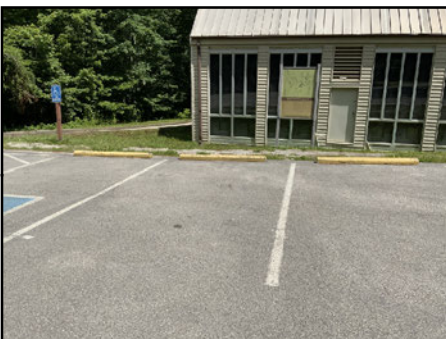
## ROUTE 0944: BANDY CREEK CAMPGROUND KIOSK PARKING

Inspection Date	FMSS Number	User Access	Surface Type
6/17/2021	53604	PUBLIC	ASPHALT
Area (Sq. Ft.)	Lane Miles (11' Widths)	Curb Reveal (Inches)	Curb Recommendation
1,281	0.022	NOT APPLICABLE	NOT APPLICABLE
Curb Type		Curb & Gutter Type	
NO CURB		NO CURB AND GUTTER	
Pavement Recommendation		Condition Rating / PCR	
PREVENTIVE MAINTENANCE		GOOD / 90

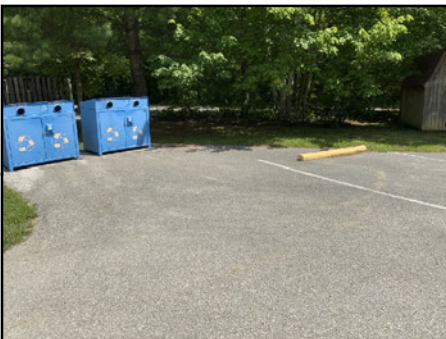
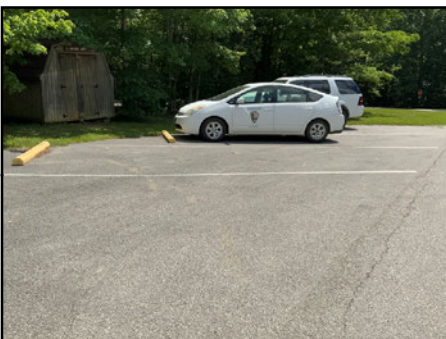
## ROUTE 0946: KENTUCKY RANGER STATION PARKING

Inspection Date	FMSS Number	User Access	Surface Type
6/17/2021	53625	PUBLIC	ASPHALT
Area (Sq. Ft.)	Lane Miles (11' Widths)	Curb Reveal (Inches)	Curb Recommendation
1,176	0.02	NOT APPLICABLE	NOT APPLICABLE
Curb Type		Curb & Gutter Type	
NO CURB		NO CURB AND GUTTER	
Pavement Recommendation		Condition Rating / PCR	
PREVENTIVE MAINTENANCE		GOOD / 90

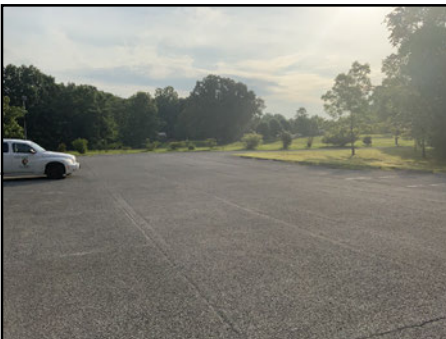
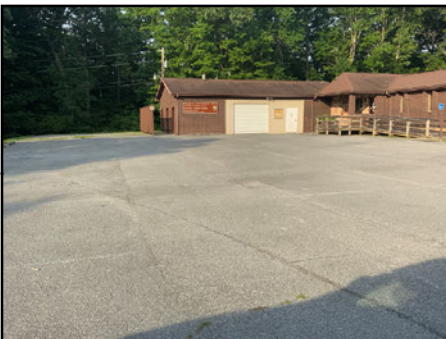
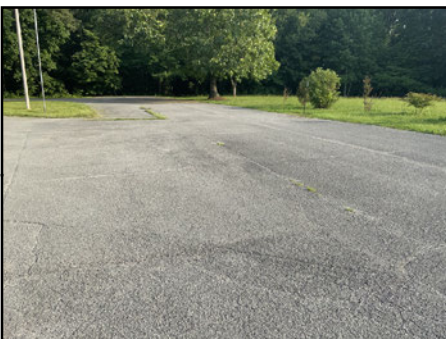
## ROUTE 0947: BLUE HERON CAMPGROUND DUMP STATION

Inspection Date	FMSS Number	User Access	Surface Type
6/19/2021	60449	PUBLIC	ASPHALT
Area (Sq. Ft.)	Lane Miles (11' Widths)	Curb Reveal (Inches)	Curb Recommendation
31,243	0.538	NOT APPLICABLE	NOT APPLICABLE
Curb Type		Curb & Gutter Type	
NO CURB		NO CURB AND GUTTER	
Pavement Recommendation		Condition Rating / PCR	
HEAVY 3R TREATMENTS		POOR / 53

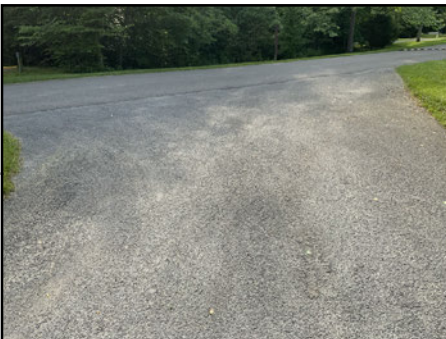
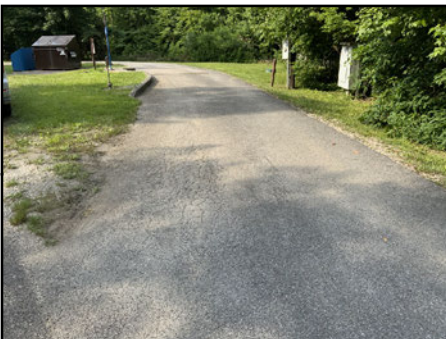
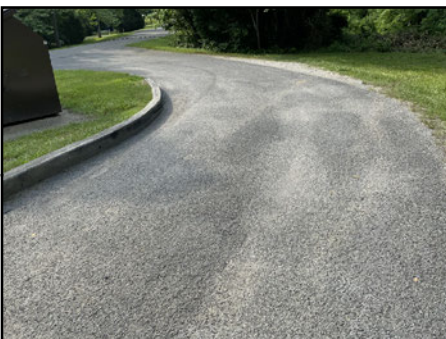
## ROUTE 0948: BLUE HERON CAMPGROUND COMFORT STATION PARKING

Inspection Date	FMSS Number	User Access	Surface Type
6/19/2021	53916	PUBLIC	ASPHALT
Area (Sq. Ft.)	Lane Miles (11' Widths)	Curb Reveal (Inches)	Curb Recommendation
2,224	0.038	7	LIGHT REPAIR
Curb Type		Curb & Gutter Type	
CONCRETE		NO CURB AND GUTTER	
Pavement Recommendation		Condition Rating / PCR	
LIGHT 3R TREATMENTS		FAIR / 73

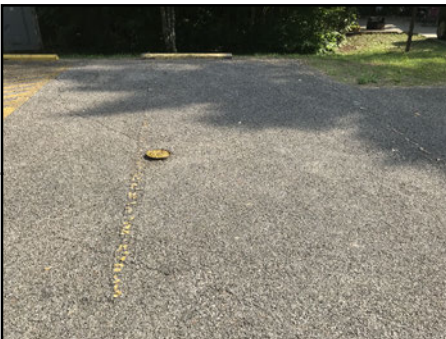
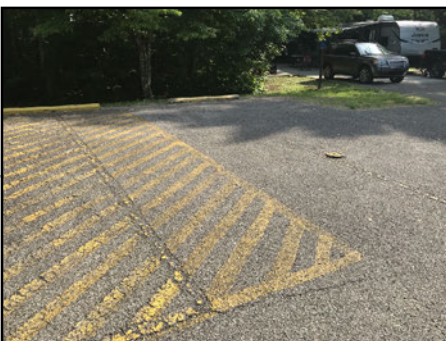
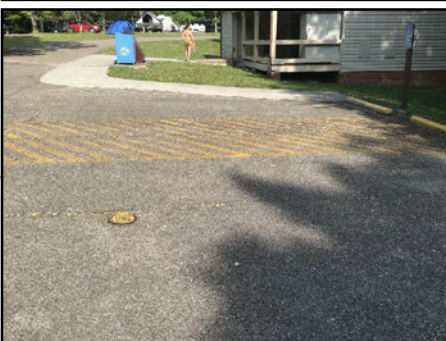
## ROUTE 0949: BLUE HERON TRAILHEAD PARKING

Inspection Date	FMSS Number	User Access	Surface Type
6/19/2021	53918	PUBLIC	ASPHALT
Area (Sq. Ft.)	Lane Miles (11' Widths)	Curb Reveal (Inches)	Curb Recommendation
846	0.015	NOT APPLICABLE	NOT APPLICABLE
Curb Type		Curb & Gutter Type	
NO CURB		NO CURB AND GUTTER	
Pavement Recommendation		Condition Rating / PCR	
LIGHT 3R TREATMENTS		FAIR / 73

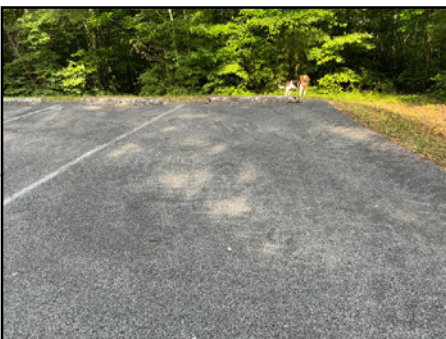
## ROUTE 0950: MINE 18 OVERLOOK PARKING

Inspection Date	FMSS Number	User Access	Surface Type
6/19/2021	53919	PUBLIC	ASPHALT
Area (Sq. Ft.)	Lane Miles (11' Widths)	Curb Reveal (Inches)	Curb Recommendation
2,431	0.042	NOT APPLICABLE	NOT APPLICABLE
Curb Type		Curb & Gutter Type	
NO CURB		NO CURB AND GUTTER	
Pavement Recommendation		Condition Rating / PCR	
LIGHT 3R TREATMENTS		FAIR / 73

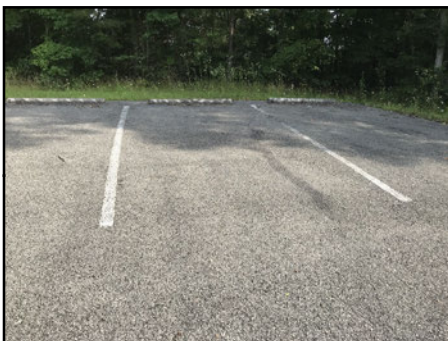
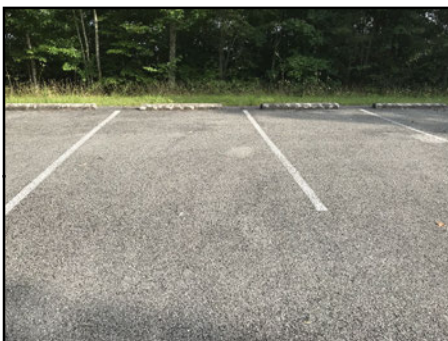
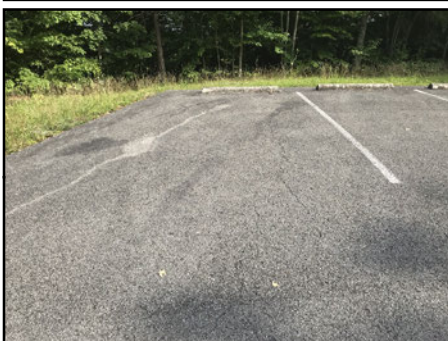
## ROUTE 0951: DEVILS JUMP OVERLOOK PARKING

Inspection Date	FMSS Number	User Access	Surface Type
6/19/2021	60454	PUBLIC	ASPHALT
Area (Sq. Ft.)	Lane Miles (11' Widths)	Curb Reveal (Inches)	Curb Recommendation
1,761	0.03	NOT APPLICABLE	NOT APPLICABLE
Curb Type		Curb & Gutter Type	
NO CURB		NO CURB AND GUTTER	
Pavement Recommendation		Condition Rating / PCR	
LIGHT 3R TREATMENTS		FAIR / 73

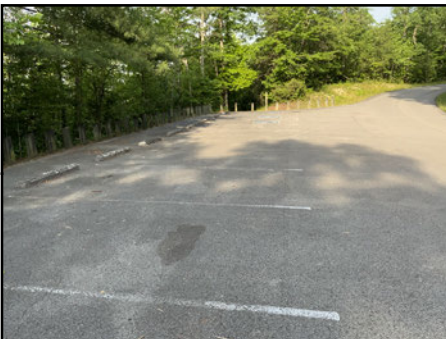
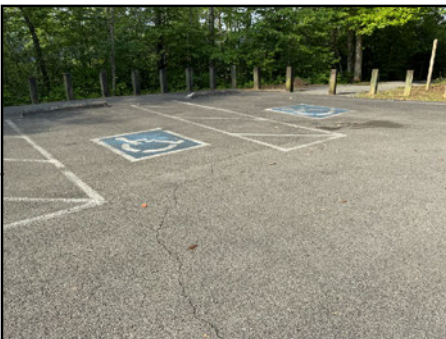
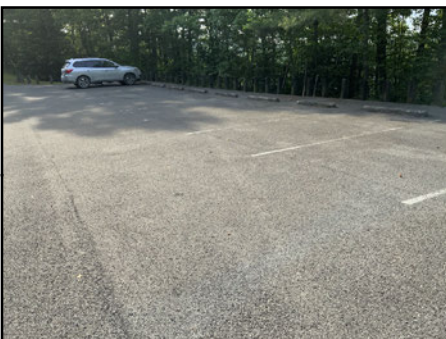
## ROUTE 0952A: RIVER PARKING A

Inspection Date	FMSS Number	User Access	Surface Type
6/19/2021	56772	PUBLIC	ASPHALT
Area (Sq. Ft.)	Lane Miles (11' Widths)	Curb Reveal (Inches)	Curb Recommendation
4,393	0.076	NOT APPLICABLE	NOT APPLICABLE
Curb Type		Curb & Gutter Type	
NO CURB		NO CURB AND GUTTER	
Pavement Recommendation		Condition Rating / PCR	
PREVENTIVE MAINTENANCE		GOOD / 90

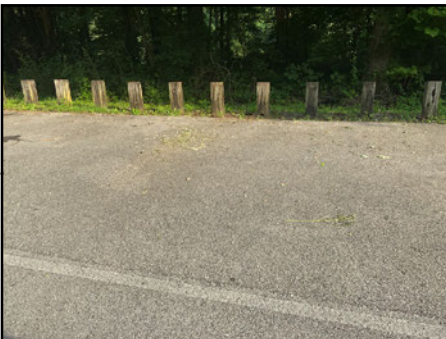
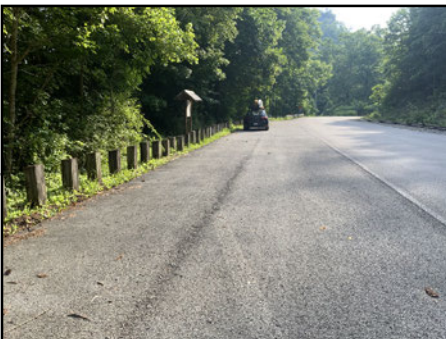
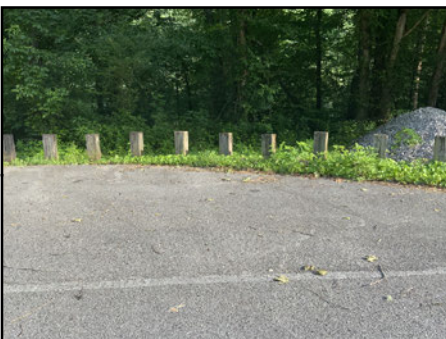
## ROUTE 0952B: RIVER PARKING B

Inspection Date	FMSS Number	User Access	Surface Type
6/19/2021	61122	PUBLIC	ASPHALT
Area (Sq. Ft.)	Lane Miles (11' Widths)	Curb Reveal (Inches)	Curb Recommendation
2,815	0.048	NOT APPLICABLE	NOT APPLICABLE
Curb Type		Curb & Gutter Type	
NO CURB		NO CURB AND GUTTER	
Pavement Recommendation		Condition Rating / PCR	
LIGHT 3R TREATMENTS		FAIR / 73

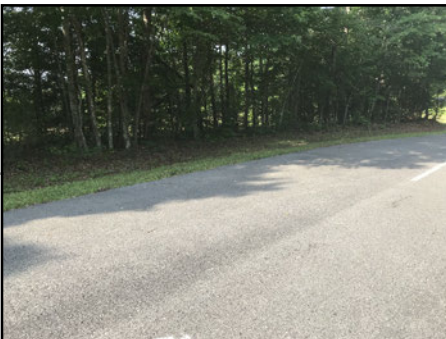
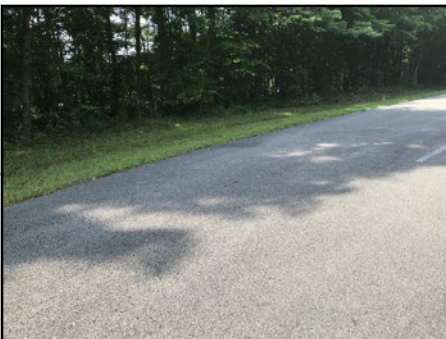
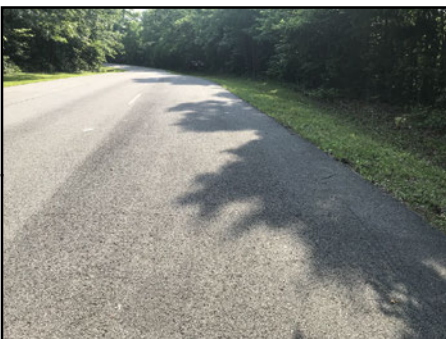
Inspection Date	FMSS Number	User Access	Surface Type
6/19/2021	114651	PUBLIC	ASPHALT
Area (Sq. Ft.)	Lane Miles (11' Widths)	Curb Reveal (Inches)	Curb Recommendation
1,771	0.03	NOT APPLICABLE	NOT APPLICABLE
Curb Type		Curb & Gutter Type	
NO CURB		NO CURB AND GUTTER	
Pavement Recommendation		Condition Rating / PCR	
PREVENTIVE MAINTENANCE		GOOD / 90

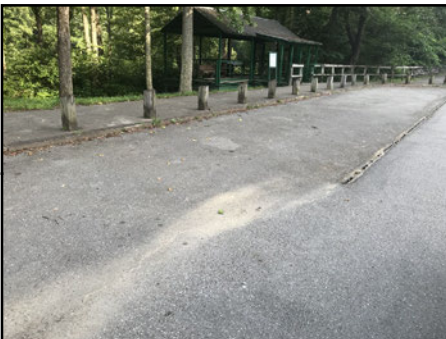
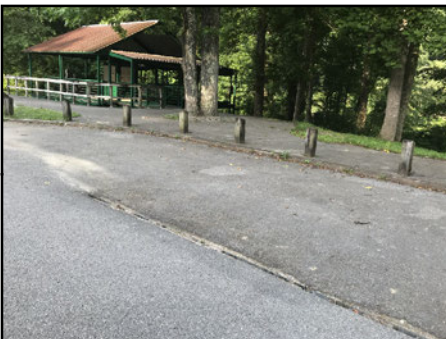
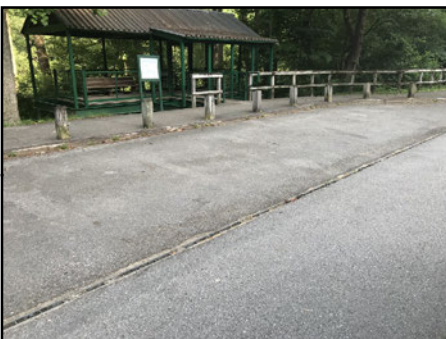
## ROUTE 0954: MINE 18 PULLOUT

Inspection Date	FMSS Number	User Access	Surface Type
6/19/2021	105030	PUBLIC	ASPHALT
Area (Sq. Ft.)	Lane Miles (11' Widths)	Curb Reveal (Inches)	Curb Recommendation
1,052	0.018	5	MODERATE REPAIR
Curb Type		Curb & Gutter Type	
WOOD		NO CURB AND GUTTER	
Pavement Recommendation		Condition Rating / PCR	
PREVENTIVE MAINTENANCE		GOOD / 90

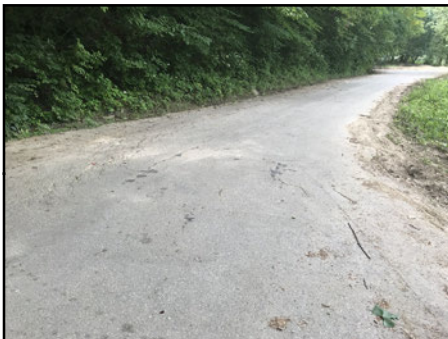
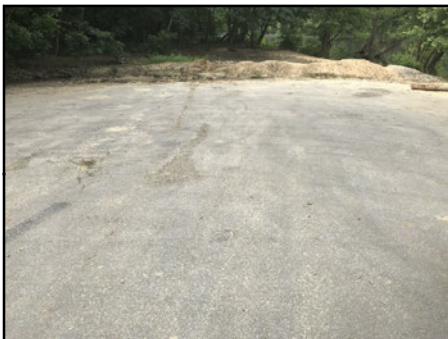
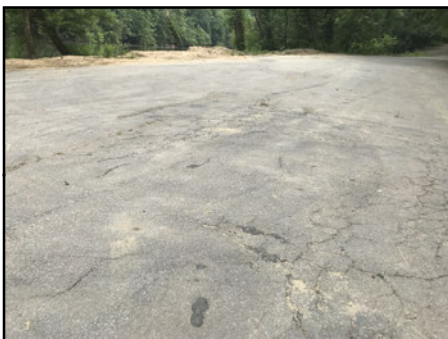
## ROUTE 0955: ALUM FORD PARKING

Inspection Date	FMSS Number	User Access	Surface Type
6/19/2021	55672	PUBLIC	ASPHALT
Area (Sq. Ft.)	Lane Miles (11' Widths)	Curb Reveal (Inches)	Curb Recommendation
19,528	0.336	NOT APPLICABLE	NOT APPLICABLE
Curb Type		Curb & Gutter Type	
NO CURB		NO CURB AND GUTTER	
Pavement Recommendation		Condition Rating / PCR	
HEAVY 3R TREATMENTS		POOR / 53

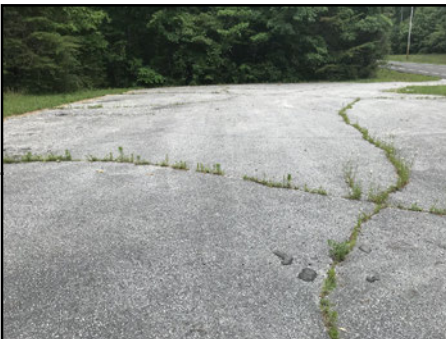
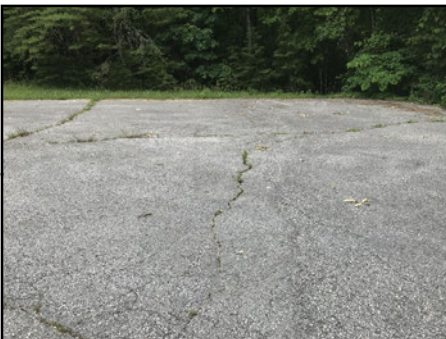
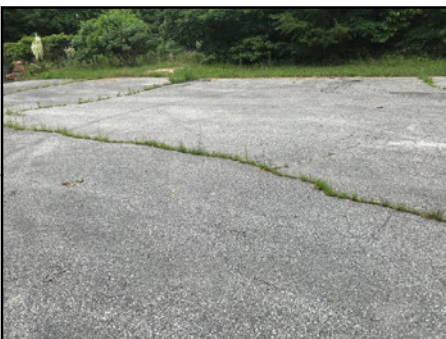
## ROUTE 0961: WEST ENTRANCE COMPOUND PARKING

Inspection Date	FMSS Number	User Access	Surface Type
6/17/2021	55933	PUBLIC	ASPHALT
Area (Sq. Ft.)	Lane Miles (11' Widths)	Curb Reveal (Inches)	Curb Recommendation
13,094	0.225	NOT APPLICABLE	NOT APPLICABLE
Curb Type		Curb & Gutter Type	
NO CURB		NO CURB AND GUTTER	
Pavement Recommendation		Condition Rating / PCR	
HEAVY 3R TREATMENTS		POOR / 53

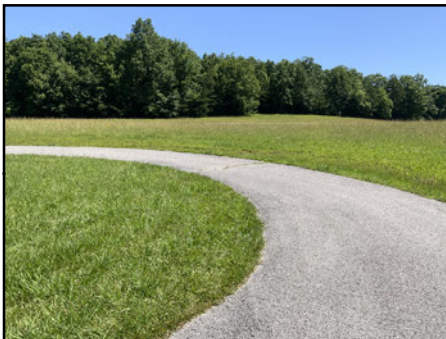
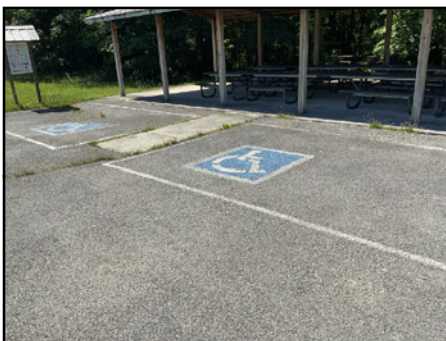
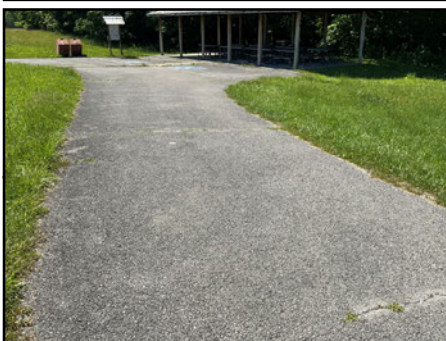
## ROUTE 0969: BANDY CREEK LOOP F PICNIC SHELTER PARKING

Inspection Date	FMSS Number	User Access	Surface Type
6/17/2021	114652	PUBLIC	ASPHALT
Area (Sq. Ft.)	Lane Miles (11' Widths)	Curb Reveal (Inches)	Curb Recommendation
5,723	0.099	NOT APPLICABLE	NOT APPLICABLE
Curb Type		Curb & Gutter Type	
NO CURB		NO CURB AND GUTTER	
Pavement Recommendation		Condition Rating / PCR	
PREVENTIVE MAINTENANCE		GOOD / 90

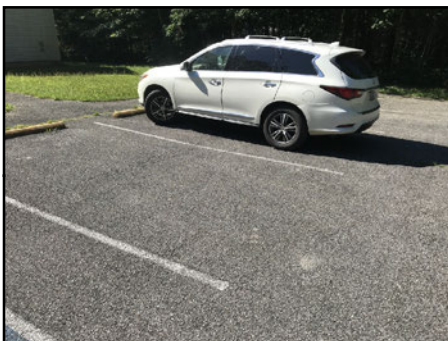
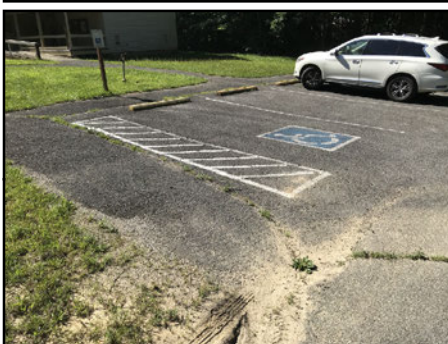
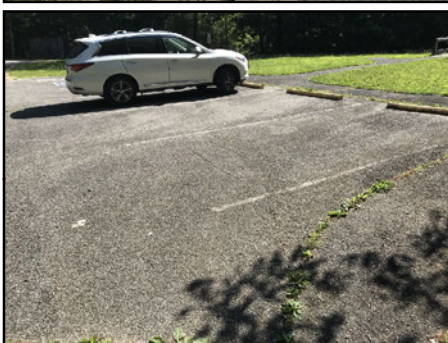
## ROUTE 0970: BANDY CREEK CAMPGROUND AREA E RESTROOM 1 PARKING

Inspection Date	FMSS Number	User Access	Surface Type
6/17/2021	105057	PUBLIC	ASPHALT
Area (Sq. Ft.)	Lane Miles (11' Widths)	Curb Reveal (Inches)	Curb Recommendation
1,522	0.026	NOT APPLICABLE	NOT APPLICABLE
Curb Type		Curb & Gutter Type	
NO CURB		NO CURB AND GUTTER	
Pavement Recommendation		Condition Rating / PCR	
LIGHT 3R TREATMENTS		FAIR / 73

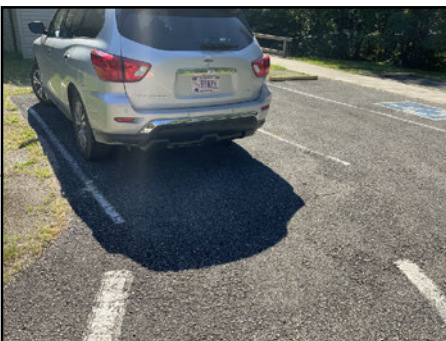
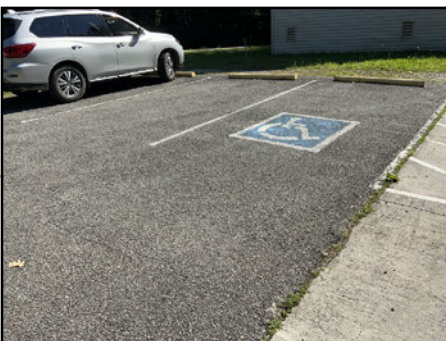
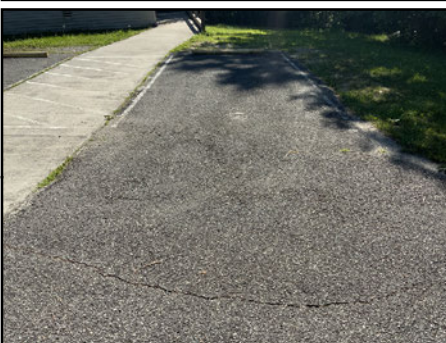
## ROUTE 0971A: BANDY CREEK CAMPGROUND AREA E RESTROOM 2 PARKING A

Inspection Date	FMSS Number	User Access	Surface Type
6/17/2021	105059	PUBLIC	ASPHALT
Area (Sq. Ft.)	Lane Miles (11' Widths)	Curb Reveal (Inches)	Curb Recommendation
1,139	0.02	NOT APPLICABLE	NOT APPLICABLE
Curb Type		Curb & Gutter Type	
NO CURB		NO CURB AND GUTTER	
Pavement Recommendation		Condition Rating / PCR	
LIGHT 3R TREATMENTS		FAIR / 73

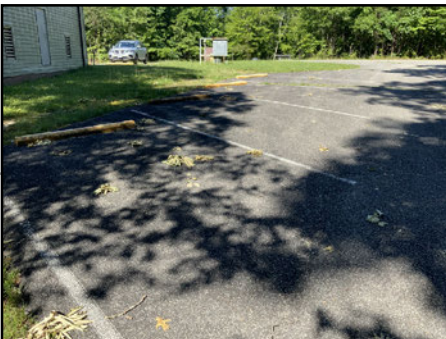
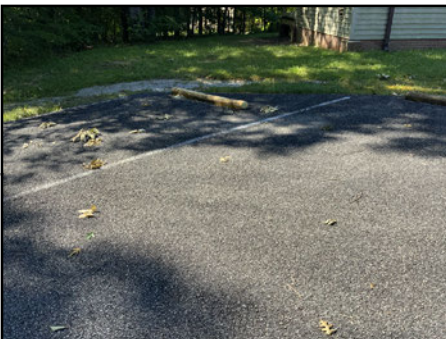
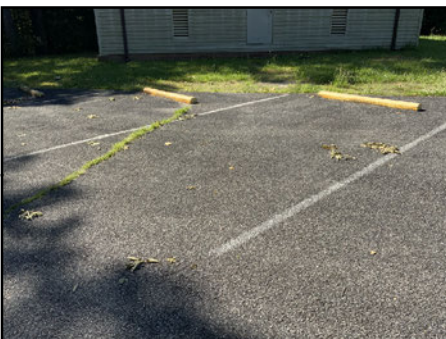
## ROUTE 0971B: BANDY CREEK CAMPGROUND AREA E RESTROOM 2 PARKING B

Inspection Date	FMSS Number	User Access	Surface Type
6/17/2021	105058	PUBLIC	ASPHALT
Area (Sq. Ft.)	Lane Miles (11' Widths)	Curb Reveal (Inches)	Curb Recommendation
1,294	0.022	NOT APPLICABLE	NOT APPLICABLE
Curb Type		Curb & Gutter Type	
NO CURB		NO CURB AND GUTTER	
Pavement Recommendation		Condition Rating / PCR	
LIGHT 3R TREATMENTS		FAIR / 73

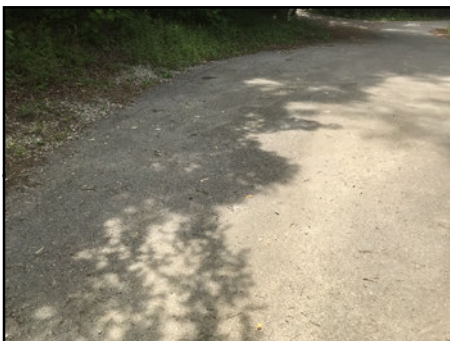
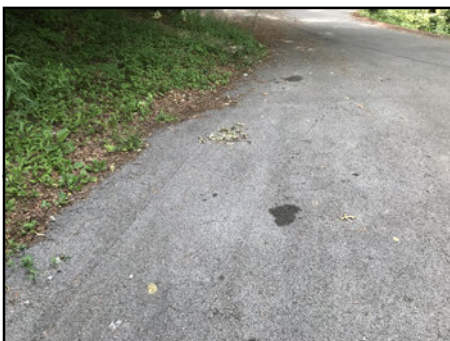
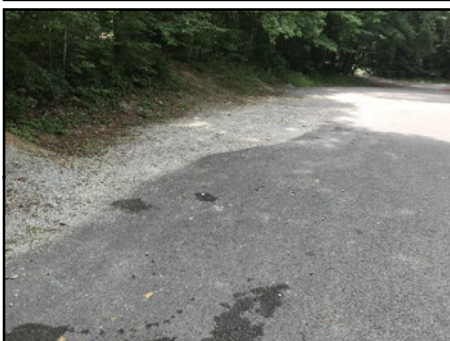
## ROUTE 0982: YAHOO FALLS GROUP PICNIC PARKING

Inspection Date	FMSS Number	User Access	Surface Type
6/19/2021	105067	PUBLIC	ASPHALT
Area (Sq. Ft.)	Lane Miles (11' Widths)	Curb Reveal (Inches)	Curb Recommendation
705	0.012	NOT APPLICABLE	NOT APPLICABLE
Curb Type		Curb & Gutter Type	
NO CURB		NO CURB AND GUTTER	
Pavement Recommendation		Condition Rating / PCR	
PREVENTIVE MAINTENANCE		GOOD / 90
