BOHA Cycle 6

Final Report

Road Inventory and Condition Assessment of Paved Routes Boston Harbor Islands National Recreation Area

Report Date: April 2020

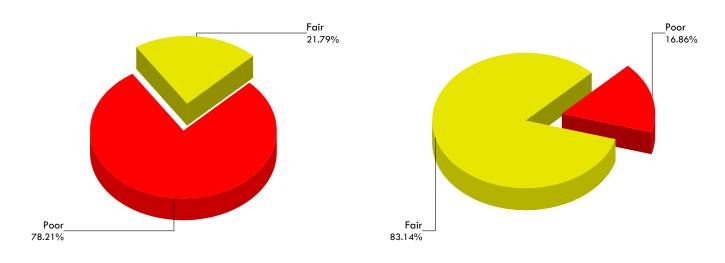
Figure 1: Pavement Condition Rating Breakdown for Paved Roads and Parking Areas

Road Condition Percentages

Parking Area Condition Percentages

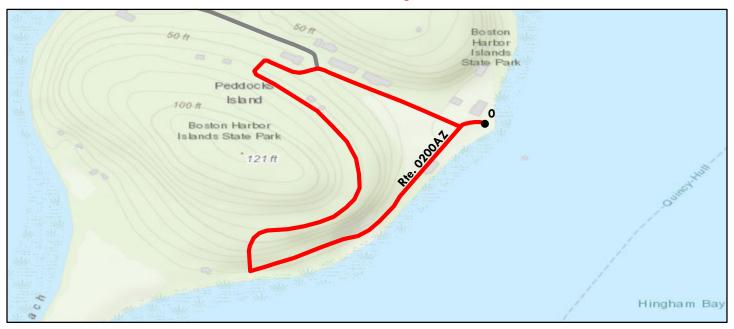
Manual Rating

Route C	Condition Legend – Pav	ement Condi	tion Rating (PCR)	
Poor (0 - 60) Fair (6	1- 84) Good ((85 - 94)	Excellent (95 - 100)	Not Rated
	See Appendix for def	initions and f	ormulas	
Inspection Date: 9/25/2019	Beginning Section MP	0.00		
Paved Length (Miles): 0.86	Section Length (MI)	0.86		
Surface Type: ASPHALT	Route Summary			•
Roadway Condition Information				
Pavement Condition Rating (PCR)	30	30		
Surface Condition Rating (SCR)	30	30		
Roughness Condition Index (RCI)	N/A	N/A		
Distress Index Values				
Structural Crack Index	N/A	N/A		
Alligator Crack Index	30	30		
Longitudinal Crack Index	53	53		
Transverse Cracking Index	53	53		
Patching Index	97	97		
Rutting Index	73	73		
International Roughness Index (IRI)	N/A	N/A		
Lane & Width Information				
Number of Lanes	1	1		
Paved Width (ft)	12	12		
Lane Width (ft)	12	12

Note: The first 0.1-mile road segment is in excellent condition. The rest of the road segment is in poor condition.
