# BOWA Cycle 6

## Final Report

### Road Inventory and Condition Assessment of Paved Routes Booker T. Washington National Monument

**Report Date: September 2020**

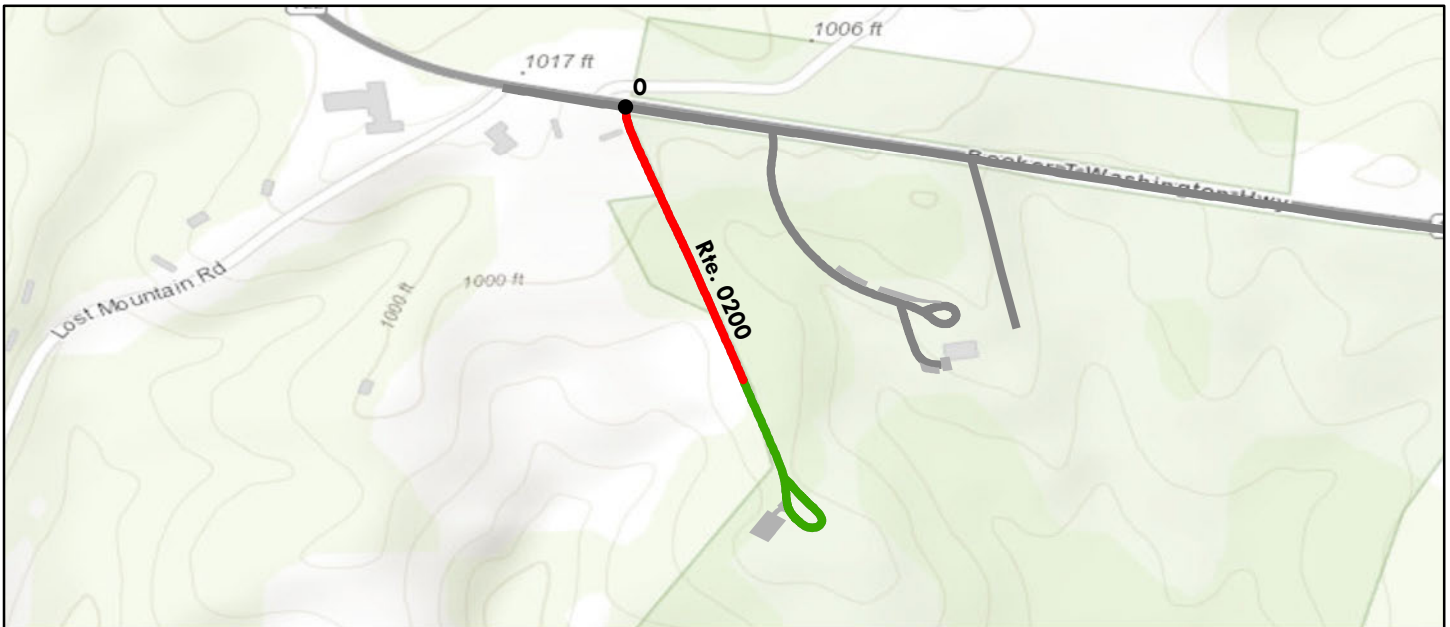
## ROUTE 0200: HEADQUARTERS ROAD

<b>Inspection Date:</b> 3/7/2019	<b>Beginning Section MP</b>	0				
<b>Paved Length (Miles):</b> 0.35	<b>Section Length (MI)</b>	0.35				
<b>Surface Type:</b> ASPHALT	<b>Route Summary</b>					
<b>Roadway Condition Information</b>						
Pavement Condition Rating (PCR)	63	63				
Surface Condition Rating (SCR)	63	63				
Roughness Condition Index (RCI)	N/A	N/A				
<b>Distress Index Values</b>						
Structural Crack Index	63	63				
Alligator Crack Index	99	99				
Longitudinal Crack Index	64	64				
Transverse Cracking Index	92	92				
Patching Index	97	97				
Rutting Index	88	88				
International Roughness Index (IRI)	N/A	N/A				
<b>Lane &amp; Width Information</b>						
Number of Lanes	1	1				
Paved Width (ft)	12.8	12.8				
Lane Width (ft)	12.8	12.8

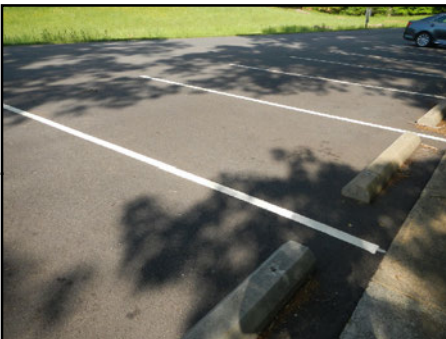
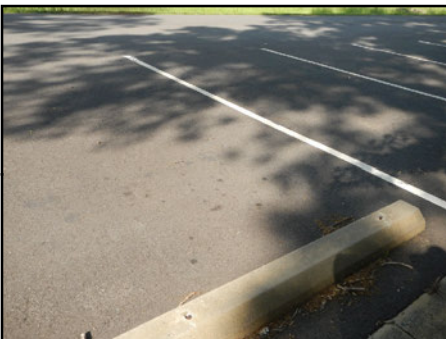
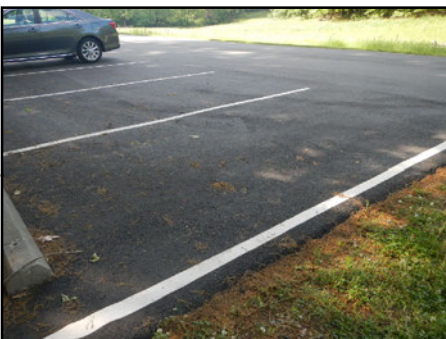
## ROUTE 0900AZ: VISITOR CENTER PARKING A

Inspection Date	FMSS Number	User Access	Surface Type
5/7/2019	61495	PUBLIC	ASPHALT
Area (Sq. Ft.)	Lane Miles (11' Widths)	Curb Reveal (Inches)	Curb Recommendation
2,223	0.038	NOT APPLICABLE	NOT APPLICABLE
Curb Type		Curb & Gutter Type	
NO CURB		NO CURB AND GUTTER	
Pavement Recommendation		Condition Rating / PCR	
PREVENTIVE MAINTENANCE		GOOD / 90

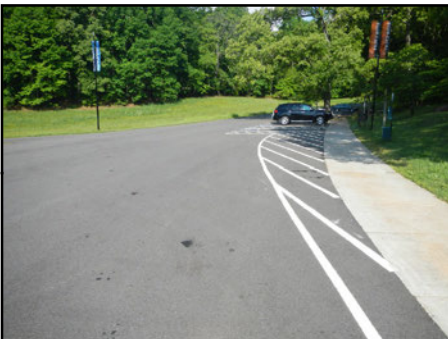
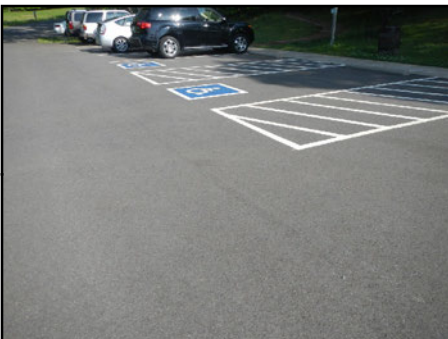
## ROUTE 0900BZ: VISITOR CENTER PARKING B

Inspection Date	FMSS Number	User Access	Surface Type
5/7/2019	61495	PUBLIC	ASPHALT
Area (Sq. Ft.)	Lane Miles (11' Widths)	Curb Reveal (Inches)	Curb Recommendation
3,308	0.057	NOT APPLICABLE	NOT APPLICABLE
Curb Type		Curb & Gutter Type	
NO CURB		NO CURB AND GUTTER	
Pavement Recommendation		Condition Rating / PCR	
PREVENTIVE MAINTENANCE		GOOD / 90

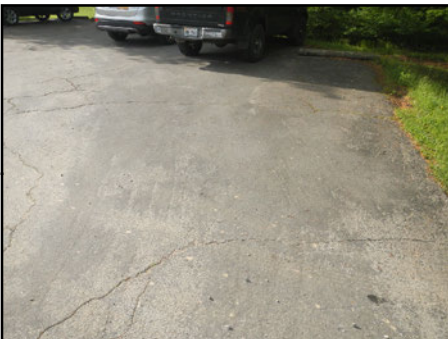
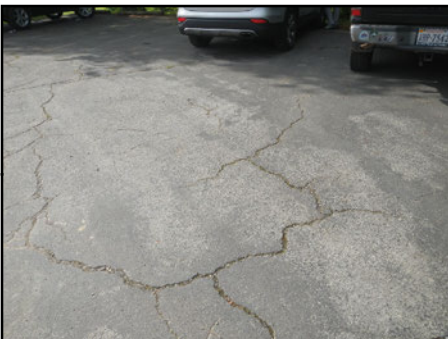
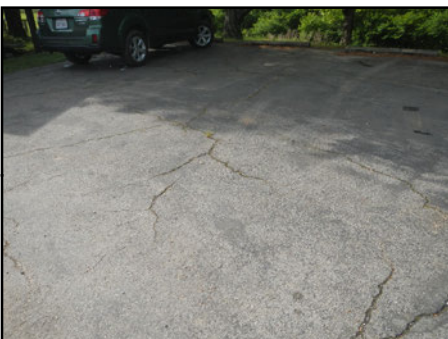
## ROUTE 0901: VISITOR CENTER EMPLOYEE PARKING

Inspection Date	FMSS Number	User Access	Surface Type
5/7/2019	61507	NONPUBLIC	ASPHALT
Area (Sq. Ft.)	Lane Miles (11' Widths)	Curb Reveal (Inches)	Curb Recommendation
1,378	0.024	NOT APPLICABLE	NOT APPLICABLE
Curb Type		Curb & Gutter Type	
NO CURB		NO CURB AND GUTTER	
Pavement Recommendation		Condition Rating / PCR	
PREVENTIVE MAINTENANCE		GOOD / 90

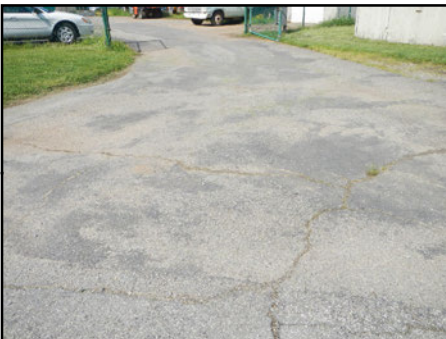
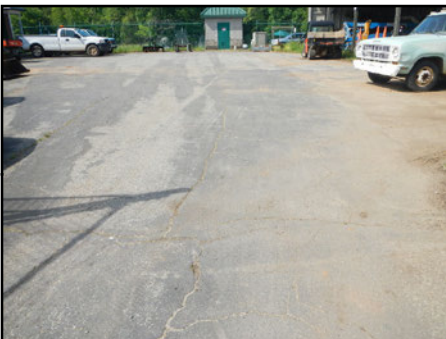
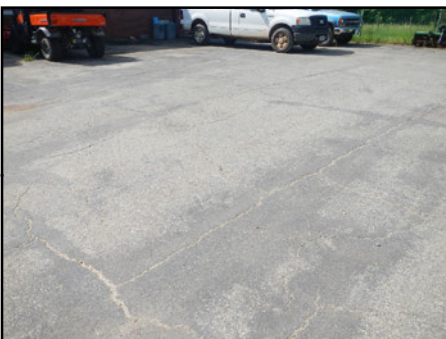
## ROUTE 0903: HEADQUARTERS COURTYARD PARKING

Inspection Date	FMSS Number	User Access	Surface Type
5/7/2019	54258	NONPUBLIC	ASPHALT
Area (Sq. Ft.)	Lane Miles (11' Widths)	Curb Reveal (Inches)	Curb Recommendation
7,703	0.133	NOT APPLICABLE	NOT APPLICABLE
Curb Type		Curb & Gutter Type	
NO CURB		NO CURB AND GUTTER	
Pavement Recommendation		Condition Rating / PCR	
HEAVY 3R TREATMENTS		POOR / 53

Note: Parking area consists of multiple surface types: 1 part Asphalt at 7,436 square feet; 2 parts Concrete at 267 square feet.

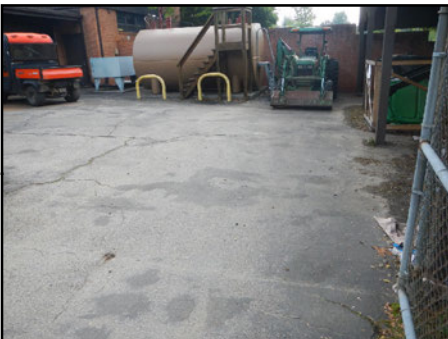
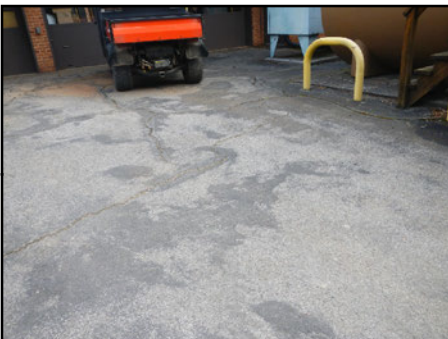
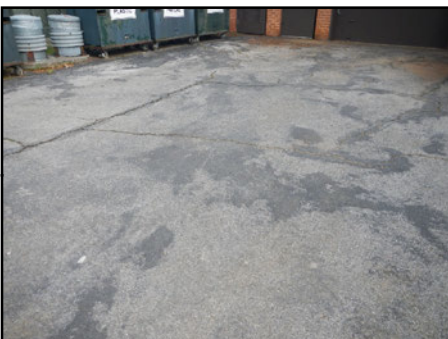
## ROUTE 0904: VISITOR CENTER COURTYARD

Inspection Date	FMSS Number	User Access	Surface Type
5/7/2019	61508	NONPUBLIC	ASPHALT
Area (Sq. Ft.)	Lane Miles (11' Widths)	Curb Reveal (Inches)	Curb Recommendation
1,430	0.025	NOT APPLICABLE	NOT APPLICABLE
Curb Type		Curb & Gutter Type	
NO CURB		NO CURB AND GUTTER	
Pavement Recommendation		Condition Rating / PCR	
HEAVY 3R TREATMENTS		POOR / 53
