# CAGR Cycle 6

### Road Inventory and Condition Assessment of Paved Routes Casa Grande Ruins National Monument

**Federal Lands Highway  
Road Inventory Program**

Report Date: May 2017

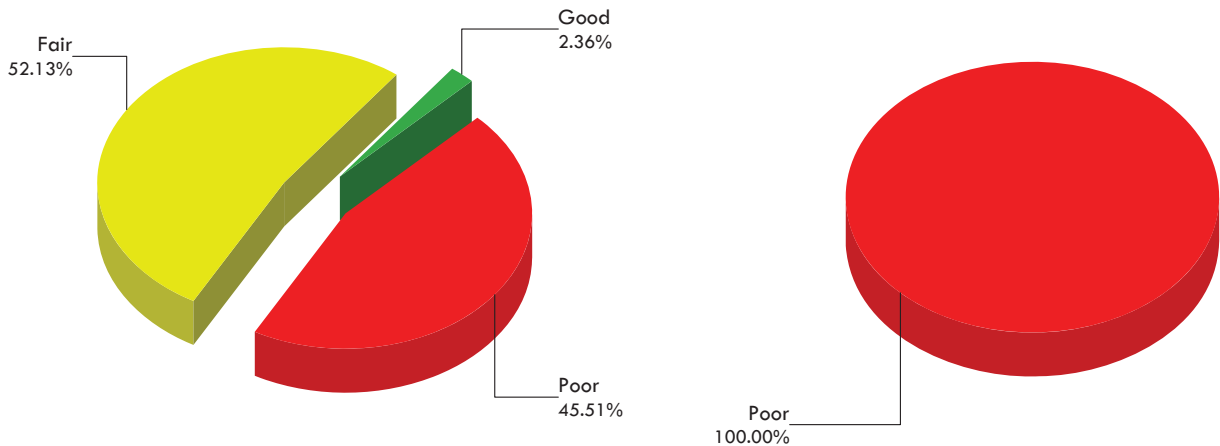
Figure 1: Pavement Condition Rating Breakdown for Paved Roads and Parking Areas

**Road Condition Percentages**

**Parking Area Condition Percentages**

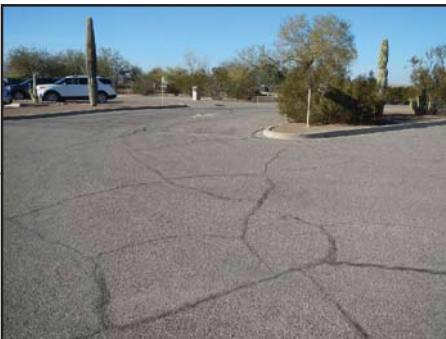
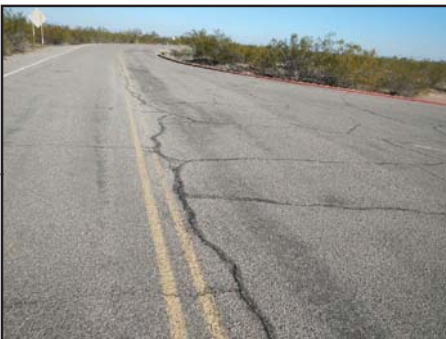
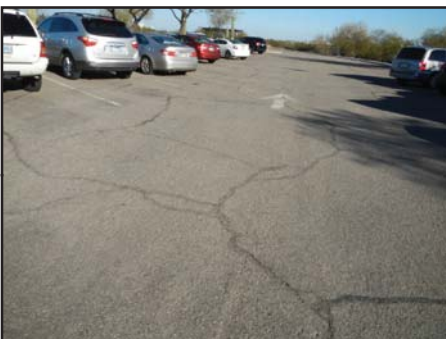
Inspection Date	FMSS Number	User Access	Surface Type
1/20/2016	40381	PUBLIC	ASPHALT
Area (Sq. Ft.)	Lane Miles (11' Widths)	Curb Reveal (Inches)	Curb Recommendation
49,156	0.846	4	DO NOTHING
Curb Type		Curb & Gutter Type	
CONCRETE		CONCRETE	
Pavement Recommendation		Condition Rating / PCR	
HEAVY 3R TREATMENTS		POOR / 53

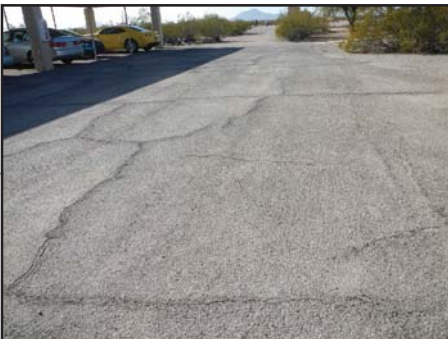
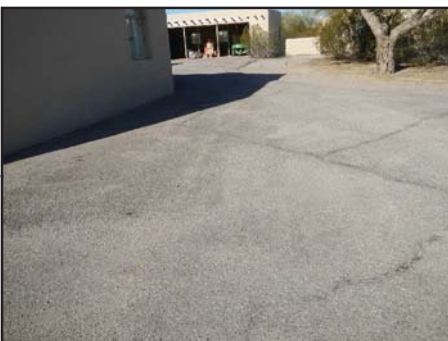
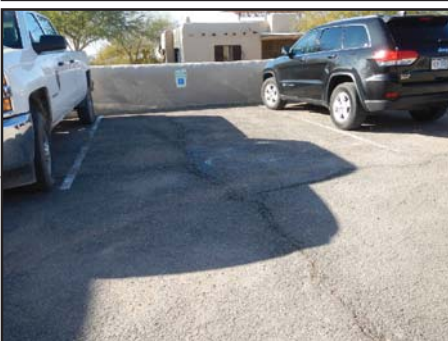
## ROUTE 0902: EMPLOYEE PARKING

Inspection Date	FMSS Number	User Access	Surface Type
1/20/2016	102809	NONPUBLIC	ASPHALT
Area (Sq. Ft.)	Lane Miles (11' Widths)	Curb Reveal (Inches)	Curb Recommendation
7,949	0.137	NOT APPLICABLE	NOT APPLICABLE
Curb Type		Curb & Gutter Type	
NO CURB		NO CURB AND GUTTER	
Pavement Recommendation		Condition Rating / PCR	
HEAVY 3R TREATMENTS		POOR / 53
