# CALO Cycle 6

## Final Report

### Road Inventory and Condition Assessment of Paved Routes Cape Lookout National Seashore

**Report Date: September 2021**

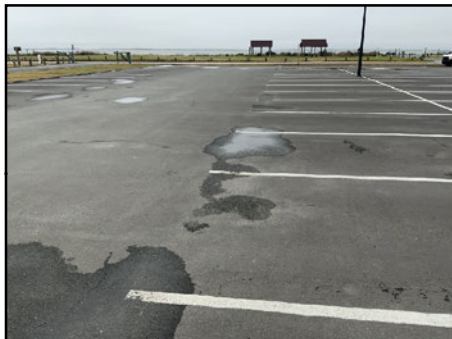
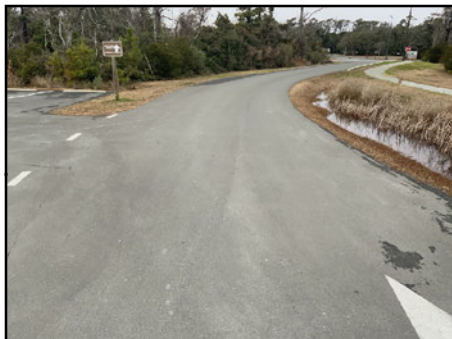
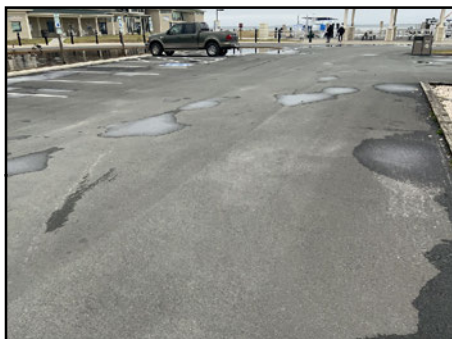
Inspection Date	FMSS Number	User Access	Surface Type
2/1/2021	54324	PUBLIC	ASPHALT
Area (Sq. Ft.)	Lane Miles (11' Widths)	Curb Reveal (Inches)	Curb Recommendation
51,365	0.884	2	LIGHT REPAIR
Curb Type		Curb & Gutter Type	
WOOD		NO CURB AND GUTTER	
Pavement Recommendation		Condition Rating / PCR	
PREVENTIVE MAINTENANCE		GOOD / 90

Multiple Surface Types: Asphalt = 49,914 sq ft; Concrete = 1,451 sq ft.

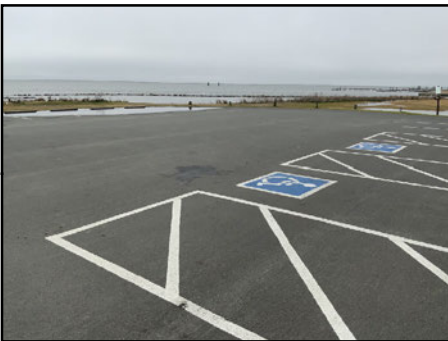
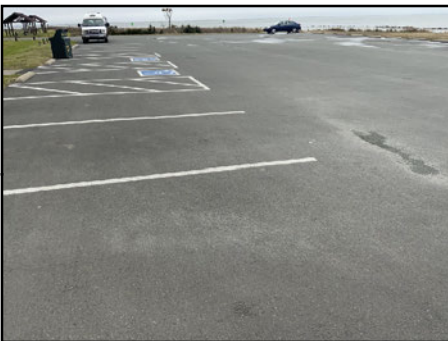
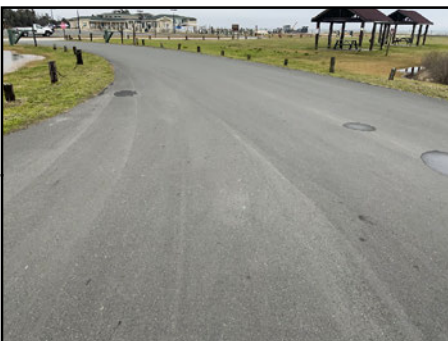
## ROUTE 0901: HARKERS ISLAND PICNIC AREA PARKING

Inspection Date	FMSS Number	User Access	Surface Type
2/1/2021	104546	PUBLIC	ASPHALT
Area (Sq. Ft.)	Lane Miles (11' Widths)	Curb Reveal (Inches)	Curb Recommendation
21,401	0.368	NOT APPLICABLE	NOT APPLICABLE
Curb Type		Curb & Gutter Type	
NO CURB		NO CURB AND GUTTER	
Pavement Recommendation		Condition Rating / PCR	
PREVENTIVE MAINTENANCE		GOOD / 90

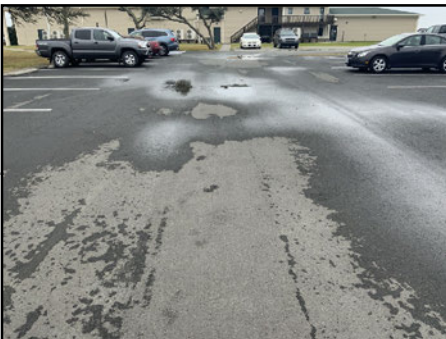
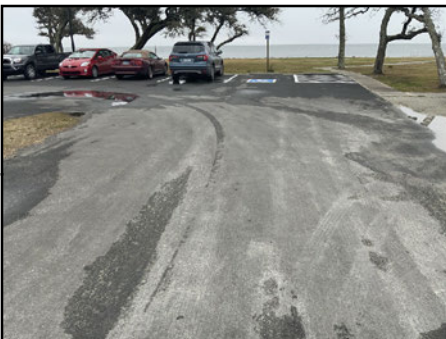
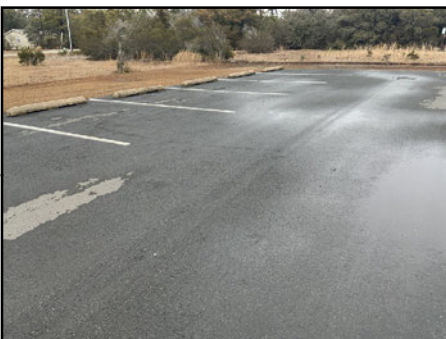
## ROUTE 0902: STAFF PARKING

Inspection Date	FMSS Number	User Access	Surface Type
2/1/2021	54328	NONPUBLIC	ASPHALT
Area (Sq. Ft.)	Lane Miles (11' Widths)	Curb Reveal (Inches)	Curb Recommendation
7,861	0.135	NOT APPLICABLE	NOT APPLICABLE
Curb Type		Curb & Gutter Type	
NO CURB		NO CURB AND GUTTER	
Pavement Recommendation		Condition Rating / PCR	
PREVENTIVE MAINTENANCE		GOOD / 90

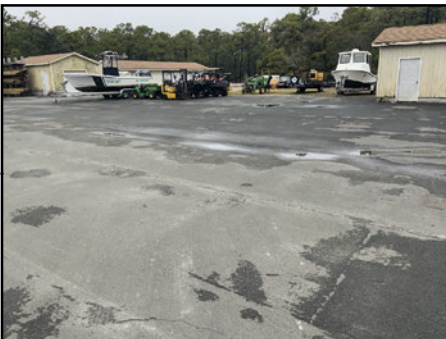
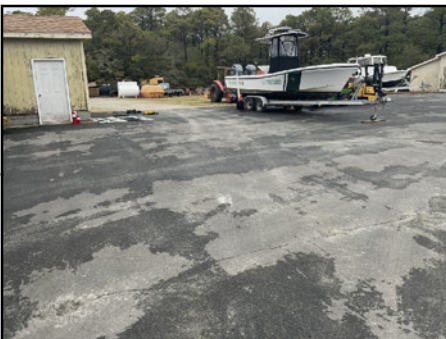
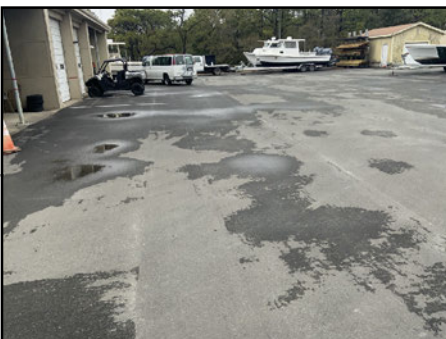
## ROUTE 0903: MAINTENANCE PARKING

Inspection Date	FMSS Number	User Access	Surface Type
2/1/2021	54329	NONPUBLIC	ASPHALT
Area (Sq. Ft.)	Lane Miles (11' Widths)	Curb Reveal (Inches)	Curb Recommendation
23,513	0.405	NOT APPLICABLE	NOT APPLICABLE
Curb Type		Curb & Gutter Type	
NO CURB		NO CURB AND GUTTER	
Pavement Recommendation		Condition Rating / PCR	
LIGHT 3R TREATMENTS		FAIR / 73

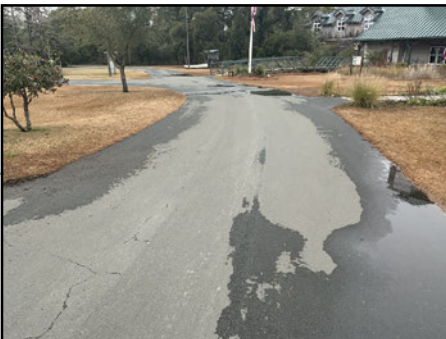
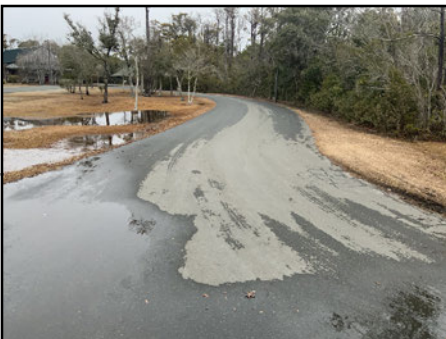
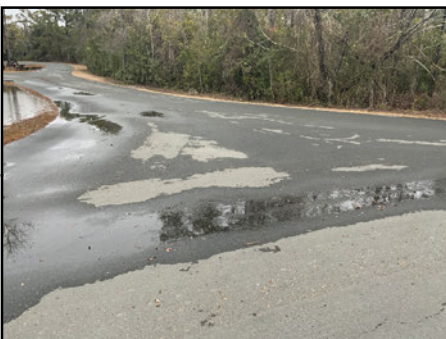
## ROUTE 0904: CORE SOUND WATERFOWL MUSEUM AND HERITAGE CENTER PARKING

Inspection Date	FMSS Number	User Access	Surface Type
2/1/2021		PUBLIC	ASPHALT
Area (Sq. Ft.)	Lane Miles (11' Widths)	Curb Reveal (Inches)	Curb Recommendation
61,199	1.054	NOT APPLICABLE	NOT APPLICABLE
Curb Type		Curb & Gutter Type	
NO CURB		NO CURB AND GUTTER	
Pavement Recommendation		Condition Rating / PCR	
PREVENTIVE MAINTENANCE		GOOD / 90

Multiple Surface Types: Asphalt = 47,248 sq ft; Concrete Pavers = 13,951 sq ft.
