# CARE Cycle 6

## Final Report

### Road Inventory and Condition Assessment of Paved Routes Capitol Reef National Park

Report Date: August 2017

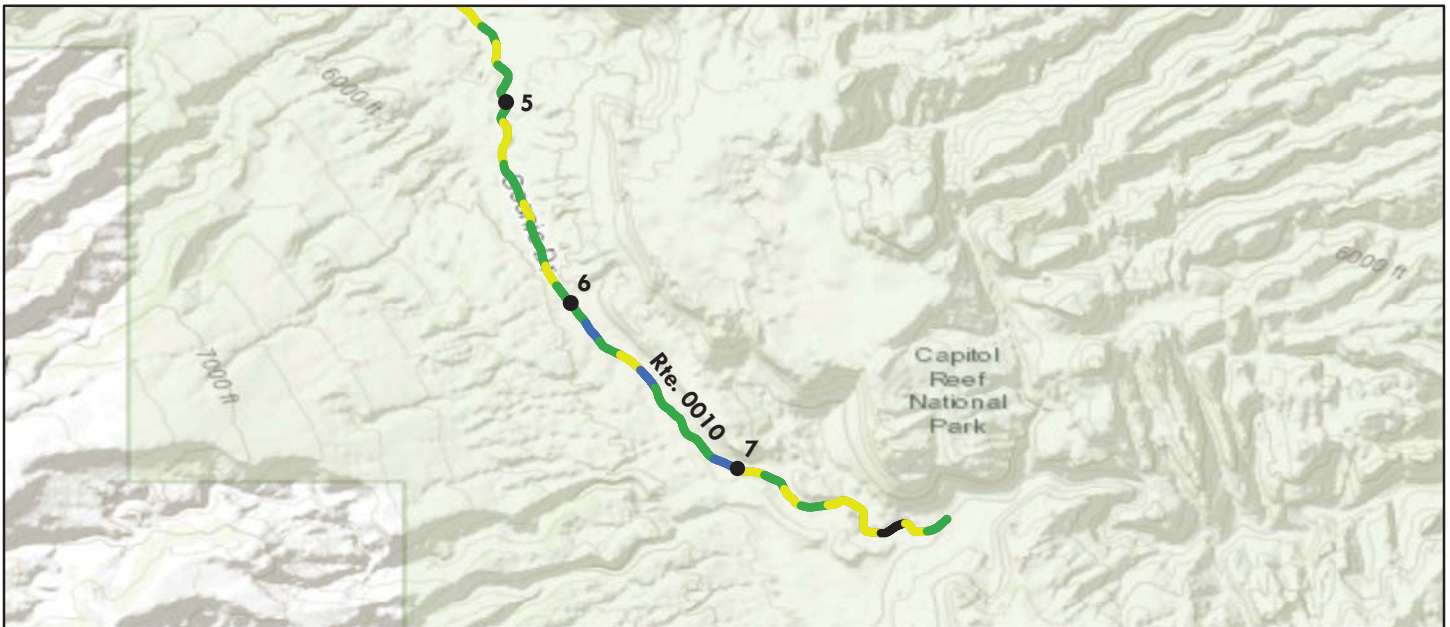
## ROUTE 0010: SCENIC DRIVE

Route Condition Legend – Pavement Condition Rating (PCR)									
Poor (0 - 60)		Fair (61- 84)		Good (85 - 94)		Excellent (95 - 100)		Not Rated	
See Appendix for definitions and formulas									
<b>Inspection Date:</b>	4/19/2017	<b>Beginning Section MP</b>	5	6	7				
<b>Paved Length (Miles):</b>	7.99	<b>Section Length (MI)</b>	1	1	0.99				
<b>Surface Type:</b>	ASPHALT	<b>Route Summary</b>							
<b>Roadway Condition Information</b>									
Pavement Condition Rating (PCR)	87	85	89	78					
Surface Condition Rating (SCR)	97	96	96	94					
Roughness Condition Index (RCI)	73	69	78	55					
<b>Distress Index Values</b>									
Structural Crack Index	100	100	100	100					
Alligator Crack Index	100	100	100	100					
Longitudinal Crack Index	100	100	100	100					
Transverse Cracking Index	100	100	100	100					
Patching Index	100	100	100	100					
Rutting Index	97	96	96	94					
International Roughness Index (IRI)	191	206	174	260

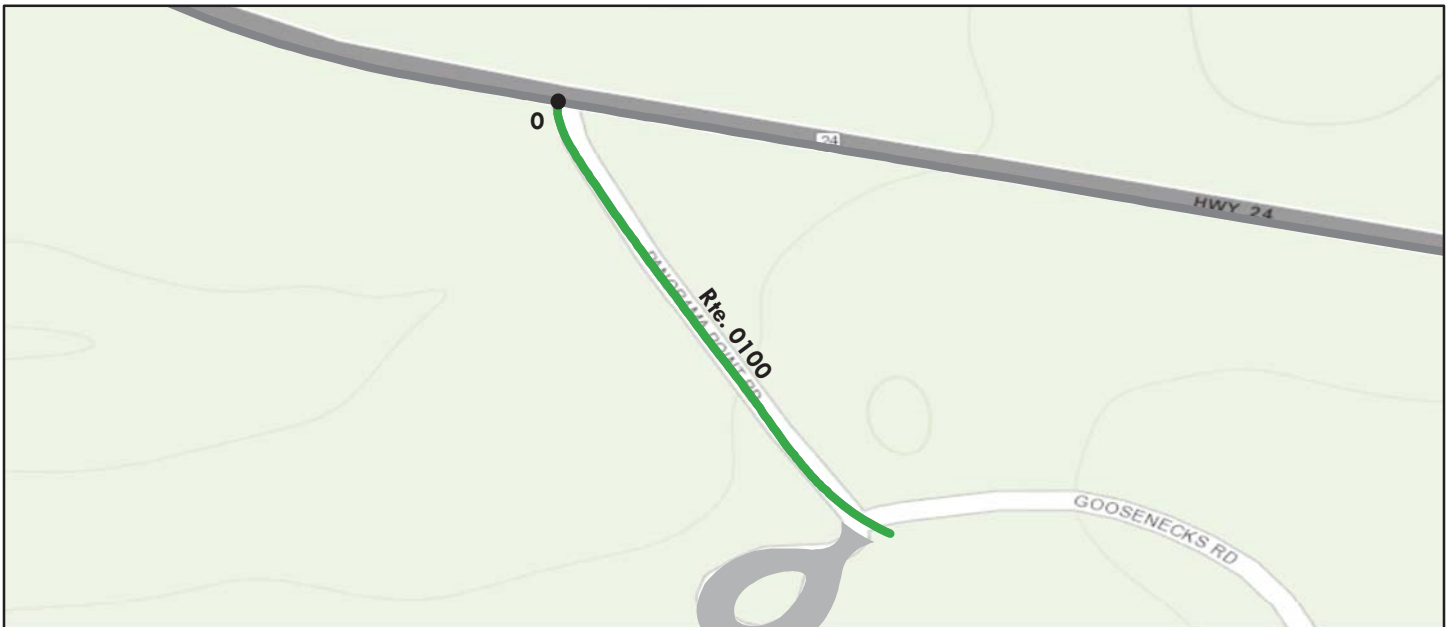
## ROUTE 0100: GOOSENECKS ROAD

Route Condition Legend – Pavement Condition Rating (PCR)						
Poor (0 - 60)	Fair (61- 84)	Good (85 - 94)	Excellent (95 - 100)	Not Rated		
See Appendix for definitions and formulas						
<b>Inspection Date:</b> 4/19/2017	<b>Beginning Section MP</b>	0				
<b>Paved Length (Miles):</b> 0.10	<b>Section Length (MI)</b>	0.10				
<b>Surface Type:</b> ASPHALT	<b>Route Summary</b>					
<b>Roadway Condition Information</b>						
Pavement Condition Rating (PCR)	91	91				
Surface Condition Rating (SCR)	91	91				
Roughness Condition Index (RCI)	N/A	N/A				
<b>Distress Index Values</b>						
Structural Crack Index	100	100				
Alligator Crack Index	100	100				
Longitudinal Crack Index	100	100				
Transverse Cracking Index	100	100				
Patching Index	100	100				
Rutting Index	91	91				
International Roughness Index (IRI)	N/A	N/A				
<b>Lane &amp; Width Information</b>						
Number of Lanes	2	2				
Paved Width (ft)	19.1	19.1

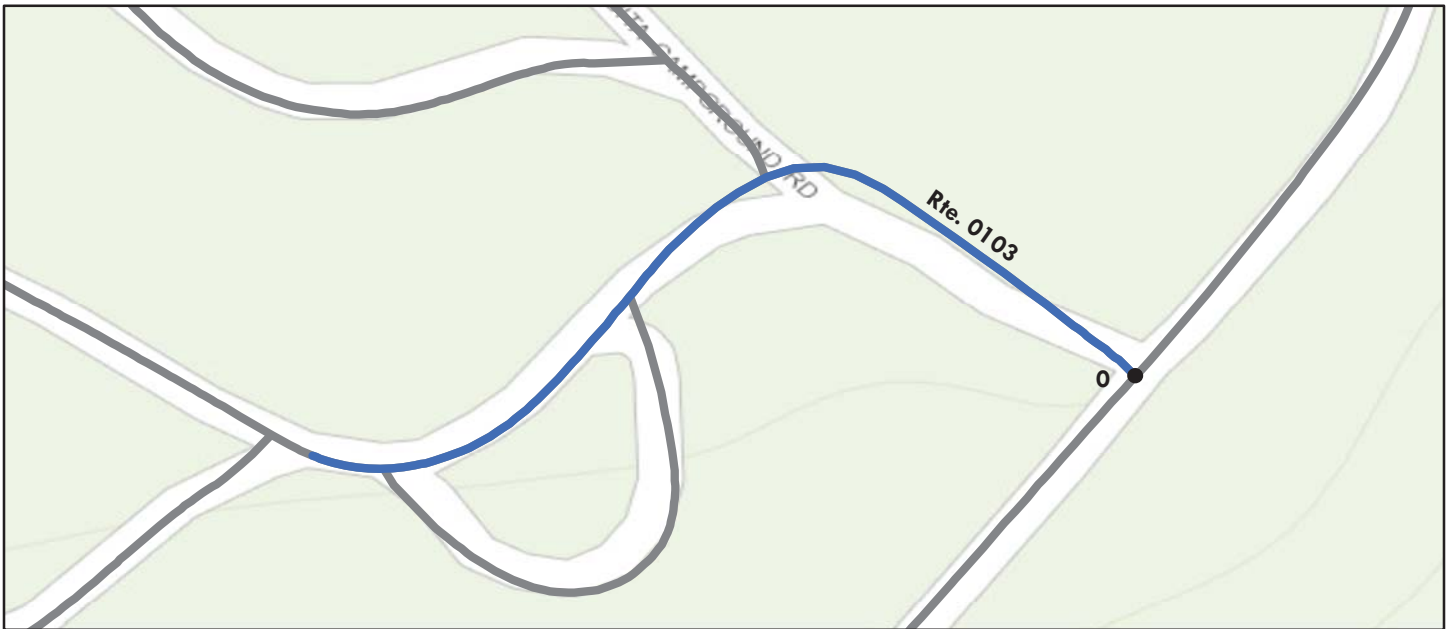
## ROUTE 0103: CAMPGROUND A AND B ACCESS ROAD

<b>Route Condition Legend – Pavement Condition Rating (PCR)</b>						
<b>Poor (0 - 60)</b>	<b>Fair (61- 84)</b>	<b>Good (85 - 94)</b>	<b>Excellent (95 - 100)</b>	<b>Not Rated</b>		
See Appendix for definitions and formulas						
<b>Inspection Date:</b> 4/19/2017	<b>Beginning Section MP</b>	0				
<b>Paved Length (Miles):</b> 0.07	<b>Section Length (MI)</b>	0.07				
<b>Surface Type:</b> ASPHALT	<b>Route Summary</b>					
<b>Roadway Condition Information</b>						
Pavement Condition Rating (PCR)	96	96				
Surface Condition Rating (SCR)	96	96				
Roughness Condition Index (RCI)	N/A	N/A				
<b>Distress Index Values</b>						
Structural Crack Index	99	99				
Alligator Crack Index	100	100				
Longitudinal Crack Index	99	99				
Transverse Cracking Index	98	98				
Patching Index	97	97				
Rutting Index	96	96				
International Roughness Index (IRI)	N/A	N/A				
<b>Lane &amp; Width Information</b>						
Number of Lanes	2	2

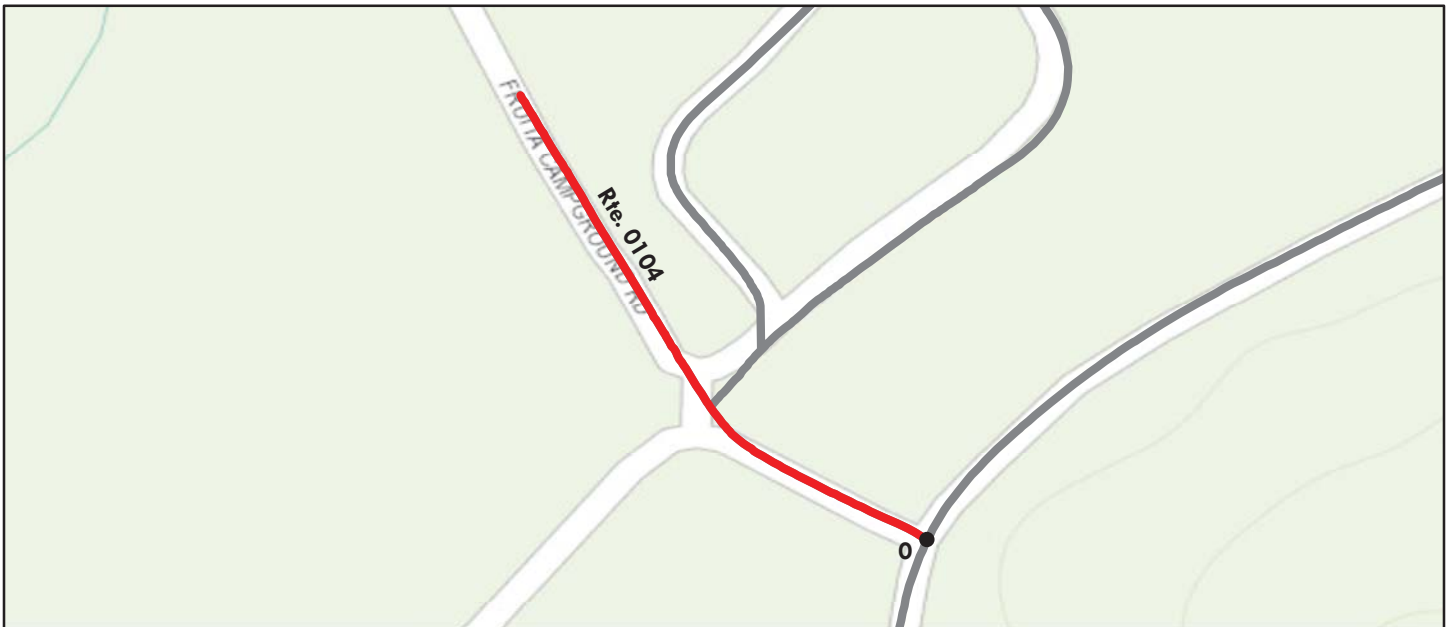
No distress indices are reported due to badly degraded asphalt. A manually rated PCR of 0 was recorded.

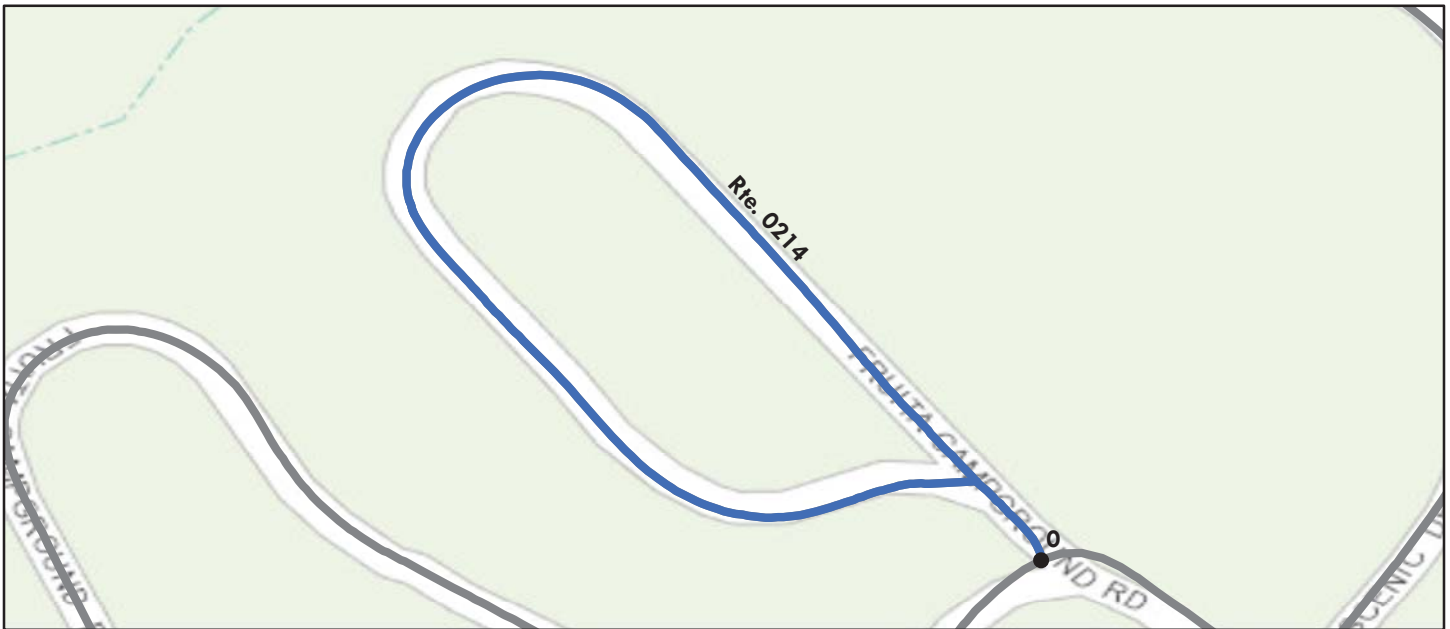
## ROUTE 0214: CAMPGROUND LOOP A

Route Condition Legend – Pavement Condition Rating (PCR)						
Poor (0 - 60)	Fair (61- 84)	Good (85 - 94)	Excellent (95 - 100)	Not Rated		
See Appendix for definitions and formulas						
<b>Inspection Date:</b> 4/19/2017	<b>Beginning Section MP</b>	0				
<b>Paved Length (Miles):</b> 0.17	<b>Section Length (MI)</b>	0.17				
<b>Surface Type:</b> ASPHALT	<b>Route Summary</b>					
<b>Roadway Condition Information</b>						
Pavement Condition Rating (PCR)	95	95				
Surface Condition Rating (SCR)	95	95				
Roughness Condition Index (RCI)	N/A	N/A				
<b>Distress Index Values</b>						
Structural Crack Index	100	100				
Alligator Crack Index	100	100				
Longitudinal Crack Index	100	100				
Transverse Cracking Index	98	98				
Patching Index	100	100				
Rutting Index	95	95				
International Roughness Index (IRI)	N/A	N/A				
<b>Lane &amp; Width Information</b>						
Number of Lanes	1	1				
Paved Width (ft)	15.2	15.2

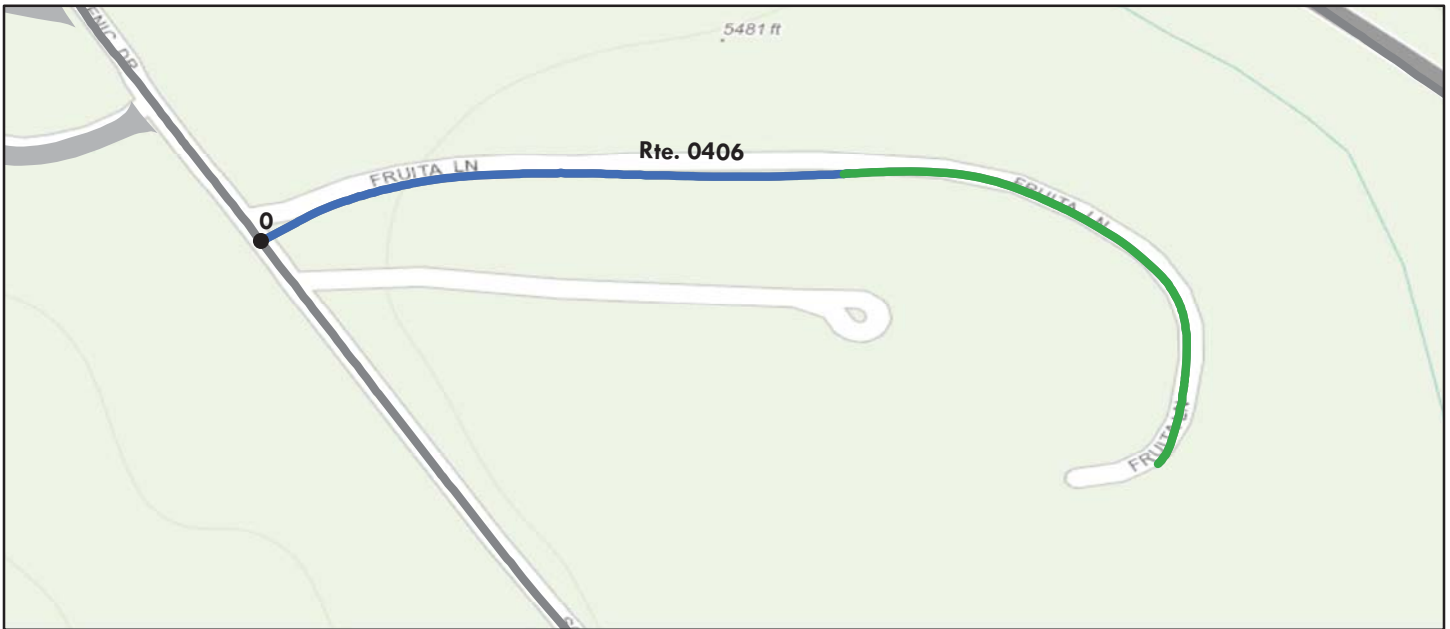
## ROUTE 0406: RESIDENCE AREA ROAD (FRUITA LANE)

<b>Route Condition Legend – Pavement Condition Rating (PCR)</b>						
<b>Poor (0 - 60)</b>	<b>Fair (61- 84)</b>	<b>Good (85 - 94)</b>	<b>Excellent (95 - 100)</b>	<b>Not Rated</b>		
See Appendix for definitions and formulas						
<b>Inspection Date:</b> 4/19/2017	<b>Beginning Section MP</b>	0				
<b>Paved Length (Miles):</b> 0.20	<b>Section Length (MI)</b>	0.20				
<b>Surface Type:</b> ASPHALT	<b>Route Summary</b>					
<b>Roadway Condition Information</b>						
Pavement Condition Rating (PCR)	95	95				
Surface Condition Rating (SCR)	95	95				
Roughness Condition Index (RCI)	N/A	N/A				
<b>Distress Index Values</b>						
Structural Crack Index	100	100				
Alligator Crack Index	100	100				
Longitudinal Crack Index	100	100				
Transverse Cracking Index	100	100				
Patching Index	100	100				
Rutting Index	95	95				
International Roughness Index (IRI)	N/A	N/A				
<b>Lane &amp; Width Information</b>						
Number of Lanes	2	2

Paved Width (ft)	21.3	21.3				
Lane Width (ft)	10.7	10.7

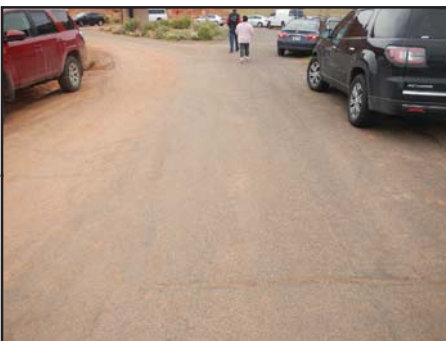
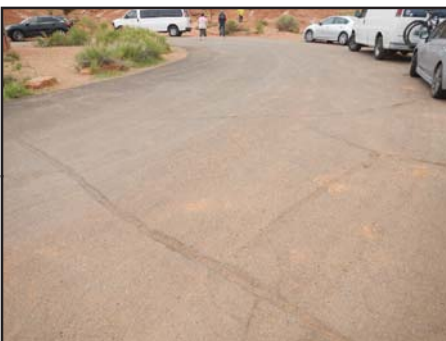
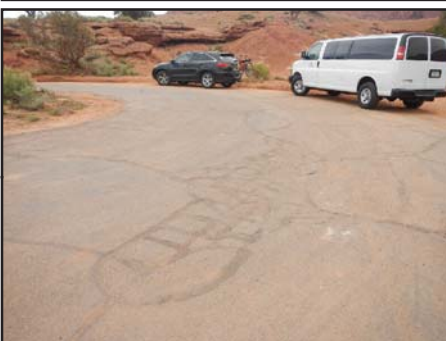
Inspection Date	FMSS Number	User Access	Surface Type
5/20/2016	82461	PUBLIC	ASPHALT
Area (Sq. Ft.)	Lane Miles (11' Widths)	Curb Reveal (Inches)	Curb Recommendation
8,304	0.143	NOT APPLICABLE	NOT APPLICABLE
Curb Type		Curb & Gutter Type	
NO CURB		NO CURB AND GUTTER	
Pavement Recommendation		Condition Rating / PCR	
HEAVY 3R TREATMENTS		POOR / 53

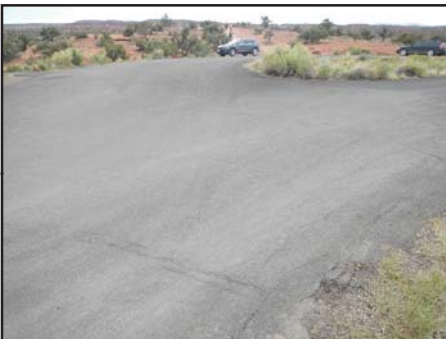
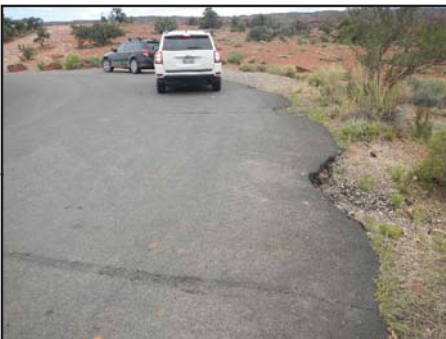
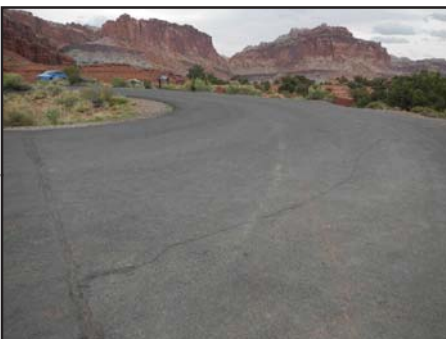
Inspection Date	FMSS Number	User Access	Surface Type
5/20/2016	82464	PUBLIC	ASPHALT
Area (Sq. Ft.)	Lane Miles (11' Widths)	Curb Reveal (Inches)	Curb Recommendation
9,297	0.16	NOT APPLICABLE	NOT APPLICABLE
Curb Type		Curb & Gutter Type	
NO CURB		NO CURB AND GUTTER	
Pavement Recommendation		Condition Rating / PCR	
LIGHT 3R TREATMENTS		FAIR / 73

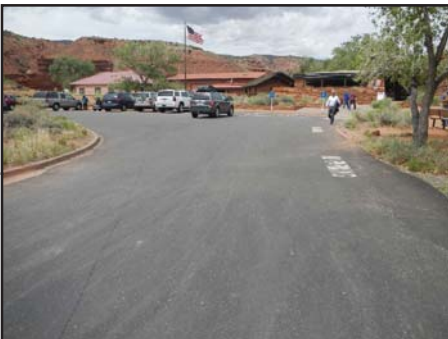
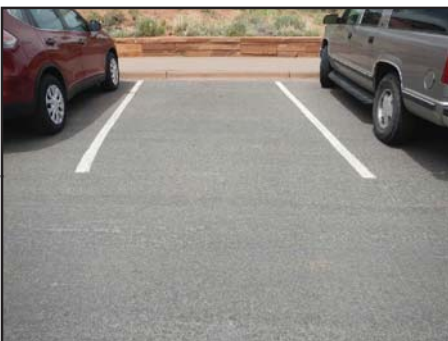
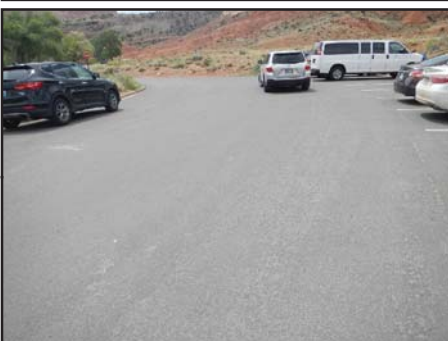
## ROUTE 0902: VISITOR CENTER PARKING

Inspection Date	FMSS Number	User Access	Surface Type
5/20/2016	78956	PUBLIC	ASPHALT
Area (Sq. Ft.)	Lane Miles (11' Widths)	Curb Reveal (Inches)	Curb Recommendation
14,762	0.254	NOT APPLICABLE	LIGHT REPAIR
Curb Type		Curb & Gutter Type	
NO CURB		CONCRETE	
Pavement Recommendation		Condition Rating / PCR	
PREVENTIVE MAINTENANCE		GOOD / 90

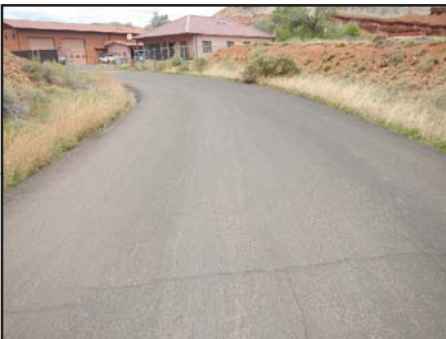
Inspection Date	FMSS Number	User Access	Surface Type
5/20/2016	78953	NONPUBLIC	ASPHALT
Area (Sq. Ft.)	Lane Miles (11' Widths)	Curb Reveal (Inches)	Curb Recommendation
42,240	0.727	3	DO NOTHING
Curb Type		Curb & Gutter Type	
CONCRETE		CONCRETE	
Pavement Recommendation		Condition Rating / PCR	
PREVENTIVE MAINTENANCE		GOOD / 90

Note: Parking area consists of multiple surface types: 1 part Asphalt at 40,255 square feet; 2 parts Concrete at 1,985 square feet.

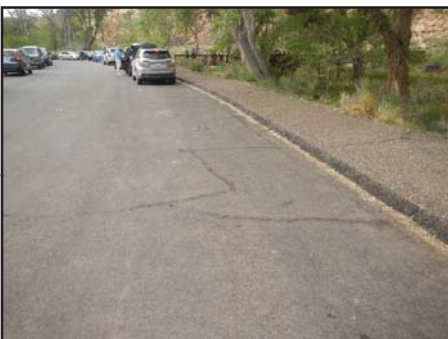
## ROUTE 0904: PETROGLYPHS PARKING

Inspection Date	FMSS Number	User Access	Surface Type
5/20/2016	82465	PUBLIC	ASPHALT
Area (Sq. Ft.)	Lane Miles (11' Widths)	Curb Reveal (Inches)	Curb Recommendation
11,520	0.198	6	DO NOTHING
Curb Type		Curb & Gutter Type	
ASPHALT		NO CURB AND GUTTER	
Pavement Recommendation		Condition Rating / PCR	
PREVENTIVE MAINTENANCE		GOOD / 90

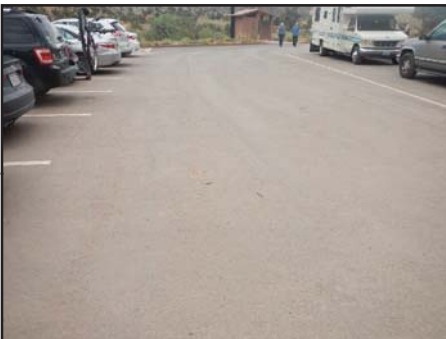
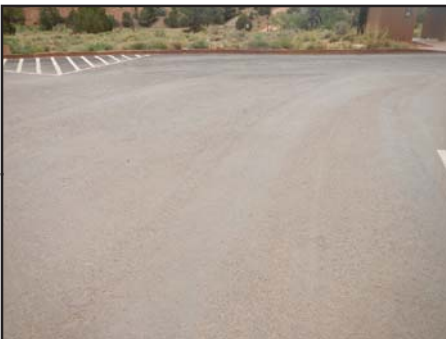
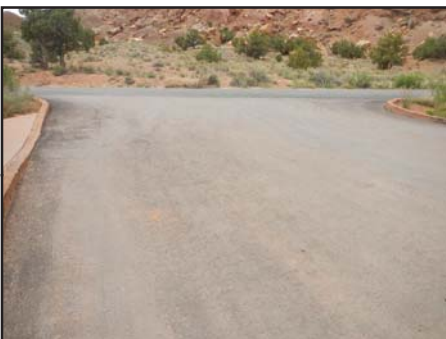
Inspection Date	FMSS Number	User Access	Surface Type
5/20/2016	82466	PUBLIC	ASPHALT
Area (Sq. Ft.)	Lane Miles (11' Widths)	Curb Reveal (Inches)	Curb Recommendation
8,172	0.141	4	DO NOTHING
Curb Type		Curb & Gutter Type	
STONE		NO CURB AND GUTTER	
Pavement Recommendation		Condition Rating / PCR	
LIGHT 3R TREATMENTS		FAIR / 73

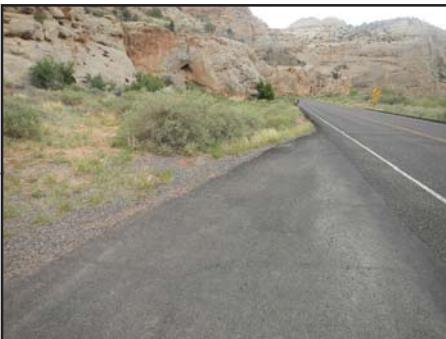
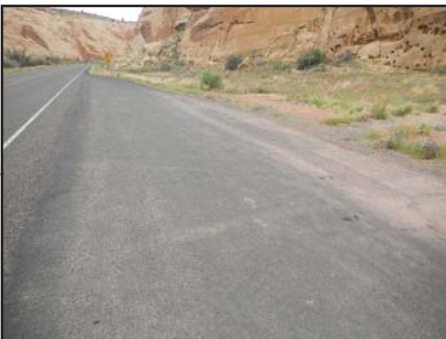
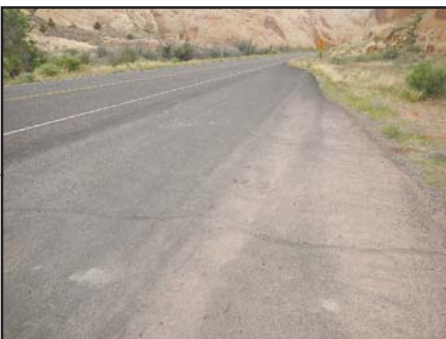
## ROUTE 0913: BEHUNIN CABIN PARKING

Inspection Date	FMSS Number	User Access	Surface Type
5/20/2016	82473	PUBLIC	ASPHALT
Area (Sq. Ft.)	Lane Miles (11' Widths)	Curb Reveal (Inches)	Curb Recommendation
3,083	0.053	NOT APPLICABLE	NOT APPLICABLE
Curb Type		Curb & Gutter Type	
NO CURB		NO CURB AND GUTTER	
Pavement Recommendation		Condition Rating / PCR	
LIGHT 3R TREATMENTS		FAIR / 73

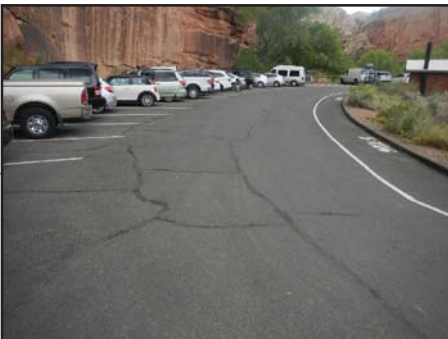
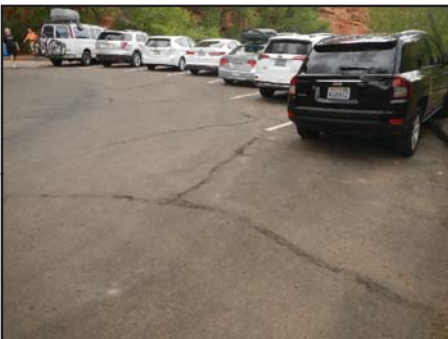
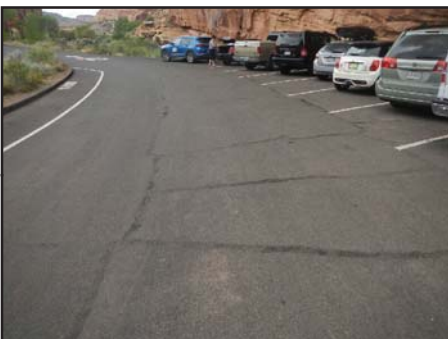
## ROUTE 0915: HICKMAN NATURAL BRIDGE PARKING

Inspection Date	FMSS Number	User Access	Surface Type
5/20/2016	71083	PUBLIC	ASPHALT
Area (Sq. Ft.)	Lane Miles (11' Widths)	Curb Reveal (Inches)	Curb Recommendation
18,836	0.324	6	DO NOTHING
Curb Type		Curb & Gutter Type	
ASPHALT		NO CURB AND GUTTER	
Pavement Recommendation		Condition Rating / PCR	
PREVENTIVE MAINTENANCE		GOOD / 90

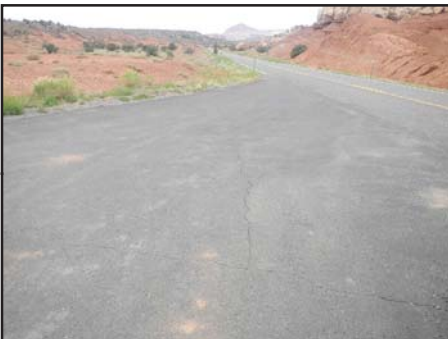
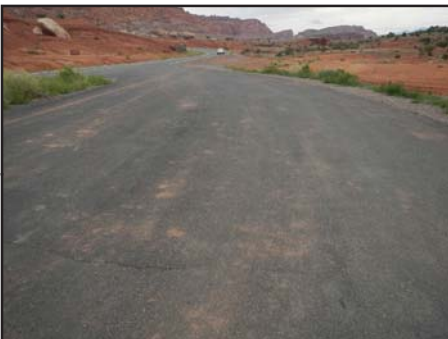
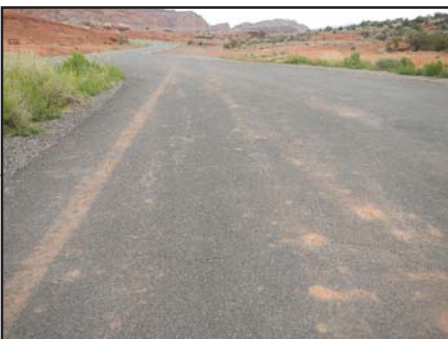
## ROUTE 0916: TWIN ROCKS PARKING

Inspection Date	FMSS Number	User Access	Surface Type
5/20/2016	82475	PUBLIC	ASPHALT
Area (Sq. Ft.)	Lane Miles (11' Widths)	Curb Reveal (Inches)	Curb Recommendation
6,160	0.106	NOT APPLICABLE	NOT APPLICABLE
Curb Type		Curb & Gutter Type	
NO CURB		NO CURB AND GUTTER	
Pavement Recommendation		Condition Rating / PCR	
PREVENTIVE MAINTENANCE		GOOD / 90

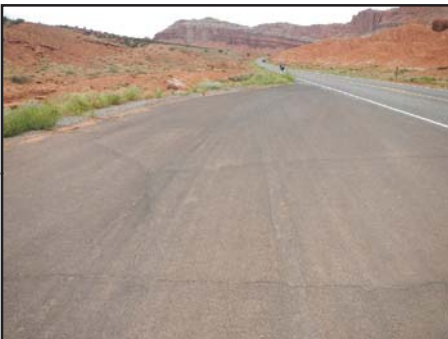
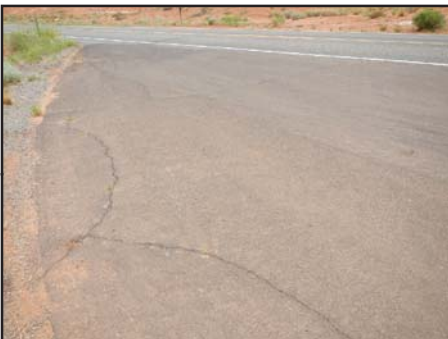
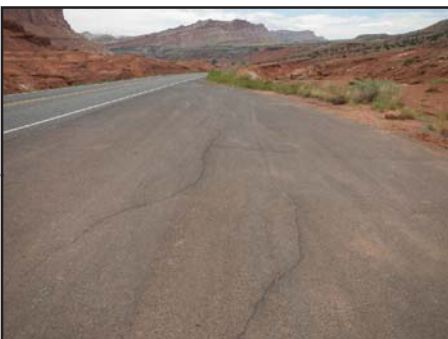
## ROUTE 0917: THE CASTLE PARKING

Inspection Date	FMSS Number	User Access	Surface Type
5/20/2016	82476	PUBLIC	ASPHALT
Area (Sq. Ft.)	Lane Miles (11' Widths)	Curb Reveal (Inches)	Curb Recommendation
7,245	0.125	NOT APPLICABLE	NOT APPLICABLE
Curb Type		Curb & Gutter Type	
NO CURB		NO CURB AND GUTTER	
Pavement Recommendation		Condition Rating / PCR	
PREVENTIVE MAINTENANCE		GOOD / 90

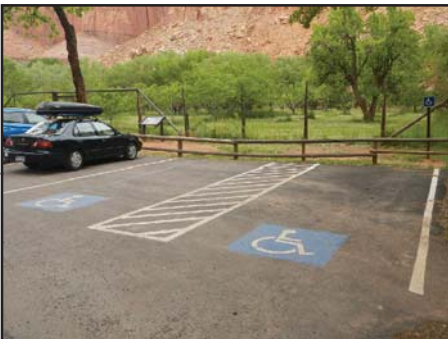
## ROUTE 0920: JOHNSON ORCHARD PARKING

Inspection Date	FMSS Number	User Access	Surface Type
5/20/2016	82478	PUBLIC	ASPHALT
Area (Sq. Ft.)	Lane Miles (11' Widths)	Curb Reveal (Inches)	Curb Recommendation
5,960	0.103	NOT APPLICABLE	NOT APPLICABLE
Curb Type		Curb & Gutter Type	
NO CURB		NO CURB AND GUTTER	
Pavement Recommendation		Condition Rating / PCR	
PREVENTIVE MAINTENANCE		GOOD / 90

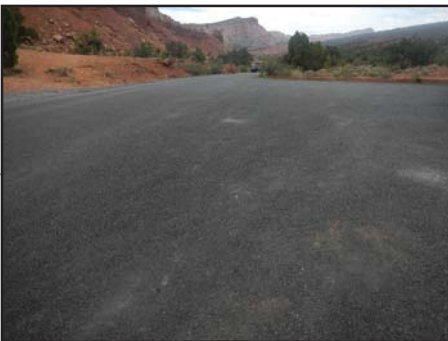
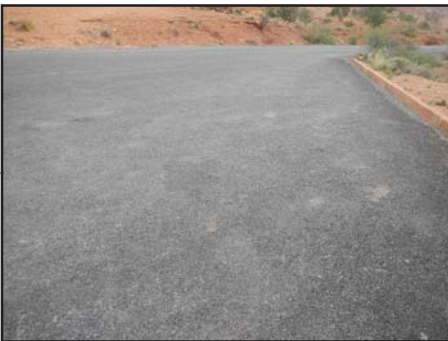
## ROUTE 0924: SLICK ROCK DIVIDE PARKING

Inspection Date	FMSS Number	User Access	Surface Type
5/20/2016	82484	PUBLIC	ASPHALT
Area (Sq. Ft.)	Lane Miles (11' Widths)	Curb Reveal (Inches)	Curb Recommendation
3,058	0.053	7	DO NOTHING
Curb Type		Curb & Gutter Type	
STONE		NO CURB AND GUTTER	
Pavement Recommendation		Condition Rating / PCR	
PREVENTIVE MAINTENANCE		GOOD / 90
