CARL Cycle 6

Final Report

Road Inventory and Condition Assessment of Paved Routes Carl Sandburg Home National Historic Site

**Federal Highway Administration
Eastern Federal Lands Highway Division
Road Inventory Program (RIP)**

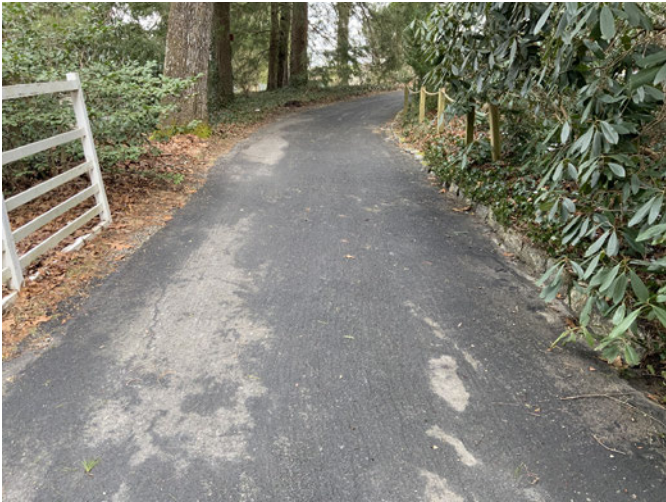
CARL_0400BZ_1.jpg

Route Condition Legend – Pavement Condition Rating (PCR)						
Poor (0 - 60)	Fair (61- 84)	Good (85 - 94)	Excellent (95 - 100)	Not Rated		
See Appendix for definitions and formulas						
Inspection Date: 2/9/2021	Beginning Section MP	0.00				
Paved Length (Miles): 0.03	Section Length (MI)	0.03				
Surface Type: ASPHALT	Route Summary					
Roadway Condition Information						
Pavement Condition Rating (PCR)	90	90				
Surface Condition Rating (SCR)	90	90				
Roughness Condition Index (RCI)	N/A	N/A				
Distress Index Values						
Structural Crack Index	N/A	N/A				
Alligator Crack Index	97	97				
Longitudinal Crack Index	97	97				
Transverse Cracking Index	90	90				
Patching Index	97	97				
Rutting Index	97	97				
International Roughness Index (IRI)	N/A	N/A				
Lane & Width Information						
Number of Lanes	1	1				
Paved Width (ft)	9.8	9.8				
Lane Width (ft)	9.8	9.8

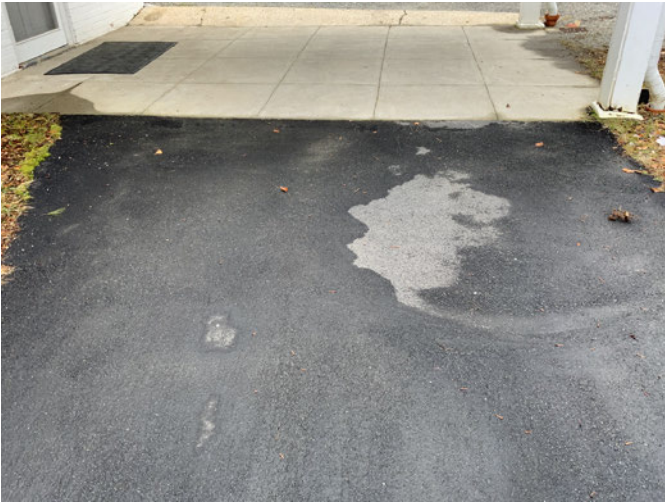
CARL_0400CZ_1.jpg

Route Condition Legend – Pavement Condition Rating (PCR)						
Poor (0 - 60)	Fair (61- 84)	Good (85 - 94)	Excellent (95 - 100)	Not Rated		
See Appendix for definitions and formulas						
Inspection Date: 2/9/2021	Beginning Section MP	0.00				
Paved Length (Miles): 0.01	Section Length (MI)	0.01				
Surface Type: ASPHALT	Route Summary					
Roadway Condition Information						
Pavement Condition Rating (PCR)	90	90				
Surface Condition Rating (SCR)	90	90				
Roughness Condition Index (RCI)	N/A	N/A				
Distress Index Values						
Structural Crack Index	N/A	N/A				
Alligator Crack Index	97	97				
Longitudinal Crack Index	97	97				
Transverse Cracking Index	90	90				
Patching Index	97	97				
Rutting Index	97	97				
International Roughness Index (IRI)	N/A	N/A				
Lane & Width Information						
Number of Lanes	1	1				
Paved Width (ft)	11.6	11.6				
Lane Width (ft)	11.6	11.6

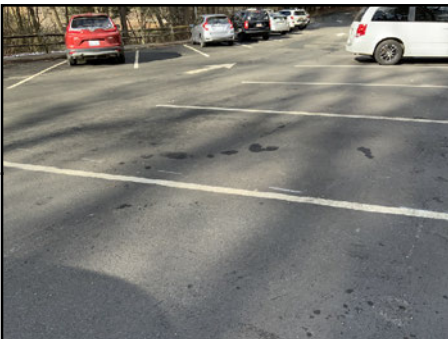
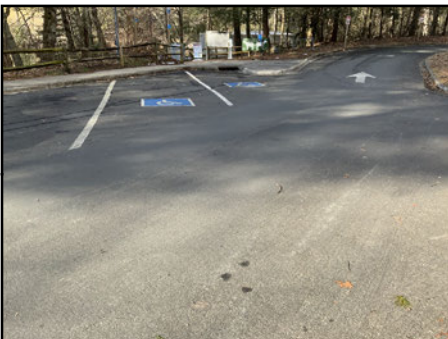
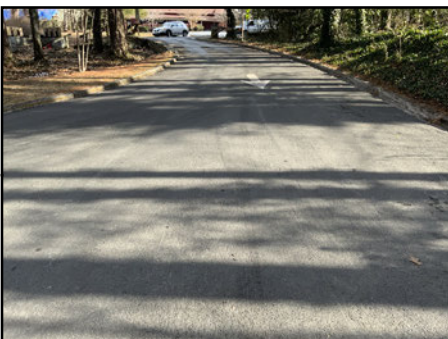
Inspection Date	FMSS Number	User Access	Surface Type
2/9/2021	79060	PUBLIC	ASPHALT
Area (Sq. Ft.)	Lane Miles (11' Widths)	Curb Reveal (Inches)	Curb Recommendation
18,388	0.317	7	DO NOTHING
Curb Type		Curb & Gutter Type	
STONE		CONCRETE	
Pavement Recommendation		Condition Rating / PCR	
PREVENTIVE MAINTENANCE		GOOD / 90

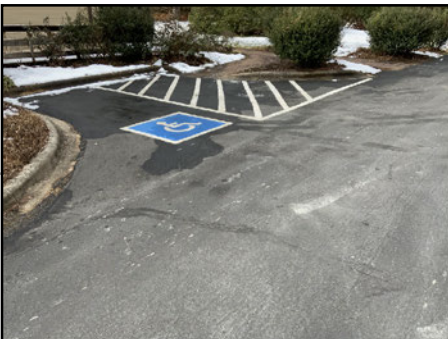
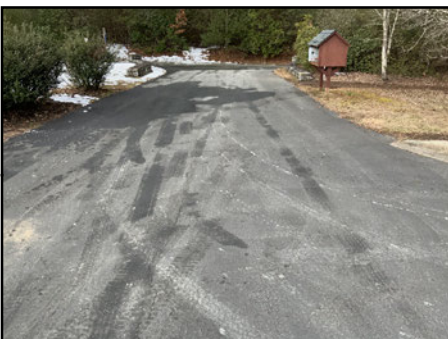
ROUTE 0901: ADMINISTRATIVE PARKING

Inspection Date	FMSS Number	User Access	Surface Type
2/9/2021	79184	NONPUBLIC	ASPHALT
Area (Sq. Ft.)	Lane Miles (11' Widths)	Curb Reveal (Inches)	Curb Recommendation
6,736	0.116	NOT APPLICABLE	DO NOTHING
Curb Type		Curb & Gutter Type	
NO CURB		CONCRETE	
Pavement Recommendation		Condition Rating / PCR	
PREVENTIVE MAINTENANCE		GOOD / 90

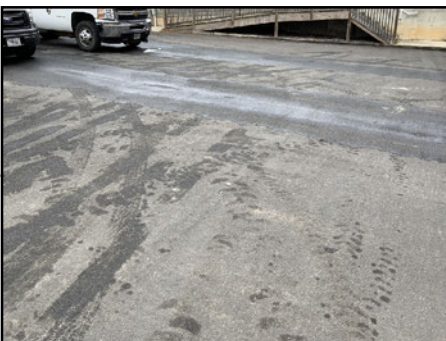
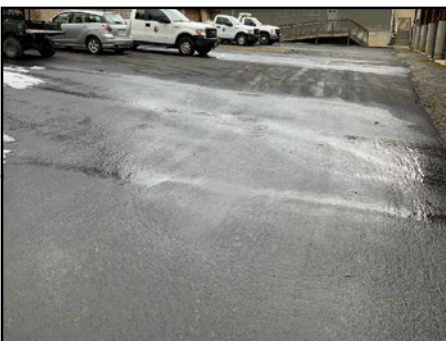
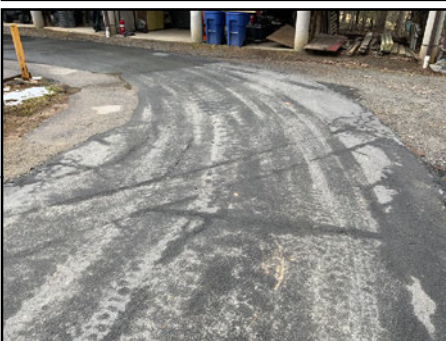
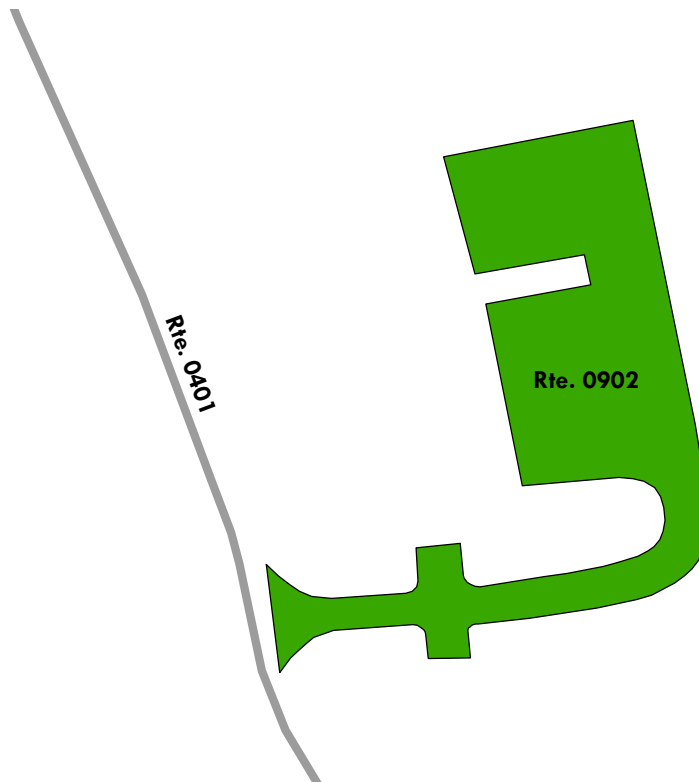
ROUTE 0902: MAINTENANCE AREA

Inspection Date	FMSS Number	User Access	Surface Type
2/9/2021	79185	NONPUBLIC	ASPHALT
Area (Sq. Ft.)	Lane Miles (11' Widths)	Curb Reveal (Inches)	Curb Recommendation
7,221	0.124	NOT APPLICABLE	NOT APPLICABLE
Curb Type		Curb & Gutter Type	
NO CURB		NO CURB AND GUTTER	
Pavement Recommendation		Condition Rating / PCR	
PREVENTIVE MAINTENANCE		GOOD / 90
