# CAVE Cycle 6

## Final Report

### Road Inventory and Condition Assessment of Paved Routes Carlsbad Caverns National Park

**Report Date: August 2017**

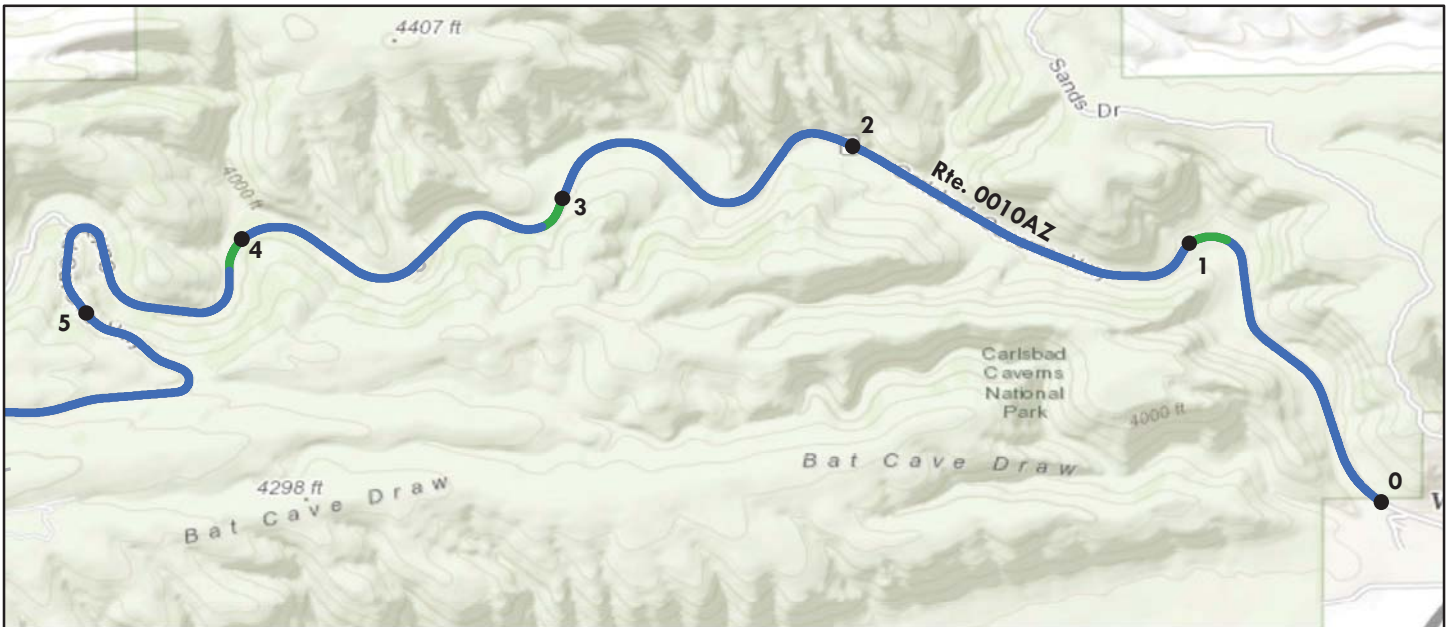
## ROUTE 0010AZ: WALNUT CANYON ENTRANCE ROAD

<b>Route Condition Legend – Pavement Condition Rating (PCR)</b>						
<b>Poor (0 - 60)</b>	<b>Fair (61- 84)</b>	<b>Good (85 - 94)</b>	<b>Excellent (95 - 100)</b>	<b>Not Rated</b>		
See Appendix for definitions and formulas						
<b>Inspection Date:</b> 3/21/2017	<b>Beginning Section MP</b>	0	1	2	3	4
<b>Paved Length (Miles):</b> 6.98	<b>Section Length (MI)</b>	1	1	1	1	1
<b>Surface Type:</b> ASPHALT	<b>Route Summary</b>					
<b>Roadway Condition Information</b>						
Pavement Condition Rating (PCR)	99	98	99	99	99	98
Surface Condition Rating (SCR)	99	99	99	99	99	98
Roughness Condition Index (RCI)	100	97	100	100	100	99
<b>Distress Index Values</b>						
Structural Crack Index	100	100	100	100	100	100
Alligator Crack Index	100	100	100	100	100	100
Longitudinal Crack Index	100	100	100	100	100	100
Transverse Cracking Index	99	99	100	99	100	98
Patching Index	100	100	100	100	100	100
Rutting Index	99	100	99	99	99	99

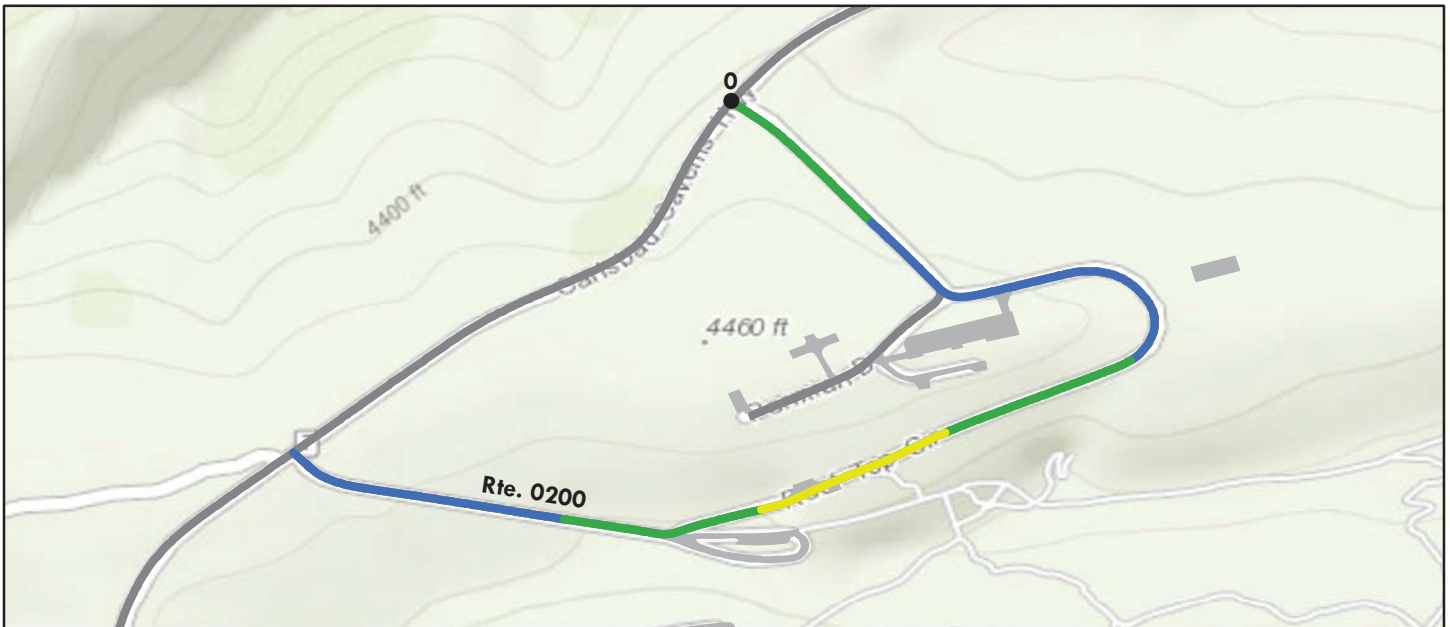
## ROUTE 0200: AMPHITHEATER ROAD

<b>Inspection Date:</b> 3/21/2017	<b>Beginning Section MP</b>	0				
<b>Paved Length (Miles):</b> 0.73	<b>Section Length (MI)</b>	0.73				
<b>Surface Type:</b> ASPHALT	<b>Route Summary</b>					
<b>Roadway Condition Information</b>						
Pavement Condition Rating (PCR)	94	94				
Surface Condition Rating (SCR)	94	94				
Roughness Condition Index (RCI)	N/A	N/A				
<b>Distress Index Values</b>						
Structural Crack Index	95	95				
Alligator Crack Index	100	100				
Longitudinal Crack Index	95	95				
Transverse Cracking Index	94	94				
Patching Index	100	100				
Rutting Index	95	95				
International Roughness Index (IRI)	N/A	N/A				
<b>Lane &amp; Width Information</b>						
Number of Lanes	2	2				
Paved Width (ft)	19.2	19.2				
Lane Width (ft)	10.2	10.2

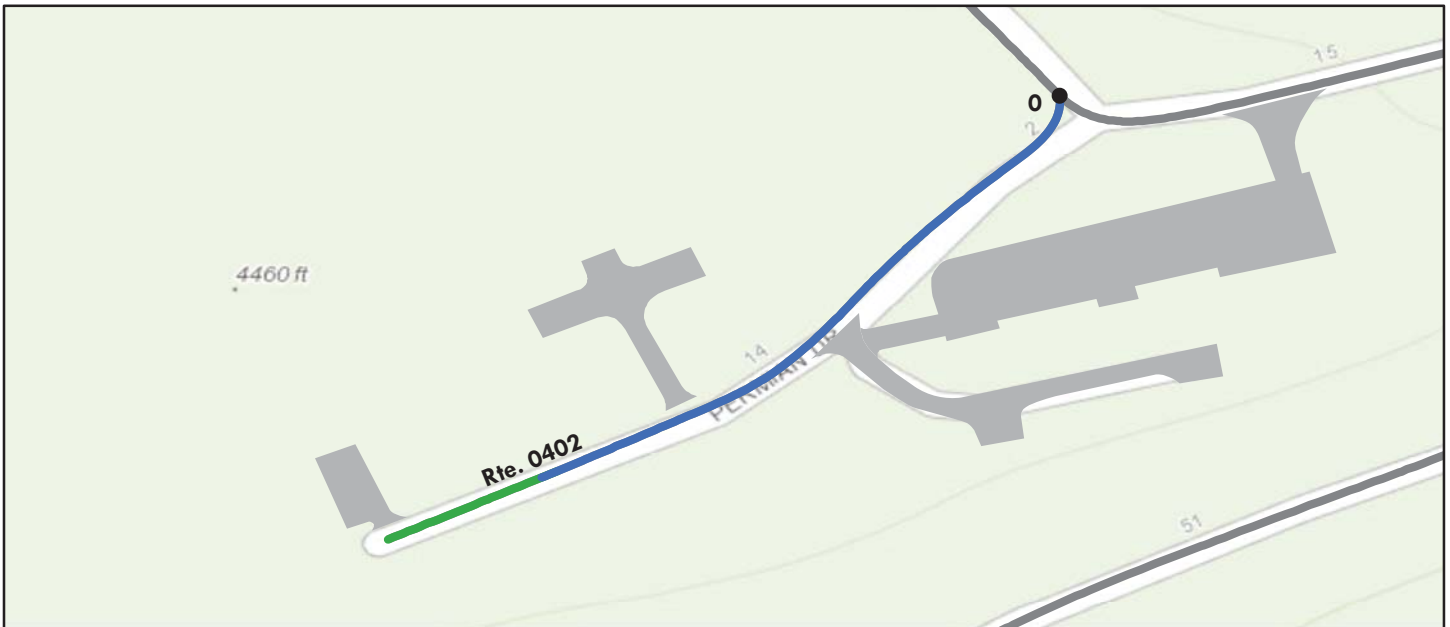
## ROUTE 0402: PERMIAN DRIVE

<b>Inspection Date:</b> 3/21/2017	<b>Beginning Section MP</b>	0				
<b>Paved Length (Miles):</b> 0.13	<b>Section Length (MI)</b>	0.13				
<b>Surface Type:</b> ASPHALT	<b>Route Summary</b>					
<b>Roadway Condition Information</b>						
Pavement Condition Rating (PCR)	97	97				
Surface Condition Rating (SCR)	97	97				
Roughness Condition Index (RCI)	N/A	N/A				
<b>Distress Index Values</b>						
Structural Crack Index	100	100				
Alligator Crack Index	100	100				
Longitudinal Crack Index	100	100				
Transverse Cracking Index	99	99				
Patching Index	100	100				
Rutting Index	97	97				
International Roughness Index (IRI)	N/A	N/A				
<b>Lane &amp; Width Information</b>						
Number of Lanes	2	2				
Paved Width (ft)	19.3	19.3				
Lane Width (ft)	9.7	9.7

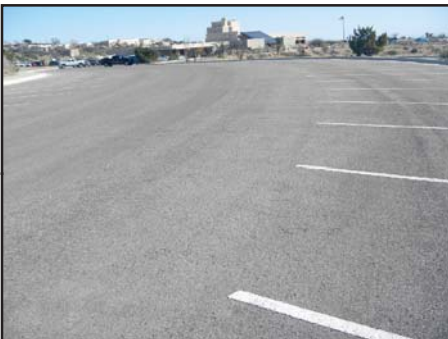
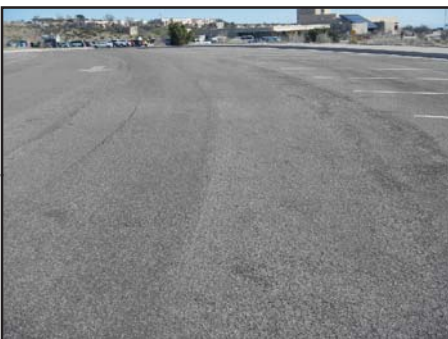
## ROUTE 0901: VISITOR CENTER WEST PARKING LOT

Inspection Date	FMSS Number	User Access	Surface Type
2/27/2017	15550	PUBLIC	ASPHALT
Area (Sq. Ft.)	Lane Miles (11' Widths)	Curb Reveal (Inches)	Curb Recommendation
133,635	2.301	NOT APPLICABLE	DO NOTHING
Curb Type		Curb & Gutter Type	
NO CURB		CONCRETE	
Pavement Recommendation		Condition Rating / PCR	
PREVENTIVE MAINTENANCE		GOOD / 90

Note: Parking area consists of multiple surface types: 1 part Asphalt at 133,474 square feet; 1 part Concrete at 161 square feet.

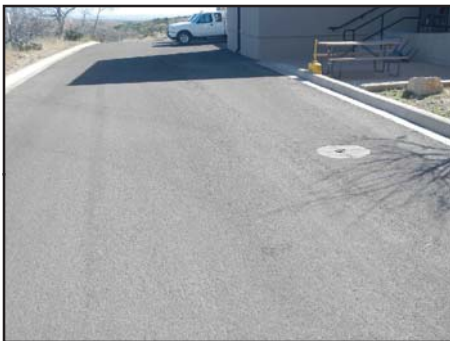
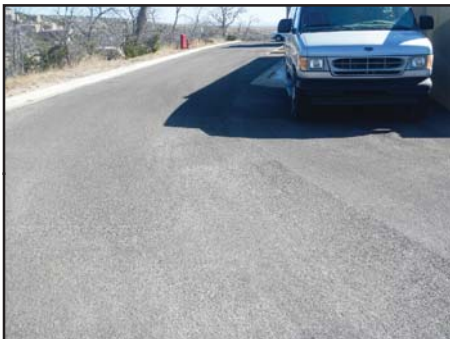
## ROUTE 0902: VISITOR CENTER EMPLOYEE PARKING

Inspection Date	FMSS Number	User Access	Surface Type
2/27/2017	91860	NONPUBLIC	ASPHALT
Area (Sq. Ft.)	Lane Miles (11' Widths)	Curb Reveal (Inches)	Curb Recommendation
9,870	0.17	5	DO NOTHING
Curb Type		Curb & Gutter Type	
CONCRETE		CONCRETE	
Pavement Recommendation		Condition Rating / PCR	
PREVENTIVE MAINTENANCE		GOOD / 90

Note: Parking area consists of multiple surface types: 1 part Asphalt at 9,429 square feet; 1 part Concrete at 441 square feet.

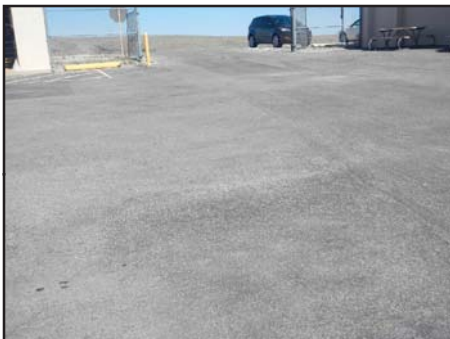
## ROUTE 0904: MAINTENANCE AREA

Inspection Date	FMSS Number	User Access	Surface Type
2/27/2017	91663	NONPUBLIC	ASPHALT
Area (Sq. Ft.)	Lane Miles (11' Widths)	Curb Reveal (Inches)	Curb Recommendation
22,752	0.392	NOT APPLICABLE	NOT APPLICABLE
Curb Type		Curb & Gutter Type	
NO CURB		NO CURB AND GUTTER	
Pavement Recommendation		Condition Rating / PCR	
PREVENTIVE MAINTENANCE		GOOD / 90

Note: Parking area consists of multiple surface types: 1 part Asphalt at 21,893 square feet; 1 part Concrete at 859 square feet.

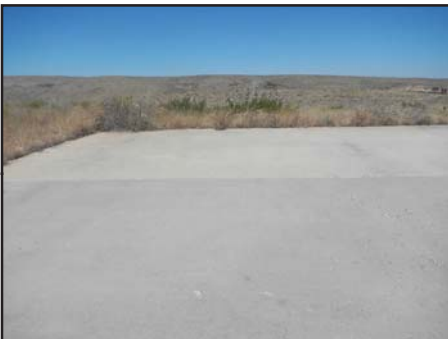
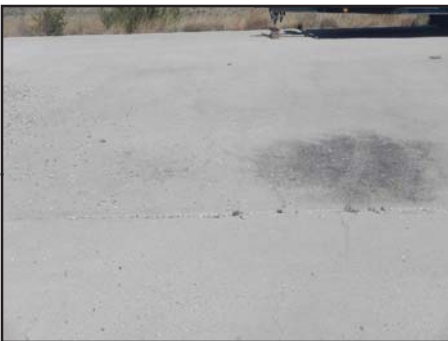
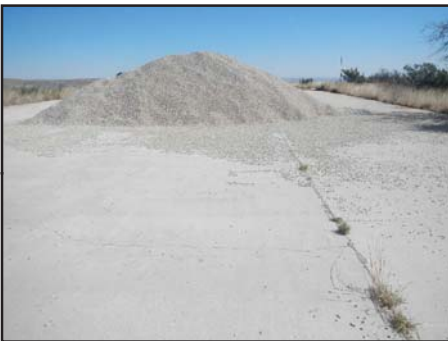
## ROUTE 0905: MAINTENANCE PARKING AREA

Inspection Date	FMSS Number	User Access	Surface Type
2/27/2017	91707	NONPUBLIC	CONCRETE
Area (Sq. Ft.)	Lane Miles (11' Widths)	Curb Reveal (Inches)	Curb Recommendation
5,886	0.101	NOT APPLICABLE	NOT APPLICABLE
Curb Type		Curb & Gutter Type	
NO CURB		NO CURB AND GUTTER	
Pavement Recommendation		Condition Rating / PCR	
PREVENTIVE MAINTENANCE		GOOD / 90

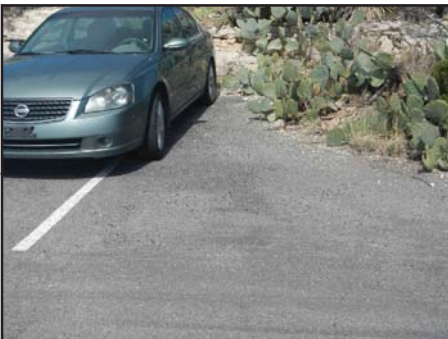
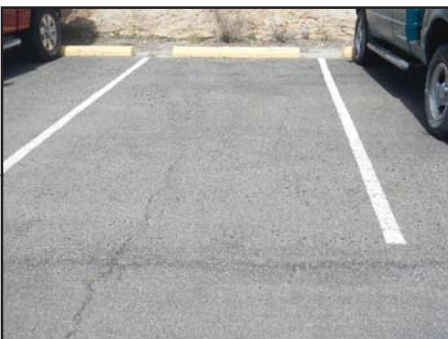
## ROUTE 0909: ADMIN EMPLOYEE PARKING

Inspection Date	FMSS Number	User Access	Surface Type
2/27/2017	91811	NONPUBLIC	ASPHALT
Area (Sq. Ft.)	Lane Miles (11' Widths)	Curb Reveal (Inches)	Curb Recommendation
2,010	0.035	NOT APPLICABLE	NOT APPLICABLE
Curb Type		Curb & Gutter Type	
NO CURB		NO CURB AND GUTTER	
Pavement Recommendation		Condition Rating / PCR	
PREVENTIVE MAINTENANCE		GOOD / 90

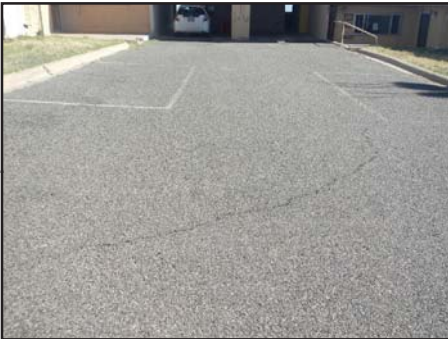
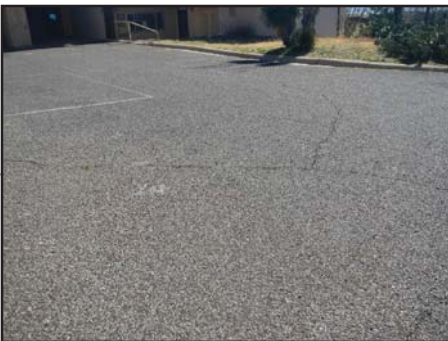
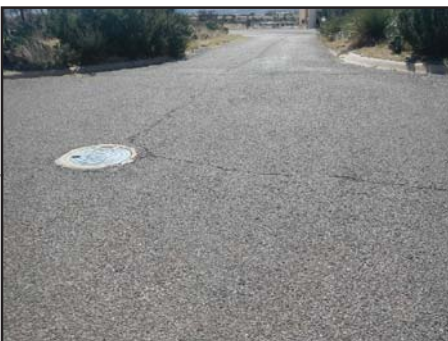
## ROUTE 0910: EAST SIXPLEX AREA

Inspection Date	FMSS Number	User Access	Surface Type
2/27/2017	91818	NONPUBLIC	ASPHALT
Area (Sq. Ft.)	Lane Miles (11' Widths)	Curb Reveal (Inches)	Curb Recommendation
5,919	0.102	NOT APPLICABLE	DO NOTHING
Curb Type		Curb & Gutter Type	
NO CURB		CONCRETE	
Pavement Recommendation		Condition Rating / PCR	
PREVENTIVE MAINTENANCE		GOOD / 90

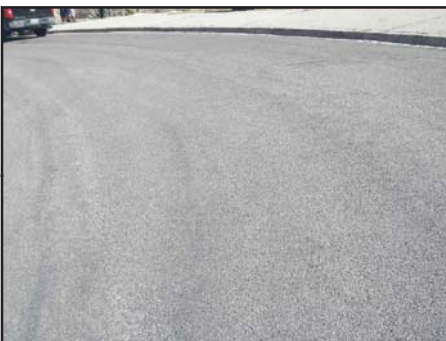
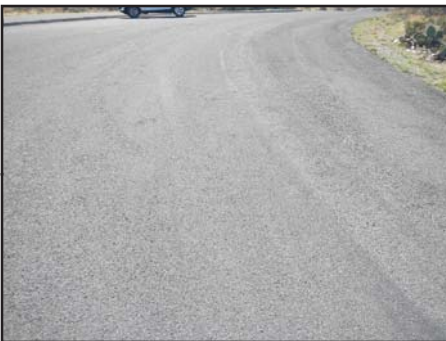
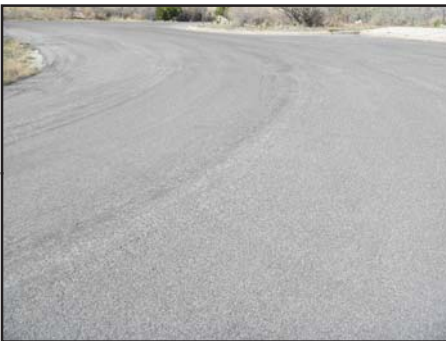
## ROUTE 0914: INDIAN ROCK SHELTER PARKING

Inspection Date	FMSS Number	User Access	Surface Type
2/26/2017	91825	PUBLIC	ASPHALT
Area (Sq. Ft.)	Lane Miles (11' Widths)	Curb Reveal (Inches)	Curb Recommendation
12,483	0.215	NOT APPLICABLE	DO NOTHING
Curb Type		Curb & Gutter Type	
NO CURB		CONCRETE	
Pavement Recommendation		Condition Rating / PCR	
PREVENTIVE MAINTENANCE		GOOD / 90

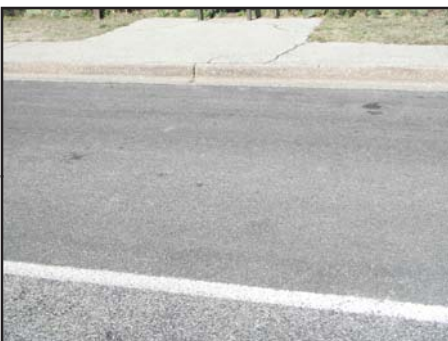
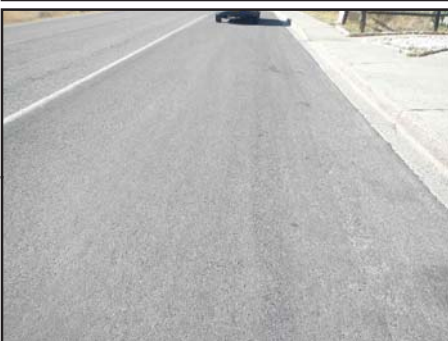
## ROUTE 0915: PICNIC PARKING

Inspection Date	FMSS Number	User Access	Surface Type
2/26/2017	91826	PUBLIC	ASPHALT
Area (Sq. Ft.)	Lane Miles (11' Widths)	Curb Reveal (Inches)	Curb Recommendation
3,162	0.054	NOT APPLICABLE	DO NOTHING
Curb Type		Curb & Gutter Type	
NO CURB		CONCRETE	
Pavement Recommendation		Condition Rating / PCR	
PREVENTIVE MAINTENANCE		GOOD / 90

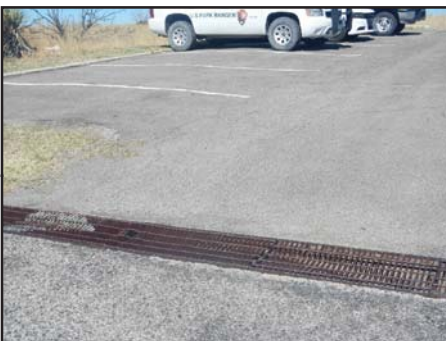
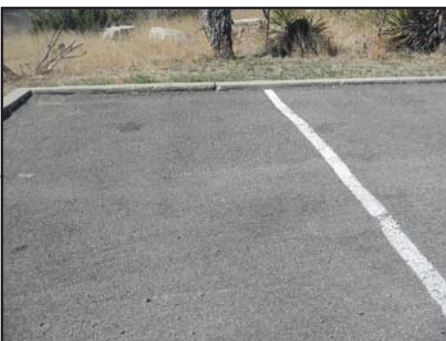
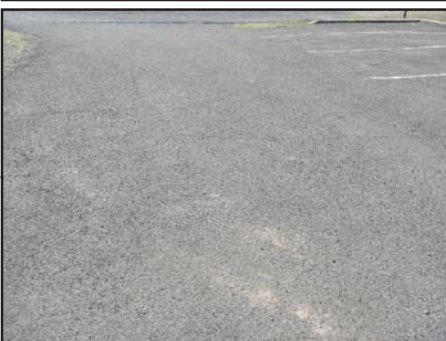
## ROUTE 0916: PERMIAN DRIVE HOUSING OVERFLOW PARKING

Inspection Date	FMSS Number	User Access	Surface Type
2/27/2017	238731	NONPUBLIC	ASPHALT
Area (Sq. Ft.)	Lane Miles (11' Widths)	Curb Reveal (Inches)	Curb Recommendation
2,379	0.041	2	DO NOTHING
Curb Type		Curb & Gutter Type	
CONCRETE		NO CURB AND GUTTER	
Pavement Recommendation		Condition Rating / PCR	
PREVENTIVE MAINTENANCE		GOOD / 90
