# CAVO Cycle 6

## Final Report

### Road Inventory and Condition Assessment of Paved Routes Capulin Volcano National Monument

Report Date: January 2018

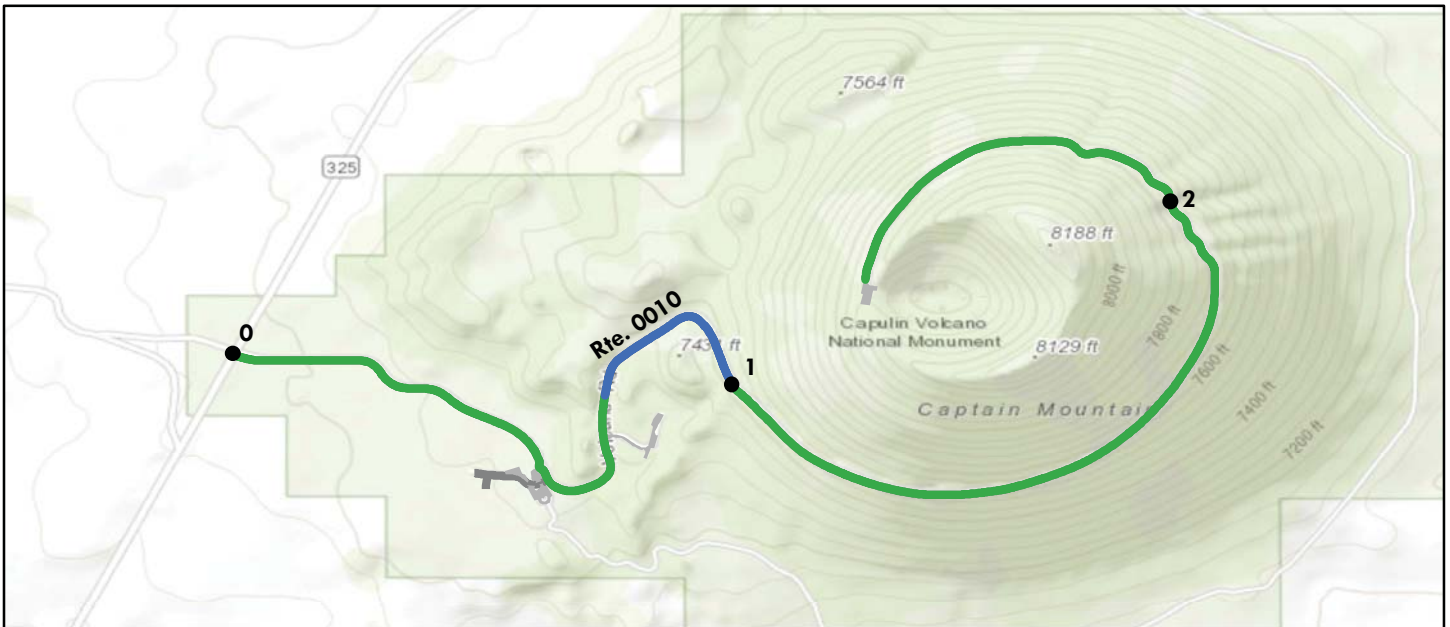
## ROUTE 0010: CAPULIN VOLCANO ROAD

Route Condition Legend – Pavement Condition Rating (PCR)						
Poor (0 - 60)	Fair (61- 84)	Good (85 - 94)	Excellent (95 - 100)	Not Rated		
See Appendix for definitions and formulas						
<b>Inspection Date:</b> 5/31/2017	<b>Beginning Section MP</b>	0	1	2		
<b>Paved Length (Miles):</b> 2.55	<b>Section Length (MI)</b>	1	1	0.55		
<b>Surface Type:</b> ASPHALT	<b>Route Summary</b>					
<b>Roadway Condition Information</b>						
Pavement Condition Rating (PCR)	92	94	90	90		
Surface Condition Rating (SCR)	92	94	90	90		
Roughness Condition Index (RCI)	N/A	N/A	N/A	N/A		
<b>Distress Index Values</b>						
Structural Crack Index	97	99	95	95		
Alligator Crack Index	100	100	100	100		
Longitudinal Crack Index	97	99	95	95		
Transverse Cracking Index	92	94	90	90		
Patching Index	100	100	100	100		
Rutting Index	96	97	95	95		
International Roughness Index (IRI)	N/A	N/A	N/A	N/A		
<b>Lane &amp; Width Information</b>						
Number of Lanes	2	2	2	2

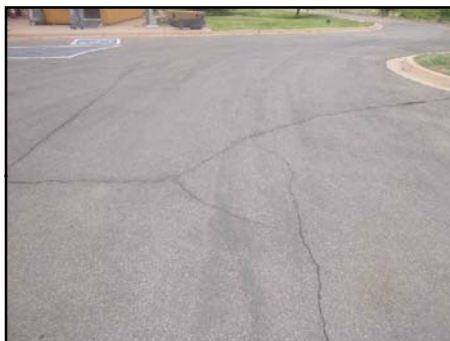
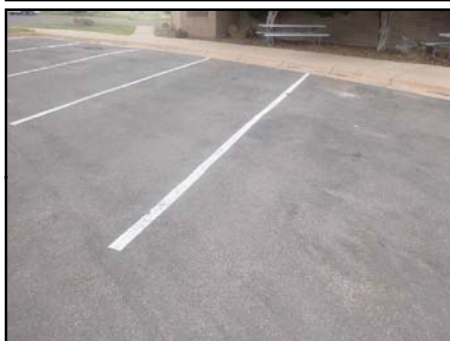
Inspection Date	FMSS Number	User Access	Surface Type
5/31/2017	91299	PUBLIC	ASPHALT
Area (Sq. Ft.)	Lane Miles (11' Widths)	Curb Reveal (Inches)	Curb Recommendation
6,351	0.109	NOT APPLICABLE	LIGHT REPAIR
Curb Type		Curb & Gutter Type	
NO CURB		CONCRETE	
Pavement Recommendation		Condition Rating / PCR	
PREVENTIVE MAINTENANCE		GOOD / 90

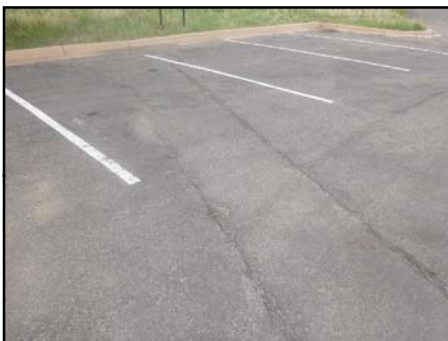
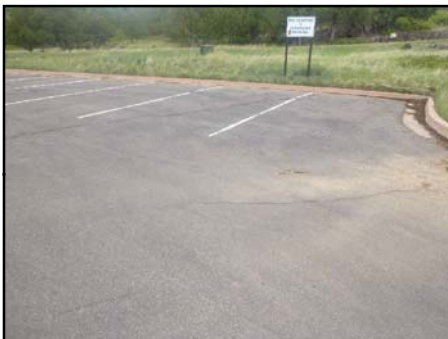
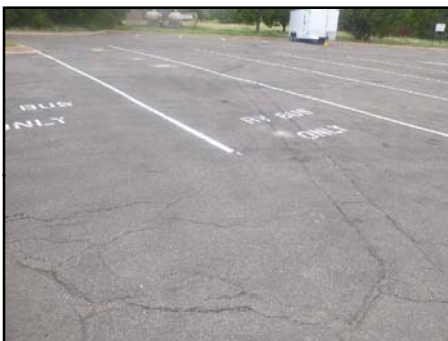
## ROUTE 0901: VISITOR CENTER OVERFLOW PARKING

Inspection Date	FMSS Number	User Access	Surface Type
5/31/2017	68790	PUBLIC	ASPHALT
Area (Sq. Ft.)	Lane Miles (11' Widths)	Curb Reveal (Inches)	Curb Recommendation
15,777	0.272	NOT APPLICABLE	DO NOTHING
Curb Type		Curb & Gutter Type	
NO CURB		CONCRETE	
Pavement Recommendation		Condition Rating / PCR	
HEAVY 3R TREATMENTS		POOR / 53

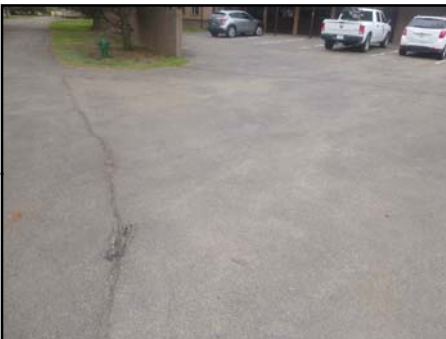
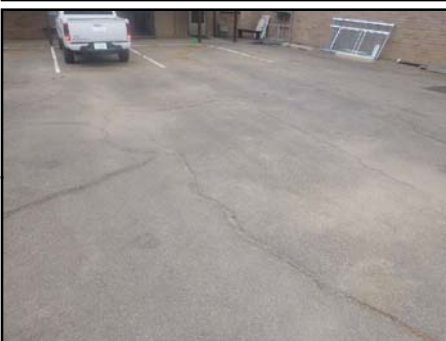
## ROUTE 0903: ADMINISTRATIVE PARKING

Inspection Date	FMSS Number	User Access	Surface Type
5/31/2017	91301	NONPUBLIC	ASPHALT
Area (Sq. Ft.)	Lane Miles (11' Widths)	Curb Reveal (Inches)	Curb Recommendation
7,531	0.13	NOT APPLICABLE	NOT APPLICABLE
Curb Type		Curb & Gutter Type	
NO CURB		NO CURB AND GUTTER	
Pavement Recommendation		Condition Rating / PCR	
HEAVY 3R TREATMENTS		POOR / 53

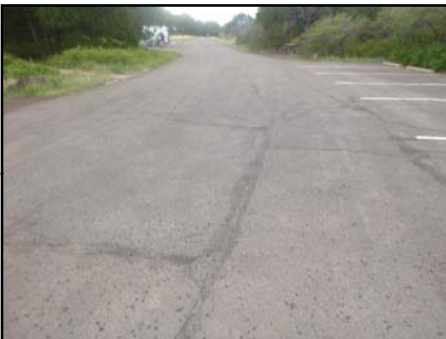
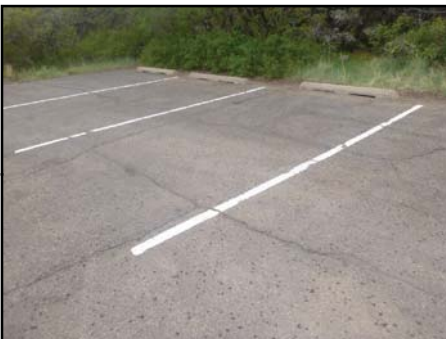
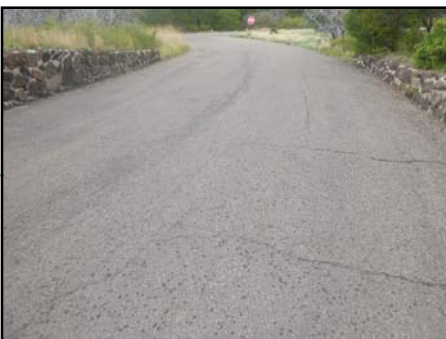
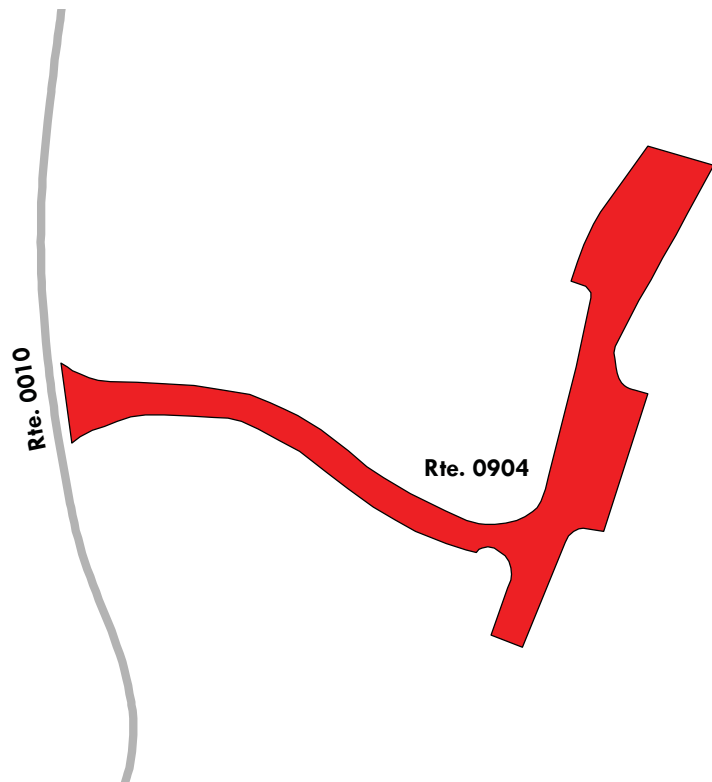
## ROUTE 0904: PICNIC PARKING AREA

Inspection Date	FMSS Number	User Access	Surface Type
5/31/2017	91302	PUBLIC	ASPHALT
Area (Sq. Ft.)	Lane Miles (11' Widths)	Curb Reveal (Inches)	Curb Recommendation
21,384	0.368	NOT APPLICABLE	NOT APPLICABLE
Curb Type		Curb & Gutter Type	
NO CURB		NO CURB AND GUTTER	
Pavement Recommendation		Condition Rating / PCR	
HEAVY 3R TREATMENTS		POOR / 53

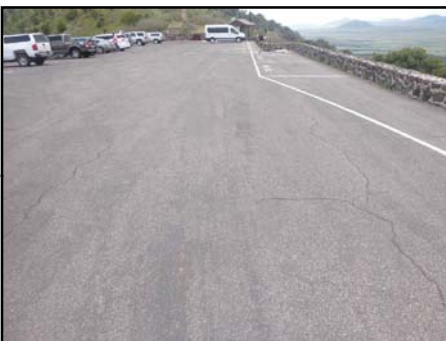
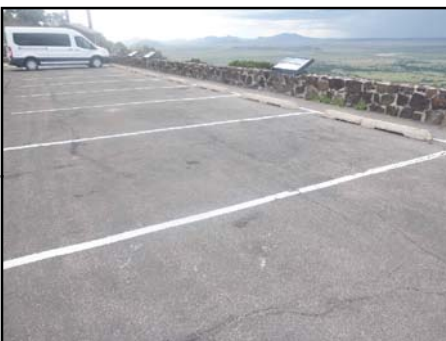
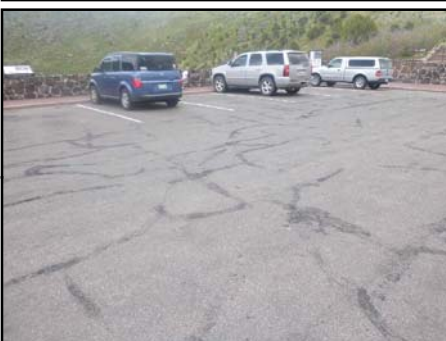
## ROUTE 0905: CRATER RIM PARKING

Inspection Date	FMSS Number	User Access	Surface Type
5/31/2017	91303	PUBLIC	ASPHALT
Area (Sq. Ft.)	Lane Miles (11' Widths)	Curb Reveal (Inches)	Curb Recommendation
13,612	0.234	NOT APPLICABLE	LIGHT REPAIR
Curb Type		Curb & Gutter Type	
NO CURB		CONCRETE	
Pavement Recommendation		Condition Rating / PCR	
HEAVY 3R TREATMENTS		POOR / 53

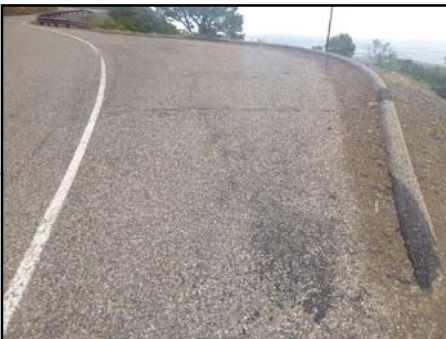
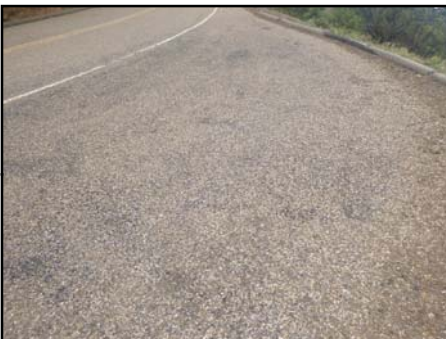
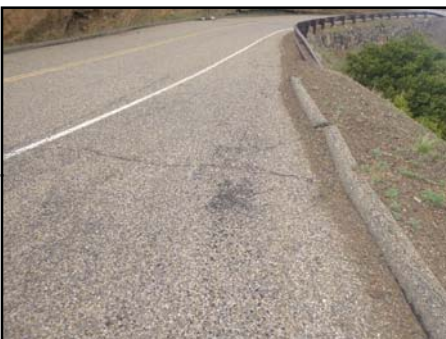
## ROUTE 0907: VOLCANO ROAD PULLOUT

Inspection Date	FMSS Number	User Access	Surface Type
5/31/2017	103619	PUBLIC	ASPHALT
Area (Sq. Ft.)	Lane Miles (11' Widths)	Curb Reveal (Inches)	Curb Recommendation
864	0.015	5	MODERATE REPAIR
Curb Type		Curb & Gutter Type	
ASPHALT		NO CURB AND GUTTER	
Pavement Recommendation		Condition Rating / PCR	
PREVENTIVE MAINTENANCE		GOOD / 90
