CHAM Cycle 6

Road Inventory and Condition Assessment of Paved Routes Chamizal National Memorial

**Federal Lands Highway
Road Inventory Program**

Report Date: July 2017

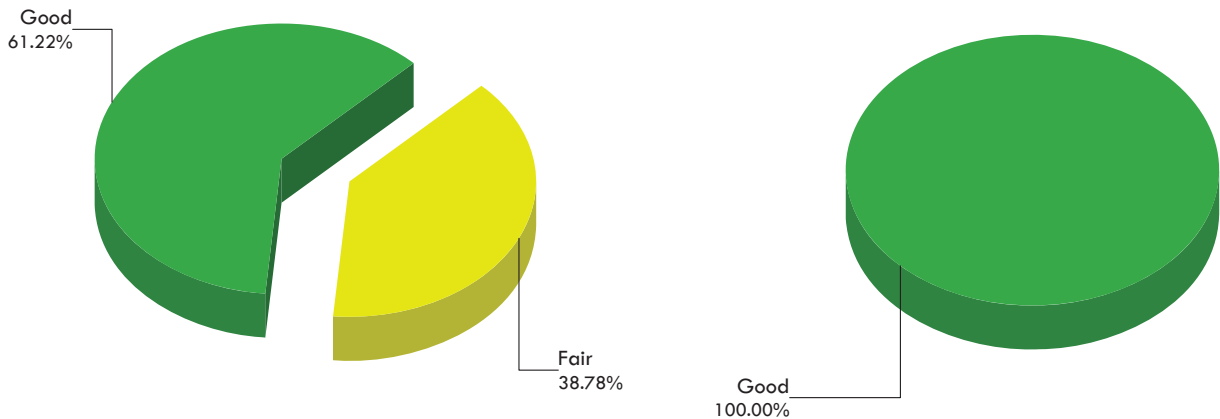
Figure 1: Pavement Condition Rating Breakdown for Paved Roads and Parking Areas

Road Condition Percentages

Parking Area Condition Percentages

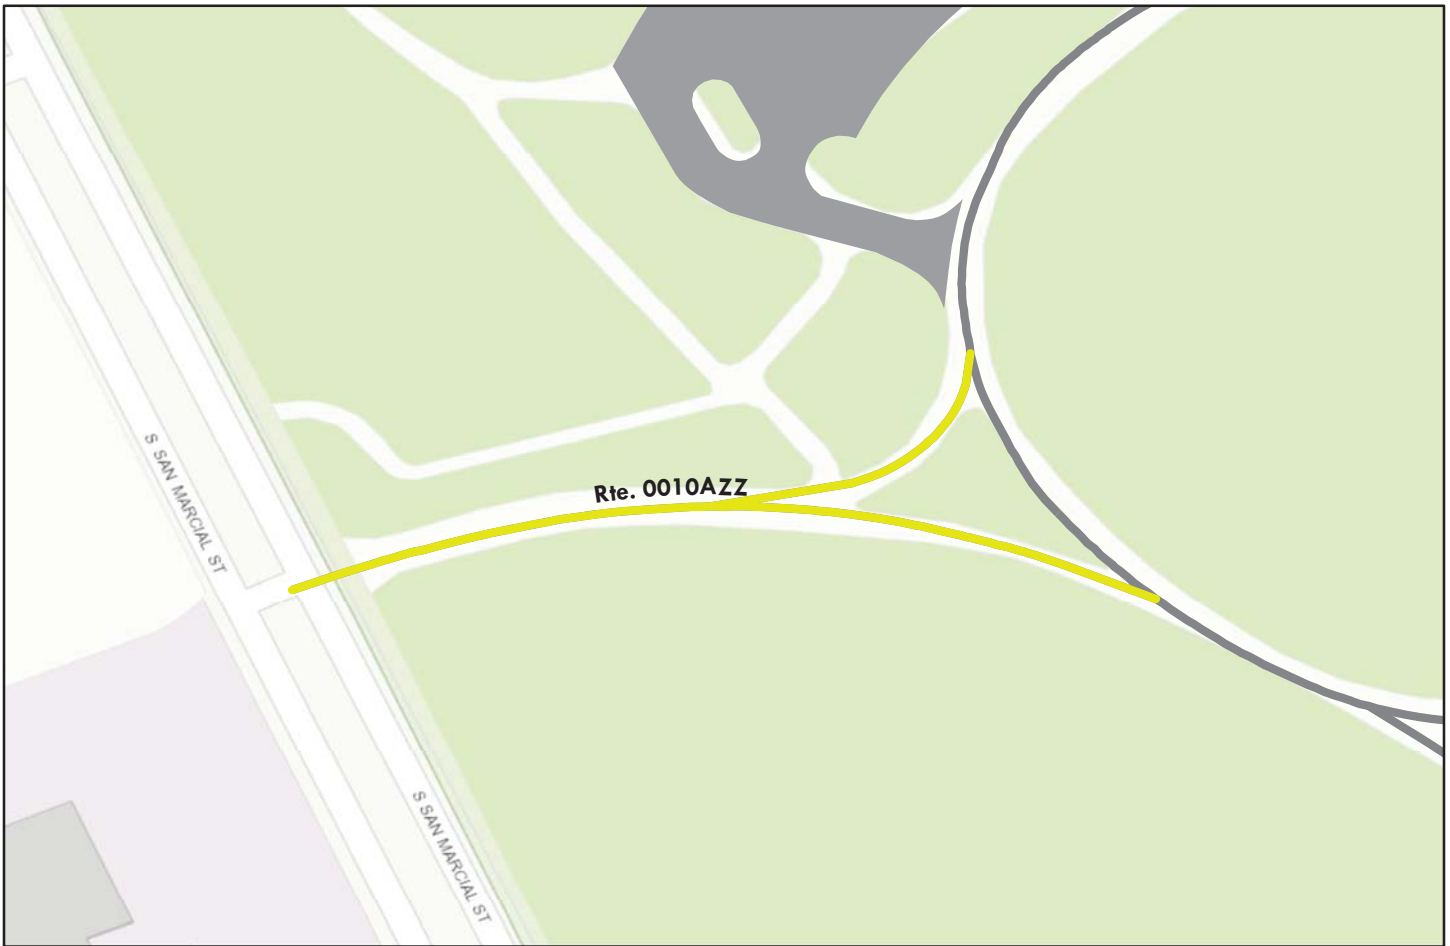
ROUTE 0010AZZ: SAN MARCIAL ENTRANCE ROADS

Note: The weighted average summary PCR value is calculated from only the sections of road where the PCR was collected. The overall PCR for the summary route may not reflect individual subcomponent ratings.

Route Condition Legend – Pavement Condition Rating (PCR)						
Poor (0 - 60)	Fair (61- 84)	Good (85 - 94)	Excellent (95 - 100)	Not Rated		
See Appendix for definitions and formulas						
Inspection Date:	3/22/2017					
Paved Length (Miles):	0.11					
Surface Type:	ASPHALT	Route Summary				
Roadway Condition Information						
Pavement Condition Rating (PCR)	84					
Lane & Width Information						
Number of Lanes	2					
Paved Width (ft)	21.4					
Lane Width (ft)	12.5

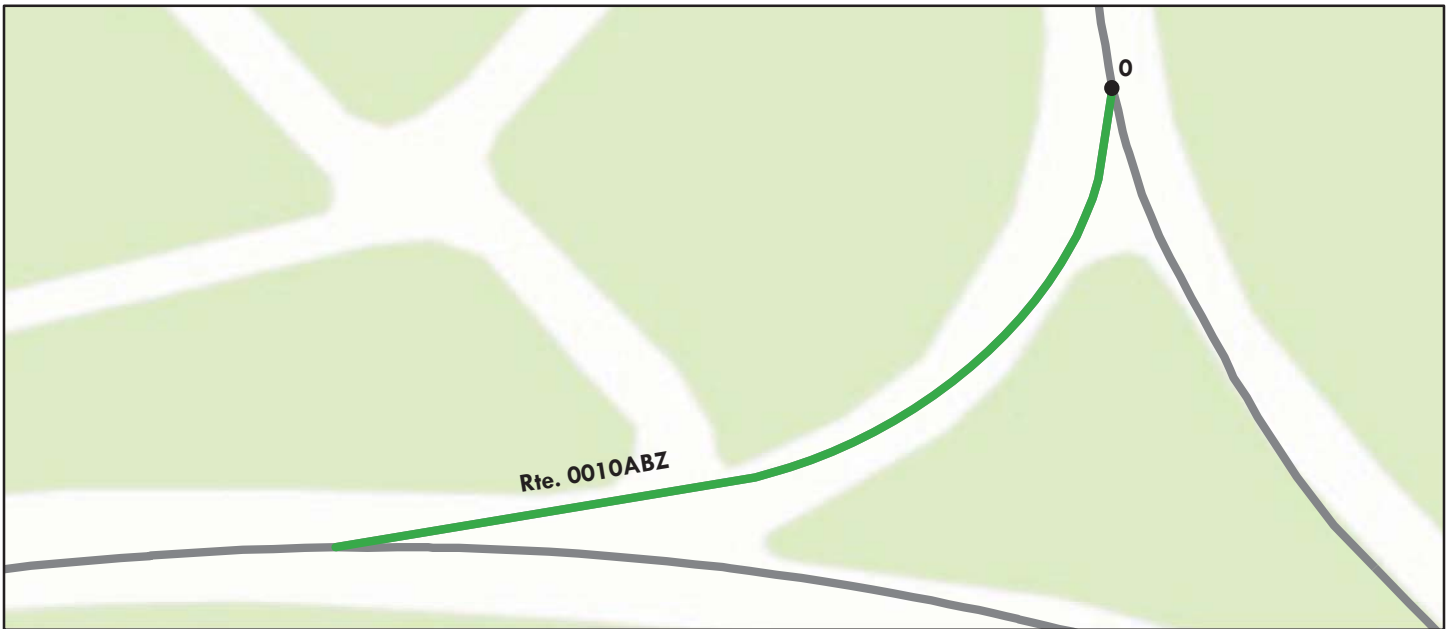
ROUTE 0010ABZ: SAN MARCIAL ENTRANCE ROAD SPUR

Subcomponent of Route CHAM-0010AZZ
Data Collection Vehicle (DCV) Rating

Route Condition Legend – Pavement Condition Rating (PCR)						
Poor (0 - 60)	Fair (61- 84)	Good (85 - 94)	Excellent (95 - 100)	Not Rated		
See Appendix for definitions and formulas						
Inspection Date: 3/22/2017	Beginning Section MP	0				
Paved Length (Miles): 0.03	Section Length (MI)	0.03				
Surface Type: ASPHALT	Route Summary					
Roadway Condition Information						
Pavement Condition Rating (PCR)	86	86				
Surface Condition Rating (SCR)	86	86				
Roughness Condition Index (RCI)	N/A	N/A				
Distress Index Values						
Structural Crack Index	95	95				
Alligator Crack Index	100	100				
Longitudinal Crack Index	95	95				
Transverse Cracking Index	86	86				
Patching Index	100	100				
Rutting Index	96	96				
International Roughness Index (IRI)	N/A	N/A				
Lane & Width Information						
Number of Lanes	1	1				
Paved Width (ft)	11.8	11.8				
Lane Width (ft)	11.8	11.8

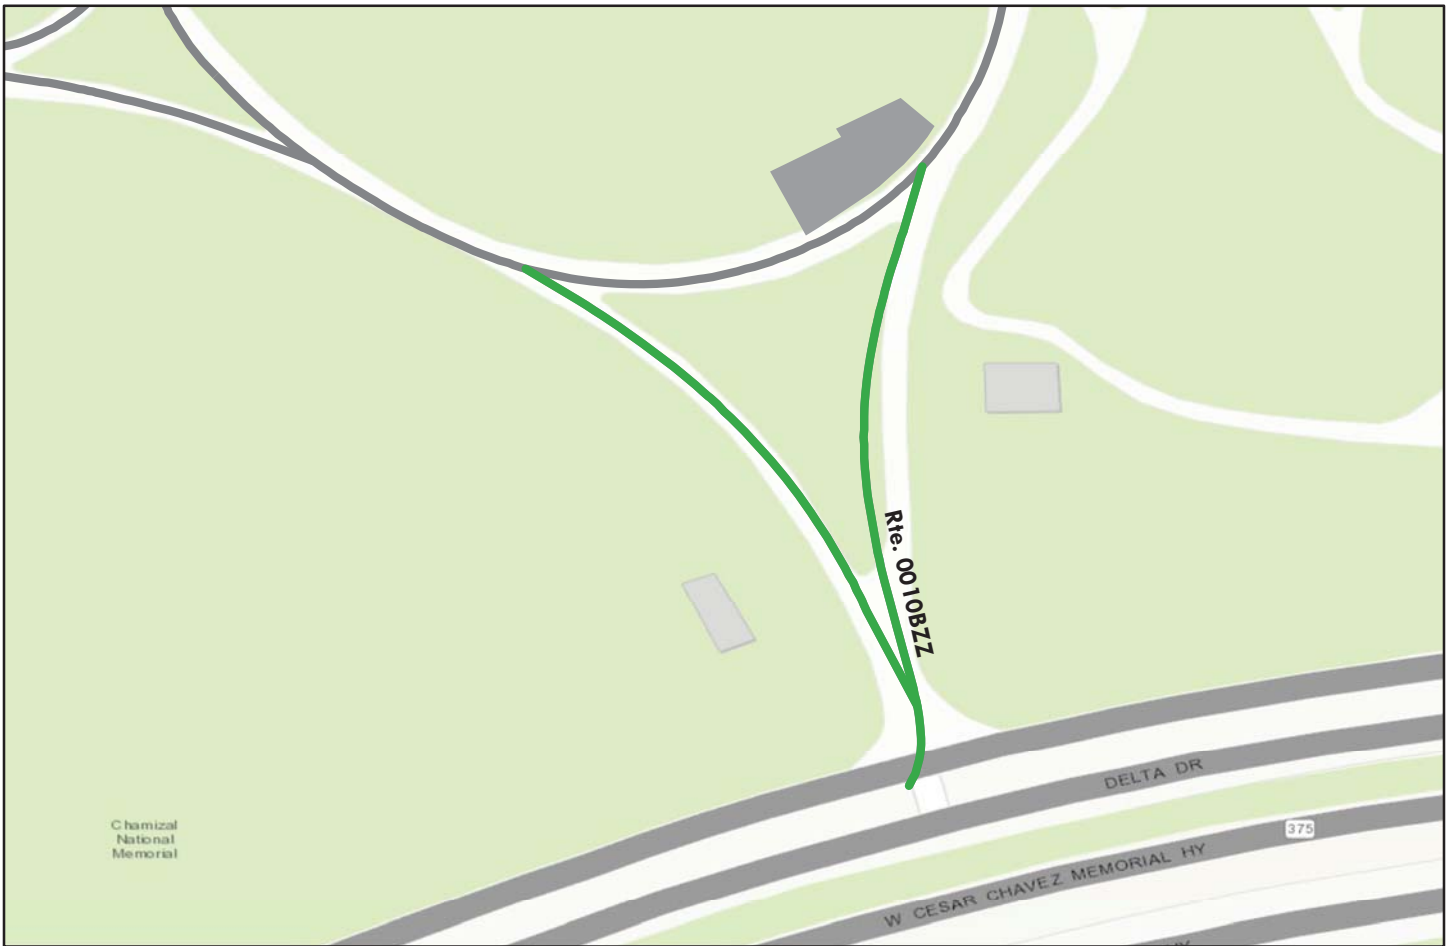
ROUTE 0010BZZ: DELTA ENTRANCE ROADS

Note: The weighted average summary PCR value is calculated from only the sections of road where the PCR was collected. The overall PCR for the summary route may not reflect individual subcomponent ratings.

Route Condition Legend – Pavement Condition Rating (PCR)						
Poor (0 - 60)	Fair (61- 84)	Good (85 - 94)	Excellent (95 - 100)	Not Rated		
See Appendix for definitions and formulas						
Inspection Date: 3/22/2017						
Paved Length (Miles): 0.12						
Surface Type: ASPHALT	Route Summary					
Roadway Condition Information						
Pavement Condition Rating (PCR)	89					
Lane & Width Information						
Number of Lanes	2					
Paved Width (ft)	16.1					
Lane Width (ft)	11.9

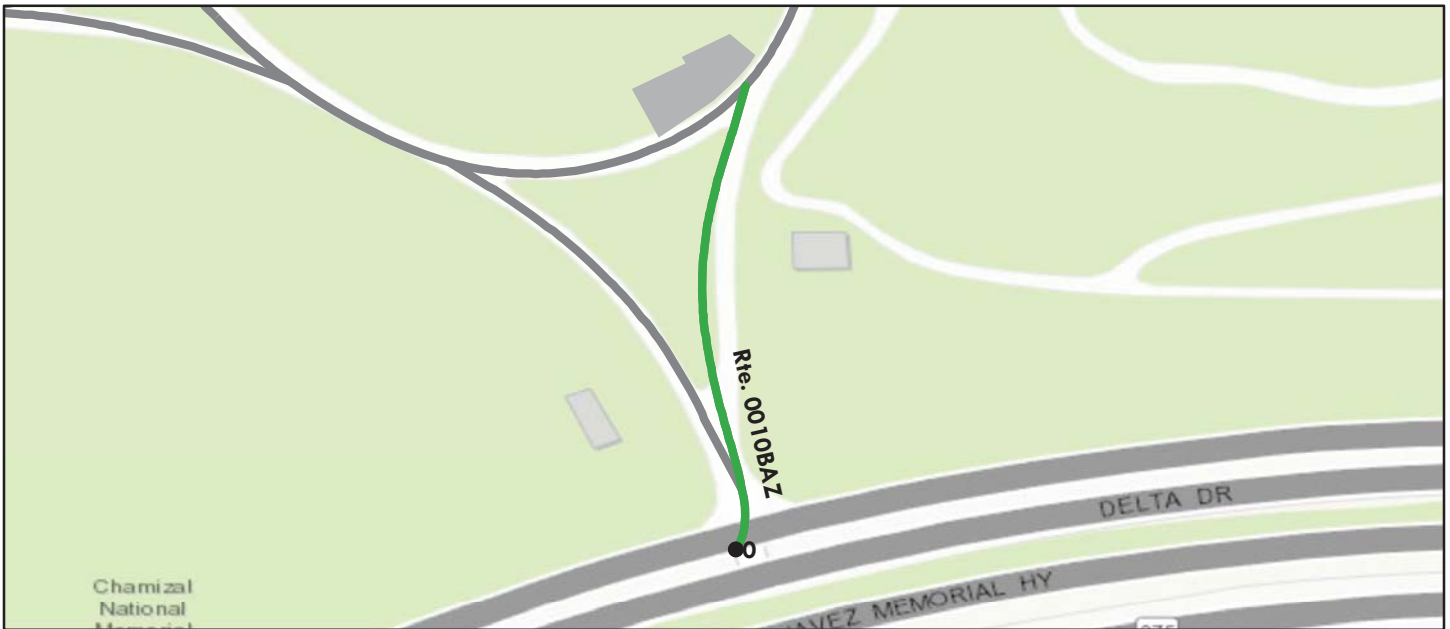
Subcomponent of Route CHAM-0010BZZ

Data Collection Vehicle (DCV) Rating

Inspection Date: 3/22/2017	Beginning Section MP	0				
Paved Length (Miles): 0.07	Section Length (MI)	0.07				
Surface Type: ASPHALT	Route Summary					
Roadway Condition Information						
Pavement Condition Rating (PCR)	89	89				
Surface Condition Rating (SCR)	89	89				
Roughness Condition Index (RCI)	N/A	N/A				
Distress Index Values						
Structural Crack Index	98	98				
Alligator Crack Index	100	100				
Longitudinal Crack Index	98	98				
Transverse Cracking Index	89	89				
Patching Index	98	98				
Rutting Index	96	96				
International Roughness Index (IRI)	N/A	N/A				
Lane & Width Information						
Number of Lanes	2	2				
Paved Width (ft)	20	20				
Lane Width (ft)	12.7	12.7

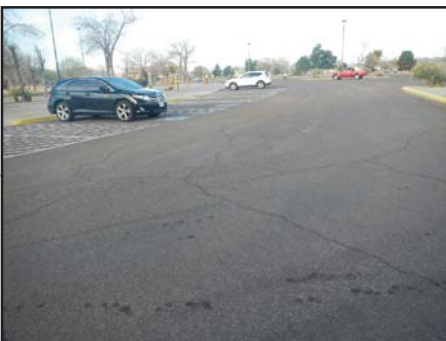
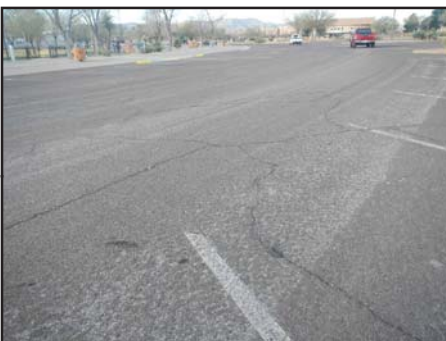
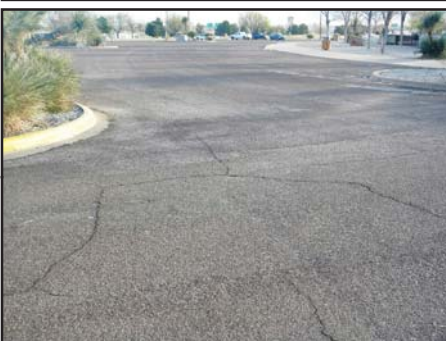
Inspection Date	FMSS Number	User Access	Surface Type
2/28/2017	73045	PUBLIC	ASPHALT
Area (Sq. Ft.)	Lane Miles (11' Widths)	Curb Reveal (Inches)	Curb Recommendation
82,270	1.416	NOT APPLICABLE	DO NOTHING
Curb Type		Curb & Gutter Type	
NO CURB		CONCRETE	
Pavement Recommendation		Condition Rating / PCR	
PREVENTIVE MAINTENANCE		GOOD / 90

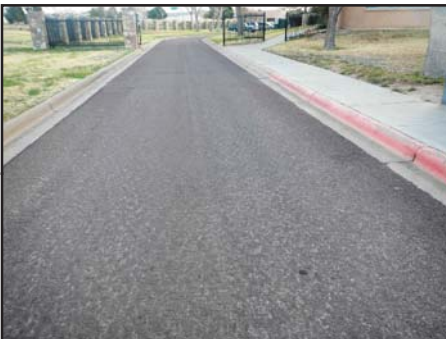
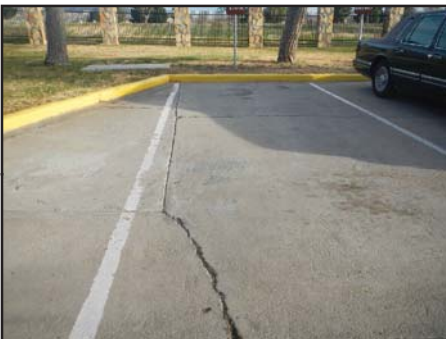
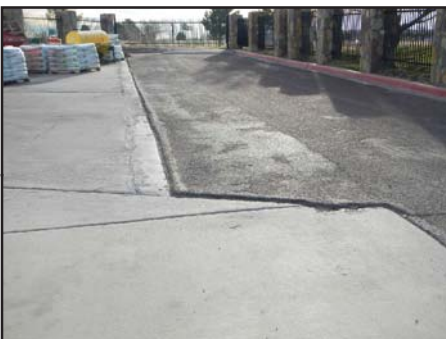
ROUTE 0901: MAINTENANCE PARKING AREA

Inspection Date	FMSS Number	User Access	Surface Type
2/28/2017	102859	PUBLIC	ASPHALT
Area (Sq. Ft.)	Lane Miles (11' Widths)	Curb Reveal (Inches)	Curb Recommendation
18,396	0.317	NOT APPLICABLE	DO NOTHING
Curb Type		Curb & Gutter Type	
NO CURB		CONCRETE	
Pavement Recommendation		Condition Rating / PCR	
PREVENTIVE MAINTENANCE		GOOD / 90

Note: Parking area consists of multiple surface types: 1 part Asphalt at 9,313 square feet; 4 parts Concrete at 8,879 square feet and 1 part Brick at 204.

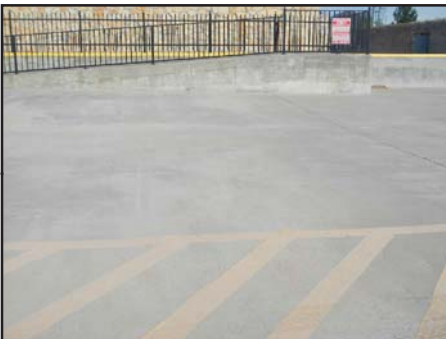
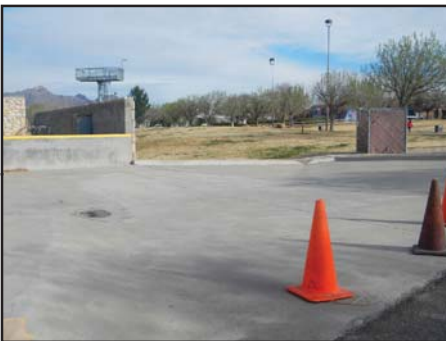
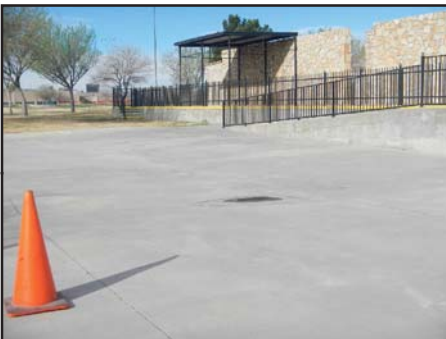
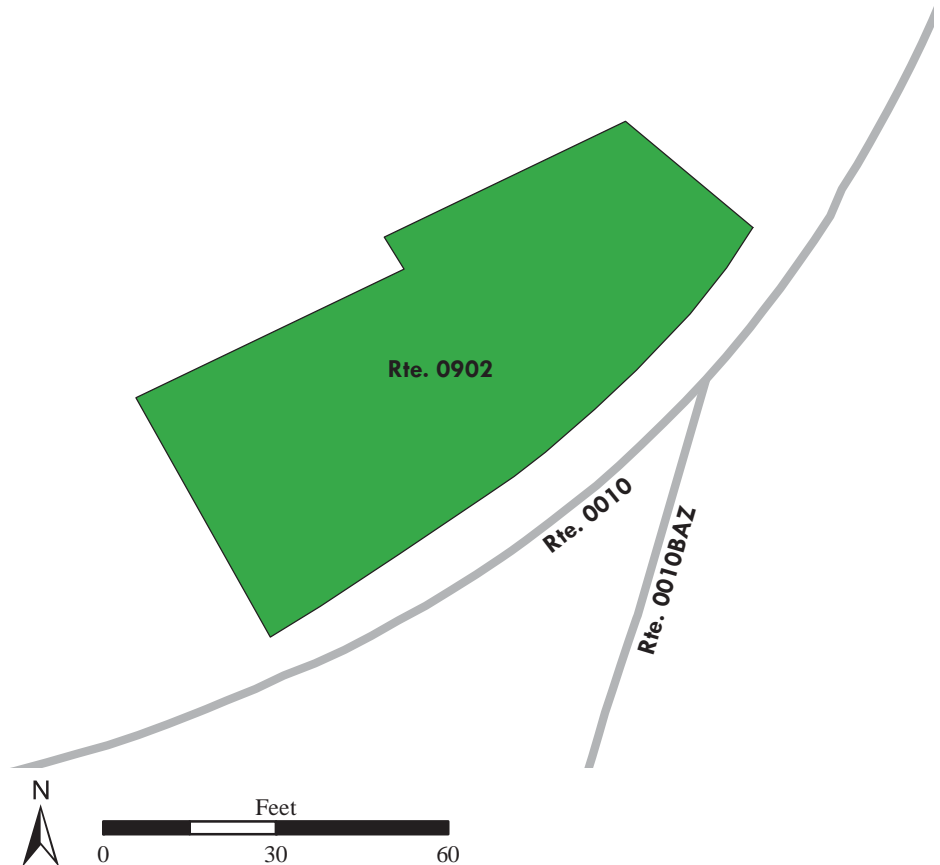
ROUTE 0902: THEATER TECH PARKING

Inspection Date	FMSS Number	User Access	Surface Type
2/28/2017	102945	PUBLIC	CONCRETE
Area (Sq. Ft.)	Lane Miles (11' Widths)	Curb Reveal (Inches)	Curb Recommendation
3,683	0.063	7	DO NOTHING
Curb Type		Curb & Gutter Type	
CONCRETE		NO CURB AND GUTTER	
Pavement Recommendation		Condition Rating / PCR	
PREVENTIVE MAINTENANCE		GOOD / 90
