# CHIC Cycle 6

# **Final Report**

# Road Inventory and Condition Assessment of Paved Routes Chickasaw National Recreation Area

**Report Date: May 2018**

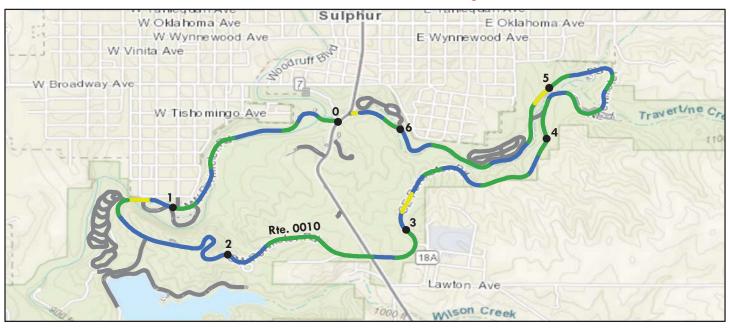
Route (	Condition Legend – Pav	ement Condi	tion Rating (	PCR)		
Poor (0 - 60) Fair (6	1- 84) Good (	(85 - 94)	<b>Excellent (95 - 100)</b>		Not Rated	
Colors on map represent cond	dition scores at 0.10-mile	intervals. Se	e Appendix fo	or definitions	and formulas.	
<b>Inspection Date:</b> 11/7/2017	<b>Beginning Section MP</b>	0	1	2	3	4
Paved Length (Miles): 6.23	Section Length (MI)	1	1	1	1	1
Surface Type: ASPHALT	Route Summary					
Roadway Condition Information						
Pavement Condition Rating (PCR)	93	92	93	94	94	94
Surface Condition Rating (SCR)	97	98	97	94	96	98
Roughness Condition Index (RCI)	88	84	88	93	90	88
Distress Index Values						
Structural Crack Index	97	98	97	94	96	98
Alligator Crack Index	100	100	100	100	100	100
Longitudinal Crack Index	97	98	97	94	96	98
Transverse Cracking Index	99	99	98	99	99	100
Patching Index	100	100	100	100	100	100
Rutting Index	98	99	99	99	98	98
International Roughness Index (IRI)	145	158	146	133	139	145

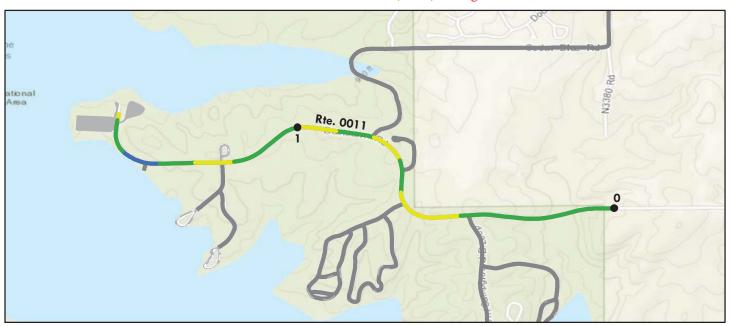
Route (	Condition Legend – Pav	ement Condi	tion Rating (	PCR)		
Poor (0 - 60			(85 - 94)	Excellent (		Not Rat	ed
Colors	on map represent con-	dition scores at 0.10-mile	intervals. Se	e Appendix fo	or definitions	and formulas.	
Inspection Date:	11/7/2017	<b>Beginning Section MP</b>	0	1			
Paved Length (Mile	es): 1.62	Section Length (MI)	1	0.62			
Surface Type:	ASPHALT	Route Summary					
Roadway Condition	n Information						
Pavement Condition	on Rating (PCR)	88	86	89			
Surface Condition R	Rating (SCR)	92	91	91			
Roughness Condition	on Index (RCI)	82	79	87			
Distress Index Valu	es						
Structural Crack In	ıdex	94	96	91			
Alligator Crack Inc	lex	100	100	100			
Longitudinal Crack	c Index	94	96	91			
Transverse Crackir	ng Index	98	99	95			
Patching Index		100	100	100			
Rutting Index		92	91	92			
International Roug	hness Index (IRI)	163	172	149			
Lane & Width Info	rmation						
Number of Lanes		2	2	2			
Paved Width (ft)		29.5	29.6	29.3

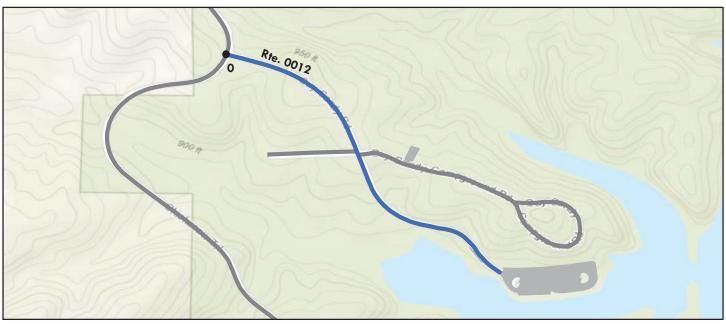
**ROUTE 0012: GUY SANDY ROAD**

Donto	Condition Legend – Pav	oment Condi	ition Doting (	DCD)		
Poor (0 - 60			(85 - 94)	Excellent (		Not Ra	ed
		•	, , , , , , , , , , , , , , , , , , , ,	`			cu
		dition scores at 0.10-mile		e Appendix 10	or definitions	and formulas.	
Inspection Date:	11/7/2017	<b>Beginning Section MP</b>	0				
Paved Length (Mile	es): 0.46	Section Length (MI)	0.46				
Surface Type:	ASPHALT	Route Summary					
Roadway Condition	n Information						
Pavement Condition	on Rating (PCR)	98	98				
Surface Condition R	Rating (SCR)	98	98				
Roughness Condition	on Index (RCI)	N/A	N/A				
Distress Index Valu	ies						
Structural Crack In	ndex	99	99				
Alligator Crack Inc	dex	100	100				
Longitudinal Crack	k Index	99	99				
Transverse Crackir	ng Index	99	99				
Patching Index		100	100				
Rutting Index		98	98				
International Roug	hness Index (IRI)	N/A	N/A				
Lane & Width Info	rmation						
Number of Lanes		2	2				
Paved Width (ft)		27.8	27.8

Lane Width (ft)		10.9	10.9

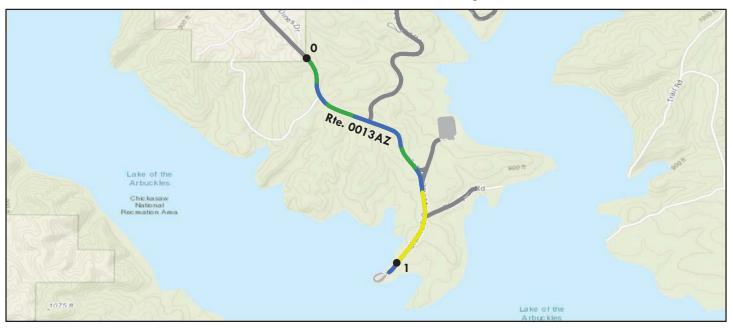
Route (	Condition Legend – Pav	ement Condi	tion Rating (	PCR)	
Poor (0 - 60) Fair (6	1- 84) Good (	(85 - 94)	Excellent (9	95 - 100)	Not Rated
Colors on map represent con-	dition scores at 0.10-mile	intervals. Se	e Appendix fo	r definitions	and formulas.
<b>Inspection Date:</b> 11/7/2017	<b>Beginning Section MP</b>	0	1		
Paved Length (Miles): 1.06	Section Length (MI)	1	0.06		
Surface Type: ASPHALT	Route Summary				
Roadway Condition Information					
Pavement Condition Rating (PCR)	91	90	96		
Surface Condition Rating (SCR)	86	85	94		
Roughness Condition Index (RCI)	98	98	98		
Distress Index Values					
Structural Crack Index	86	85	97		
Alligator Crack Index	100	100	100		
Longitudinal Crack Index	86	85	97		
Transverse Cracking Index	99	98	99		
Patching Index	100	100	94		
Rutting Index	99	99	99		
International Roughness Index (IRI)	119	119	119		
Lane & Width Information					
Number of Lanes	2	2	2		
Paved Width (ft)	25.1	24.8	28.5

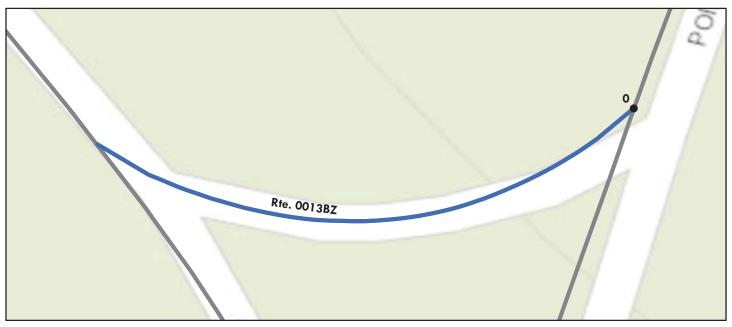
Route (	Condition Legend – Pav	ement Condi	tion Rating (	PCR)		
Poor (0 - 60			(85 - 94)	Excellent (		Not Ra	ted
		dition scores at 0.10-mile	1			and formulas.	
Inspection Date:	11/7/2017	Beginning Section MP	0				
Paved Length (Mile	es): 0.03	Section Length (MI)	0.03				
Surface Type:	ASPHALT	Route Summary					
Roadway Condition	n Information						
Pavement Conditio	n Rating (PCR)	98	98				
Surface Condition R	ating (SCR)	98	98				
Roughness Conditio	n Index (RCI)	N/A	N/A				
Distress Index Valu	es						
Structural Crack In	dex	100	100				
Alligator Crack Inc	lex	100	100				
Longitudinal Crack	Index	100	100				
Transverse Crackin	ig Index	98	98				
Patching Index		100	100				
Rutting Index		98	98				
International Rough	hness Index (IRI)	N/A	N/A				
Lane & Width Info	rmation						
Number of Lanes		2	2				
Paved Width (ft)		25.8	25.8				
Lane Width (ft)		12.3	12.3

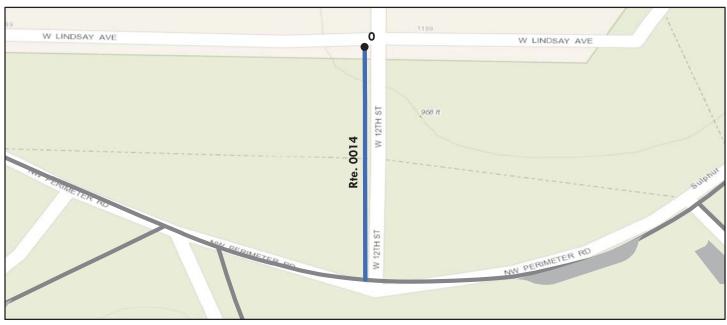
## ROUTE 0014: TWELFTH STREET ENTRANCE ROAD

Route (	Condition Legend – Pav	ement Condi	tion Rating (	PCR)		
Poor (0 - 6			(85 - 94)	Excellent (		Not Ra	ted
Colors	on map represent con-	dition scores at 0.10-mile	intervals. Se	e Appendix fo	or definitions	and formulas.	
Inspection Date:	11/7/2017	<b>Beginning Section MP</b>	0				
Paved Length (Mile	es): 0.05	Section Length (MI)	0.05				
Surface Type:	ASPHALT	Route Summary					
Roadway Condition	n Information						
Pavement Condition	on Rating (PCR)	97	97				
Surface Condition F	Rating (SCR)	97	97				
Roughness Condition	on Index (RCI)	N/A	N/A				
Distress Index Valu	ies						
Structural Crack In	ndex	99	99				
Alligator Crack Inc	dex	100	100				
Longitudinal Cracl	k Index	99	99				
Transverse Crackin	ng Index	97	97				
Patching Index		99	99				
Rutting Index		98	98				
International Roug	hness Index (IRI)	N/A	N/A				
Lane & Width Info	rmation						
Number of Lanes		2	2				
Paved Width (ft)		20.5	20.5

Lane Width (ft)		10	10

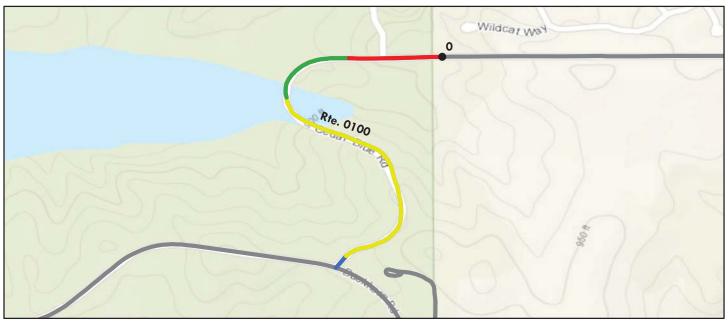
ROUTE 0100: CEDAR BLUE ENTRANCE ROAD

Route (	Condition Legend – Pav	ement Condi	ition Rating (	PCR)		
Poor (0 - 60			(85 - 94)	Excellent (9		Not Ra	ted
	· ·	dition scores at 0.10-mile	1				
Inspection Date:	11/7/2017	Beginning Section MP			1 definitions		
^							
Paved Length (Mile	es): 0.51	Section Length (MI)	0.51				
Surface Type:	ASPHALT	Route Summary					
Roadway Condition	n Information						
Pavement Condition	on Rating (PCR)	78	78				
Surface Condition R	Rating (SCR)	91	91				
Roughness Condition	on Index (RCI)	59	59				
Distress Index Valu	es						
Structural Crack In	ıdex	92	92				
Alligator Crack Inc	lex	100	100				
Longitudinal Crack	c Index	92	92				
Transverse Crackir	ng Index	98	98				
Patching Index		100	100				
Rutting Index		91	91				
International Roug	hness Index (IRI)	245	245				
Lane & Width Info	rmation						
Number of Lanes		2	2				
Paved Width (ft)		25.4	25.4				
Lane Width (ft)		10	10

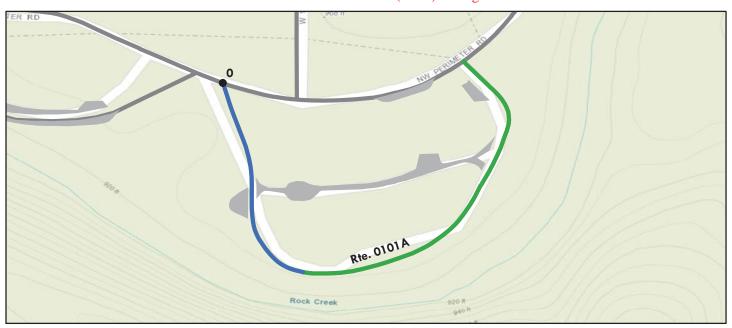
Route (	Condition Legend – Pav	ement Condi	tion Rating (	PCR)		
Poor (0 - 60			(85 - 94)	Excellent (		Not Ra	ted
Colors	on map represent con	dition scores at 0.10-mile	intervals. Se	e Appendix fo	or definitions	and formulas.	
Inspection Date:	11/7/2017	<b>Beginning Section MP</b>	0				
Paved Length (Mile	es): 0.25	Section Length (MI)	0.25				
Surface Type:	ASPHALT	Route Summary					
Roadway Condition	n Information						
Pavement Conditio	n Rating (PCR)	92	92				
Surface Condition R	ating (SCR)	92	92				
Roughness Conditio	n Index (RCI)	N/A	N/A				
Distress Index Valu	es						
Structural Crack In	dex	99	99				
Alligator Crack Inc	lex	100	100				
Longitudinal Crack	Index	99	99				
Transverse Crackin	ig Index	98	98				
Patching Index		100	100				
Rutting Index		92	92				
International Rough	hness Index (IRI)	N/A	N/A				
Lane & Width Info	rmation						
Number of Lanes		1	1				
Paved Width (ft)		12	12				
Lane Width (ft)		9.5	9.5

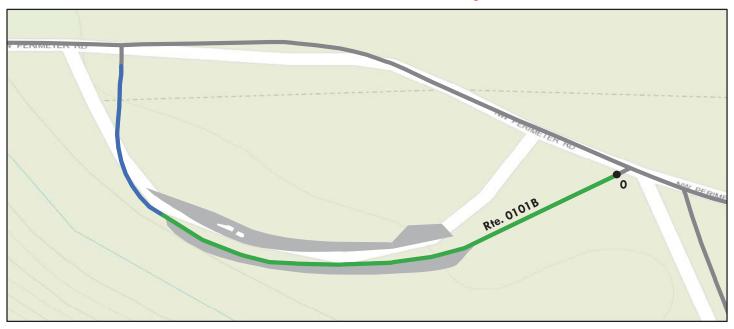
Route (	Condition Legend – Pav	ement Condi	tion Rating (l	PCR)		
Poor (0 - 60) Fair (6	1- 84) Good (	(85 - 94)	Excellent (9	<b>95 - 100</b> )	Not Rat	ted
Colors on map represent con-	dition scores at 0.10-mile	intervals. Se	e Appendix for	r definitions	and formulas.	
<b>Inspection Date:</b> 11/7/2017	<b>Beginning Section MP</b>	0				
Paved Length (Miles): 0.14	Section Length (MI)	0.14				
Surface Type: ASPHALT	Route Summary					
Roadway Condition Information						
Pavement Condition Rating (PCR)	92	92				
Surface Condition Rating (SCR)	92	92				
Roughness Condition Index (RCI)	N/A	N/A				
Distress Index Values						
Structural Crack Index	98	98				
Alligator Crack Index	100	100				
Longitudinal Crack Index	98	98				
Transverse Cracking Index	97	97				
Patching Index	100	100				
Rutting Index	92	92				
International Roughness Index (IRI)	N/A	N/A				
Lane & Width Information						
Number of Lanes	2	2				
Paved Width (ft)	27.1	27.1

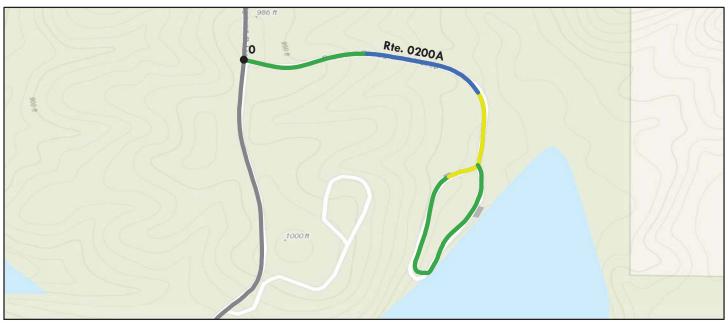
## ROUTE 0200A: BUCKHORN CAMPGROUND LOOPA

Route (	Condition Legend – Pav	ement Condi	tion Rating (	PCR)		
Poor (0 - 60			(85 - 94)	Excellent (		Not Ra	ted
Colors	on map represent con	dition scores at 0.10-mile	intervals. Se	e Appendix fo	or definitions	and formulas.	
Inspection Date:	11/7/2017	<b>Beginning Section MP</b>	0				
Paved Length (Mile	es): 0.53	Section Length (MI)	0.53				
Surface Type:	ASPHALT	Route Summary					
Roadway Condition	n Information						
Pavement Conditio	n Rating (PCR)	91	91				
Surface Condition R	ating (SCR)	91	91				
Roughness Conditio	n Index (RCI)	N/A	N/A				
Distress Index Valu	es						
Structural Crack In	dex	91	91				
Alligator Crack Inc	lex	100	100				
Longitudinal Crack	Index	91	91				
Transverse Crackin	ig Index	99	99				
Patching Index		100	100				
Rutting Index		94	94				
International Rough	hness Index (IRI)	N/A	N/A				
Lane & Width Info	rmation						
Number of Lanes		2	2				
Paved Width (ft)		20.1	20.1				
Lane Width (ft)		12	12

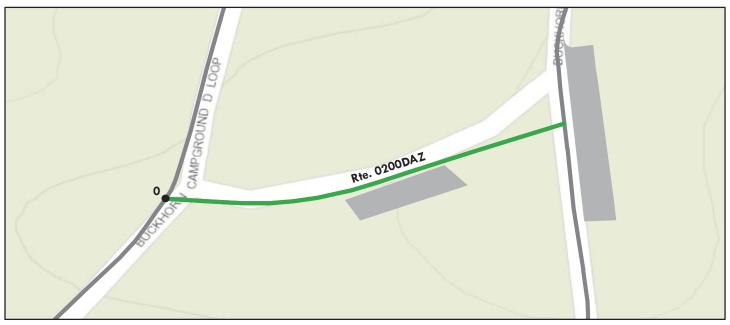
Route (	Condition Legend – Pav	ement Cond	ition Rating (	PCR)		
Poor (0 - 6			(85 - 94)	Excellent (		Not Ra	ted
Colors	on map represent con-	dition scores at 0.10-mile	intervals. Se	e Appendix fo	or definitions	and formulas.	
Inspection Date:	11/7/2017	<b>Beginning Section MP</b>	0				
Paved Length (Mile	es): 0.05	Section Length (MI)	0.05				
Surface Type:	ASPHALT	Route Summary					
Roadway Condition	n Information						
Pavement Condition	on Rating (PCR)	88	88				
Surface Condition F	Rating (SCR)	88	88				
Roughness Condition	on Index (RCI)	N/A	N/A				
Distress Index Valu	ies						
Structural Crack In	ndex	99	99				
Alligator Crack Inc	dex	100	100				
Longitudinal Cracl	k Index	99	99				
Transverse Crackin	ng Index	100	100				
Patching Index		100	100				
Rutting Index		88	88				
International Roug	hness Index (IRI)	N/A	N/A				
Lane & Width Info	rmation						
Number of Lanes		2	2				
Paved Width (ft)		24.8	24.8

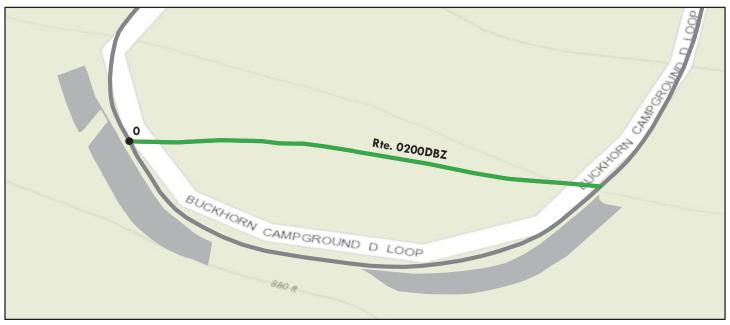
Route (	Condition Legend – Pav	ement Condi	ition Rating (	PCR)		
Poor (0 - 6			(85 - 94)	Excellent (		Not Ra	ted
Colors	on map represent con	dition scores at 0.10-mile	e intervals. Se	e Appendix fo	r definitions	and formulas.	
Inspection Date:	11/7/2017	<b>Beginning Section MP</b>	0				
Paved Length (Mil	les): 0.06	Section Length (MI)	0.06				
Surface Type:	ASPHALT	Route Summary					
Roadway Conditio	n Information						
Pavement Condition	on Rating (PCR)	92	92				
Surface Condition l	Rating (SCR)	92	92				
Roughness Condition	on Index (RCI)	N/A	N/A				
Distress Index Valu	ies						
Structural Crack In	ndex	92	92				
Alligator Crack In	dex	100	100				
Longitudinal Crac	k Index	92	92				
Transverse Cracki	ng Index	100	100				
Patching Index		100	100				
Rutting Index		92	92				
International Roug	ghness Index (IRI)	N/A	N/A				
Lane & Width Info	ormation						
Number of Lanes		2	2				
Paved Width (ft)		15.7	15.7

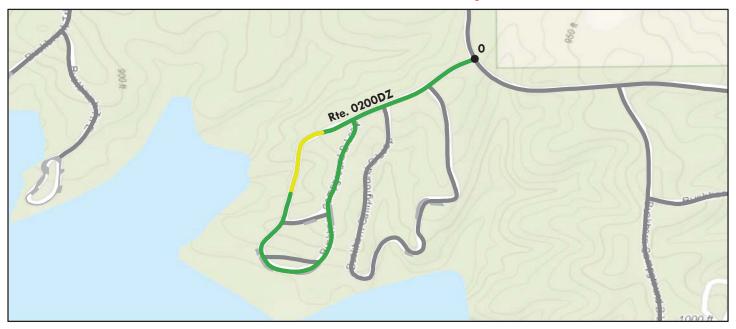
Route Condition Legend – Pavement Condition Rating (PCR)									
Poor (0 - 60			(85 - 94)	Excellent (		Not Ra	ted .			
		dition scores at 0.10-mile								
Inspection Date:	11/7/2017	Beginning Section MP								
1 -										
Paved Length (Mile	es): 0.68	Section Length (MI)	0.68							
Surface Type:	ASPHALT	Route Summary								
<b>Roadway Condition</b>	n Information									
Pavement Conditio	n Rating (PCR)	89	89							
Surface Condition R	tating (SCR)	89	89							
Roughness Conditio	n Index (RCI)	N/A	N/A							
Distress Index Valu	es									
Structural Crack In	dex	94	94							
Alligator Crack Inc	lex	100	100							
Longitudinal Crack	Index	94	94							
Transverse Crackin	ng Index	99	99							
Patching Index		100	100							
Rutting Index		89	89							
International Rough	hness Index (IRI)	N/A	N/A							
Lane & Width Info	rmation									
Number of Lanes		2	2							
Paved Width (ft)		16.8	16.8							
Lane Width (ft)		11.1	11.1

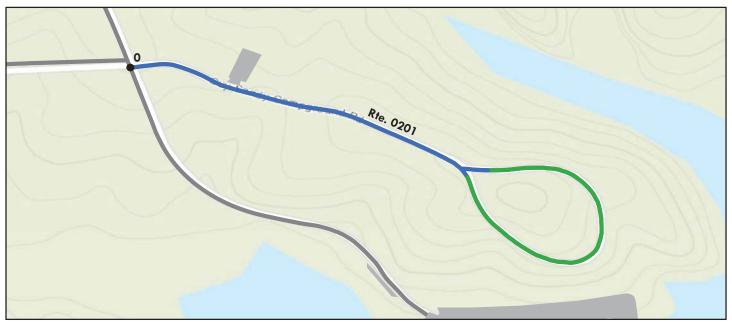
Route (	Condition Legend – Pav	ement Condi	tion Rating (	PCR)		
Poor (0 - 60			(85 - 94)	Excellent (9		Not Ra	ted
Colors	on map represent con-	dition scores at 0.10-mile	intervals. Se	e Appendix fo	r definitions	and formulas.	
Inspection Date:	11/7/2017	<b>Beginning Section MP</b>	0				
Paved Length (Mile	es): 0.41	Section Length (MI)	0.41				
Surface Type:	ASPHALT	Route Summary					
Roadway Condition	n Information						
Pavement Condition	on Rating (PCR)	95	95				
Surface Condition R	Rating (SCR)	95	95				
Roughness Condition	on Index (RCI)	N/A	N/A				
Distress Index Valu	es						
Structural Crack In	ıdex	95	95				
Alligator Crack Inc	lex	100	100				
Longitudinal Crack	c Index	95	95				
Transverse Crackin	ng Index	97	97				
Patching Index		100	100				
Rutting Index		96	96				
International Roug	hness Index (IRI)	N/A	N/A				
Lane & Width Info	rmation						
Number of Lanes		1	1				
Paved Width (ft)		15.3	15.3

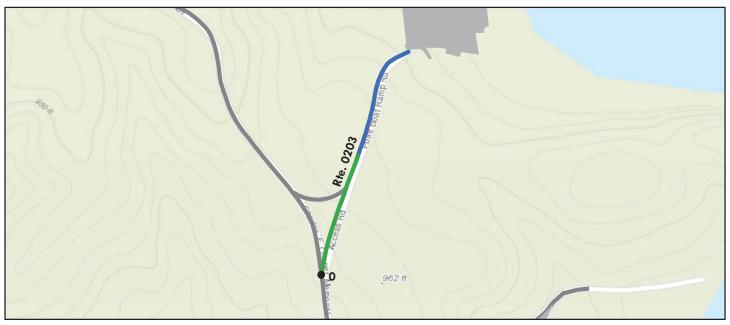
Route (	Condition Legend – Pav	ement Condi	ition Rating (	PCR)		
Poor (0 - 60						Not Ra	ted
Colors	on map represent con	dition scores at 0.10-mile	intervals. Se	e Appendix fo	or definitions	and formulas.	
Inspection Date:	11/7/2017	<b>Beginning Section MP</b>	0				
Paved Length (Mile	es): 0.2	Section Length (MI)	0.2				
Surface Type:	ASPHALT	Route Summary					
Roadway Condition	Information						
Pavement Conditio	n Rating (PCR)	93	93				
Surface Condition R	ating (SCR)	93	93				
Roughness Conditio	n Index (RCI)	N/A	N/A				
Distress Index Valu	es						
Structural Crack In	dex	93	93				
Alligator Crack Inc	lex	100	100				
Longitudinal Crack	Index	93	93				
Transverse Crackin	g Index	99	99				
Patching Index		99	99				
Rutting Index		99	99				
International Rough	nness Index (IRI)	N/A	N/A				
Lane & Width Info	rmation						
Number of Lanes		2	2				
Paved Width (ft)		25.1	25.1				
Lane Width (ft)		12.1	12.1

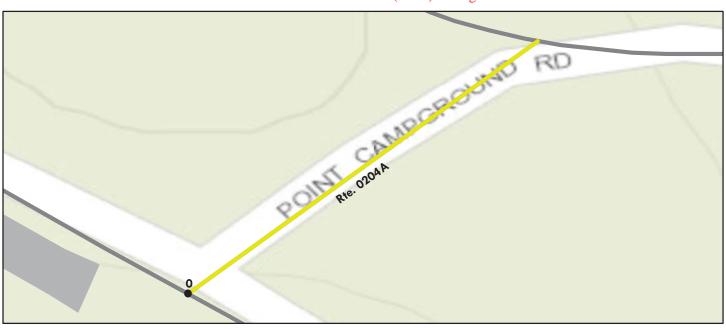
Route (	Condition Legend – Pav	ement Condi	ition Rating (	PCR)		
Poor (0 - 6			(85 - 94)	Excellent (		Not Ra	ted
Colors	on map represent con-	dition scores at 0.10-mile	intervals. Se	e Appendix fo	or definitions	and formulas.	
Inspection Date:	11/7/2017	<b>Beginning Section MP</b>	0				
Paved Length (Mile	<b>es):</b> 0.03	Section Length (MI)	0.03				
Surface Type:	ASPHALT	Route Summary					
Roadway Condition	n Information						
Pavement Condition	on Rating (PCR)	81	81				
Surface Condition F	Rating (SCR)	81	81				
Roughness Condition	on Index (RCI)	N/A	N/A				
Distress Index Valu	ies						
Structural Crack In	ndex	94	94				
Alligator Crack Inc	dex	100	100				
Longitudinal Cracl	k Index	94	94				
Transverse Crackin	ng Index	98	98				
Patching Index		100	100				
Rutting Index		81	81				
International Roug	hness Index (IRI)	N/A	N/A				
Lane & Width Info	ormation						
Number of Lanes		2	2				
Paved Width (ft)		19.1	19.1

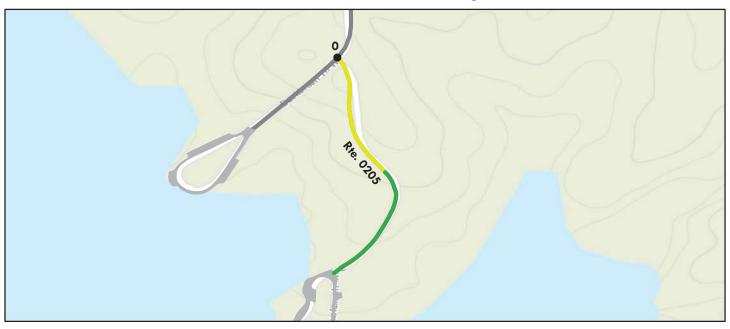
Route (	Condition Legend – Pav	ement Condi	tion Rating (	PCR)		
Poor (0 - 60			(85 - 94)	Excellent (		Not Ra	ted
Colors	on map represent con	dition scores at 0.10-mile	e intervals. Se	e Appendix fo	r definitions	and formulas.	
Inspection Date:	11/7/2017	<b>Beginning Section MP</b>	0				
Paved Length (Mile	es): 0.2	Section Length (MI)	0.2				
Surface Type:	ASPHALT	Route Summary				•	
Roadway Condition	Information						
Pavement Conditio	n Rating (PCR)	80	80				
Surface Condition R	ating (SCR)	80	80				
Roughness Condition	n Index (RCI)	N/A	N/A				
Distress Index Valu	es						
Structural Crack In-	dex	80	80				
Alligator Crack Ind	lex	100	100				
Longitudinal Crack	Index	80	80				
Transverse Crackin	g Index	99	99				
Patching Index		95	95				
Rutting Index		91	91				
International Rough	hness Index (IRI)	N/A	N/A				
Lane & Width Info	rmation						
Number of Lanes		2	2				
Paved Width (ft)		26.2	26.2				
Lane Width (ft)		11	11

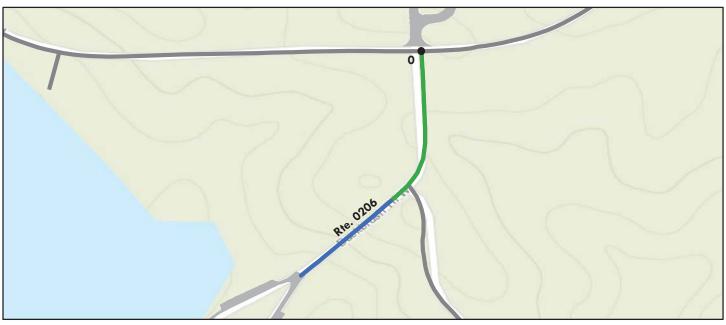
ROUTE 0206: BUCKHORN TRAIL WEST

Route Condition Legend – Pavement Condition Rating (PCR)									
Poor (0 - 60			(85 - 94)	Excellent (		Not Ra	tod			
		•	1				ieu			
Colors	on map represent con-	dition scores at 0.10-mile	intervals. Se	e Appendix fo	or definitions	and formulas.				
Inspection Date:	11/7/2017	<b>Beginning Section MP</b>	0							
Paved Length (Mile	es): 0.17	Section Length (MI)	0.17							
Surface Type:	ASPHALT	Route Summary								
Roadway Condition	n Information									
Pavement Conditio	on Rating (PCR)	94	94							
Surface Condition R	Rating (SCR)	94	94							
Roughness Condition	on Index (RCI)	N/A	N/A							
Distress Index Valu	es									
Structural Crack In	ıdex	95	95							
Alligator Crack Inc	lex	100	100							
Longitudinal Crack	c Index	95	95							
Transverse Crackin	ng Index	99	99							
Patching Index		100	100							
Rutting Index		94	94							
International Rougi	hness Index (IRI)	N/A	N/A							
Lane & Width Info	rmation

Number of Lanes		2	2							
Paved Width (ft)		28.2	28.2							
Lane Width (ft)		11.2	11.2

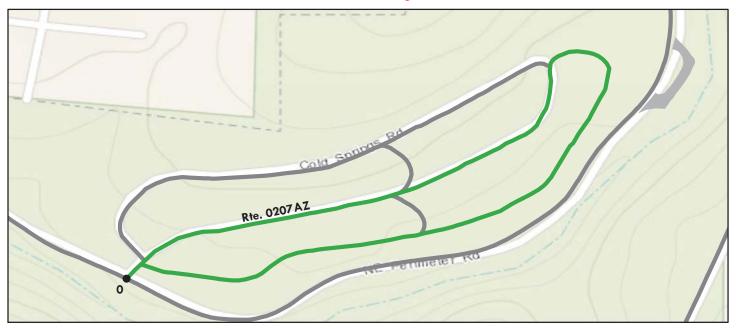
Route (	Condition Legend – Pav	ement Condi	tion Rating (	PCR)		
Poor (0 - 60	_		(85 - 94)	Excellent (9		Not Ra	ted
		See Appendix for def	finitions and f	ormulas			
Inspection Date:	9/16/2017	<b>Beginning Section MP</b>	0.00				
Paved Length (Miles	s): 0.57	Section Length (MI)	0.57				
Surface Type:	ASPHALT	Route Summary					
Roadway Condition	Information						
Pavement Condition	n Rating (PCR)	90	90				
Surface Condition Ra	ating (SCR)	90	90				
Roughness Condition	n Index (RCI)	N/A	N/A				
Distress Index Value	es						
Structural Crack Inc	lex	N/A	N/A				
Alligator Crack Inde	ex	90	90				
Longitudinal Crack	Index	97	97				
Transverse Cracking	g Index	97	97				
Patching Index		90	90				
Rutting Index		90	90				
International Rough	ness Index (IRI)	N/A	N/A				
Lane & Width Infor	mation				·		·
Number of Lanes		1	1				
Paved Width (ft)		10	10				
Lane Width (ft)		10	10

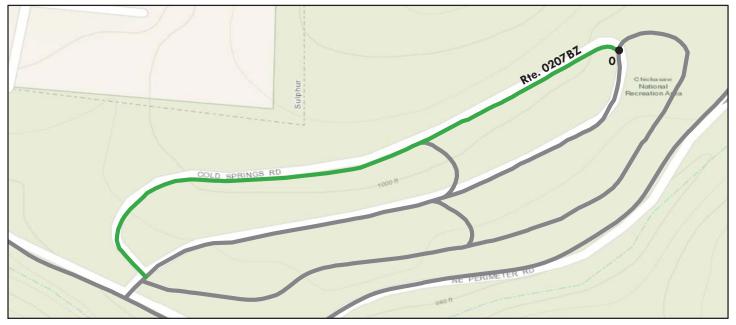
Route (	Condition Legend – Pav	ement Condi	ition Rating (	PCR)		
Poor (0 - 6			(85 - 94)	Excellent (9		Not Rat	ted
		See Appendix for def	finitions and f	formulas			
Inspection Date:	9/16/2017	<b>Beginning Section MP</b>	0.00				
Paved Length (Mil	<b>es</b> ): 0.26	Section Length (MI)	0.26				
Surface Type:	ASPHALT	Route Summary					
Roadway Conditio	n Information						
Pavement Condition	on Rating (PCR)	90	90				
Surface Condition I	Rating (SCR)	90	90				
Roughness Condition	on Index (RCI)	N/A	N/A				
Distress Index Valu	ies						
Structural Crack In	ndex	N/A	N/A				
Alligator Crack In	dex	97	97				
Longitudinal Crac	k Index	90	90				
Transverse Cracki	ng Index	90	90				
Patching Index		90	90				
Rutting Index		97	97				
International Roug	ghness Index (IRI)	N/A	N/A				
Lane & Width Info	ormation				·		
Number of Lanes		1	1				
Paved Width (ft)		10	10				
Lane Width (ft)		10	10

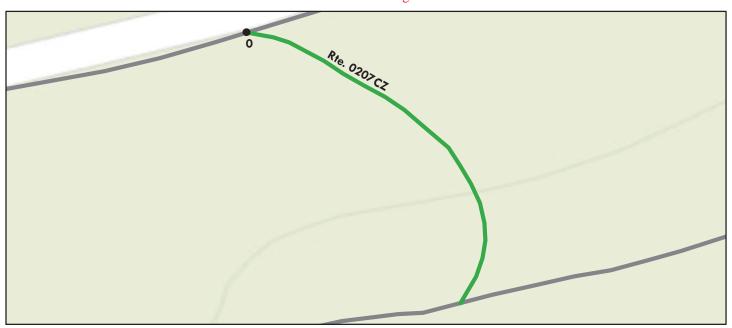
Route (	Condition Legend – Pav	ement Condi	tion Rating (	PCR)		
Poor (0 - 60			(85 - 94)	Excellent (9		Not Ra	ted
		See Appendix for def	initions and f	ormulas			
Inspection Date:	9/16/2017	<b>Beginning Section MP</b>	0.00				
Paved Length (Mile	es): 0.03	Section Length (MI)	0.03				
Surface Type:	ASPHALT	Route Summary					
Roadway Condition	n Information						
Pavement Condition	on Rating (PCR)	90	90				
Surface Condition R	Rating (SCR)	90	90				
Roughness Condition	on Index (RCI)	N/A	N/A				
Distress Index Valu	ies						
Structural Crack In	ıdex	N/A	N/A				
Alligator Crack Inc	dex	97	97				
Longitudinal Crack	x Index	97	97				
Transverse Crackin	ng Index	97	97				
Patching Index		90	90				
Rutting Index		97	97				
International Roug	hness Index (IRI)	N/A	N/A				
Lane & Width Info	rmation						
Number of Lanes		1	1				
Paved Width (ft)		10	10				
Lane Width (ft)		10	10

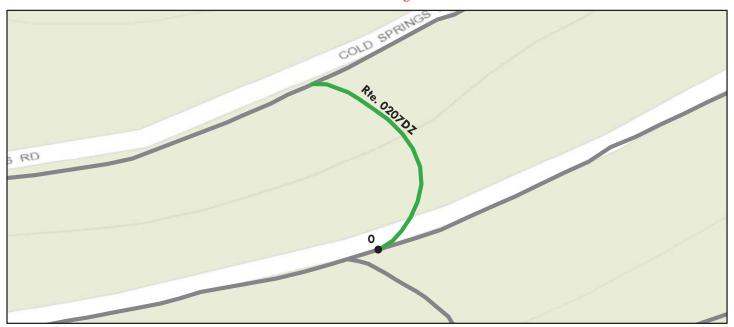
Route (	Condition Legend – Pav	ement Condi	tion Rating (PCR)	
Poor (0 - 60) Fair (6	1- 84) Good (	(85 - 94)	Excellent (95 - 100)	Not Rated
	See Appendix for def	initions and f	ormulas	
<b>Inspection Date:</b> 9/16/2017	<b>Beginning Section MP</b>	0.00		
Paved Length (Miles): 0.04	Section Length (MI)	0.04		
Surface Type: ASPHALT	Route Summary		•	•
Roadway Condition Information				
Pavement Condition Rating (PCR)	90	90		
Surface Condition Rating (SCR)	90	90		
Roughness Condition Index (RCI)	N/A	N/A		
Distress Index Values				
Structural Crack Index	N/A	N/A		
Alligator Crack Index	97	97		
Longitudinal Crack Index	90	90		
Transverse Cracking Index	90	90		
Patching Index	90	90		
Rutting Index	97	97		
International Roughness Index (IRI)	N/A	N/A		
Lane & Width Information				
Number of Lanes	1	1		
Paved Width (ft)	10	10		
Lane Width (ft)	10	10

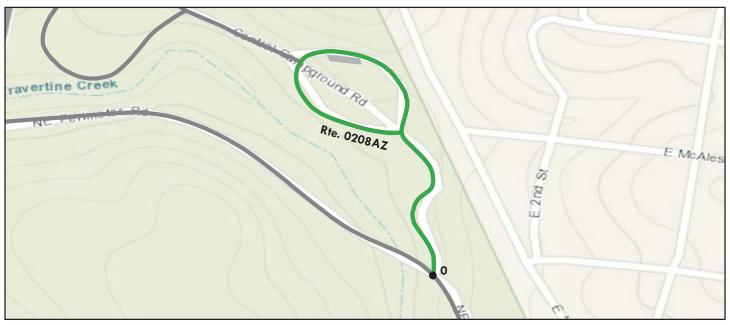
Route (	Condition Legend – Pav	ement Cond	ition Rating (	PCR)		
Poor (0 - 6			(85 - 94)	Excellent (9		Not Ra	ted
Colors	on map represent con	dition scores at 0.10-mile	e intervals. Se	e Appendix fo	r definitions	and formulas.	
Inspection Date:	11/7/2017	<b>Beginning Section MP</b>	0				
Paved Length (Mil	les): 0.24	Section Length (MI)	0.24				
Surface Type:	ASPHALT	Route Summary					
Roadway Conditio	n Information						
Pavement Condition	on Rating (PCR)	93	93				
Surface Condition I	Rating (SCR)	93	93				
Roughness Condition	on Index (RCI)	N/A	N/A				
Distress Index Valu	ies						
Structural Crack In	ndex	95	95				
Alligator Crack In	dex	100	100				
Longitudinal Crac	k Index	95	95				
Transverse Cracki	ng Index	95	95				
Patching Index		100	100				
Rutting Index		93	93				
International Roug	ghness Index (IRI)	N/A	N/A				
Lane & Width Info	ormation				·		
Number of Lanes		1	1				
Paved Width (ft)		15.3	15.3

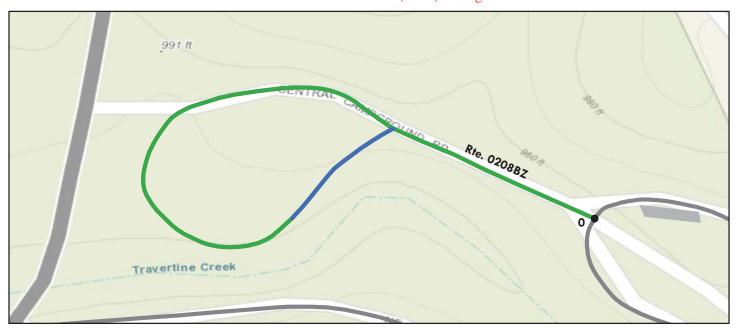
Route	Condition Legend – Pav	ement Cond	ition Rating (F	PCR)				
Poor (0 - 6			(85 - 94)	Excellent (9		Not Ra	ted		
Colors	on map represent con-	dition scores at 0.10-mile	ition scores at 0.10-mile intervals. See Appendix for definitions and formulas.						
Inspection Date:	11/7/2017	<b>Beginning Section MP</b>	0						
Paved Length (Mil	es): 0.24	Section Length (MI)	0.24						
Surface Type:	ASPHALT	Route Summary							
Roadway Condition	n Information								
Pavement Condition	on Rating (PCR)	93	93						
Surface Condition I	Rating (SCR)	93	93						
Roughness Condition	on Index (RCI)	N/A	N/A						
Distress Index Valu	ies								
Structural Crack Ir	ndex	95	95						
Alligator Crack In	dex	100	100						
Longitudinal Cracl	k Index	95	95						
Transverse Cracking	ng Index	93	93						
Patching Index		100	100						
Rutting Index		93	93						
International Roug	ghness Index (IRI)	N/A	N/A						
Lane & Width Info	ormation

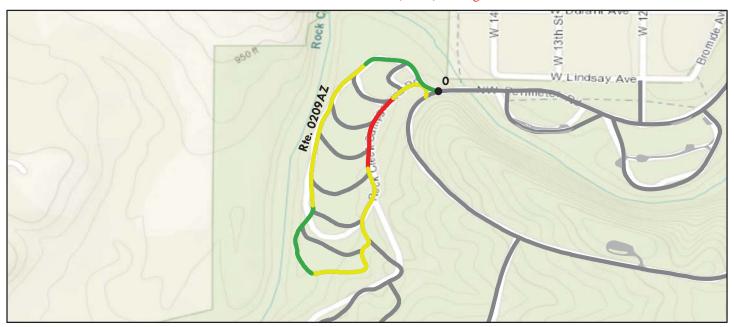
Route	Condition Legend – Pav	ement Condi	tion Rating (	PCR)				
Poor (0 - 6			(85 - 94)	Excellent (9		Not Ra	ted		
		*	ion scores at 0.10-mile intervals. See Appendix for definitions and formulas.						
Inspection Date:	11/7/2017	<b>Beginning Section MP</b>	0						
Paved Length (Mil	<b>es):</b> 0.75	Section Length (MI)	0.75						
Surface Type:	ASPHALT	Route Summary							
Roadway Condition	n Information								
Pavement Condition	on Rating (PCR)	84	84						
Surface Condition I	Rating (SCR)	84	84						
Roughness Condition	on Index (RCI)	N/A	N/A						
Distress Index Valu	ies								
Structural Crack In	ndex	84	84						
Alligator Crack In	dex	100	100						
Longitudinal Craci	k Index	84	84						
Transverse Cracking	ng Index	96	96						
Patching Index		100	100						
Rutting Index		86	86						
International Roug	ghness Index (IRI)	N/A	N/A						
Lane & Width Info	ormation								
Number of Lanes		1	1						
Paved Width (ft)		12.2	12.2

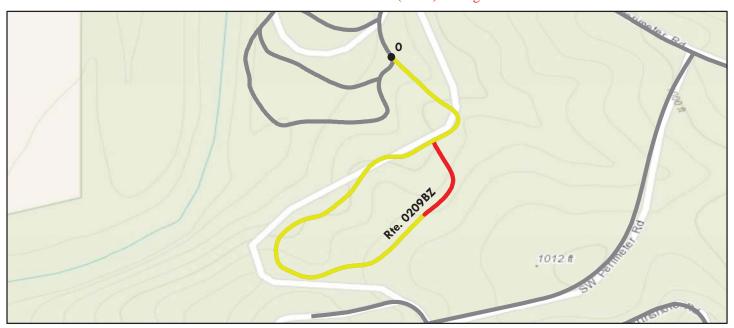
Route (	Condition Legend – Pav	ement Condi	ition Rating (	PCR)		
Poor (0 - 6			(85 - 94)	Excellent (		Not Ra	ted
Colors	on map represent con	dition scores at 0.10-mile	intervals. Se	e Appendix fo	or definitions	and formulas.	
Inspection Date:	11/7/2017	<b>Beginning Section MP</b>	0				
Paved Length (Mile	es): 0.35	Section Length (MI)	0.35				
Surface Type:	ASPHALT	Route Summary					
Roadway Condition	n Information						
Pavement Condition	on Rating (PCR)	71	71				
Surface Condition F	Rating (SCR)	71	71				
Roughness Condition	on Index (RCI)	N/A	N/A				
Distress Index Valu	ies						
Structural Crack In	ndex	71	71				
Alligator Crack Inc	dex	100	100				
Longitudinal Cracl	k Index	71	71				
Transverse Crackin	ng Index	90	90				
Patching Index		100	100				
Rutting Index		87	87				
International Roug	hness Index (IRI)	N/A	N/A				
Lane & Width Info	rmation						
Number of Lanes		1	1				
Paved Width (ft)		15.2	15.2

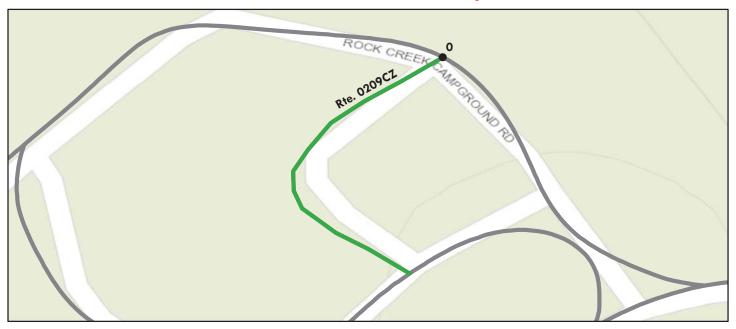
Route	Condition Legend – Pav	ement Condi	ition Rating (	PCR)		
Poor (0 - 6			(85 - 94)	Excellent (9		Not Ra	ted
		dition scores at 0.10-mile	· /			and formulas.	
Inspection Date:	11/7/2017	<b>Beginning Section MP</b>	0				
Paved Length (Mil	es): 0.05	Section Length (MI)	0.05				
Surface Type:	ASPHALT	Route Summary					
Roadway Condition	n Information						
Pavement Condition	on Rating (PCR)	87	87				
Surface Condition I	Rating (SCR)	87	87				
Roughness Condition	on Index (RCI)	N/A	N/A				
Distress Index Valu	ies						
Structural Crack Ir	ndex	97	97				
Alligator Crack Inc	dex	100	100				
Longitudinal Cracl	k Index	97	97				
Transverse Cracking	ng Index	99	99				
Patching Index		100	100				
Rutting Index		87	87				
International Roug	ghness Index (IRI)	N/A	N/A				
Lane & Width Info	ormation						
Number of Lanes		1	1				
Paved Width (ft)		11.6	11.6				
Lane Width (ft)		11.6	11.6

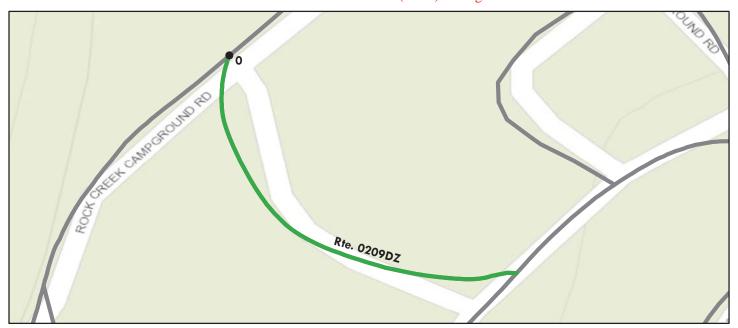
Route	Condition Legend – Pav	ement Condi	ition Rating (I	PCR)		
Poor (0 - 6			(85 - 94)	Excellent (9		Not Ra	ted
Colors	on map represent con	dition scores at 0.10-mile	e intervals. Se	e Appendix for	r definitions	and formulas.	
Inspection Date:	11/7/2017	<b>Beginning Section MP</b>	0				
Paved Length (Mil	<b>es):</b> 0.06	Section Length (MI)	0.06			1	
Surface Type:	ASPHALT	Route Summary					
Roadway Condition	n Information						
Pavement Condition	on Rating (PCR)	85	85				
Surface Condition I	Rating (SCR)	85	85				
Roughness Condition	on Index (RCI)	N/A	N/A				
Distress Index Valu	ies						
Structural Crack Ir	ndex	97	97				
Alligator Crack In	dex	100	100				
Longitudinal Cracl	k Index	97	97				
Transverse Cracking	ng Index	99	99				
Patching Index		100	100				
Rutting Index		85	85				
International Roug	ghness Index (IRI)	N/A	N/A				
Lane & Width Info	ormation						
Number of Lanes		1	1				
Paved Width (ft)		15.3	15.3

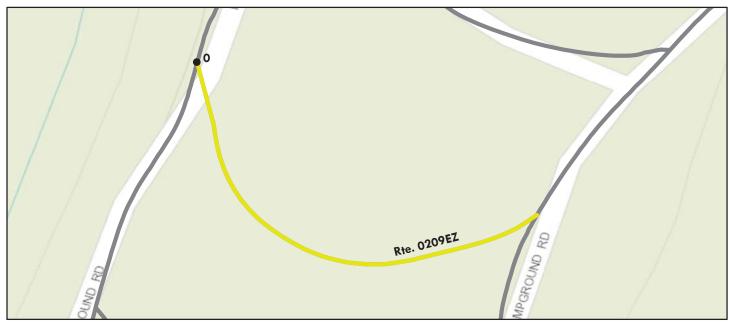
Route (	Condition Legend – Pav	ement Condi	ition Rating (	PCR)		
Poor (0 - 6			(85 - 94)	Excellent (		Not Ra	ted
Colors	on map represent con	dition scores at 0.10-mile	intervals. Se	e Appendix fo	or definitions	and formulas.	
Inspection Date:	11/7/2017	<b>Beginning Section MP</b>	0				
Paved Length (Mile	<b>es):</b> 0.07	Section Length (MI)	0.07				
Surface Type:	ASPHALT	Route Summary					
Roadway Condition	n Information						
Pavement Condition	on Rating (PCR)	81	81				
Surface Condition F	Rating (SCR)	81	81				
Roughness Condition	on Index (RCI)	N/A	N/A				
Distress Index Valu	ies						
Structural Crack In	ndex	81	81				
Alligator Crack Inc	dex	100	100				
Longitudinal Cracl	k Index	81	81				
Transverse Crackin	ng Index	95	95				
Patching Index		100	100				
Rutting Index		83	83				
International Roug	hness Index (IRI)	N/A	N/A				
Lane & Width Info	ormation						
Number of Lanes		1	1				
Paved Width (ft)		12.1	12.1

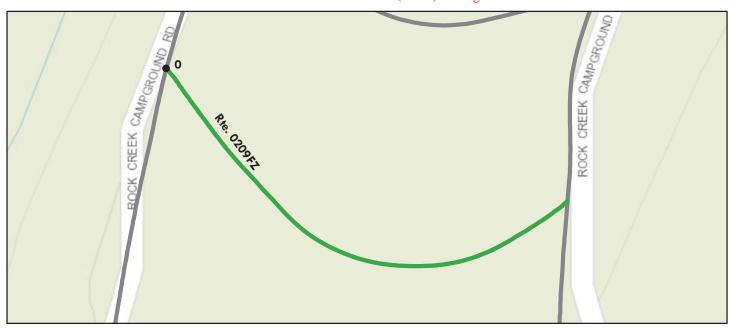
Route (	Condition Legend – Pav	ement Condi	tion Rating (	PCR)		
Poor (0 - 6			(85 - 94)	Excellent (		Not Ra	ted
Colors	on map represent con	dition scores at 0.10-mile	intervals. Se	e Appendix fo	r definitions	and formulas.	
Inspection Date:	11/7/2017	<b>Beginning Section MP</b>	0				
Paved Length (Mil	<b>es):</b> 0.07	Section Length (MI)	0.07				
Surface Type:	ASPHALT	Route Summary					
Roadway Conditio	n Information						
Pavement Condition	on Rating (PCR)	87	87				
Surface Condition I	Rating (SCR)	87	87				
Roughness Condition	on Index (RCI)	N/A	N/A				
Distress Index Valu	ies						
Structural Crack In	ndex	99	99				
Alligator Crack In	dex	100	100				
Longitudinal Crac	k Index	99	99				
Transverse Cracki	ng Index	100	100				
Patching Index		100	100				
Rutting Index		87	87				
International Roug	ghness Index (IRI)	N/A	N/A				
Lane & Width Info	ormation						
Number of Lanes		1	1				
Paved Width (ft)		7.8	7.8

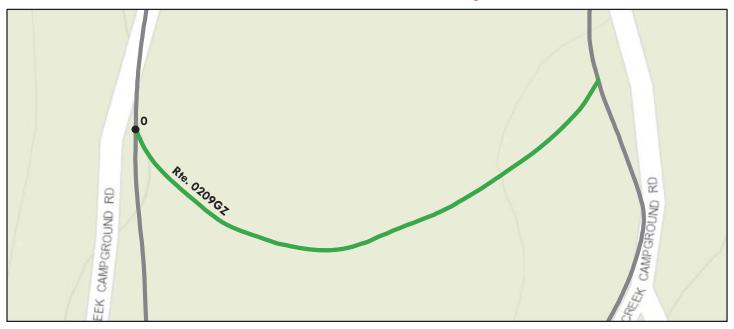
Route (	Condition Legend – Pav	ement Condi	tion Rating (	PCR)			
Poor (0 - 6	_		(85 - 94)	Excellent (9		Not Ra	ted	
Colors on map represent condition scores at 0.10-mile intervals. See Appendix for definitions and formulas.								
Inspection Date:	11/7/2017	<b>Beginning Section MP</b>	0					
Paved Length (Mile	<b>es):</b> 0.08	Section Length (MI)	0.08					
Surface Type:	ASPHALT	Route Summary						
Roadway Condition	n Information							
Pavement Condition	on Rating (PCR)	85	85					
Surface Condition F	Rating (SCR)	85	85					
Roughness Condition	on Index (RCI)	N/A	N/A					
Distress Index Valu	ies							
Structural Crack Ir	ndex	89	89					
Alligator Crack Inc	dex	100	100					
Longitudinal Cracl	k Index	89	89					
Transverse Crackin	ng Index	100	100					
Patching Index		100	100					
Rutting Index		85	85					
International Roug	hness Index (IRI)	N/A	N/A					
Lane & Width Info	ormation							
Number of Lanes		1	1

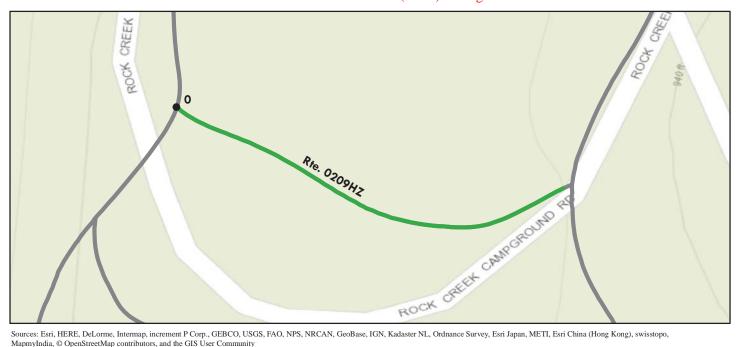
Route	Condition Legend – Pav	ement Condi	ition Rating (	PCR)			
Poor (0 - 6			(85 - 94)	Excellent (9		Not Ra	ted	
Colors on map represent condition scores at 0.10-mile intervals. See Appendix for definitions and formulas.								
Inspection Date:	11/7/2017	<b>Beginning Section MP</b>	0					
Paved Length (Mil	<b>es):</b> 0.06	Section Length (MI)	0.06					
Surface Type:	ASPHALT	Route Summary						
Roadway Condition	n Information							
Pavement Condition	on Rating (PCR)	85	85					
Surface Condition I	Rating (SCR)	85	85					
Roughness Condition	on Index (RCI)	N/A	N/A					
Distress Index Valu	ies							
Structural Crack Ir	ndex	96	96					
Alligator Crack In	dex	100	100					
Longitudinal Cracl	k Index	96	96					
Transverse Cracking	ng Index	99	99					
Patching Index		99	99					
Rutting Index		85	85					
International Roug	ghness Index (IRI)	N/A	N/A					
Lane & Width Info	ormation							
Number of Lanes		1	1

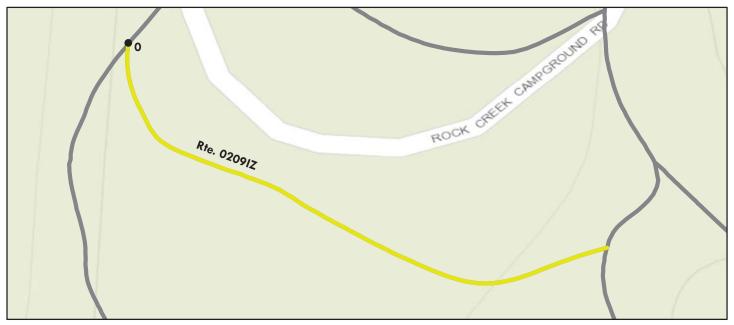
Route (	Condition Legend – Pav	ement Condi	ition Rating (	PCR)				
Poor (0 - 6	_		(85 - 94)	Excellent (9		Not Ra	ted		
Colors	Colors on map represent condition scores at 0.10-mile intervals. See Appendix for definitions and formulas.								
Inspection Date:	11/7/2017	<b>Beginning Section MP</b>	0						
Paved Length (Mil	<b>es</b> ): 0.09	Section Length (MI)	0.09						
Surface Type:	ASPHALT	Route Summary							
Roadway Conditio	n Information								
Pavement Condition	on Rating (PCR)	77	77						
Surface Condition I	Rating (SCR)	77	77						
Roughness Condition	on Index (RCI)	N/A	N/A						
Distress Index Valu	ies								
Structural Crack In	ndex	77	77						
Alligator Crack In	dex	100	100						
Longitudinal Crac	k Index	77	77						
Transverse Cracking	ng Index	98	98						
Patching Index		100	100						
Rutting Index		84	84						
International Roug	ghness Index (IRI)	N/A	N/A						
Lane & Width Info	ormation

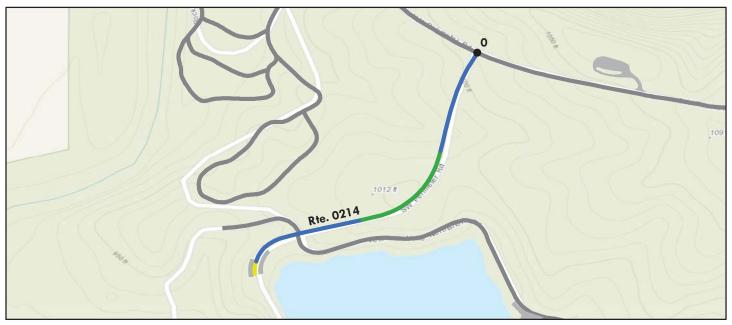
Route (	Condition Legend – Pav	ement Condi	ition Rating (	PCR)		
Poor (0 - 60			(85 - 94)	Excellent (		Not Ra	ted
Colors	on map represent con	dition scores at 0.10-mile	intervals. Se	e Appendix fo	r definitions	and formulas.	
Inspection Date:	11/7/2017	<b>Beginning Section MP</b>	0				
Paved Length (Mile	es): 0.31	Section Length (MI)	on Length (MI) 0.31				
Surface Type:	ASPHALT	Route Summary					
Roadway Condition	n Information						
Pavement Condition	on Rating (PCR)	96	96				
Surface Condition R	Rating (SCR)	96	96				
Roughness Condition	on Index (RCI)	N/A	N/A				
Distress Index Valu	es						
Structural Crack In	ıdex	98	98				
Alligator Crack Inc	lex	100	100				
Longitudinal Crack	c Index	98	98				
Transverse Crackin	ng Index	96	96				
Patching Index		99	99				
Rutting Index		97	97				
International Roug	hness Index (IRI)	N/A	N/A				
Lane & Width Info	rmation						
Number of Lanes		2	2				
Paved Width (ft)		20.3	20.3

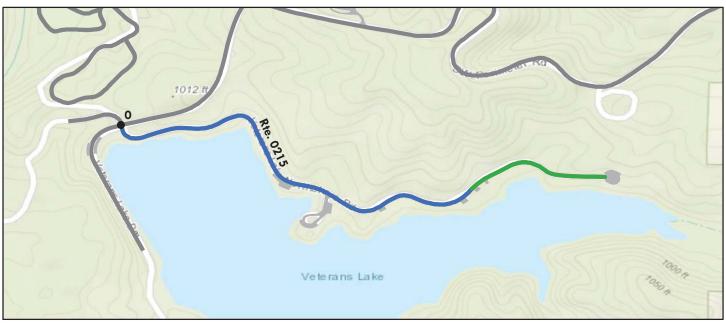
**ROUTE 0215: VETERANS LAKE ROAD**

Route (	Condition Legend – Pav	ement Condi	tion Rating (	PCR)		
Poor (0 - 6			(85 - 94)	Excellent (		Not Ra	ted
Colors	on map represent con-	dition scores at 0.10-mile	intervals. Se	e Appendix fo	or definitions	and formulas.	
Inspection Date:	11/7/2017	<b>Beginning Section MP</b>	0				
Paved Length (Mile	es): 0.67	Section Length (MI) 0.67					
Surface Type:	ASPHALT	Route Summary					
Roadway Condition	n Information						
Pavement Condition	on Rating (PCR)	97	97				
Surface Condition F	Rating (SCR)	97	97				
Roughness Condition	on Index (RCI)	N/A	N/A				
Distress Index Valu	ies						
Structural Crack In	ıdex	100	100				
Alligator Crack Inc	dex	100	100				
Longitudinal Cracl	k Index	100	100				
Transverse Crackin	ng Index	99	99				
Patching Index		97	97				
Rutting Index		99	99				
International Roug	hness Index (IRI)	N/A	N/A				
Lane & Width Info	rmation						
Number of Lanes		2	2				
Paved Width (ft)		29.1	29.1

Lane Width (ft)		11.1	11.1

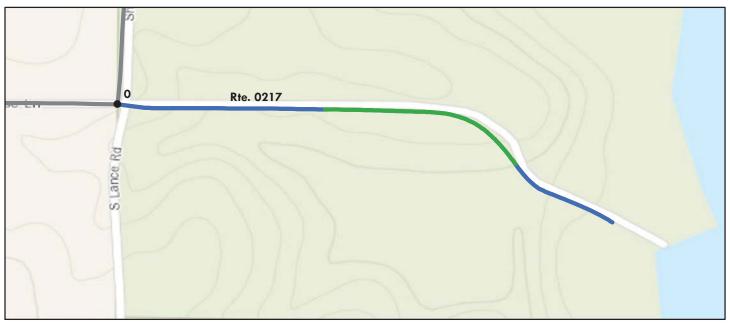
Route Condition Legend – Pavement Condition Rating (PCR)								
Poor (0 - 60			(85 - 94)	Excellent (		Not Ra	ted		
Colors	on map represent con	dition scores at 0.10-mile	intervals. Se	e Appendix fo	or definitions	and formulas.			
Inspection Date:	11/7/2017	<b>Beginning Section MP</b>	0						
Paved Length (Mile	es): 0.26	Section Length (MI)	0.26						
Surface Type:	ASPHALT	Route Summary							
Roadway Condition	Information								
Pavement Condition	n Rating (PCR)	95	95						
Surface Condition R	ating (SCR)	95	95						
Roughness Condition	n Index (RCI)	N/A	N/A						
Distress Index Value	es								
Structural Crack In-	dex	95	95						
Alligator Crack Ind	lex	100	100						
Longitudinal Crack	Index	95	95						
Transverse Crackin	g Index	100	100						
Patching Index		100	100						
Rutting Index		99	99						
International Rough	nness Index (IRI)	N/A	N/A						
Lane & Width Info	rmation								
Number of Lanes		2	2

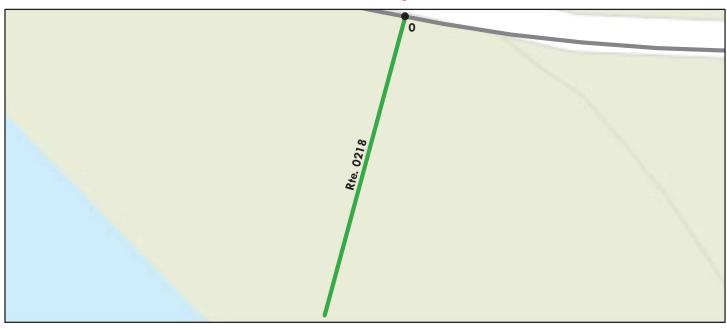
Route (	Condition Legend – Pav	rement Condi	ition Rating (	PCR)		
Poor (0 - 6			(85 - 94)	Excellent (9		Not Ra	ted
		See Appendix for def	finitions and f	ormulas			
Inspection Date:	9/16/2017	<b>Beginning Section MP</b>	0.00				
Paved Length (Mil	<b>es</b> ): 0.03	Section Length (MI)	0.03				
Surface Type:	ASPHALT	Route Summary					
Roadway Condition	n Information						
Pavement Condition	on Rating (PCR)	90	90				
Surface Condition I	Rating (SCR)	90	90				
Roughness Condition	on Index (RCI)	N/A	N/A				
Distress Index Valu	ies						
Structural Crack Ir	ndex	N/A	N/A				
Alligator Crack Inc	dex	97	97				
Longitudinal Crack	k Index	90	90				
Transverse Cracking	ng Index	90	90				
Patching Index		97	97				
Rutting Index		97	97				
International Roug	ghness Index (IRI)	N/A	N/A				
Lane & Width Info	ormation						
Number of Lanes		2	2				
Paved Width (ft)		24	24				
Lane Width (ft)		12	12

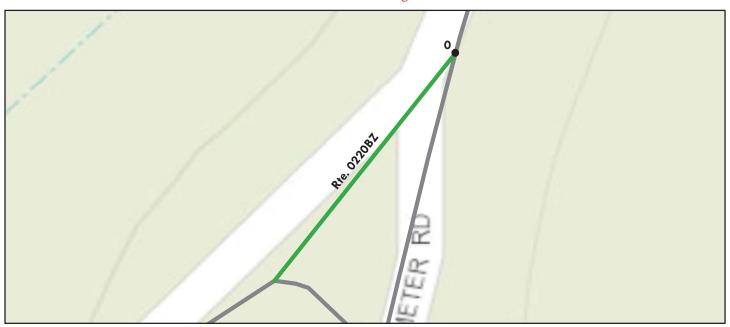
Route (	Condition Legend – Pav	ement Condi	tion Rating (	PCR)		
Poor (0 - 60)	_		(85 - 94)	Excellent (		Not Ra	ted
		See Appendix for de	finitions and f	ormulas			
Inspection Date:	9/16/2017	<b>Beginning Section MP</b>	0.00				
Paved Length (Miles	9): 0.02	Section Length (MI)	0.02				
Surface Type:	ASPHALT	Route Summary					
Roadway Condition	Information						
Pavement Condition	Rating (PCR)	90	90				
Surface Condition Ra	ting (SCR)	90	90				
Roughness Condition	Index (RCI)	N/A	N/A				
Distress Index Values	s						
Structural Crack Ind	ex	N/A	N/A				
Alligator Crack Inde	ex	97	97				
Longitudinal Crack	Index	90	90				
Transverse Cracking	Index	90	90				
Patching Index		90	90				
Rutting Index		90	90				
International Rough	ness Index (IRI)	N/A	N/A				
Lane & Width Inform	mation						
Number of Lanes		1	1				
Paved Width (ft)		11	11				
Lane Width (ft)		11	11

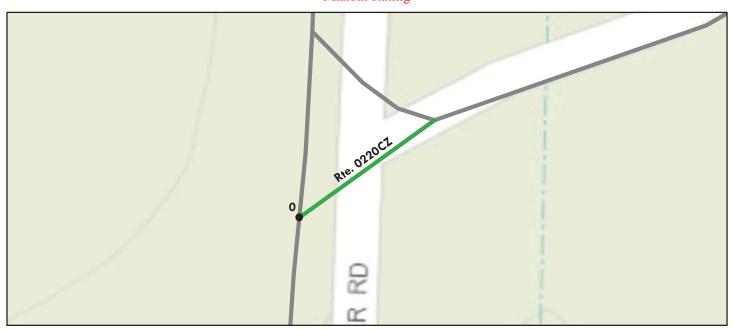
Route (	Condition Legend – Pav	ement Condi	ition Rating (	PCR)		
Poor (0 - 6			(85 - 94)	Excellent (9		Not Ra	ted
		See Appendix for def	initions and f	ormulas			
Inspection Date:	9/16/2017	<b>Beginning Section MP</b>	0.00				
Paved Length (Mil	<b>es):</b> 0.01	Section Length (MI)	0.01				
Surface Type:	ASPHALT	Route Summary					
Roadway Condition	n Information						
Pavement Condition	on Rating (PCR)	90	90				
Surface Condition I	Rating (SCR)	90	90				
Roughness Condition	on Index (RCI)	N/A	N/A				
Distress Index Valu	ies						
Structural Crack Ir	ndex	N/A	N/A				
Alligator Crack In	dex	97	97				
Longitudinal Crack	k Index	90	90				
Transverse Cracking	ng Index	90	90				
Patching Index		90	90				
Rutting Index		90	90				
International Roug	hness Index (IRI)	N/A	N/A				
Lane & Width Info	ormation						
Number of Lanes		1	1				
Paved Width (ft)		11	11				
Lane Width (ft)		11	11

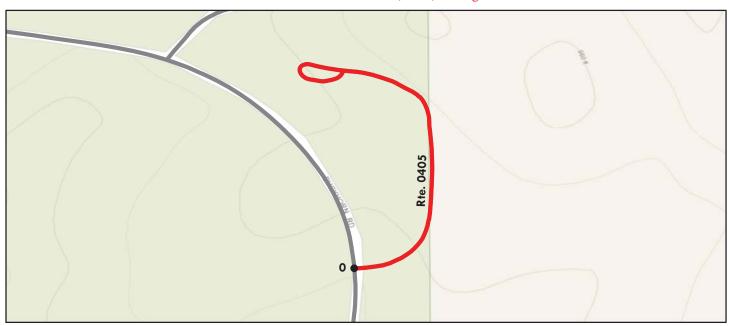
Route (	Condition Legend – Pav	ement Cond	ition Rating (	PCR)		
Poor (0 - 6			(85 - 94)	Excellent (		Not Ra	ted
Colors		dition scores at 0.10-mile		e Appendix fo	or definitions	and formulas.	
Inspection Date:	11/7/2017	<b>Beginning Section MP</b>	0				
Paved Length (Mile	<b>es):</b> 0.17	Section Length (MI)	0.17				
Surface Type:	ASPHALT	Route Summary					
Roadway Condition	n Information						
Pavement Condition	on Rating (PCR)	46	46				
Surface Condition F	Rating (SCR)	46	46				
Roughness Condition	on Index (RCI)	N/A	N/A				
Distress Index Valu	ies						
Structural Crack Ir	ndex	46	46				
Alligator Crack Inc	dex	100	100				
Longitudinal Cracl	k Index	46	46				
Transverse Crackii	ng Index	95	95				
Patching Index		98	98				
Rutting Index		85	85				
International Roug	hness Index (IRI)	N/A	N/A				
Lane & Width Info	ormation						
Number of Lanes		2	2				
Paved Width (ft)		17.4	17.4				
Lane Width (ft)		9.8	9.8

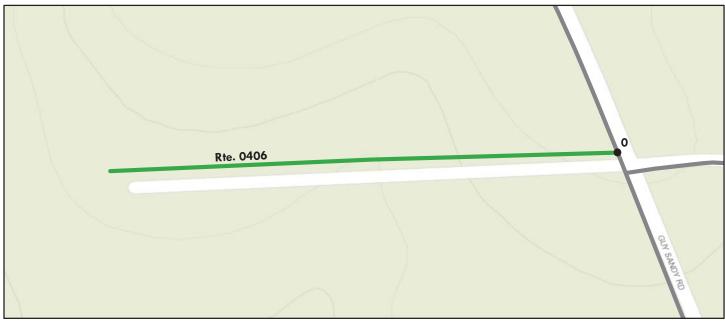
ROUTE 0406: GUY SANDY MAINTENANCE AREA ROAD

Route (	Condition Legend – Pav	ement Condi	tion Rating (	PCR)		
Poor (0 - 60			(85 - 94)	Excellent (		Not Ra	ted
		See Appendix for det	finitions and f	ormulas			
Inspection Date:	9/17/2017	<b>Beginning Section MP</b>	0.00				
Paved Length (Mile	s): 0.10	Section Length (MI)	0.10				
Surface Type:	ASPHALT	Route Summary					
Roadway Condition	Information						
Pavement Condition	n Rating (PCR)	90	90				
Surface Condition Ra	ating (SCR)	90	90				
Roughness Condition	n Index (RCI)	N/A	N/A				
Distress Index Value	es						
Structural Crack Inc	dex	N/A	N/A				
Alligator Crack Ind	ex	97	97				
Longitudinal Crack	Index	90	90				
Transverse Cracking	g Index	90	90				
Patching Index		97	97				
Rutting Index		90	90				
International Rough	nness Index (IRI)	N/A	N/A				
Lane & Width Infor	mation						
Number of Lanes		2	2				
Paved Width (ft)		14	14				
Lane Width (ft)		7	7

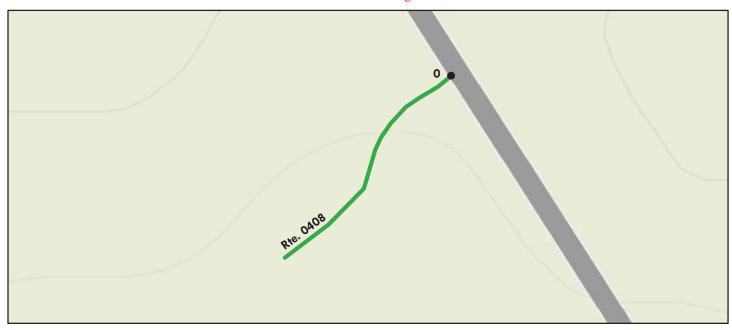
Route	Condition Legend – Pav	ement Condi	tion Rating (PCR)	
Poor (0 - 60) Fair (	Good (	(85 - 94)	<b>Excellent (95 - 100)</b>	Not Rated
	See Appendix for def	initions and f	ormulas	
<b>Inspection Date:</b> 9/16/2017	<b>Beginning Section MP</b>	0.00		
Paved Length (Miles): 0.04	Section Length (MI)	0.04		
Surface Type: ASPHALT	Route Summary			•
Roadway Condition Information				
Pavement Condition Rating (PCR)	90	90		
Surface Condition Rating (SCR)	90	90		
Roughness Condition Index (RCI)	N/A	N/A		
Distress Index Values				
Structural Crack Index	N/A	N/A		
Alligator Crack Index	97	97		
Longitudinal Crack Index	90	90		
Transverse Cracking Index	97	97		
Patching Index	90	90		
Rutting Index	90	90		
International Roughness Index (IRI)	N/A	N/A		
Lane & Width Information				
Number of Lanes	1	1		
Paved Width (ft)	12	12		
Lane Width (ft)	12	12

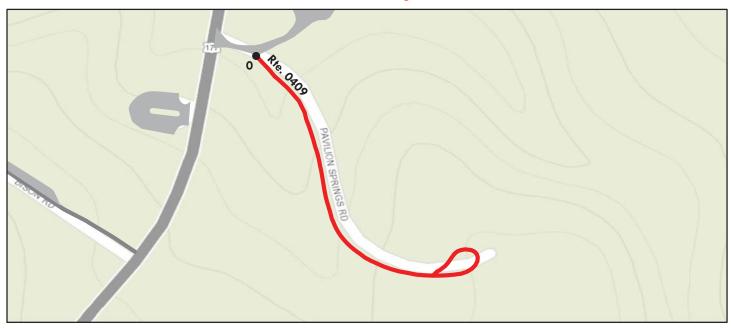
Route (	Condition Legend – Pav	ement Condi	tion Rating (	PCR)		
Poor (0 - 60			(85 - 94)	Excellent (		Not Ra	ted
		See Appendix for def	finitions and f	ormulas			
Inspection Date:	9/16/2017	<b>Beginning Section MP</b>	0.00				
Paved Length (Mile	es): 0.16	Section Length (MI)	0.16				
Surface Type:	ASPHALT	Route Summary					
Roadway Condition	n Information						
Pavement Condition	on Rating (PCR)	53	53				
Surface Condition R	Rating (SCR)	53	53				
Roughness Condition	on Index (RCI)	N/A	N/A				
Distress Index Valu	es						
Structural Crack In	ıdex	N/A	N/A				
Alligator Crack Inc	lex	73	73				
Longitudinal Crack	c Index	73	73				
Transverse Crackir	ng Index	73	73				
Patching Index		53	53				
Rutting Index		97	97				
International Roug	hness Index (IRI)	N/A	N/A				
Lane & Width Info	rmation						
Number of Lanes		1	1				
Paved Width (ft)		12	12				
Lane Width (ft)		12	12

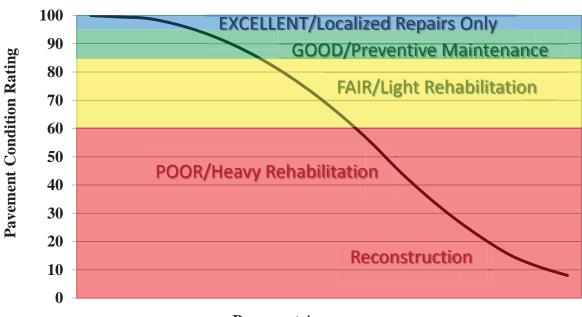
### **Condition Categories and Treatments**

**Pavement Age**
