Final Report

Road Inventory and Condition Assessment of Paved Routes Chiricahua National Monument

Federal Highway Administration
Eastern Federal Lands Highway Division
Road Inventory Program (RIP)

Report Date: May 2017

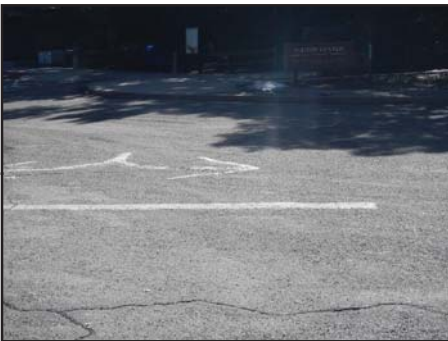
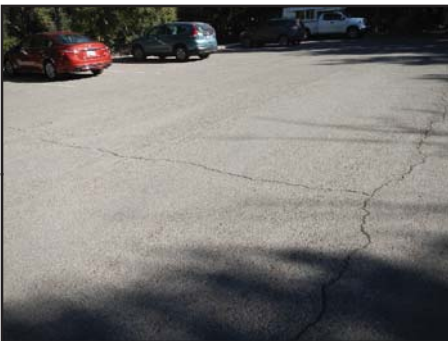
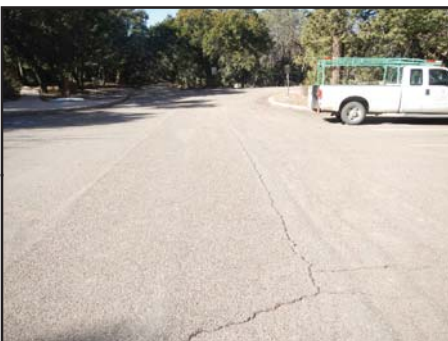
Inspection Date	FMSS Number	User Access	Surface Type
1/23/2016	75539	PUBLIC	ASPHALT
Area (Sq. Ft.)	Lane Miles (11' Widths)	Curb Reveal (Inches)	Curb Recommendation
12,751	0.22	6	DO NOTHING
Curb Type		Curb & Gutter Type	
CONCRETE		CONCRETE	
Pavement Recommendation		Condition Rating / PCR	
PREVENTIVE MAINTENANCE		GOOD / 90

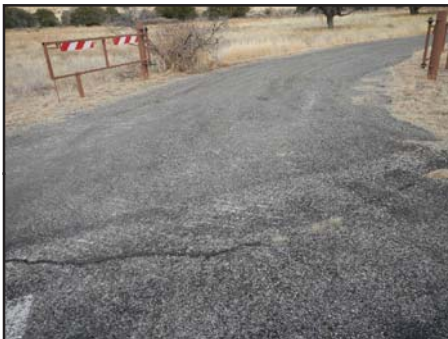
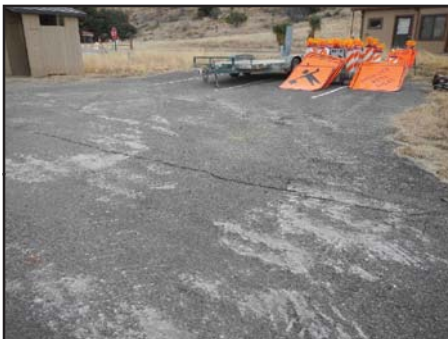
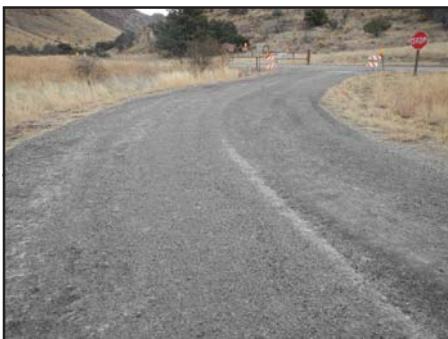
ROUTE 0901: ENTRANCE STATION PARKING

Inspection Date	FMSS Number	User Access	Surface Type
1/23/2016	69232	NONPUBLIC	ASPHALT
Area (Sq. Ft.)	Lane Miles (11' Widths)	Curb Reveal (Inches)	Curb Recommendation
6,311	0.109	NOT APPLICABLE	NOT APPLICABLE
Curb Type		Curb & Gutter Type	
NO CURB		NO CURB AND GUTTER	
Pavement Recommendation		Condition Rating / PCR	
LIGHT 3R TREATMENTS		FAIR / 73

Note: Some damage to pavement from construction equipment.

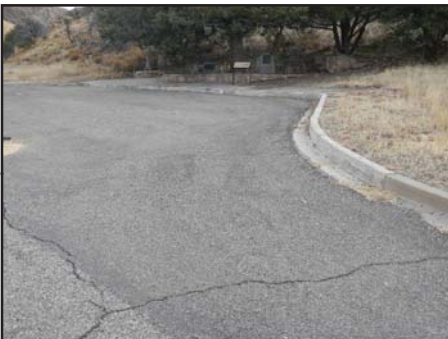
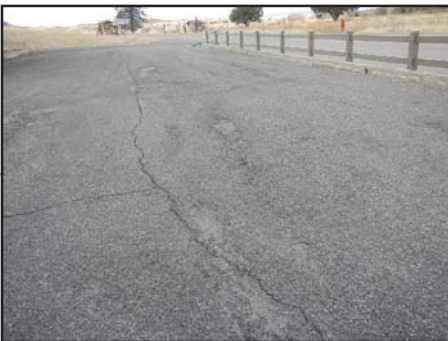
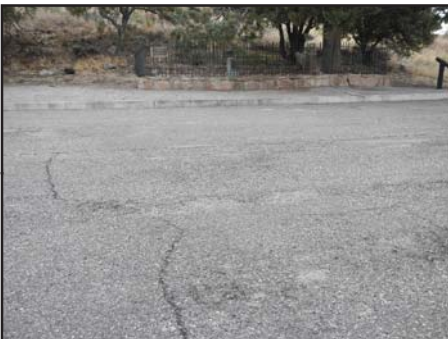
ROUTE 0902: ERICKSON CEMETERY PARKING

Inspection Date	FMSS Number	User Access	Surface Type
1/23/2016	77591	PUBLIC	ASPHALT
Area (Sq. Ft.)	Lane Miles (11' Widths)	Curb Reveal (Inches)	Curb Recommendation
4,737	0.082	NOT APPLICABLE	DO NOTHING
Curb Type		Curb & Gutter Type	
NO CURB		CONCRETE	
Pavement Recommendation		Condition Rating / PCR	
LIGHT 3R TREATMENTS		FAIR / 73

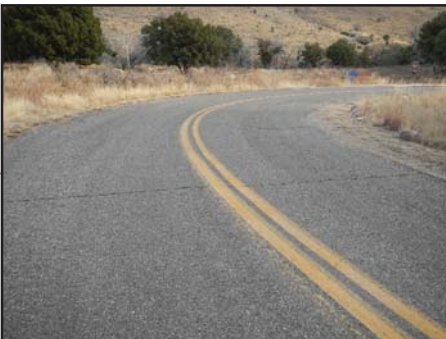
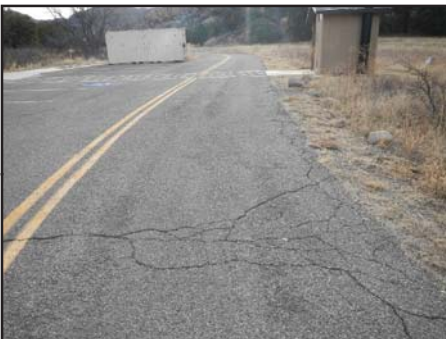
ROUTE 0903: BONITA CREEK PICNIC AREA

Inspection Date	FMSS Number	User Access	Surface Type
1/23/2016	69240	PUBLIC	ASPHALT
Area (Sq. Ft.)	Lane Miles (11' Widths)	Curb Reveal (Inches)	Curb Recommendation
11,253	0.194	NOT APPLICABLE	DO NOTHING
Curb Type		Curb & Gutter Type	
NO CURB		CONCRETE	
Pavement Recommendation		Condition Rating / PCR	
HEAVY 3R TREATMENTS		POOR / 53

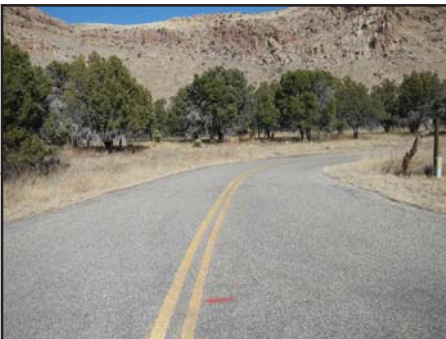
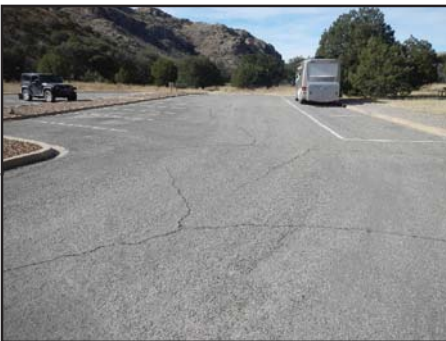
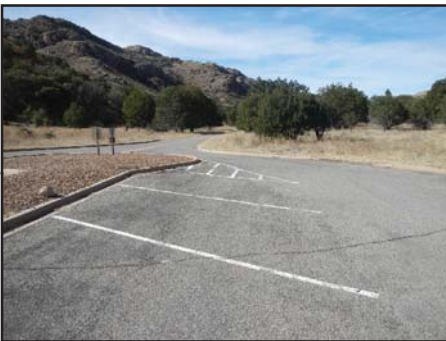
ROUTE 0904: FARAWAY RANCH PICNIC PARKING

Inspection Date	FMSS Number	User Access	Surface Type
1/23/2016	69252	PUBLIC	ASPHALT
Area (Sq. Ft.)	Lane Miles (11' Widths)	Curb Reveal (Inches)	Curb Recommendation
22,818	0.393	NOT APPLICABLE	DO NOTHING
Curb Type		Curb & Gutter Type	
NO CURB		CONCRETE	
Pavement Recommendation		Condition Rating / PCR	
LIGHT 3R TREATMENTS		FAIR / 73

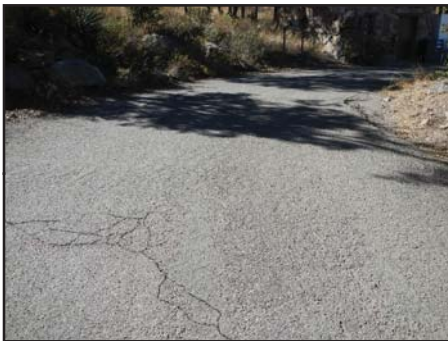
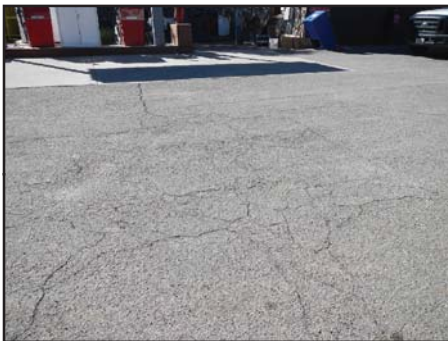
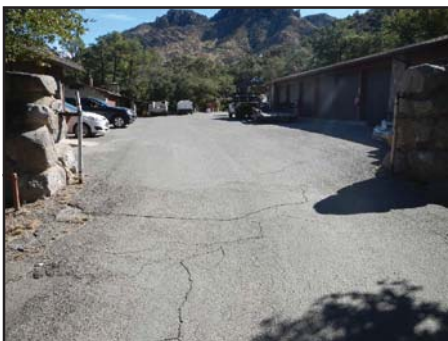
ROUTE 0906: MAINTENANCE AREA

Inspection Date	FMSS Number	User Access	Surface Type
1/23/2016	79636	NONPUBLIC	ASPHALT
Area (Sq. Ft.)	Lane Miles (11' Widths)	Curb Reveal (Inches)	Curb Recommendation
11,560	0.199	NOT APPLICABLE	NOT APPLICABLE
Curb Type		Curb & Gutter Type	
NO CURB		NO CURB AND GUTTER	
Pavement Recommendation		Condition Rating / PCR	
HEAVY 3R TREATMENTS		POOR / 53

Note: Parking area consists of multiple surface types: 1 part Asphalt at 11,106 square feet; 1 part Concrete at 454 square feet.

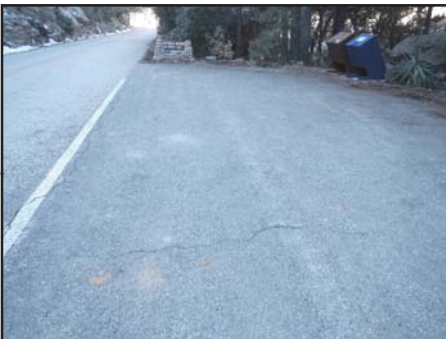
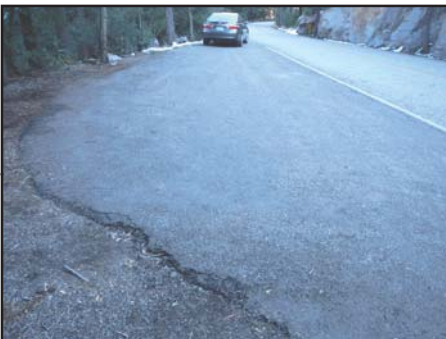
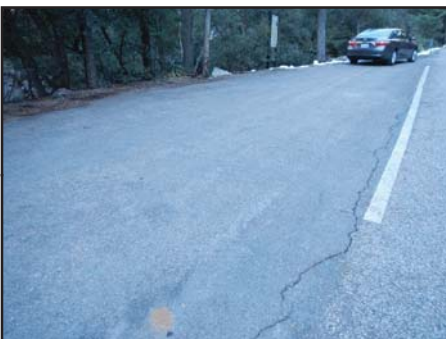
ROUTE 0907: NATURAL BRIDGE TRAILHEAD PARKING

Inspection Date	FMSS Number	User Access	Surface Type
1/23/2016	79626	PUBLIC	ASPHALT
Area (Sq. Ft.)	Lane Miles (11' Widths)	Curb Reveal (Inches)	Curb Recommendation
1,568	0.027	NOT APPLICABLE	NOT APPLICABLE
Curb Type		Curb & Gutter Type	
NO CURB		NO CURB AND GUTTER	
Pavement Recommendation		Condition Rating / PCR	
LIGHT 3R TREATMENTS		FAIR / 73

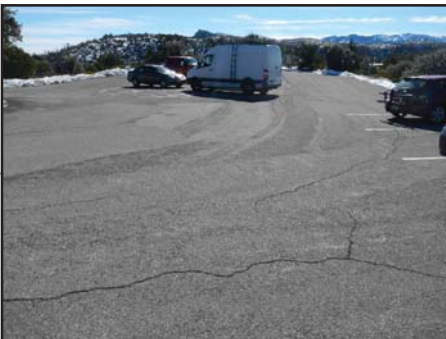
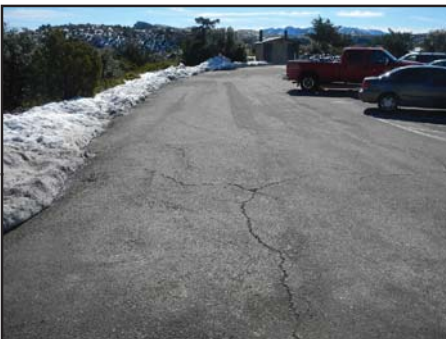
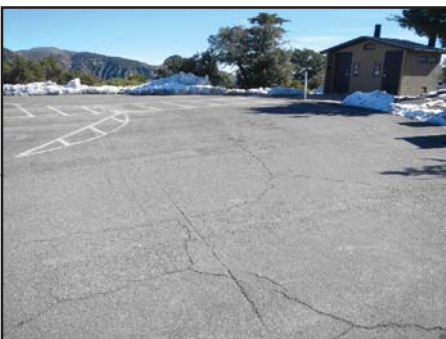
ROUTE 0908: ECHO CANYON PARKING

Inspection Date	FMSS Number	User Access	Surface Type
1/23/2016	77276	PUBLIC	ASPHALT
Area (Sq. Ft.)	Lane Miles (11' Widths)	Curb Reveal (Inches)	Curb Recommendation
15,865	0.273	NOT APPLICABLE	DO NOTHING
Curb Type		Curb & Gutter Type	
NO CURB		CONCRETE	
Pavement Recommendation		Condition Rating / PCR	
LIGHT 3R TREATMENTS		FAIR / 73

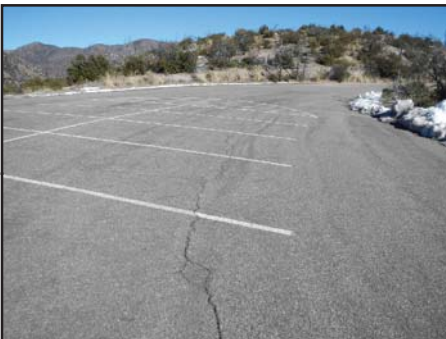
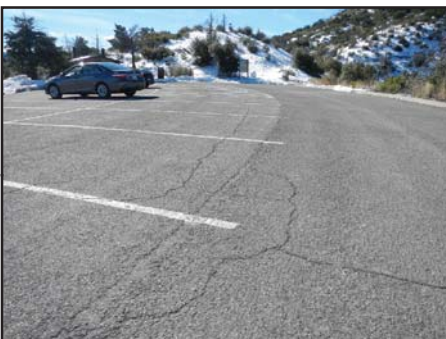
ROUTE 0909: SUGARLOAF PARKING

Inspection Date	FMSS Number	User Access	Surface Type
1/23/2016	77211	PUBLIC	ASPHALT
Area (Sq. Ft.)	Lane Miles (11' Widths)	Curb Reveal (Inches)	Curb Recommendation
14,004	0.241	NOT APPLICABLE	DO NOTHING
Curb Type		Curb & Gutter Type	
NO CURB		CONCRETE	
Pavement Recommendation		Condition Rating / PCR	
LIGHT 3R TREATMENTS		FAIR / 73

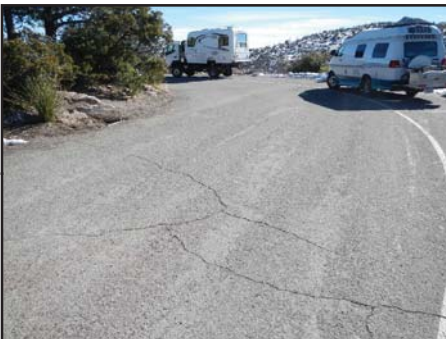
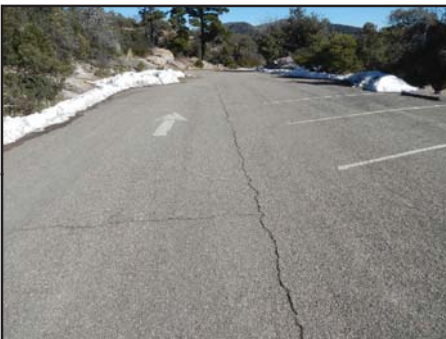
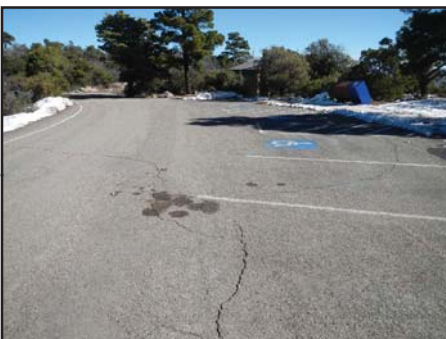
ROUTE 0910: MASSAI POINT PARKING

Inspection Date	FMSS Number	User Access	Surface Type
1/23/2016	77085	PUBLIC	ASPHALT
Area (Sq. Ft.)	Lane Miles (11' Widths)	Curb Reveal (Inches)	Curb Recommendation
23,019	0.396	NOT APPLICABLE	NOT APPLICABLE
Curb Type		Curb & Gutter Type	
NO CURB		NO CURB AND GUTTER	
Pavement Recommendation		Condition Rating / PCR	
LIGHT 3R TREATMENTS		FAIR / 73

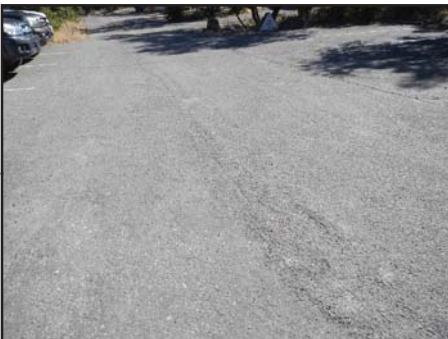
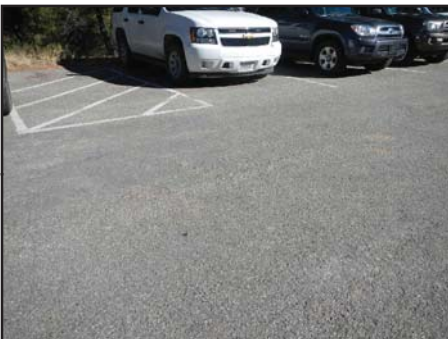
ROUTE 0912: SEASONAL HOUSING AREA PARKING

Inspection Date	FMSS Number	User Access	Surface Type
1/23/2016	240547	NONPUBLIC	ASPHALT
Area (Sq. Ft.)	Lane Miles (11' Widths)	Curb Reveal (Inches)	Curb Recommendation
3,393	0.058	NOT APPLICABLE	NOT APPLICABLE
Curb Type		Curb & Gutter Type	
NO CURB		NO CURB AND GUTTER	
Pavement Recommendation		Condition Rating / PCR	
PREVENTIVE MAINTENANCE		GOOD / 90
