CONG Cycle 6

Road Inventory and Condition Assessment of Paved Routes Congaree National Park

Report Date: November 2021

Congaree National Park in South Carolina

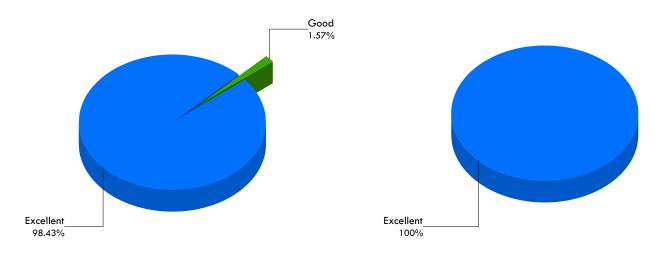
Figure 1: Pavement Condition Rating Breakdown for Paved Roads and Parking Areas

Road Condition Percentages

Parking Area Condition Percentages

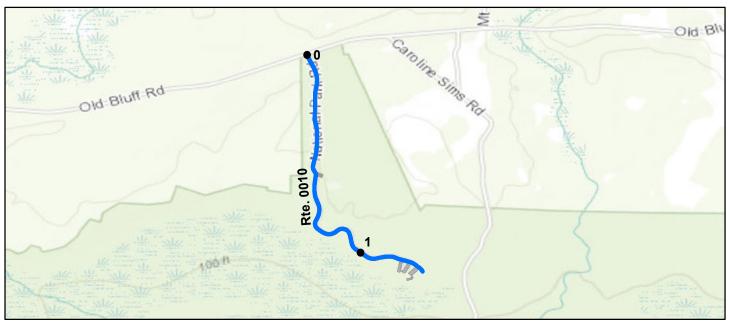
ROUTE 0010: ENTRANCE ROAD

Route (Condition Legend – Pav	ement Condi	ition Rating (PCR)		
Poor (0 - 6			(85 - 94)	Excellent (Not Ra	ted
Colors	on map represent con-	dition scores at 0.10-mile	intervals. Se	e Appendix fo	or definitions	and formulas.	
Inspection Date:	2/8/2021	Beginning Section MP	0	1			
Paved Length (Mil	es): 1.25	Section Length (MI)	1	0.25			
Surface Type:	ASPHALT	Route Summary		•	•	•	
Roadway Conditio	n Information						
Pavement Condition	on Rating (PCR)	100	100	98			
Surface Condition Rating (SCR)		100	100	98			
Roughness Condition	on Index (RCI)	N/A	N/A	N/A			
Distress Index Valu	ies						
Structural Crack Ir	ndex	100	100	100			
Alligator Crack In	dex	100	100	100			
Longitudinal Cracl	k Index	100	100	100			
Transverse Crackin	ng Index	100	100	100			
Patching Index		100	100	100			
Rutting Index		100	100	98			
International Roug	hness Index (IRI)	N/A	N/A	N/A			
Lane & Width Info	ormation						
Number of Lanes		2	2	2

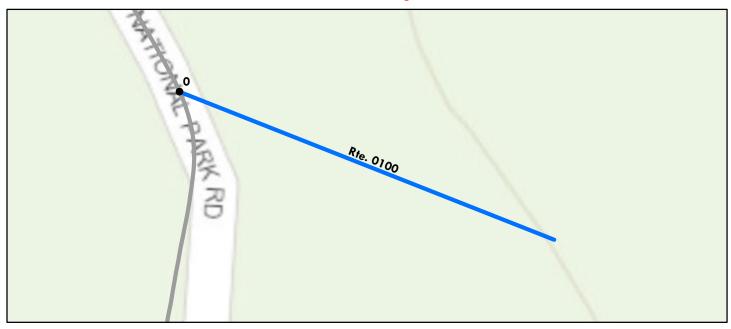
ROUTE 0100: LONGLEAF CAMPGROUND ACCESS ROAD

Route (Condition Legend – Pav	ement Condi	tion Rating (PCR)		
Poor (0 - 60				Excellent (95 - 100)		Not Rated	
,		See Appendix for def		× .	/		
Inspection Date:	2/8/2021	Beginning Section MP	0.00				
Paved Length (Miles): 0.02		Section Length (MI)	0.02				
Surface Type:	ASPHALT	Route Summary				•	
Roadway Condition Information							
Pavement Condition	on Rating (PCR)	98	98				
Surface Condition R	Rating (SCR)	98	98				
Roughness Condition Index (RCI)		N/A	N/A				
Distress Index Values							
Structural Crack In	ıdex	98	98				
Alligator Crack Index		99	99				
Longitudinal Crack	c Index	99	99				
Transverse Crackir	ng Index	99	99				
Patching Index		100	100				
Rutting Index		100	100				
International Roughness Index (IRI)		N/A	N/A				
Lane & Width Information							
Number of Lanes		2	2				
Paved Width (ft)		15	15				
Lane Width (ft)		7.5	7.5

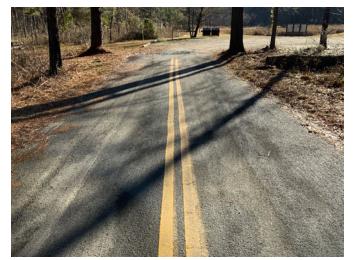
CONG_0100_1.jpg

Condition photos are shown only for manually rated roads. Use the PathView program to see images of DCV rated roads.

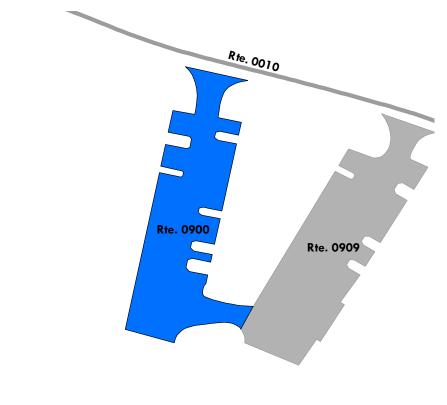
ROUTE 0900: VISITOR CENTER FIRST PARKING

Inspection Date	FMSS Number	User Access	Surface Type	
2/8/2021	49064	PUBLIC	ASPHALT	
Area (Sq. Ft.)	Lane Miles (11' Widths)	Curb Reveal (Inches)	Curb Recommendation	
13,648	0.235	4	DO NOTHING	
Curb	Туре	Curb & Gutter Type		
WC	OOD	NO CURB AND GUTTER		
Pavement Rec	commendation	Condition Rating / PCR		
DO NO	THING	EXCELLENT / 97		
Route Condition Legend – Pavement Condition Rating (PCR)

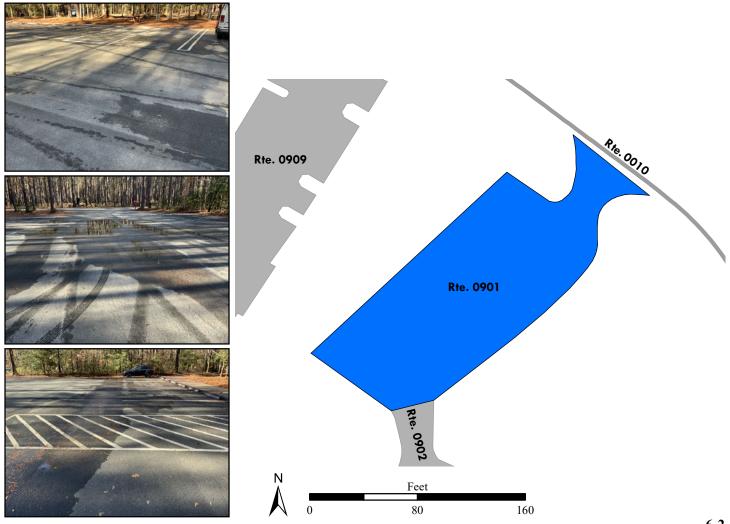
ROUTE 0901: VISITOR CENTER BUS PARKING

Inspection Date	FMSS Number	User Access	Surface Type	
2/8/2021	225801	PUBLIC	ASPHALT	
Area (Sq. Ft.)	Lane Miles (11' Widths)	Curb Reveal (Inches)	Curb Recommendation	
16,499	0.284	NOT APPLICABLE	NOT APPLICABLE	
Curb	Туре	Curb & Gutter Type		
NO C	CURB	NO CURB AND GUTTER		
Pavement Rec	commendation	Condition Rating / PCR		
DO NO	THING	EXCELLENT / 97		
Route Condition Legend – Pavement Condition Rating (PCR)				
Poor (0 - 60) Fair (61- 84) Good (85 - 94) Excellent (95 - 100) Not Rated See Appendix for definitions and formulas

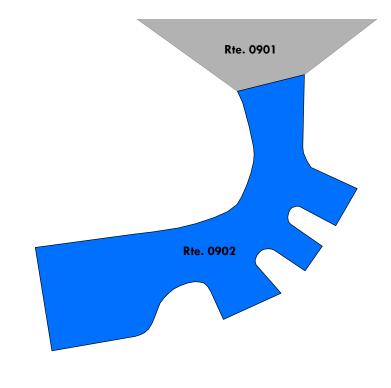
ROUTE 0902: EMPLOYEE PARKING

Inspection Date	FMSS Number	User Access	Surface Type	
2/8/2021	241977	NONPUBLIC	ASPHALT	
Area (Sq. Ft.)	Lane Miles (11' Widths)	Curb Reveal (Inches)	Curb Recommendation	
5,804	0.1	NOT APPLICABLE	NOT APPLICABLE	
Curb	Туре	Curb & Gutter Type		
NO C	CURB	NO CURB AND GUTTER		
Pavement Rec	commendation	Condition Rating / PCR		
DO NO	THING	EXCELLENT / 97

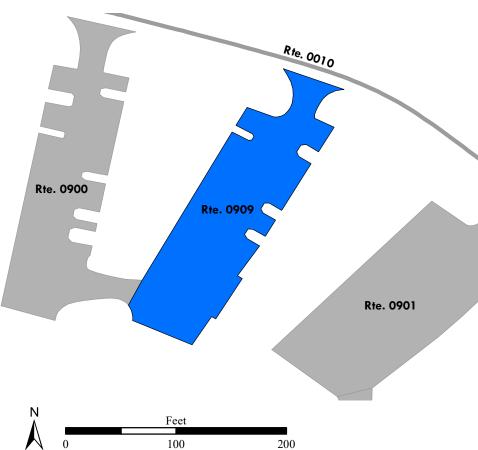
ROUTE 0909: VISITOR CENTER MIDDLE PARKING

Inspection Date	FMSS Number	User Access	Surface Type	
2/8/2021	225800	PUBLIC	ASPHALT	
Area (Sq. Ft.)	Lane Miles (11' Widths)	Curb Reveal (Inches)	Curb Recommendation	
14,462	0.249	3	DO NOTHING	
Curb	Туре	Curb & Gutter Type		
WO	OOD	NO CURB AND GUTTER		
Pavement Re	commendation	Condition Rating / PCR		
DO NO	THING	EXCELLENT / 97		
Route Condition Legend – Pavement Condition Rating (PCR)				
Poor (0 = 60) Fair (61 = 84) Cood (85 = 94) Excellent (95 = 100) Not Rated
