# CORO Cycle 6

## Final Report

### Road Inventory and Condition Assessment of Paved Routes Coronado National Memorial

Report Date: May 2017

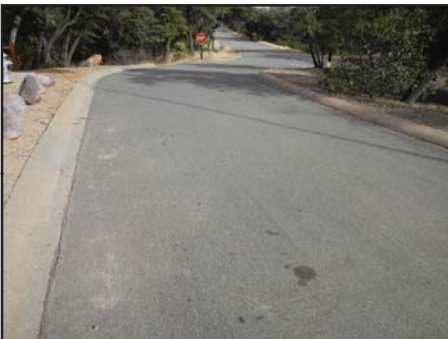
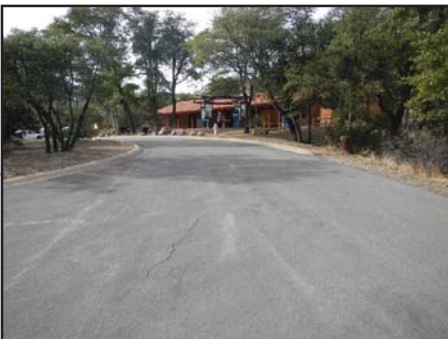
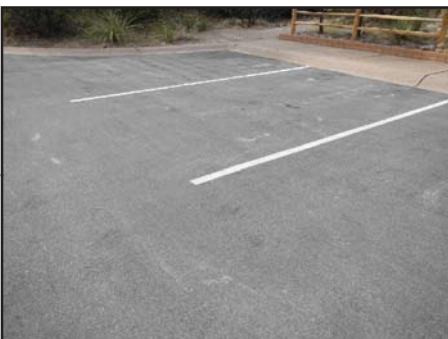
Inspection Date	FMSS Number	User Access	Surface Type
1/23/2016	91250	PUBLIC	ASPHALT
Area (Sq. Ft.)	Lane Miles (11' Widths)	Curb Reveal (Inches)	Curb Recommendation
10,657	0.183	NOT APPLICABLE	DO NOTHING
Curb Type		Curb & Gutter Type	
NO CURB		CONCRETE	
Pavement Recommendation		Condition Rating / PCR	
PREVENTIVE MAINTENANCE		GOOD / 90

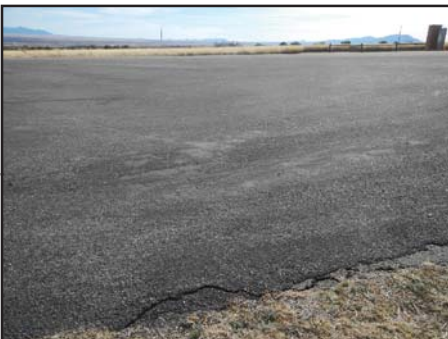
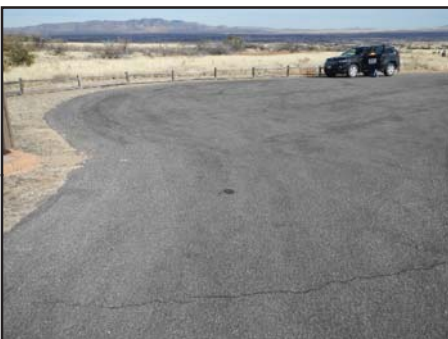
## ROUTE 0901: ENTRANCE SIGN PARKING

Inspection Date	FMSS Number	User Access	Surface Type
1/23/2016	91248	PUBLIC	ASPHALT
Area (Sq. Ft.)	Lane Miles (11' Widths)	Curb Reveal (Inches)	Curb Recommendation
3,560	0.061	NOT APPLICABLE	NOT APPLICABLE
Curb Type		Curb & Gutter Type	
NO CURB		NO CURB AND GUTTER	
Pavement Recommendation		Condition Rating / PCR	
PREVENTIVE MAINTENANCE		GOOD / 90

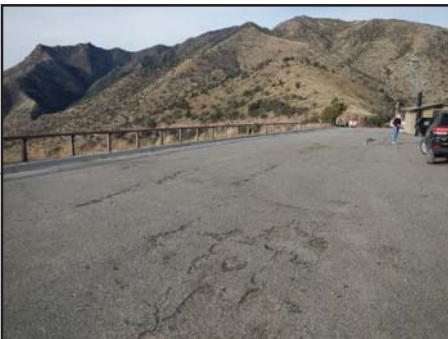
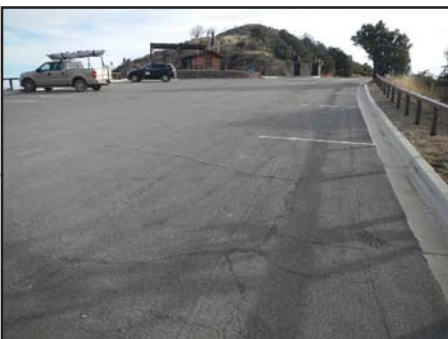
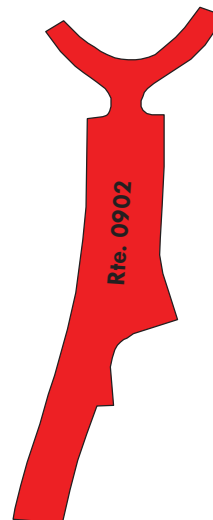
## ROUTE 0902: MONTEZUMA PASS PARKING

Inspection Date	FMSS Number	User Access	Surface Type
1/23/2016	91247	PUBLIC	ASPHALT
Area (Sq. Ft.)	Lane Miles (11' Widths)	Curb Reveal (Inches)	Curb Recommendation
27,095	0.467	6	DO NOTHING
Curb Type		Curb & Gutter Type	
CONCRETE		CONCRETE	
Pavement Recommendation		Condition Rating / PCR	
RECONSTRUCTION		POOR / 30

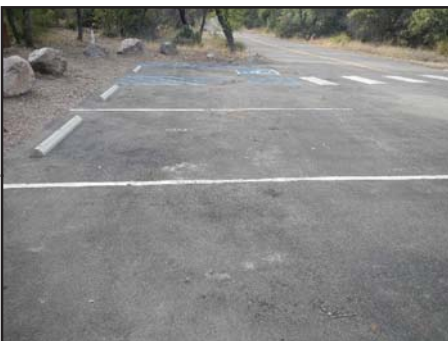
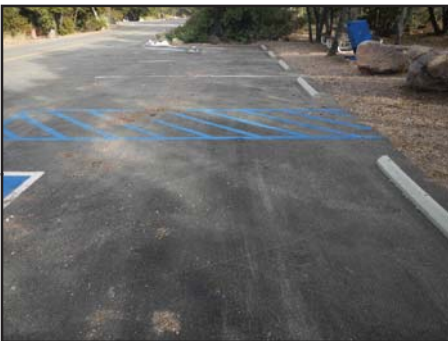
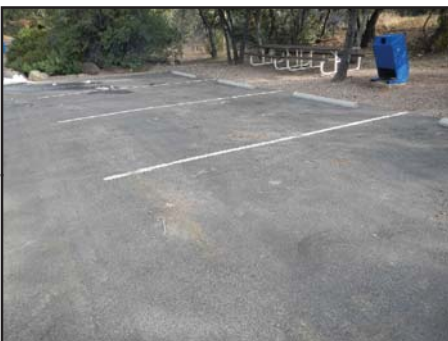
## ROUTE 0903A: PICNIC AREA PARKING A

Inspection Date	FMSS Number	User Access	Surface Type
1/23/2016	91245	PUBLIC	ASPHALT
Area (Sq. Ft.)	Lane Miles (11' Widths)	Curb Reveal (Inches)	Curb Recommendation
1,652	0.028	NOT APPLICABLE	NOT APPLICABLE
Curb Type		Curb & Gutter Type	
NO CURB		NO CURB AND GUTTER	
Pavement Recommendation		Condition Rating / PCR	
PREVENTIVE MAINTENANCE		GOOD / 90

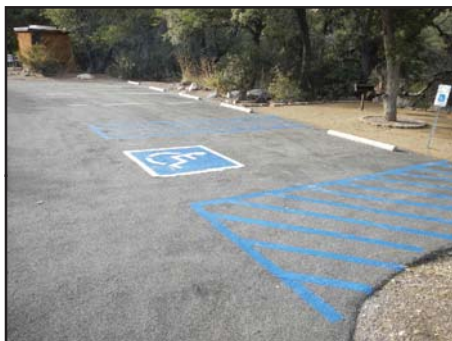
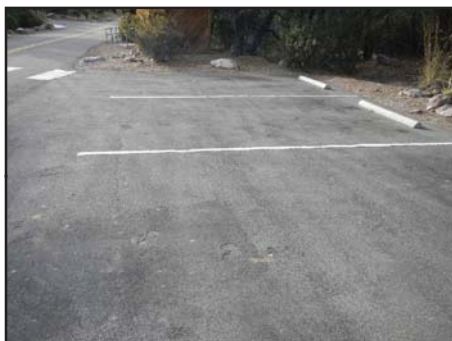
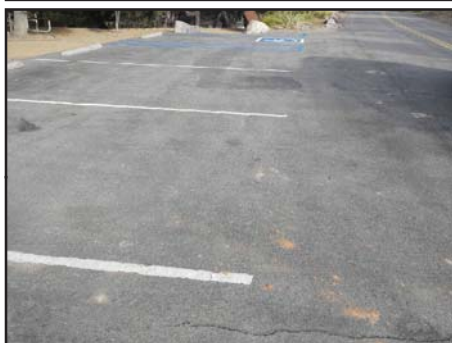
## ROUTE 0903B: PICNIC AREA PARKING B

Inspection Date	FMSS Number	User Access	Surface Type
1/23/2016	103129	PUBLIC	ASPHALT
Area (Sq. Ft.)	Lane Miles (11' Widths)	Curb Reveal (Inches)	Curb Recommendation
1,592	0.027	NOT APPLICABLE	NOT APPLICABLE
Curb Type		Curb & Gutter Type	
NO CURB		NO CURB AND GUTTER	
Pavement Recommendation		Condition Rating / PCR	
PREVENTIVE MAINTENANCE		GOOD / 90

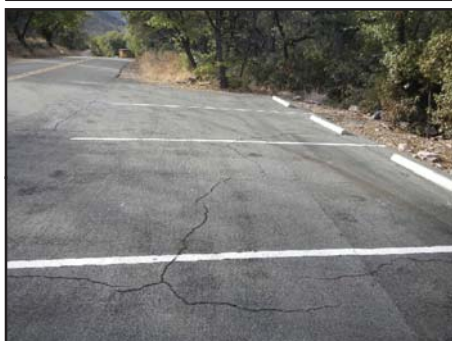
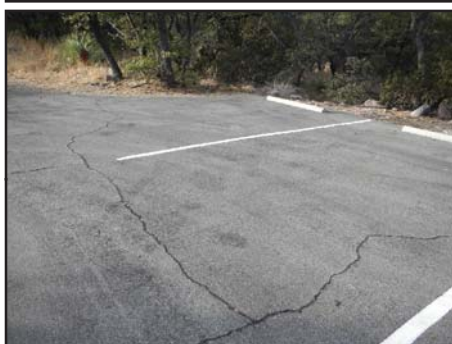
## ROUTE 0903C: PICNIC AREA PARKING C

Inspection Date	FMSS Number	User Access	Surface Type
1/23/2016	103131	PUBLIC	ASPHALT
Area (Sq. Ft.)	Lane Miles (11' Widths)	Curb Reveal (Inches)	Curb Recommendation
1,484	0.026	NOT APPLICABLE	NOT APPLICABLE
Curb Type		Curb & Gutter Type	
NO CURB		NO CURB AND GUTTER	
Pavement Recommendation		Condition Rating / PCR	
PREVENTIVE MAINTENANCE		GOOD / 90

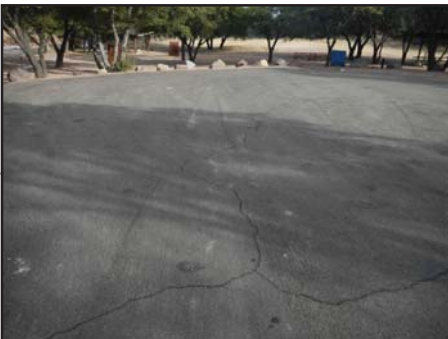
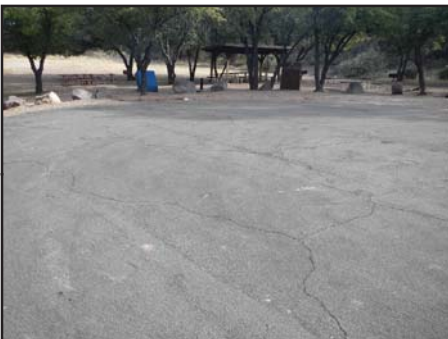
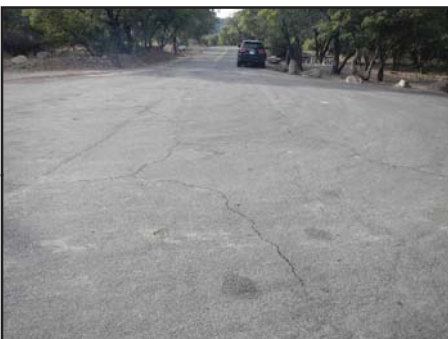
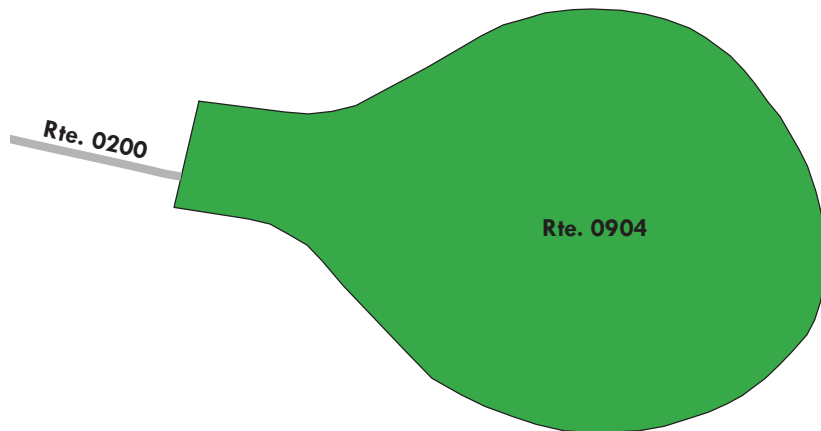
## ROUTE 0904: PICNIC AREA CUL DE SAC PARKING

Inspection Date	FMSS Number	User Access	Surface Type
1/23/2016	91243	PUBLIC	ASPHALT
Area (Sq. Ft.)	Lane Miles (11' Widths)	Curb Reveal (Inches)	Curb Recommendation
3,820	0.066	NOT APPLICABLE	NOT APPLICABLE
Curb Type		Curb & Gutter Type	
NO CURB		NO CURB AND GUTTER	
Pavement Recommendation		Condition Rating / PCR	
PREVENTIVE MAINTENANCE		GOOD / 90

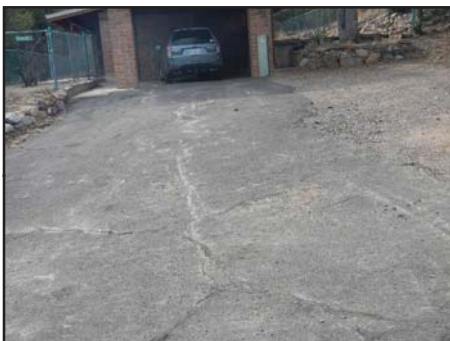
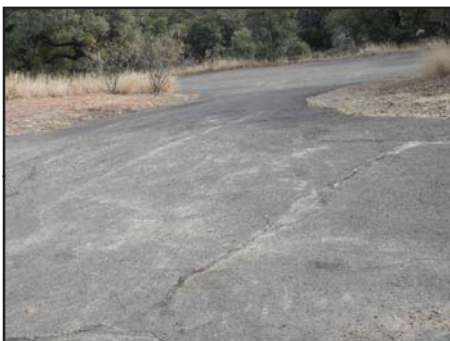
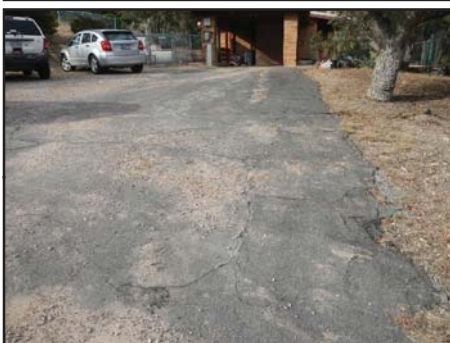
## ROUTE 0906: QUARTERS 1 AND 2 PARKING

Inspection Date	FMSS Number	User Access	Surface Type
1/23/2016	91242	NONPUBLIC	ASPHALT
Area (Sq. Ft.)	Lane Miles (11' Widths)	Curb Reveal (Inches)	Curb Recommendation
2,868	0.049	NOT APPLICABLE	NOT APPLICABLE
Curb Type		Curb & Gutter Type	
NO CURB		NO CURB AND GUTTER	
Pavement Recommendation		Condition Rating / PCR	
HEAVY 3R TREATMENTS		POOR / 53

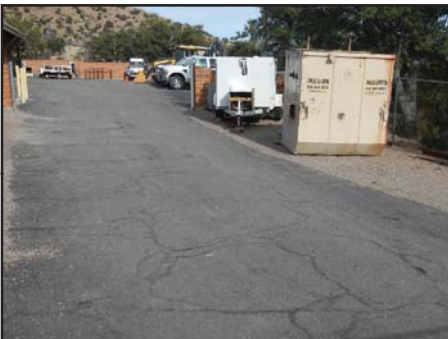
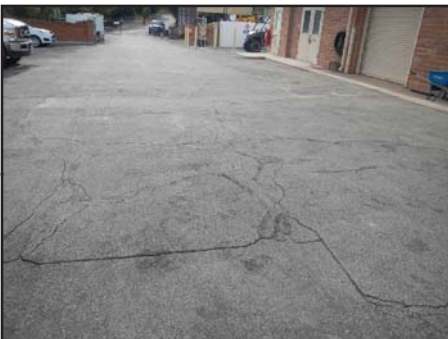
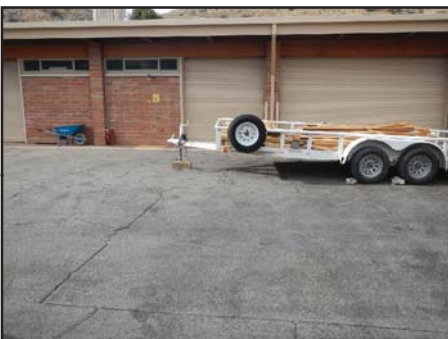
## ROUTE 0907: MAINTENANCE YARD

Inspection Date	FMSS Number	User Access	Surface Type
1/23/2016	91240	NONPUBLIC	ASPHALT
Area (Sq. Ft.)	Lane Miles (11' Widths)	Curb Reveal (Inches)	Curb Recommendation
7,718	0.133	NOT APPLICABLE	NOT APPLICABLE
Curb Type		Curb & Gutter Type	
NO CURB		NO CURB AND GUTTER	
Pavement Recommendation		Condition Rating / PCR	
HEAVY 3R TREATMENTS		POOR / 53

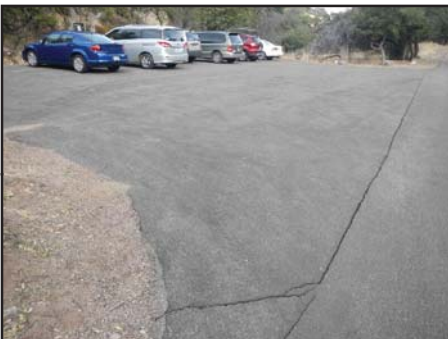
## ROUTE 0908: CAVE TRAIL PARKING

Inspection Date	FMSS Number	User Access	Surface Type
1/23/2016	234755	PUBLIC	ASPHALT
Area (Sq. Ft.)	Lane Miles (11' Widths)	Curb Reveal (Inches)	Curb Recommendation
3,596	0.062	NOT APPLICABLE	NOT APPLICABLE
Curb Type		Curb & Gutter Type	
NO CURB		NO CURB AND GUTTER	
Pavement Recommendation		Condition Rating / PCR	
PREVENTIVE MAINTENANCE		GOOD / 90

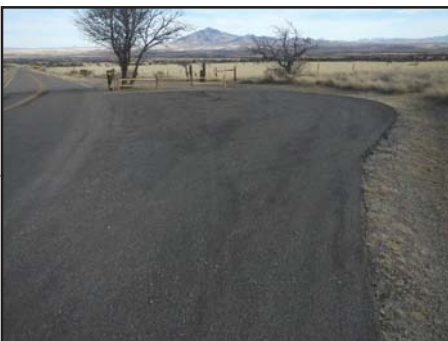
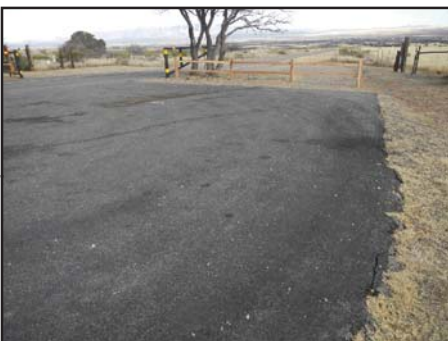
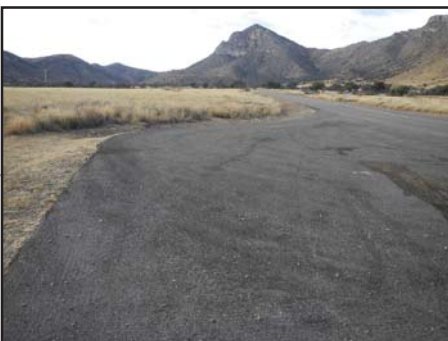
## ROUTE 0909: LAW ENFORCEMENT PARKING

Inspection Date	FMSS Number	User Access	Surface Type
1/23/2016	234756	PUBLIC	ASPHALT
Area (Sq. Ft.)	Lane Miles (11' Widths)	Curb Reveal (Inches)	Curb Recommendation
1,882	0.032	NOT APPLICABLE	NOT APPLICABLE
Curb Type		Curb & Gutter Type	
NO CURB		NO CURB AND GUTTER	
Pavement Recommendation		Condition Rating / PCR	
PREVENTIVE MAINTENANCE		GOOD / 90
