DETO Cycle 6

Road Inventory and Condition Assessment of Paved Routes Devils Tower National Monument

**Federal Lands Highway
Road Inventory Program**

Report Date: January 2018

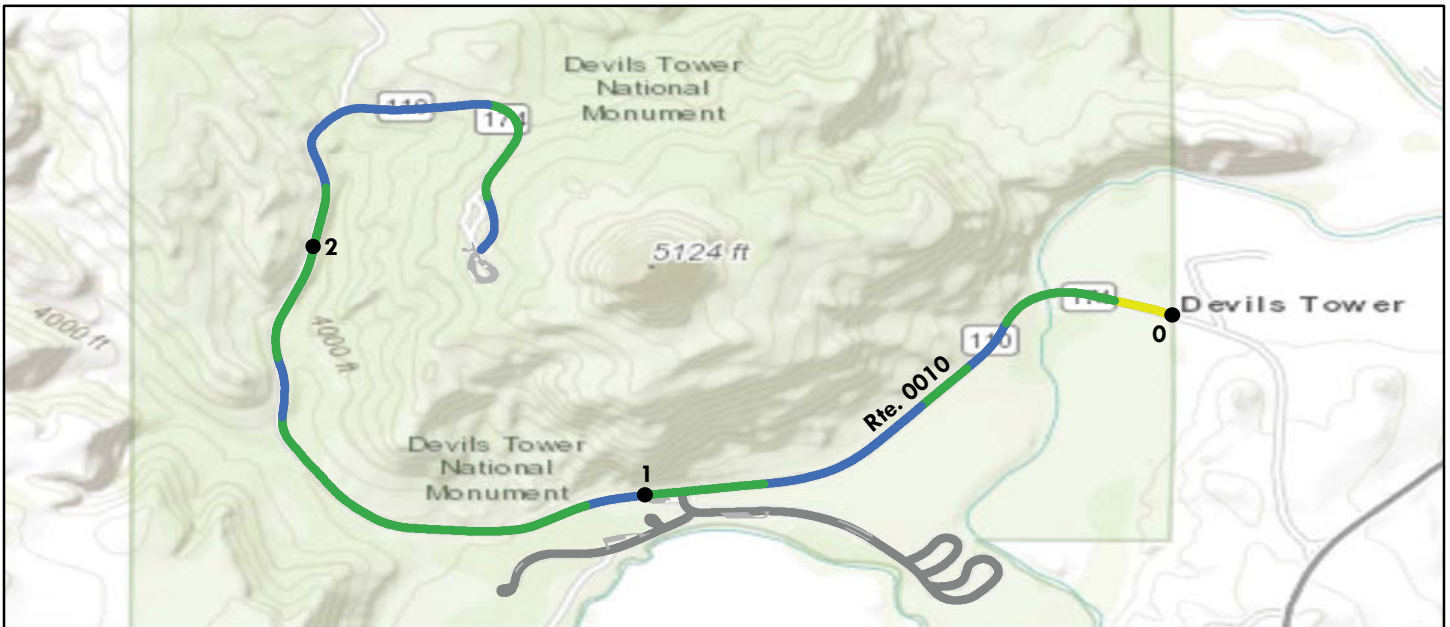
ROUTE 0010: MAIN PARK ROAD

Route Condition Legend – Pavement Condition Rating (PCR)						
Poor (0 - 60)	Fair (61- 84)	Good (85 - 94)	Excellent (95 - 100)	Not Rated		
See Appendix for definitions and formulas						
Inspection Date: 7/20/2017	Beginning Section MP	0	1	2		
Paved Length (Miles): 2.80	Section Length (MI)	1	1	0.8		
Surface Type: ASPHALT	Route Summary					
Roadway Condition Information						
Pavement Condition Rating (PCR)	93	94	92	93		
Surface Condition Rating (SCR)	93	92	93	93		
Roughness Condition Index (RCI)	93	97	90	93		
Distress Index Values						
Structural Crack Index	100	100	100	100		
Alligator Crack Index	100	100	100	100		
Longitudinal Crack Index	100	100	100	100		
Transverse Cracking Index	99	99	99	100		
Patching Index	100	100	100	100		
Rutting Index	93	92	93	93		
International Roughness Index (IRI)	132	122	142	132		
Lane & Width Information						
Number of Lanes	2	2	2	2		
Paved Width (ft)	25.7	30.7	23.2	22.6		
Lane Width (ft)	10	10.3	9.9	9.7

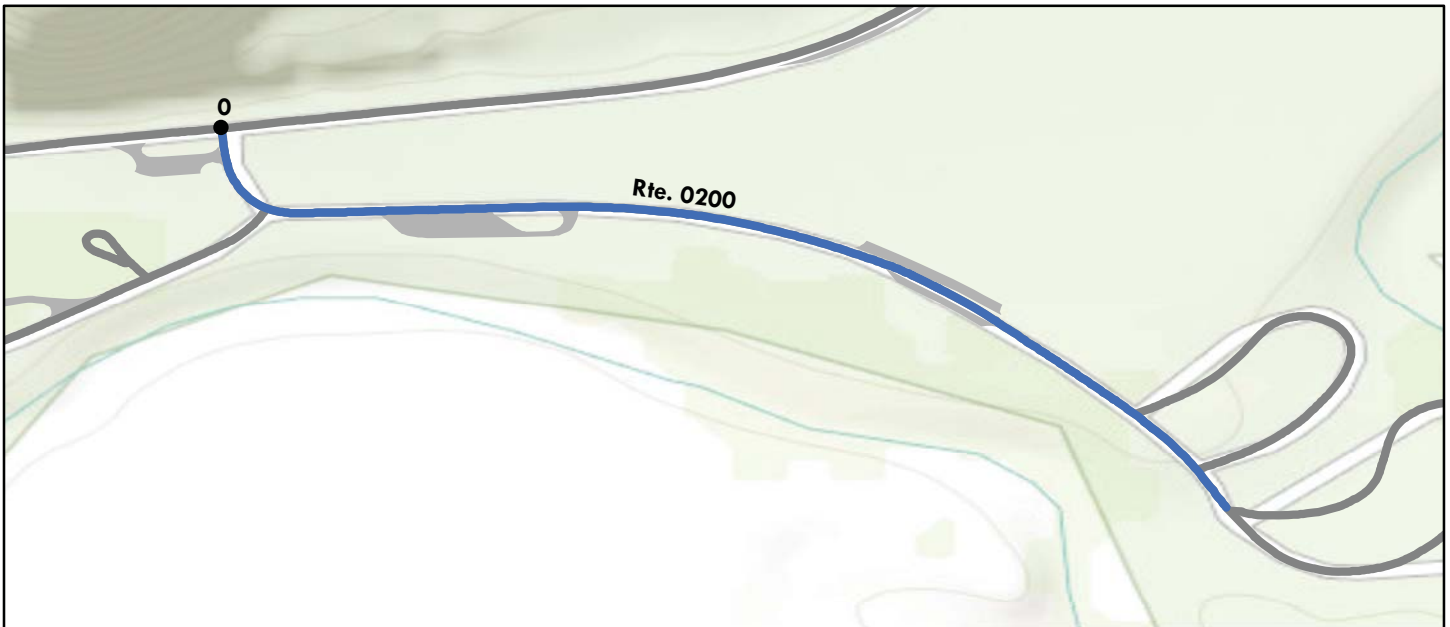
ROUTE 0200: CAMPGROUND ROAD

Route Condition Legend – Pavement Condition Rating (PCR)						
Poor (0 - 60)	Fair (61- 84)	Good (85 - 94)	Excellent (95 - 100)	Not Rated		
See Appendix for definitions and formulas						
Inspection Date: 7/20/2017	Beginning Section MP	0				
Paved Length (Miles): 0.44	Section Length (MI)	0.44				
Surface Type: ASPHALT	Route Summary					
Roadway Condition Information						
Pavement Condition Rating (PCR)	99	99				
Surface Condition Rating (SCR)	99	99				
Roughness Condition Index (RCI)	N/A	N/A				
Distress Index Values						
Structural Crack Index	100	100				
Alligator Crack Index	100	100				
Longitudinal Crack Index	100	100				
Transverse Cracking Index	100	100				
Patching Index	100	100				
Rutting Index	99	99				
International Roughness Index (IRI)	N/A	N/A				
Lane & Width Information						
Number of Lanes	2	2				
Paved Width (ft)	19.2	19.2				
Lane Width (ft)	9.7	9.7

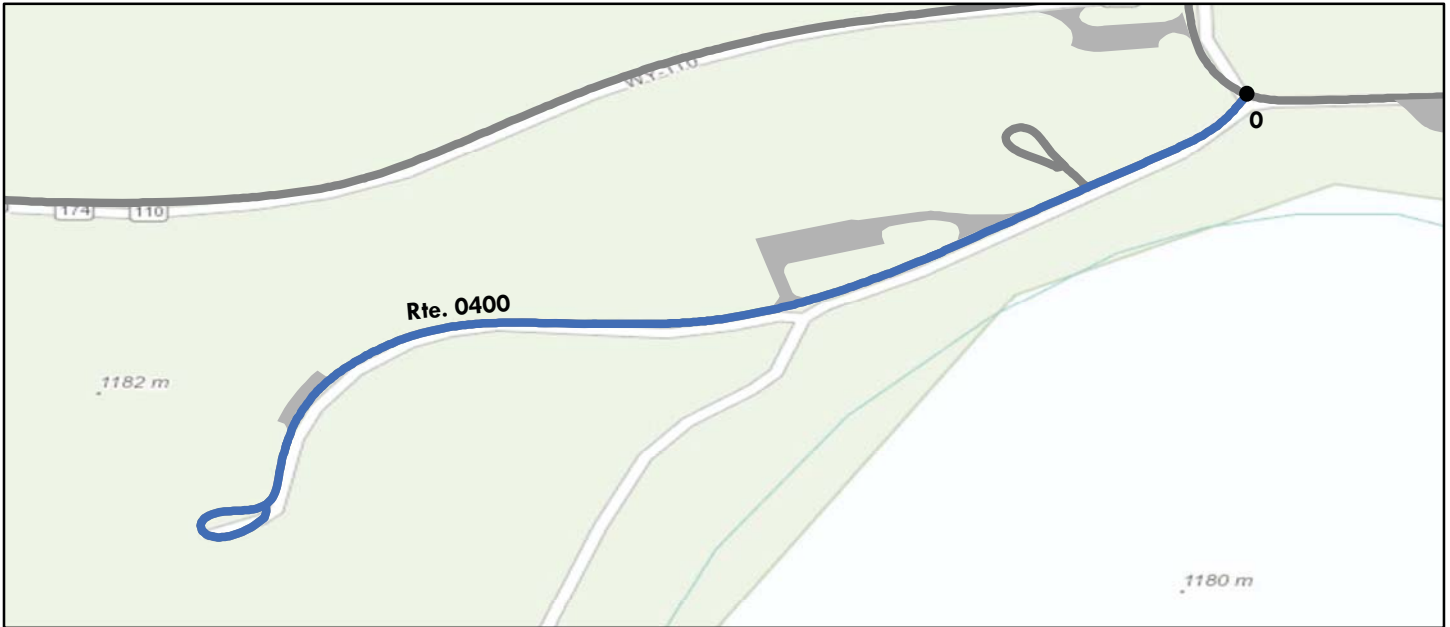
ROUTE 0400: ADMINISTRATION / HOUSING ROAD

Route Condition Legend – Pavement Condition Rating (PCR)						
Poor (0 - 60)	Fair (61- 84)	Good (85 - 94)	Excellent (95 - 100)	Not Rated		
See Appendix for definitions and formulas						
Inspection Date: 7/20/2017	Beginning Section MP	0				
Paved Length (Miles): 0.36	Section Length (MI)	0.36				
Surface Type: ASPHALT	Route Summary					
Roadway Condition Information						
Pavement Condition Rating (PCR)	99	99				
Surface Condition Rating (SCR)	99	99				
Roughness Condition Index (RCI)	N/A	N/A				
Distress Index Values						
Structural Crack Index	100	100				
Alligator Crack Index	100	100				
Longitudinal Crack Index	100	100				
Transverse Cracking Index	99	99				
Patching Index	100	100				
Rutting Index	99	99				
International Roughness Index (IRI)	N/A	N/A				
Lane & Width Information						
Number of Lanes	2	2				
Paved Width (ft)	18.8	18.8				
Lane Width (ft)	9.2	9.2

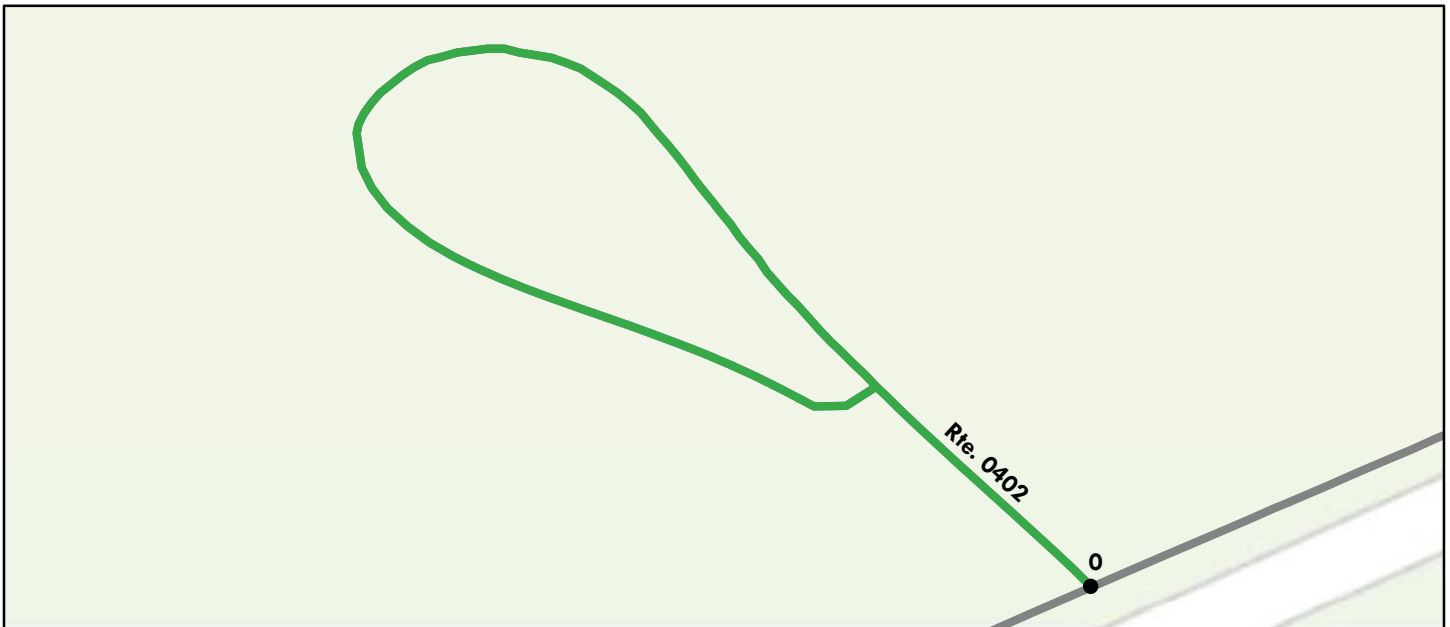
ROUTE 0402: OFFICES B24 DRIVEWAY LOOP

Route Condition Legend – Pavement Condition Rating (PCR)						
Poor (0 - 60)	Fair (61- 84)	Good (85 - 94)	Excellent (95 - 100)	Not Rated		
See Appendix for definitions and formulas						
Inspection Date: 7/20/2017	Beginning Section MP	0				
Paved Length (Miles): 0.05	Section Length (MI)	0.05				
Surface Type: ASPHALT	Route Summary					
Roadway Condition Information						
Pavement Condition Rating (PCR)	94	94				
Surface Condition Rating (SCR)	94	94				
Roughness Condition Index (RCI)	N/A	N/A				
Distress Index Values						
Structural Crack Index	100	100				
Alligator Crack Index	100	100				
Longitudinal Crack Index	100	100				
Transverse Cracking Index	99	99				
Patching Index	100	100				
Rutting Index	94	94				
International Roughness Index (IRI)	N/A	N/A				
Lane & Width Information						
Number of Lanes	2	2				
Paved Width (ft)	17.5	17.5				
Lane Width (ft)	8.8	8.8

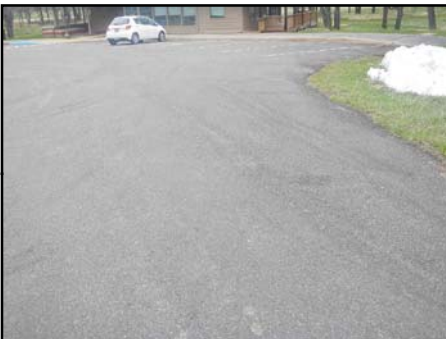
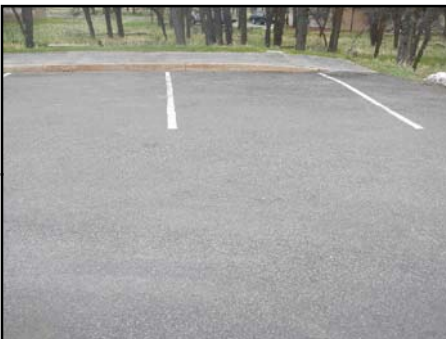
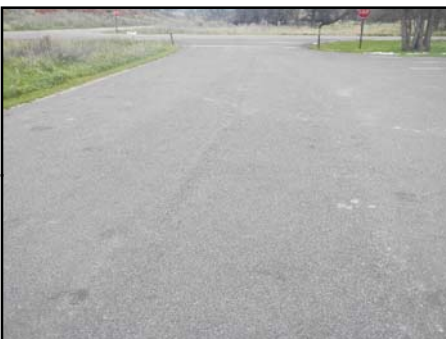
ROUTE 0901: ADMINISTRATIVE OFFICE PARKING LOT

Inspection Date	FMSS Number	User Access	Surface Type
4/28/2017	89751	PUBLIC	ASPHALT
Area (Sq. Ft.)	Lane Miles (11' Widths)	Curb Reveal (Inches)	Curb Recommendation
8,487	0.146	6	DO NOTHING
Curb Type		Curb & Gutter Type	
CONCRETE		NO CURB AND GUTTER	
Pavement Recommendation		Condition Rating / PCR	
PREVENTIVE MAINTENANCE		GOOD / 90

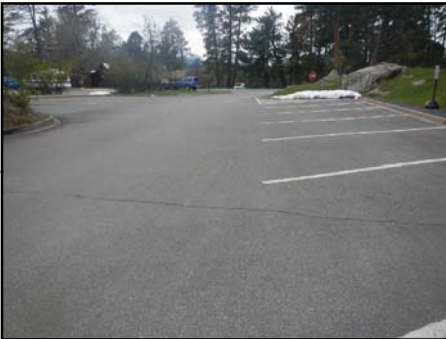
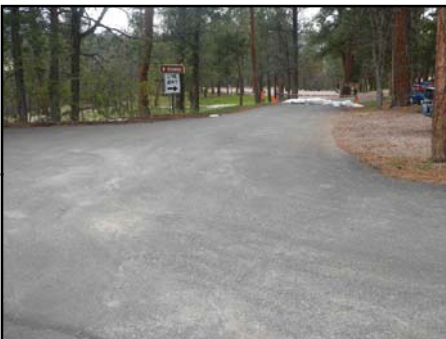
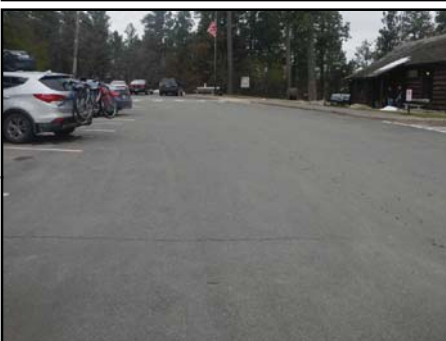
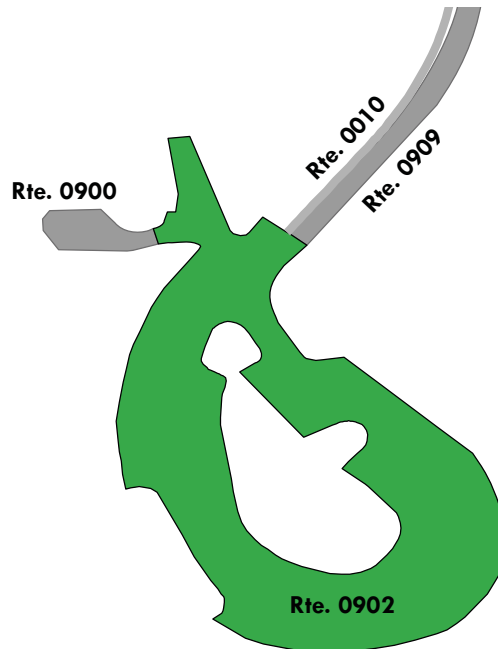
ROUTE 0902: VISITOR CENTER PARKING

Inspection Date	FMSS Number	User Access	Surface Type
4/28/2017	63125	PUBLIC	ASPHALT
Area (Sq. Ft.)	Lane Miles (11' Widths)	Curb Reveal (Inches)	Curb Recommendation
42,381	0.73	NOT APPLICABLE	DO NOTHING
Curb Type		Curb & Gutter Type	
NO CURB		CONCRETE	
Pavement Recommendation		Condition Rating / PCR	
PREVENTIVE MAINTENANCE		GOOD / 90

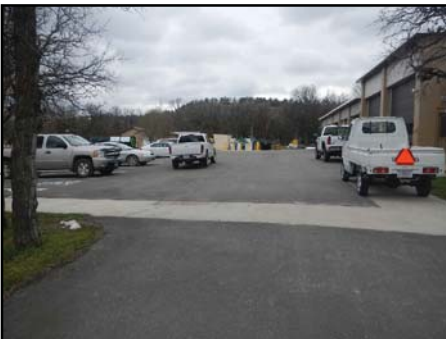
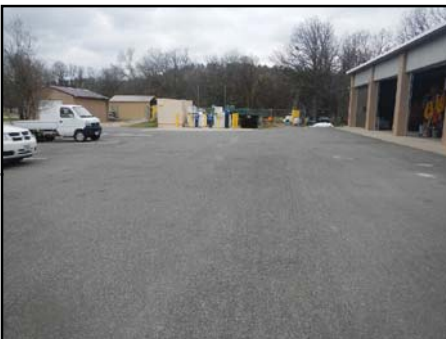
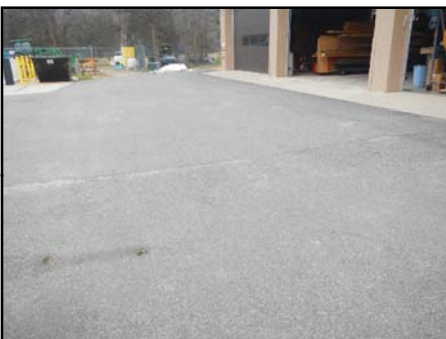
ROUTE 0905: MAINTENANCE SHOP PARKING LOT

Inspection Date	FMSS Number	User Access	Surface Type
4/28/2017	89769	NONPUBLIC	ASPHALT
Area (Sq. Ft.)	Lane Miles (11' Widths)	Curb Reveal (Inches)	Curb Recommendation
15,816	0.272	5	DO NOTHING
Curb Type		Curb & Gutter Type	
CONCRETE		NO CURB AND GUTTER	
Pavement Recommendation		Condition Rating / PCR	
PREVENTIVE MAINTENANCE		GOOD / 90

Note: Parking area consists of multiple surface types: 1 part Asphalt at 15,322 square feet; 1 part Concrete at 494 square feet.

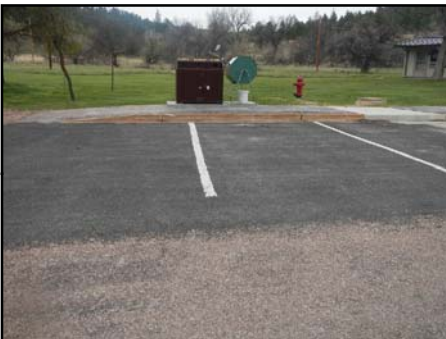
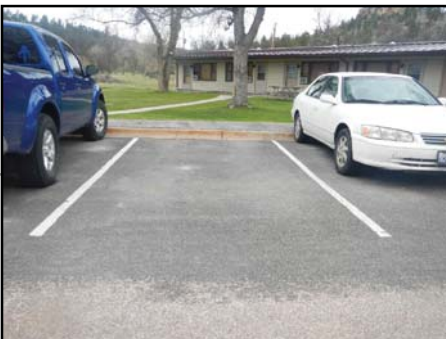
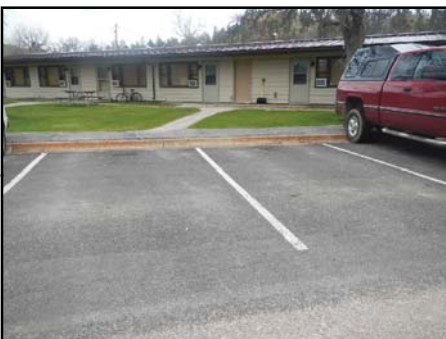
ROUTE 0906: SEASONAL RESIDENCE PARKING

Inspection Date	FMSS Number	User Access	Surface Type
4/28/2017	89770	NONPUBLIC	ASPHALT
Area (Sq. Ft.)	Lane Miles (11' Widths)	Curb Reveal (Inches)	Curb Recommendation
2,110	0.036	NOT APPLICABLE	DO NOTHING
Curb Type		Curb & Gutter Type	
NO CURB		CONCRETE	
Pavement Recommendation		Condition Rating / PCR	
PREVENTIVE MAINTENANCE		GOOD / 90

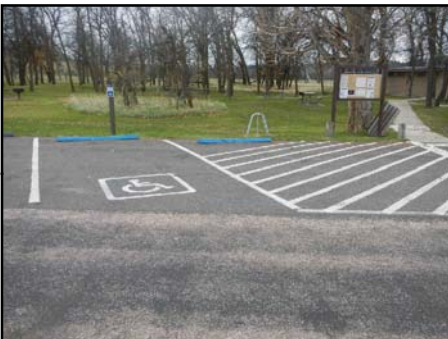
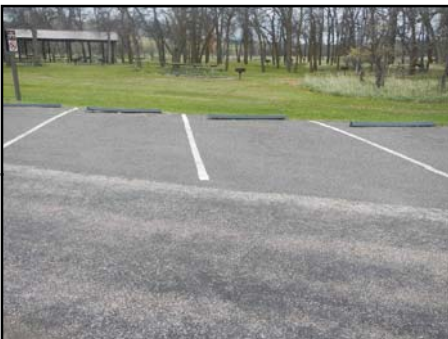
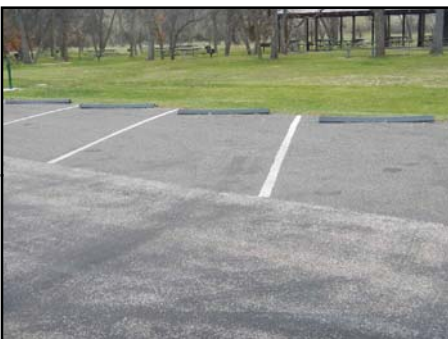
ROUTE 0907A: PICNIC GROUNDS PARKING LOT A

Inspection Date	FMSS Number	User Access	Surface Type
4/28/2017	89772	PUBLIC	ASPHALT
Area (Sq. Ft.)	Lane Miles (11' Widths)	Curb Reveal (Inches)	Curb Recommendation
3,643	0.063	NOT APPLICABLE	NOT APPLICABLE
Curb Type		Curb & Gutter Type	
NO CURB		NO CURB AND GUTTER	
Pavement Recommendation		Condition Rating / PCR	
PREVENTIVE MAINTENANCE		GOOD / 90

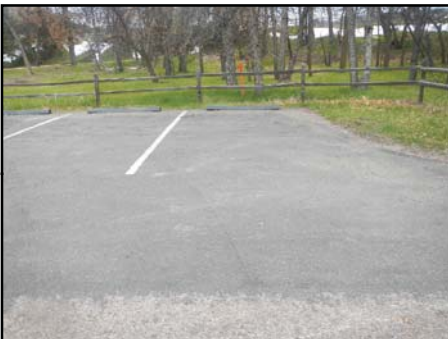
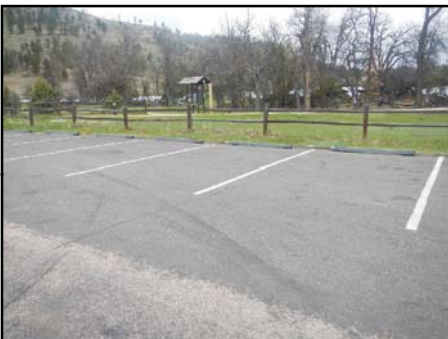
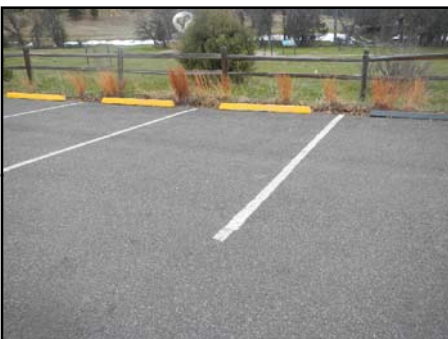
ROUTE 0907B: PICNIC GROUNDS PARKING LOT B

Inspection Date	FMSS Number	User Access	Surface Type
4/28/2017	89773	PUBLIC	ASPHALT
Area (Sq. Ft.)	Lane Miles (11' Widths)	Curb Reveal (Inches)	Curb Recommendation
7,151	0.123	NOT APPLICABLE	NOT APPLICABLE
Curb Type		Curb & Gutter Type	
NO CURB		NO CURB AND GUTTER	
Pavement Recommendation		Condition Rating / PCR	
PREVENTIVE MAINTENANCE		GOOD / 90

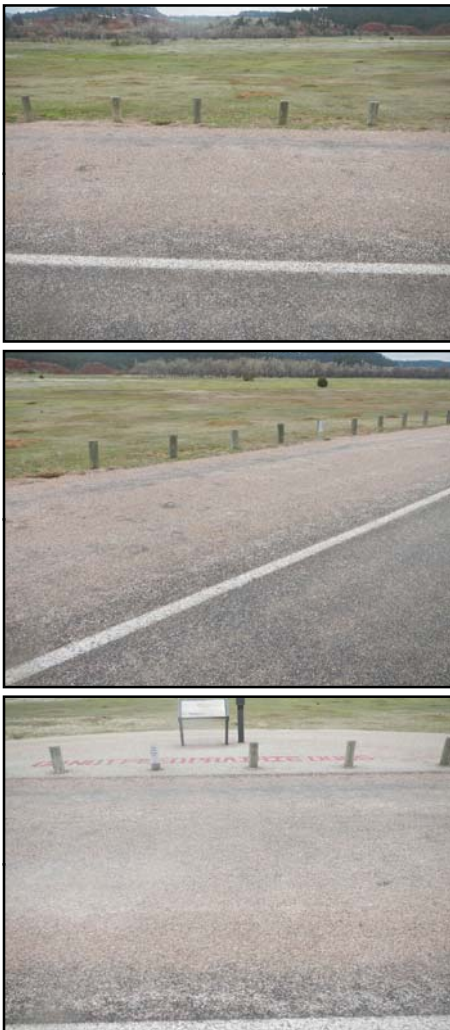
ROUTE 0908A: PRAIRIE DOG PULLOUT PARKING A

Inspection Date	FMSS Number	User Access	Surface Type
4/28/2017	90338	PUBLIC	ASPHALT
Area (Sq. Ft.)	Lane Miles (11' Widths)	Curb Reveal (Inches)	Curb Recommendation
3,596	0.062	NOT APPLICABLE	NOT APPLICABLE
Curb Type		Curb & Gutter Type	
NO CURB		NO CURB AND GUTTER	
Pavement Recommendation		Condition Rating / PCR	
PREVENTIVE MAINTENANCE		GOOD / 90

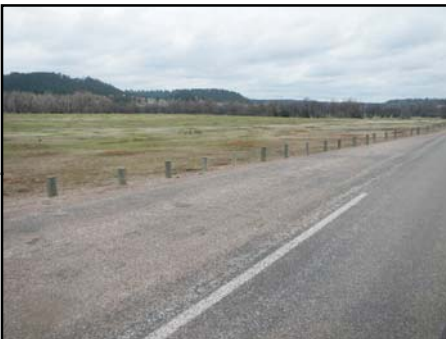
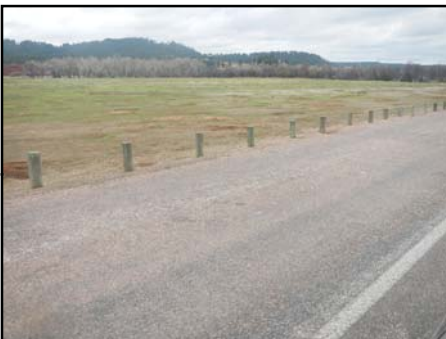
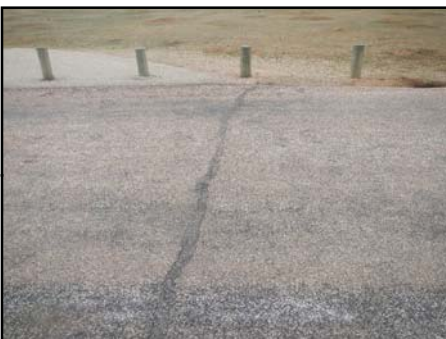
ROUTE 0908B: PRAIRIE DOG PULLOUT PARKING B

Inspection Date	FMSS Number	User Access	Surface Type
4/28/2017	90342	PUBLIC	ASPHALT
Area (Sq. Ft.)	Lane Miles (11' Widths)	Curb Reveal (Inches)	Curb Recommendation
5,019	0.086	NOT APPLICABLE	NOT APPLICABLE
Curb Type		Curb & Gutter Type	
NO CURB		NO CURB AND GUTTER	
Pavement Recommendation		Condition Rating / PCR	
PREVENTIVE MAINTENANCE		GOOD / 90

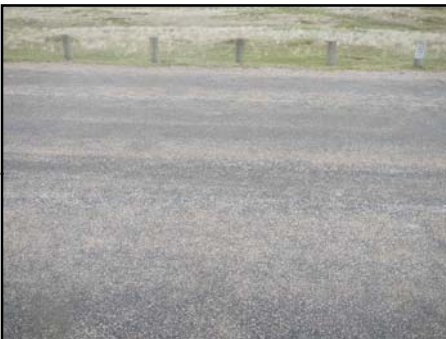
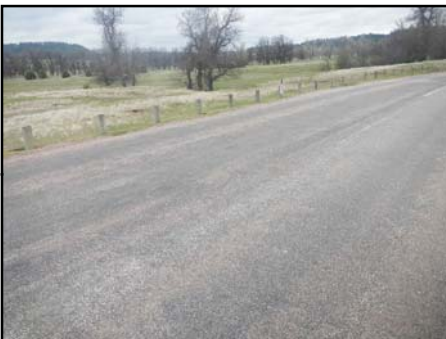
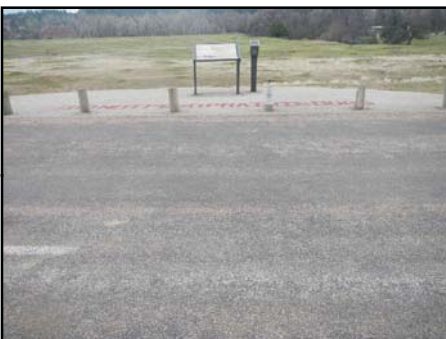
ROUTE 0908C: PRAIRIE DOG PULLOUT PARKING C

Inspection Date	FMSS Number	User Access	Surface Type
4/28/2017	90343	PUBLIC	ASPHALT
Area (Sq. Ft.)	Lane Miles (11' Widths)	Curb Reveal (Inches)	Curb Recommendation
4,005	0.069	NOT APPLICABLE	NOT APPLICABLE
Curb Type		Curb & Gutter Type	
NO CURB		NO CURB AND GUTTER	
Pavement Recommendation		Condition Rating / PCR	
PREVENTIVE MAINTENANCE		GOOD / 90

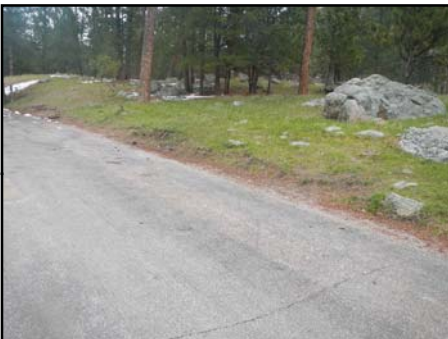
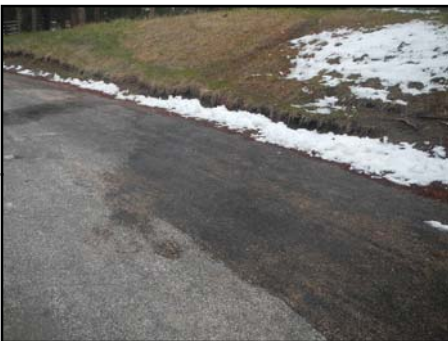
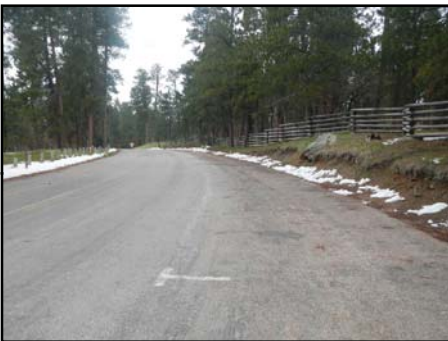
ROUTE 0909: VISITOR CENTER LONG RV PARKING

Inspection Date	FMSS Number	User Access	Surface Type
4/28/2017	90333	PUBLIC	ASPHALT
Area (Sq. Ft.)	Lane Miles (11' Widths)	Curb Reveal (Inches)	Curb Recommendation
6,779	0.117	NOT APPLICABLE	NOT APPLICABLE
Curb Type		Curb & Gutter Type	
NO CURB		NO CURB AND GUTTER	
Pavement Recommendation		Condition Rating / PCR	
PREVENTIVE MAINTENANCE		GOOD / 90

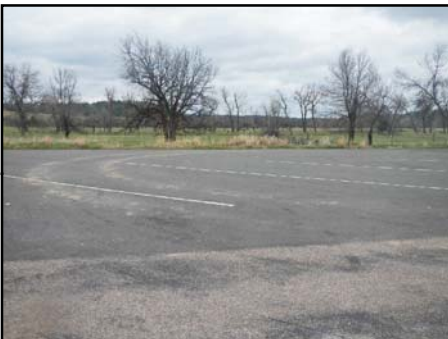
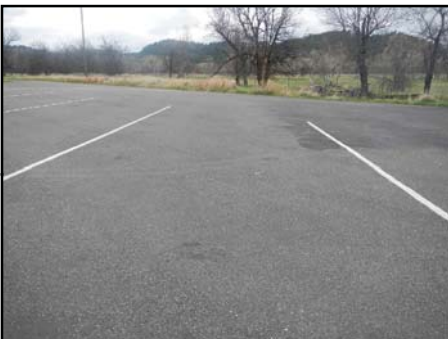
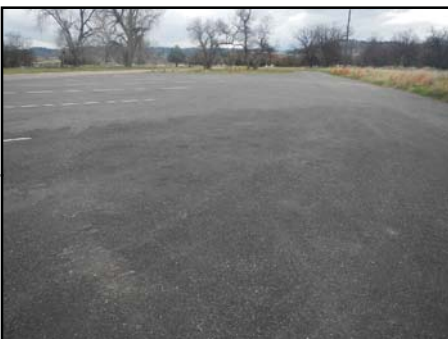
ROUTE 0910: LOWER LONG VEHICLE / OVERFLOW PARKING LOT

Inspection Date	FMSS Number	User Access	Surface Type
4/28/2017	225745	PUBLIC	ASPHALT
Area (Sq. Ft.)	Lane Miles (11' Widths)	Curb Reveal (Inches)	Curb Recommendation
17,860	0.308	NOT APPLICABLE	NOT APPLICABLE
Curb Type		Curb & Gutter Type	
NO CURB		NO CURB AND GUTTER	
Pavement Recommendation		Condition Rating / PCR	
PREVENTIVE MAINTENANCE		GOOD / 90
