DEVA Cycle 6

Final Report

Road Inventory and Condition Assessment of Paved Routes Death Valley National Park

Federal Highway Administration Eastern Federal Lands Highway Division Road Inventory Program (RIP)

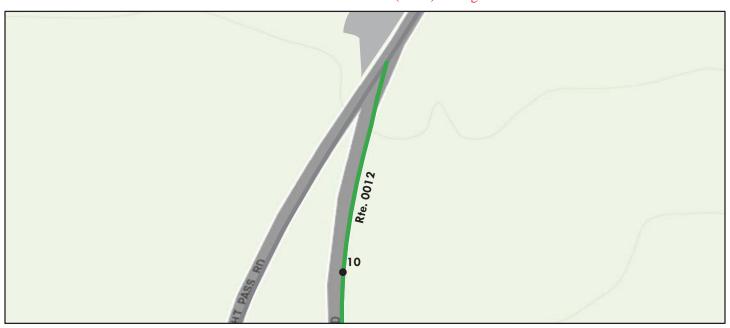
ROUTE 0012: BEATTY CUTOFF ROAD

Roy	te Condition Legend – Pav	ement Cond	ition Rating (PCR)	
		(85 - 94)	Excellent (95 - 100)	Not Rated
- C - 10)	See Appendix for det			
Inspection Date: 3/9/2015	Beginning Section MP			
Paved Length (Miles): 10.07	Section Length (MI)	0.07		
Surface Type: ASPHALT	Route Summary		1	
Roadway Condition Information				
Pavement Condition Rating (PCR)	84	88		
Surface Condition Rating (SCR)	91	96		
Roughness Condition Index (RCI)	74	75		
Distress Index Values				
Structural Crack Index	100	100		
Alligator Crack Index	100	100		
Longitudinal Crack Index	100	100		
Transverse Cracking Index	100	100		
Patching Index	100	100		
Rutting Index	91	96		
International Roughness Index (IRI)	187	186		
Lane & Width Information				
Number of Lanes	2	2		
Paved Width (ft)	20	24.2		
Lane Width (ft)	9.5	10.3

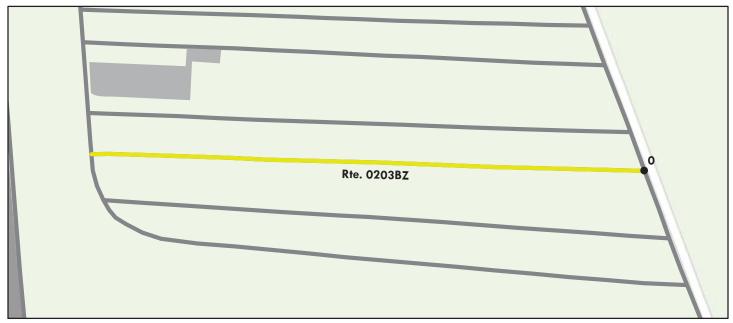
ROUTE 0203BZ: SUNSET CAMPGROUND ROAD B

Route (Condition Legend – Pav	ement Condi	ition Rating (PCR)		
Poor (0 - 60)	Fair (6		(85 - 94)	Excellent (9		Not Ra	ted
		See Appendix for def	,		· ·		
Inspection Date:	3/11/2015	Beginning Section MP	0				
Paved Length (Miles):	0.14	Section Length (MI)	0.14				
Surface Type:	ASPHALT	Route Summary					
Roadway Condition In	formation						
Pavement Condition R	Cating (PCR)	71	71				
Surface Condition Ratir	ng (SCR)	71	71				
Roughness Condition Ir	ndex (RCI)	N/A	N/A				
Distress Index Values							
Structural Crack Index		71	71				
Alligator Crack Index		100	100				
Longitudinal Crack In-	dex	71	71				
Transverse Cracking In	ndex	72	72				
Patching Index		99	99				
Rutting Index		95	95				
International Roughne	ss Index (IRI)	N/A	N/A				
Lane & Width Informa	ation						
Number of Lanes		2	2				
Paved Width (ft)		17.3	17.3				
Lane Width (ft)		8.7	8.7

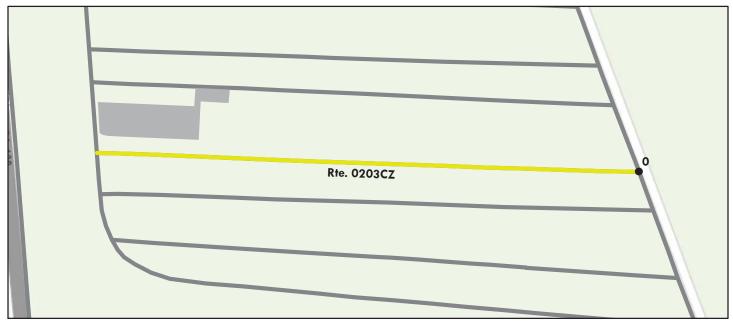
ROUTE 0203CZ: SUNSET CAMPGROUND ROAD C

Route (Condition Legend – Pav	ement Condi	ition Rating (PCR)		
Poor (0 - 60)	_		(85 - 94)	Excellent (9		Not Ra	ted
		See Appendix for def	,		,		
Inspection Date:	3/11/2015	Beginning Section MP	0				
Paved Length (Miles)): 0.14	Section Length (MI)	0.14				
Surface Type:	ASPHALT	Route Summary				•	
Roadway Condition	Information						
Pavement Condition	Rating (PCR)	75	75				
Surface Condition Rat	ting (SCR)	75	75				
Roughness Condition	Index (RCI)	N/A	N/A				
Distress Index Values	8						
Structural Crack Inde	ex	76	76				
Alligator Crack Inde	X	100	100				
Longitudinal Crack 1	Index	76	76				
Transverse Cracking	Index	75	75				
Patching Index		100	100				
Rutting Index		94	94				
International Roughr	ness Index (IRI)	N/A	N/A				
Lane & Width Infori	mation						
Number of Lanes		1	1				
Paved Width (ft)		18.8	18.8				
Lane Width (ft)		18.8	18.8

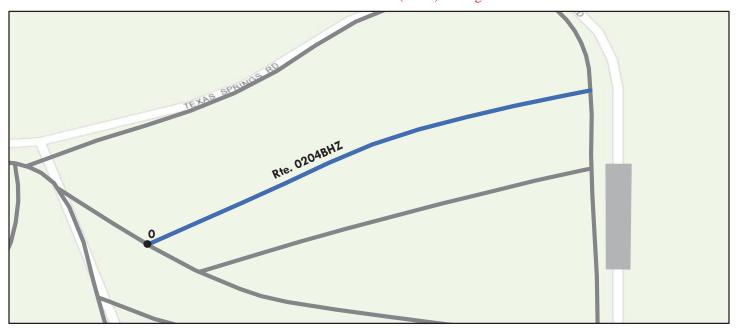
ROUTE 0204BHZ: TEXAS SPRING CAMPGROUND LOOP H

Route (Condition Legend – Pav	ement Condi	ition Rating (PCR)		
Poor (0 - 60	_		(85 - 94)	Excellent (9		Not Ra	ted
,		See Appendix for def	,		· ·		
Inspection Date:	3/11/2015	Beginning Section MP	0				
Paved Length (Mile	s): 0.09	Section Length (MI)	0.09				
Surface Type:	ASPHALT	Route Summary					
Roadway Condition	Information						
Pavement Condition	n Rating (PCR)	99	99				
Surface Condition R	ating (SCR)	99	99				
Roughness Condition	n Index (RCI)	N/A	N/A				
Distress Index Value	es						
Structural Crack Inc	dex	99	99				
Alligator Crack Ind	ex	100	100				
Longitudinal Crack	Index	99	99				
Transverse Crackin	g Index	100	100				
Patching Index		100	100				
Rutting Index		99	99				
International Rough	nness Index (IRI)	N/A	N/A				
Lane & Width Info	rmation						
Number of Lanes		2	2				
Paved Width (ft)		20.4	20.4				
Lane Width (ft)		10.2	10.2

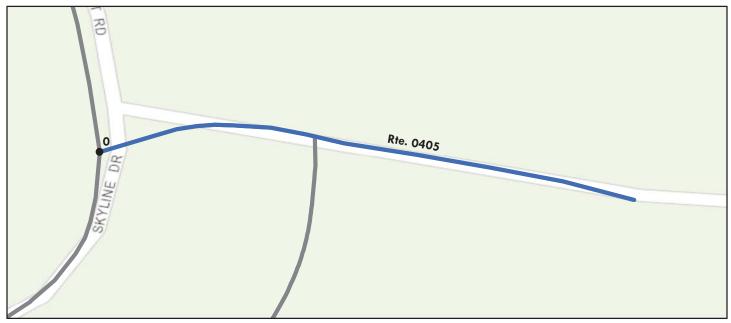
ROUTE 0405: NEVARES ROAD

Ro	ute Condition Legend – Pav	ement Cond	ition Rating (PCR)	
		(85 - 94)	Excellent (95 - 100)	Not Rated
1 301 (8 33)	See Appendix for def			2100 21000
Inspection Date: 3/12/2015	Beginning Section MP		T	
Paved Length (Miles): 0.07	Section Length (MI)	0.07		
Surface Type: ASPHALT	Route Summary			l l
Roadway Condition Information				
Pavement Condition Rating (PCR)	95	95		
Surface Condition Rating (SCR)	95	95		
Roughness Condition Index (RCI)	N/A	N/A		
Distress Index Values				
Structural Crack Index	100	100		
Alligator Crack Index	100	100		
Longitudinal Crack Index	100	100		
Transverse Cracking Index	100	100		
Patching Index	100	100		
Rutting Index	95	95		
International Roughness Index (IRI)	N/A	N/A		
Lane & Width Information				
Number of Lanes	2	2		
Paved Width (ft)	22.6	22.6		
Lane Width (ft)	11.3	11.3

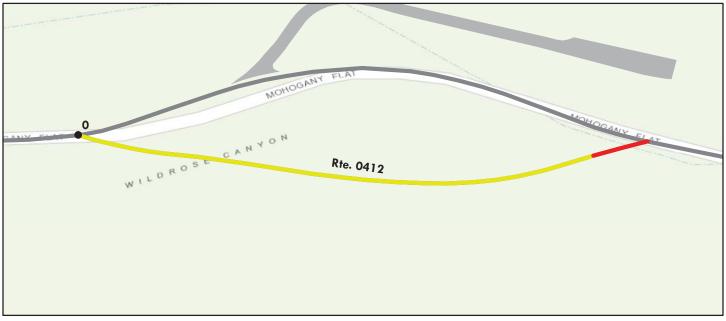
ROUTE 0412: WILDROSE RESIDENCE ROAD

Route (Condition Legend – Pav	ement Condi	ition Rating (P	PCR)		
Poor (0 - 60			(85 - 94)	Excellent (9:		Not Rat	ted
		See Appendix for def	1				
Inspection Date:	3/11/2015	Beginning Section MP	0				
Paved Length (Mile	s): 0.11	Section Length (MI)	0.11				
Surface Type:	ASPHALT	Route Summary					
Roadway Condition	Information						
Pavement Condition	n Rating (PCR)	74	74				
Surface Condition Ra	ating (SCR)	74	74				
Roughness Condition	n Index (RCI)	N/A	N/A				
Distress Index Value	es						
Structural Crack Inc	dex	88	88				
Alligator Crack Ind	ex	100	100				
Longitudinal Crack	Index	88	88				
Transverse Cracking	g Index	74	74				
Patching Index		94	94				
Rutting Index		87	87				
International Rough	nness Index (IRI)	N/A	N/A				
Lane & Width Infor	rmation						
Number of Lanes		1	1				
Paved Width (ft)		14.2	14.2				
Lane Width (ft)		14.2	14.2	1

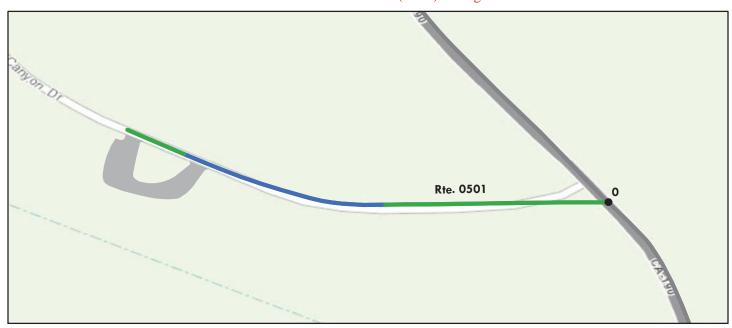
ROUTE 0501: HARMONY BORAX WORKS ROAD

Route Condition Legend – Pavement Condition Rating (PCR)						
Poor (0 - 60	_		(85 - 94)	Excellent (9		Not Ra	ted
,		See Appendix for def	,				
Inspection Date:	3/11/2015	Beginning Section MP	0				
Paved Length (Mile	es): 0.23	Section Length (MI)	0.23				
Surface Type:	ASPHALT	Route Summary					
Roadway Condition	Information						
Pavement Condition	n Rating (PCR)	92	92				
Surface Condition R	ating (SCR)	92	92				
Roughness Condition	n Index (RCI)	N/A	N/A				
Distress Index Value	es						
Structural Crack Inc	dex	99	99				
Alligator Crack Ind	lex	100	100				
Longitudinal Crack	Index	99	99				
Transverse Crackin	g Index	98	98				
Patching Index		100	100				
Rutting Index		92	92				
International Rough	nness Index (IRI)	N/A	N/A				
Lane & Width Info	rmation						
Number of Lanes		2	2				
Paved Width (ft)		19.9	19.9				
Lane Width (ft)		10.1	10.1

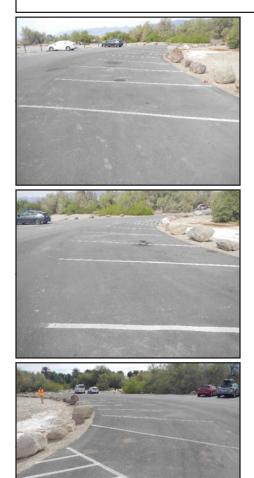
$ADJACENT\ TO\ ROUTE\ 0201DZ\ (FURNACE\ CREEK\ CAMPGROUND\ LOOP\ D\ (WALK-IN\ SITES))$ AT MP 0.11 ON LEFT

Inspection Date	FMSS Number	User Access	Surface Type
3/10/2015	245459	PUBLIC	ASPHALT
Area (Sq. Ft.)	Lane Miles (11' Widths)	Curb Reveal (Inches)	Curb Recommendation
2,857	0.049	NOT APPLICABLE	NOT APPLICABLE
Curb Type Curb & Gutter T		utter Type	
NO CURB		NO CURB AND GUTTER	
Pavement Recommendation Condition Rating / PCR		ating / PCR	
PREVENTIVE N	PREVENTIVE MAINTENANCE GOOD / 90		0 / 90
Route Condition Legend – Pavement Condition Rating (PCR)			
Poor (0 - 60)	Fair (61- 84) Good ((85 - 94) Excellent (95 - 10	0) Not Rated
See Appendix for definitions and formulas
